LOCKS NO. 27 MISSISSIPPI RIVER
FAILURE OF MAIN LOCK MITER GATE DIAGONAL TENSION RODS
DAILY STATUS REPORT

AUGUST 1, 2004

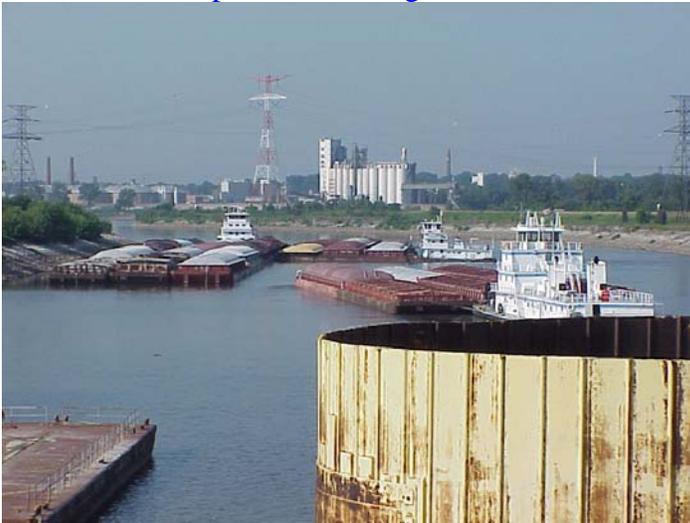
A Northbound tow is used as a landing area for remaking the tow of the southbound locked tow. Helper boat holding 1st cut. 2nd cut of locked tow in route.

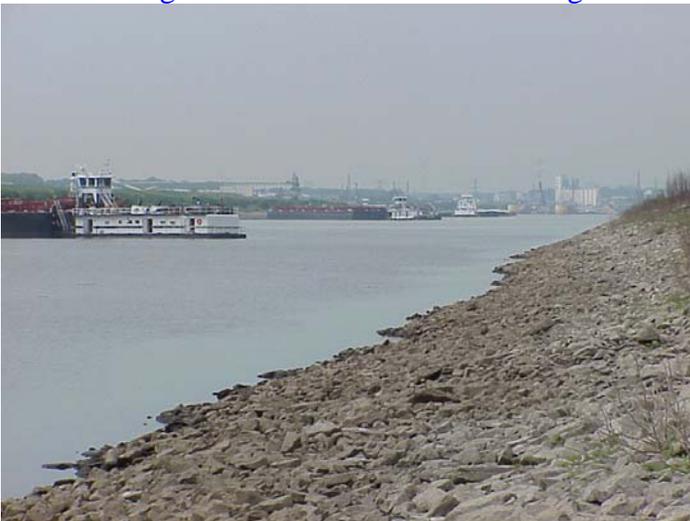
Tows waiting in canal for Southbound lockage.

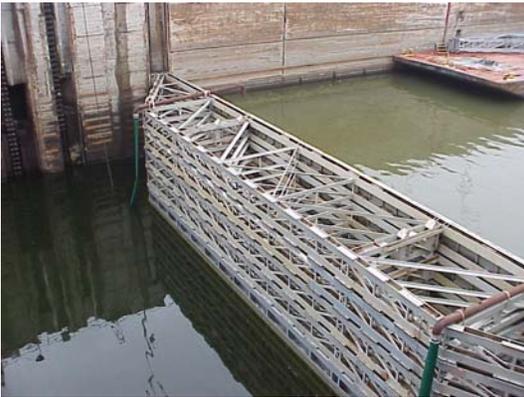
All bulkheads were installed. Pumping began, but bulkhead seal is poor. Chamber level still at tail water elevation. Installing additional pumps to increase head differential to create better seal on bulkheads.

Dewatering is anticipated to start on 8/1 and take 48 to 60 hours to reach minimum water levels inside the lock chamber.
