**US Army Corps  
of Engineers,**  
St. Louis District

# **Archaeological Research Collections Center Evaluations for the U.S. Department of Interior Bureau of Reclamation Great Plains Region**

## **Final**

**March 2004**

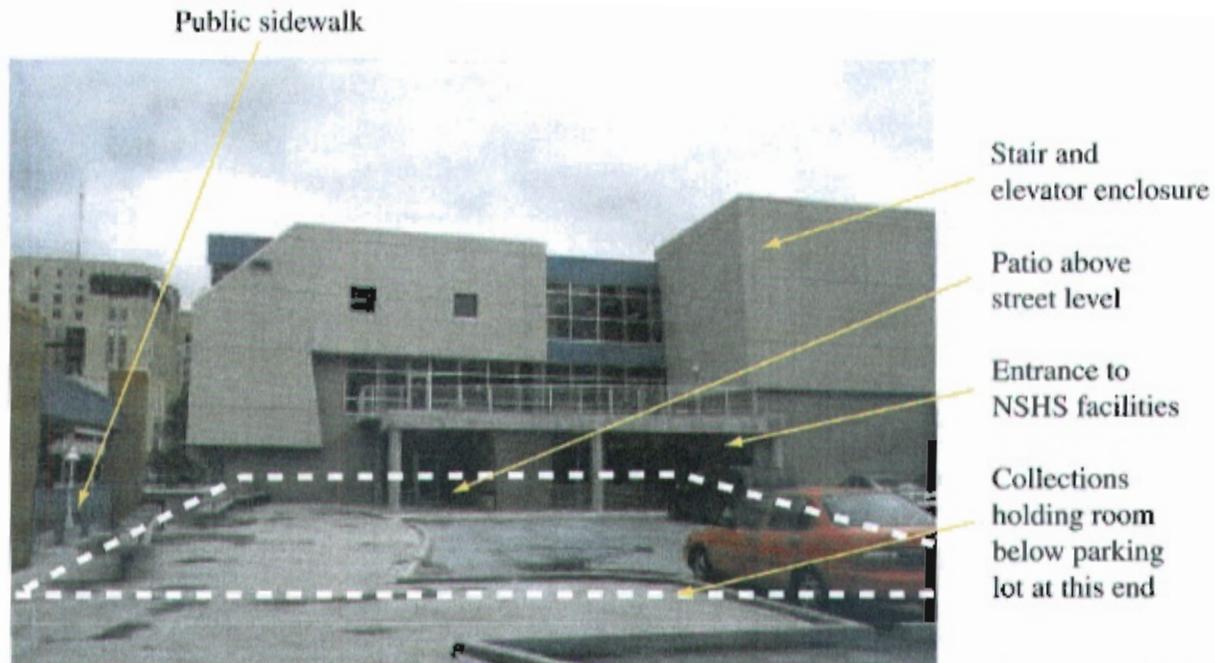
**Figure 3. West side of the Children's Museum building showing the raised patio, parking lot, and the entrance to the NSHS facilities. The nearest public sidewalk is to the left. Accessible access (to the NSHS facility) is achieved by using the parking lot, then maneuvering to the building entrance, located behind the dark colored van.**

that enter and pass through the basement en route to the city storm drain system. Maintaining a dry environment in the storage room requires regular maintenance staff attention to the pipe joints.

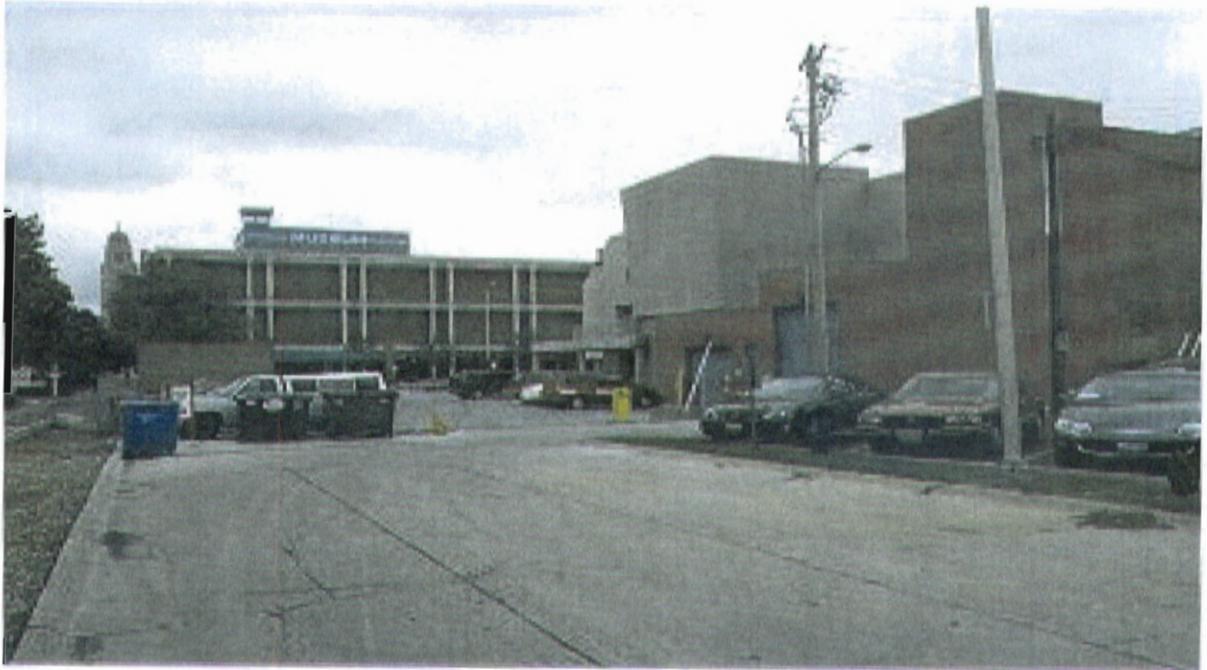
Vehicular traffic over the parking surface is restricted by a control gate (Figure 4). Refuse containers are located in the public alley and eliminate the need for trash trucks to drive over the parking lot surface. A mulched area on the east side of the parking lot divides the city-owned plaza property from the Children's Museum property (Figure 5). The mulched strip was previously landscaped and the ground sloped toward the museum property, encouraging water to migrate into the collections holding room. Removal of the plant material and the creation of a swale (see Figure 5) improved drainage and significantly reduced storm-water flow into the basement level collections holding room.

**Figure 4. View (looking south) of the restricted parking lot. The Children's Museum is located on the right and the Museum of Nebraska History is in the background. The two overhead doors and one personnel door on the right side of the photograph lead to the freight elevator.**

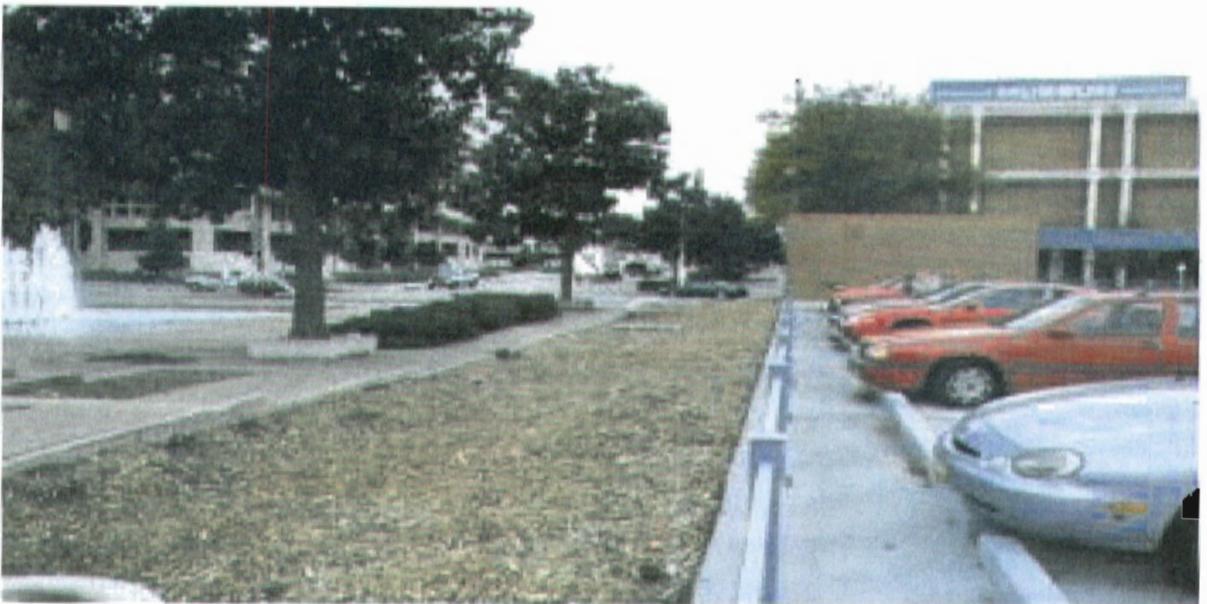
**Figure 5. View of the east side of parking lot showing the mulched area that divides the city-owned plaza property (left) from the Children's Museum property (right). The collections holding room is below the parking lot.**

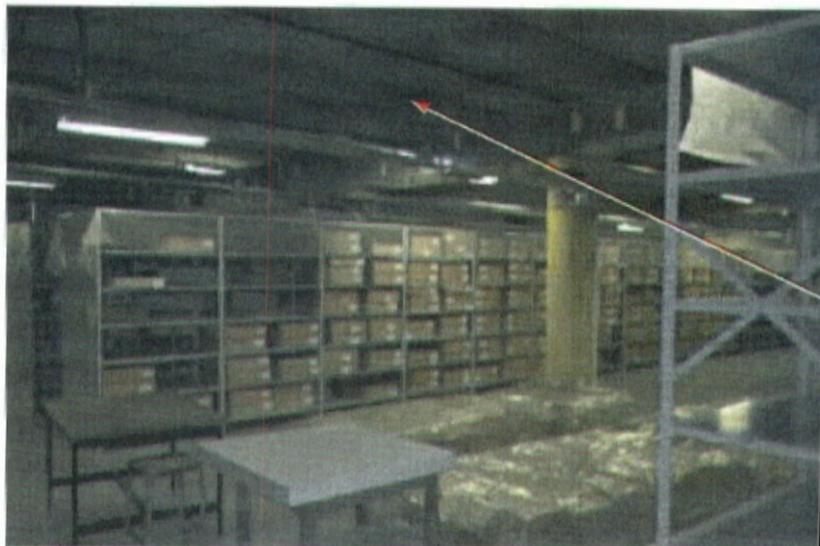
The Collections Storage Room for NSHS is located directly below the parking lot (Figure 14). Runoff from the parking surface flows into the storm drain pipes suspended from the underside of the deck and in turn to the city's storm water system (Figure 15). Four drain lines (joints) have developed leaks, and three have been repaired. On the day of site inspection, the fourth line was being scheduled for repair. The fragile nature of the drain lines and joints is expected to be a source of constant repair by building maintenance personnel.

Figure 14. View of the Collections Holding Room in the basement of the Children's Museum.

A cost estimate is not provided in this document. It is recommended that archaeological materials being stored in the basement of the Childrens Museum now be moved to a room above the basement level that is not subject to storm water damage.

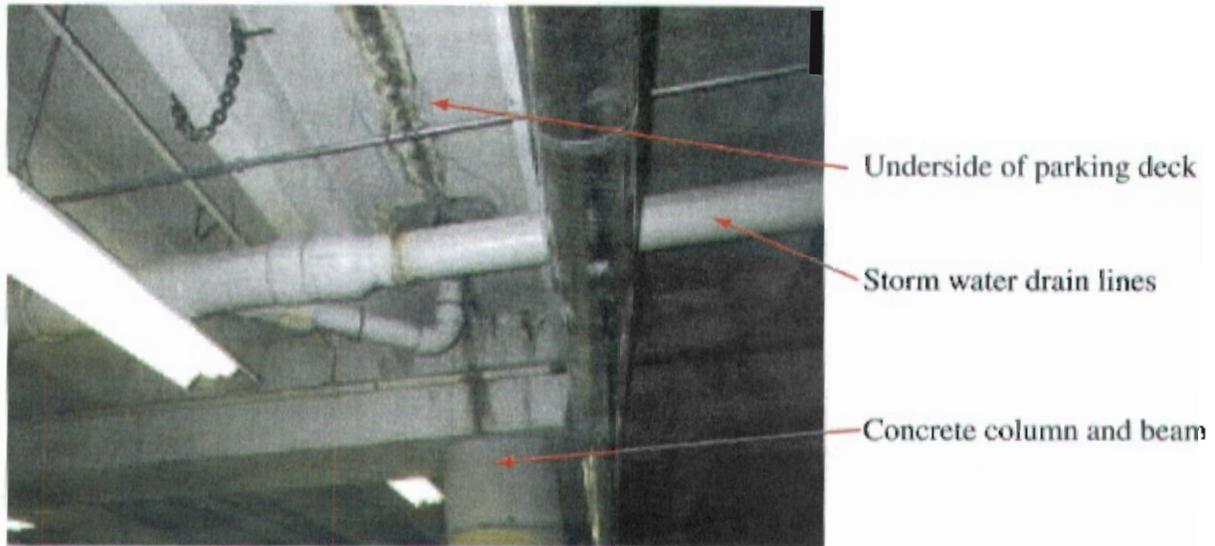
Figure 15. View of the underside of the concrete parking deck showing piping that collects drainage from the surface above.

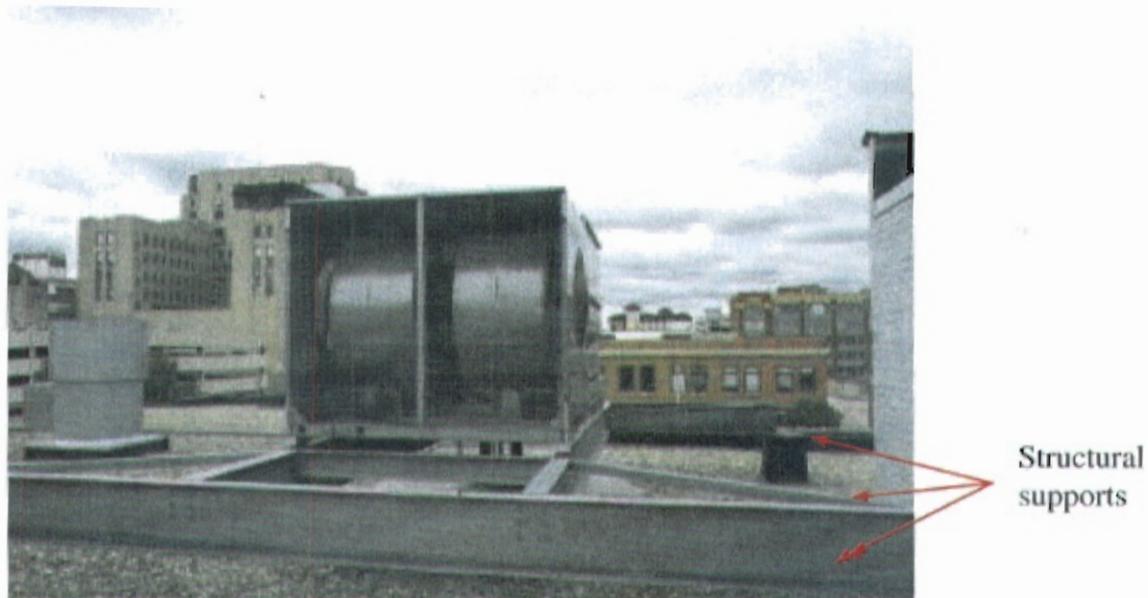
Figure 16. The HVAC unit (center) is elevated above the surface by structural steel. The structural supports (arrows) absorb vibrations, minimize joints between the metal equipment and roof membrane, and aid in the prevention of roof leaks.

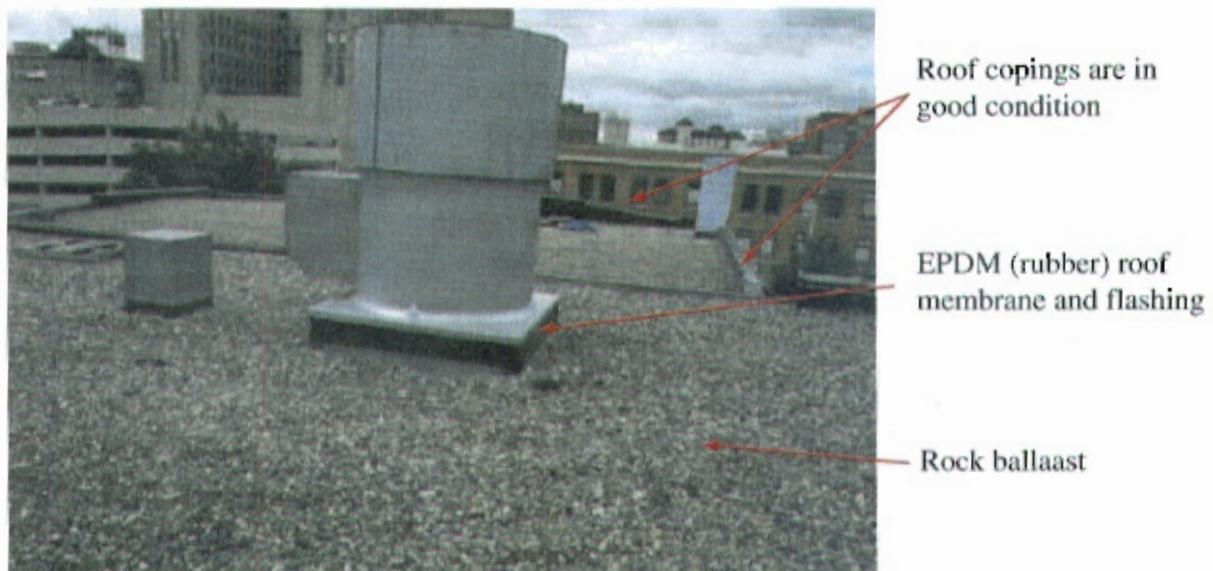
The primary structural material of the Children's Museum building is reinforced concrete. Some structural steel additions were made during rehabilitation efforts. Other noticeable materials include brick, tile, and exterior insulation and finish system. The roof membrane and flashing are in good condition (Figure 18). The entire structure is in good condition.

**Figure 18. The rubber ballasted roof system is in good condition, as are the equipment flashing and perimeter coping joints.**

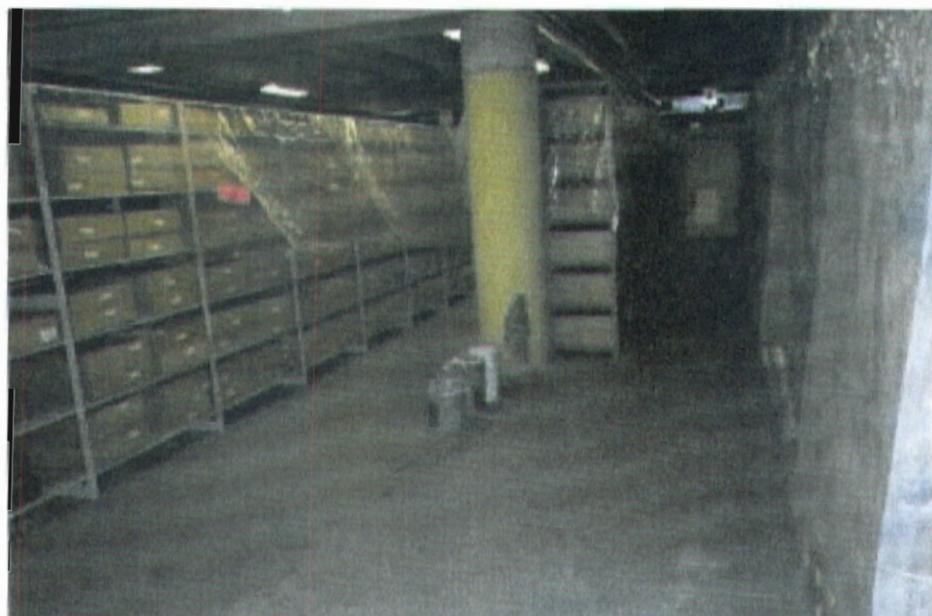
The site inspection revealed a deep sense of care being given to Reclamation collections housed in the building. The curatorial staff members have covered storage racks with polyethylene sheet film and the maintenance staff displays serious awareness of the concerns to keep this space dry (Figure 19).

Figure 19. Basement curation space.

The Children's Museum Building meets the local building code and most requirements for a federal repository; however, the storage space for archaeological materials does not adhere to the intent of the 36 CFR Part 79. The location of the artifact storage room in the basement, under the parking lot, with storm drainage passing through, and susceptible to leaking, renders artifacts stored in the basement at high risk of serious water damage.

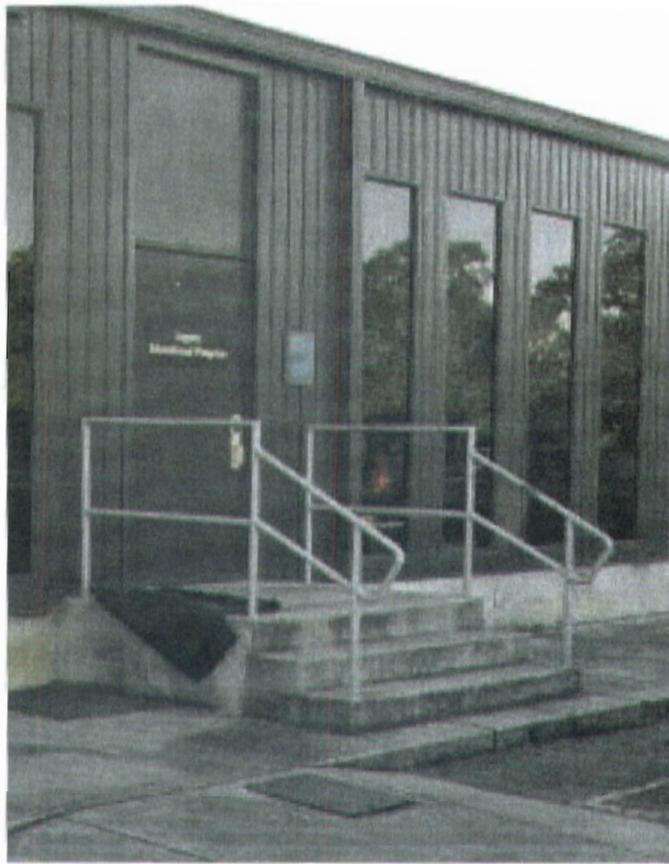
**Figure 25. View of the main entrance to CAR. The finished floor elevation is approximately twenty-four inches above grade. The door is kept locked and serves primarily as an exit. All exterior doors are equipped with an IDS; however, windows are not.**

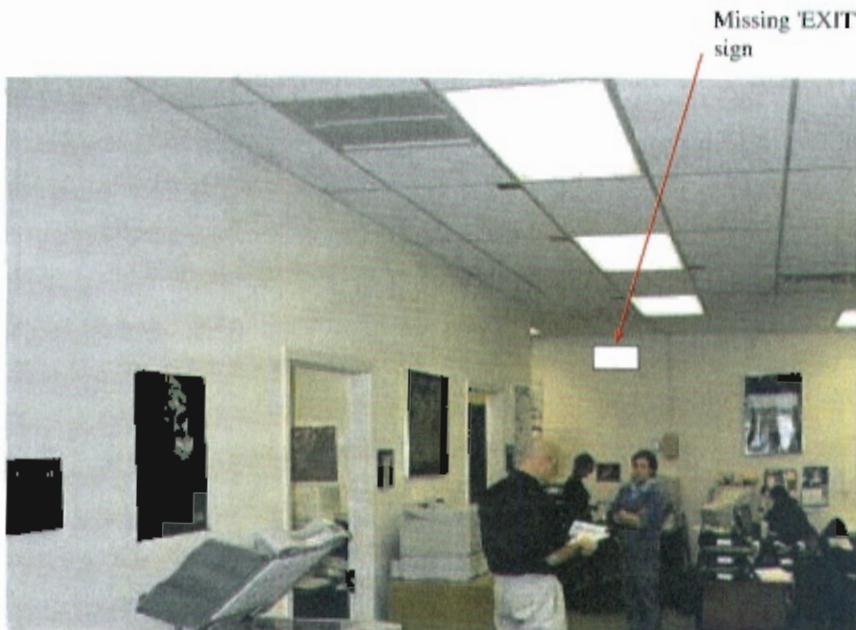
**Figure 31.** View of the administrative offices in the front of the building. A previous building code analysis recommended the addition of a visible exit sign.

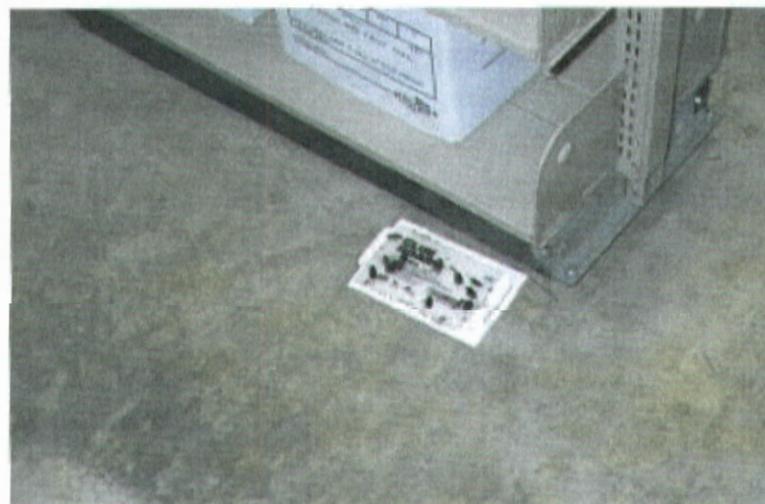
Insect infestation at CAR is monitored and controlled with glue boards (Figure 36). At the time of the facility inspection, CAR staff members were planning to consult with an entomologist for identification and deterrence measure recommendations associated with local pests.

**Figure 36. Insect infestation at the CAR is monitored and controlled with glue boards, such as the one shown above.**

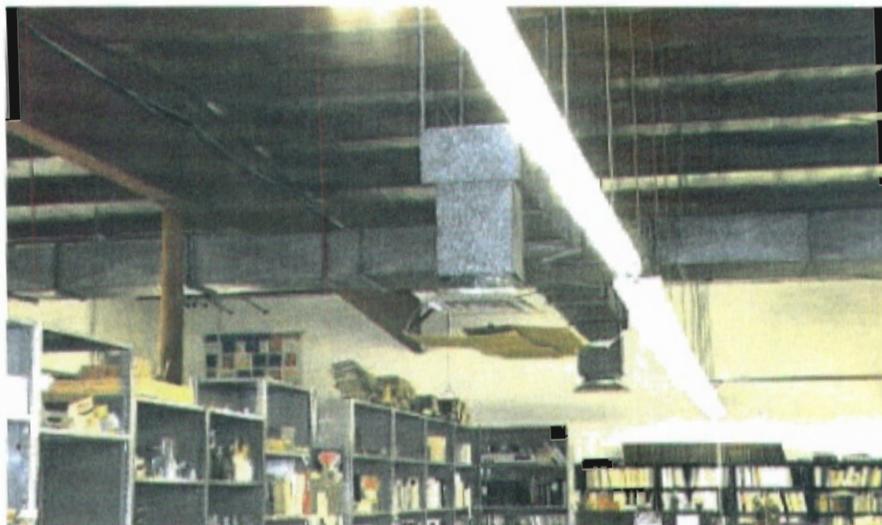
All of the building systems are in good condition and are functioning properly. The inspection found no rust or corrosion of the steel structure and no sagging of roof insulation. The forced-air HVAC system is not filtered, although a spot check for dust on horizontal surfaces resulted in negative findings. A record of temperatures and relative humidity levels is not maintained for this building.

Figure 37. The photograph above illustrates the structural framing system, HVAC ductwork, and lighting in the CAR facility.

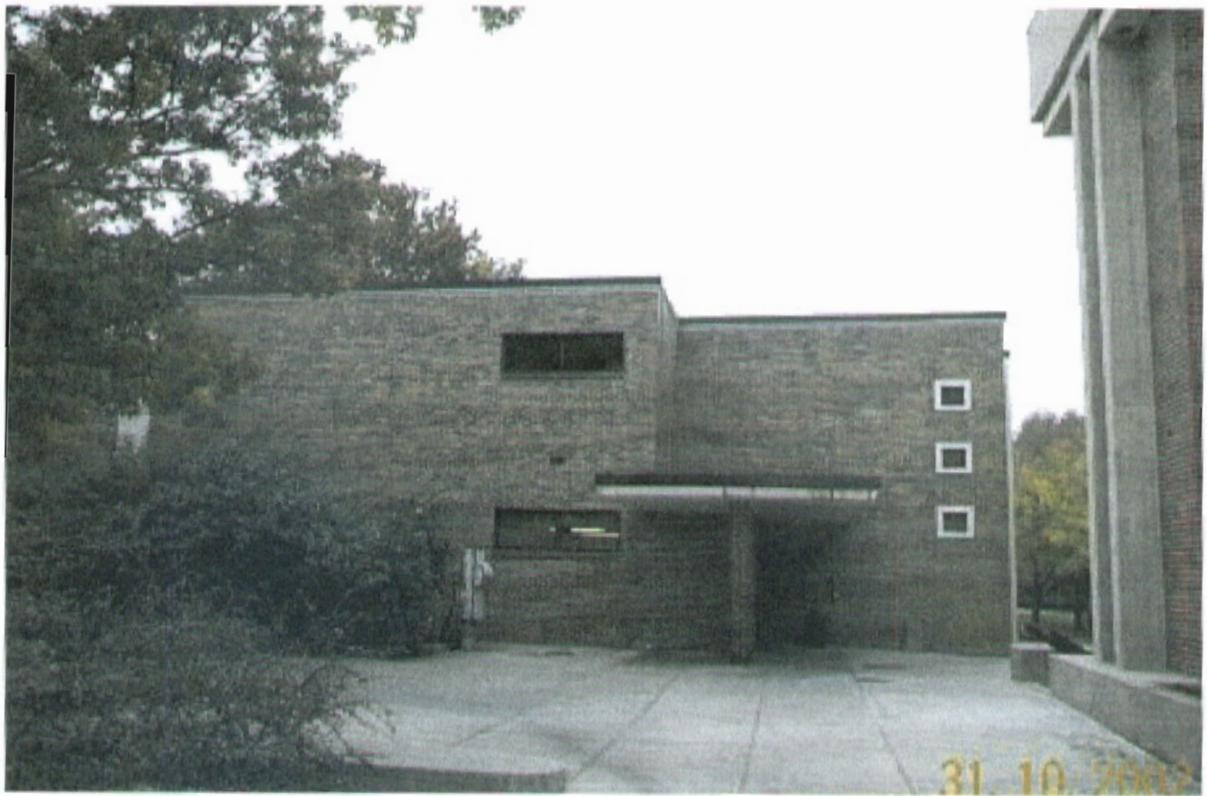
**Figure 40. The north entrance to Neff Hall is under a canopy. The concrete pavement was constructed with a modest surface slope away from the doors. The building underwent extensive remodeling a few years ago to include significant accessibility provisions that conform to ADA.**

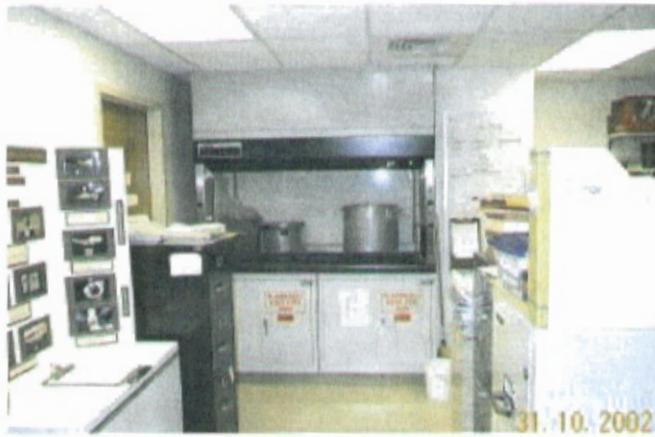
**Figure 48.** The fume hood in Room 218 is vented directly to the exterior.

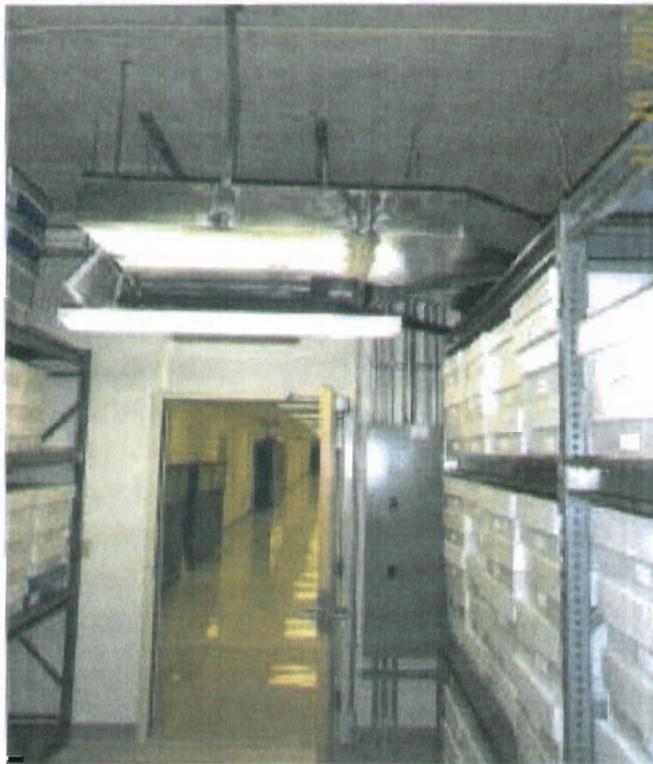
Room 201 is used exclusively for the storage of federally owned archaeological materials that have been cleaned, catalogued, and boxed to professional standards (Figure 49). Unfortunately, this room (and the rest of the building) is not equipped with an automatic sprinkler system. The temperature in this room at the time of the assessment was 62.9° F, and the relative humidity was 61%. A portion of the Museum gallery, Room 109, can be seen in Figure 50.

**Figure 49.** Collections storage room for federal collections that have been appropriately processed.

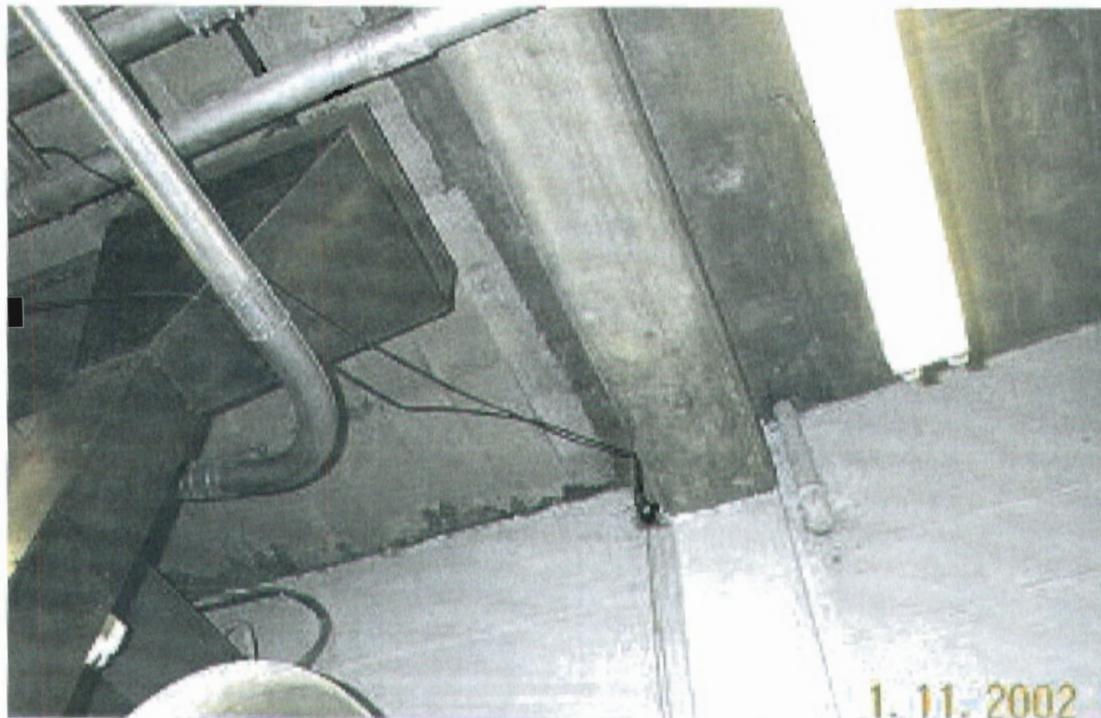
Figure 51. Concrete beams and floor are visible in the partial basement.

However, if Neff Hall were a federal repository, the occupancy or primary use (as defined by building codes) could change and storage functions could occupy more floor space than now. As a result, the building, while now structurally adequate, could become inadequate if subjected to a significant increase in floor loading as a result of expanded storage functions. To further explain, the current occupancy (as defined by the 1994 Uniform Building Code) is "B" or Business, and the corresponding live floor load for design purposes is 50 pounds per square foot. If storage functions were to increase beyond 10% of the total building area, a reclassification to "S" or storage would be appropriate. If that occurred, a review for structural adequacy would require comparison to the minimum code-mandated design loads for a storage occupancy, as follows.

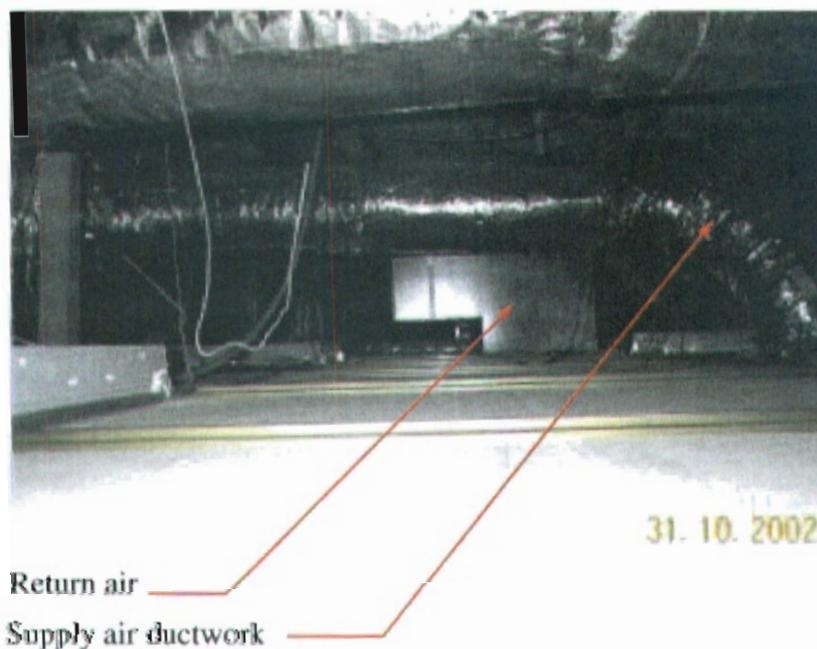
**Figure 54.** Photograph taken above the ceiling in Room 202 showing the supply air ductwork and a partial sheet metal duct, which is connected to the return air register mounted in the ceiling.
