<p>U.S. ARMY ENGINEER DISTRICT, ST. LOUIS CORPS OF ENGINEERS ST. LOUIS, MO</p>	
<p>PREPARED BY: M. RODGERS CHECKED BY: R. DAVINROY</p>

<p>KASKASKIA RIVER BANK EROSION STUDY</p> <p><u>BANK EROSION OTTER BRANCH CREEK</u></p>	
	<p>Plot Date: 9/02</p>	<p>PLATE NO. 9</p>

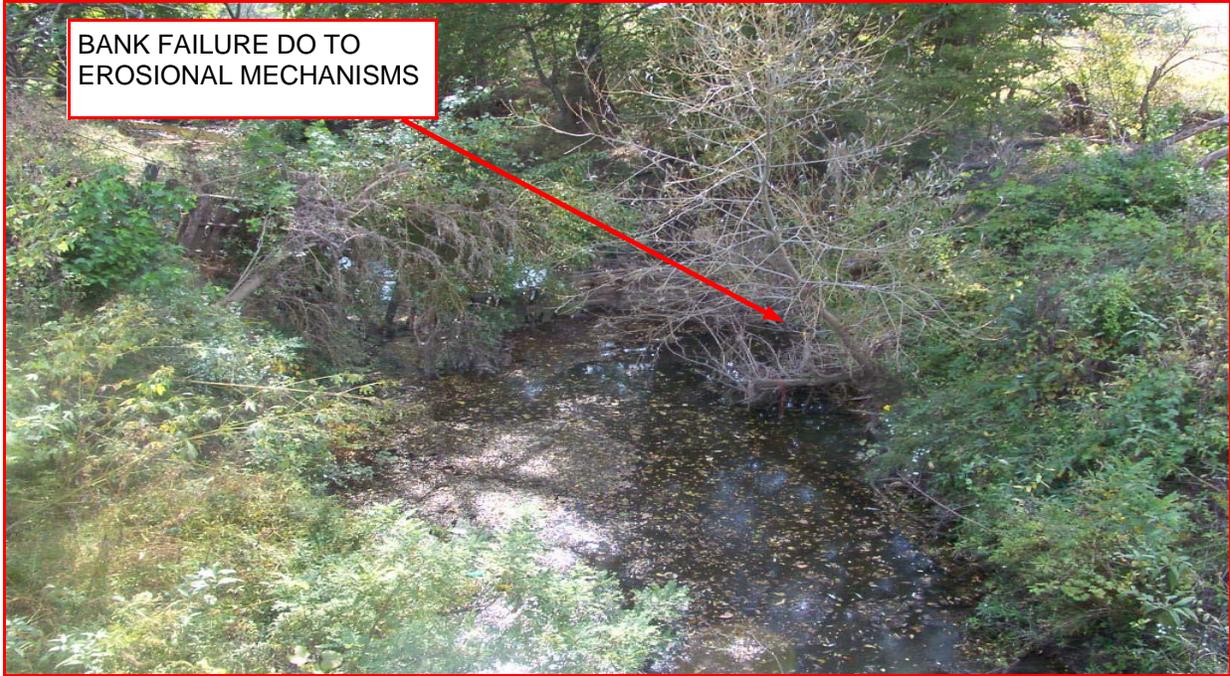
BANK FAILURE DO TO
EROSIONAL MECHANISMS

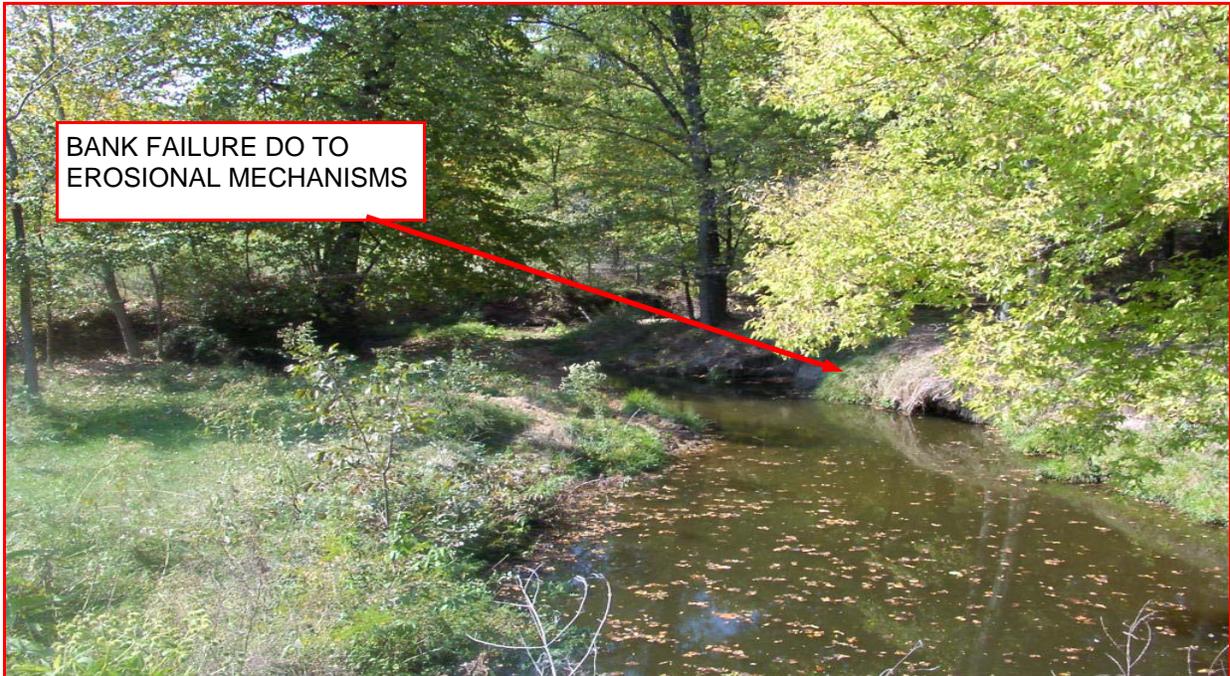
BANK FAILURE DO TO
EROSIONAL MECHANISMS
