# ***Conditions Affecting Missouri Levee Systems Reliability***

***Mark Alvey, PE,  
Chief, Geotechnical and HTRW Branch  
St. Louis District***

***November 26, 2007***

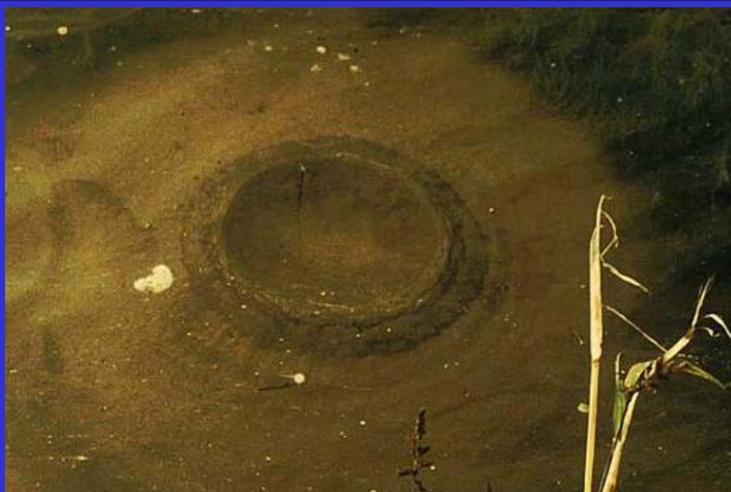
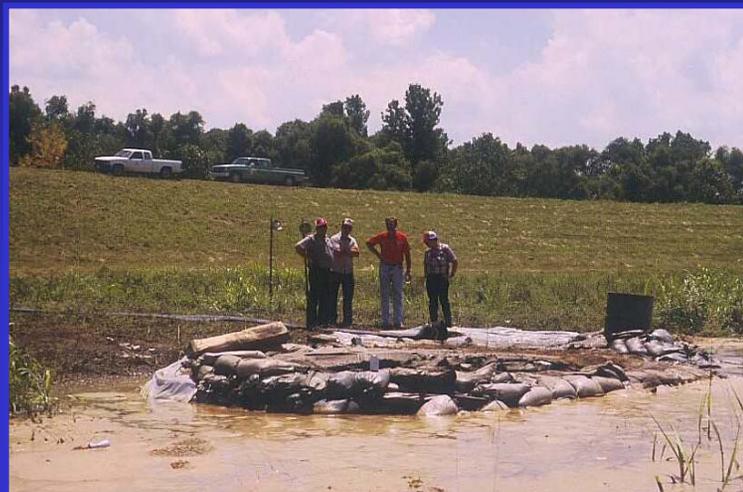
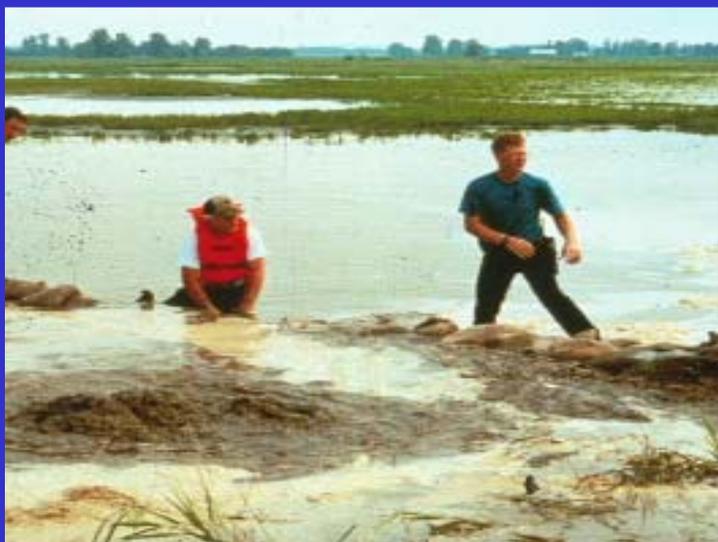
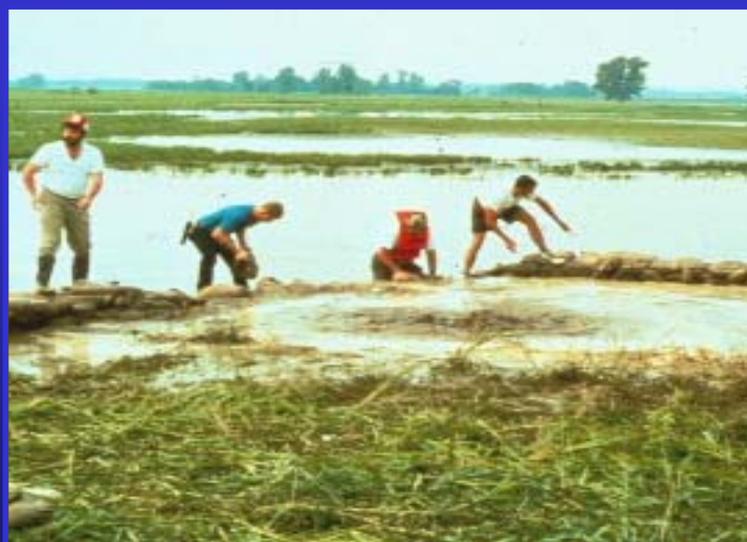
# Kaskaskia Island D&LD

## Uncontrolled Seepage July 1993 Flood

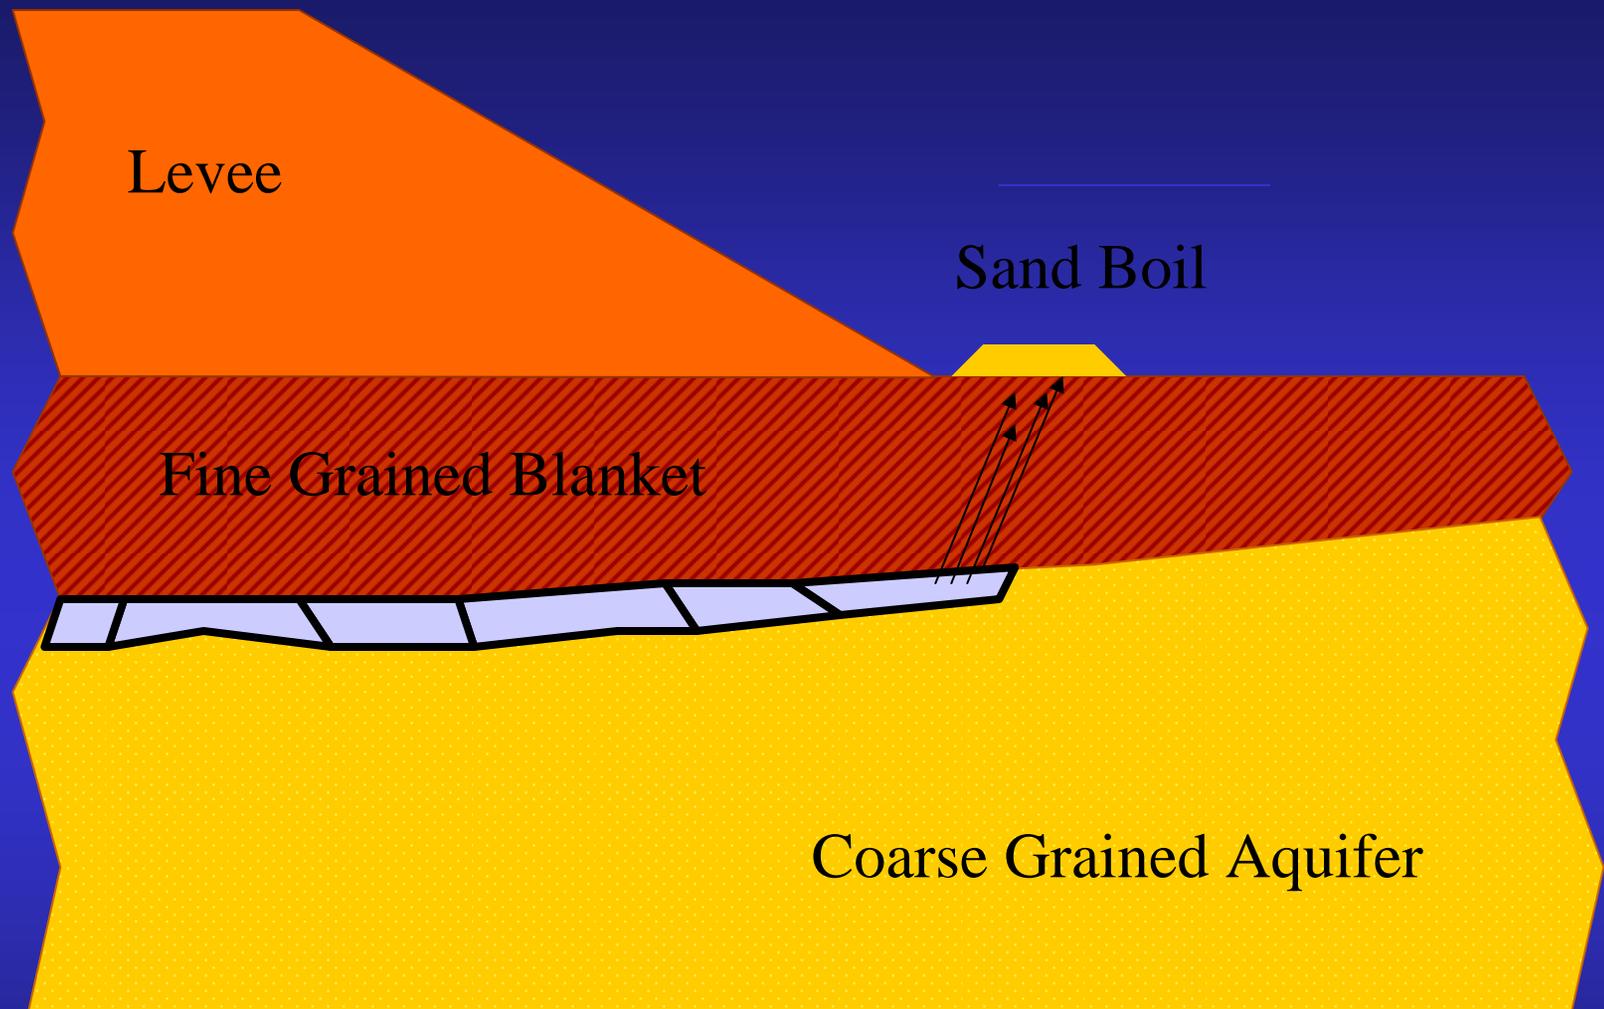
## Piping in the Aquifer

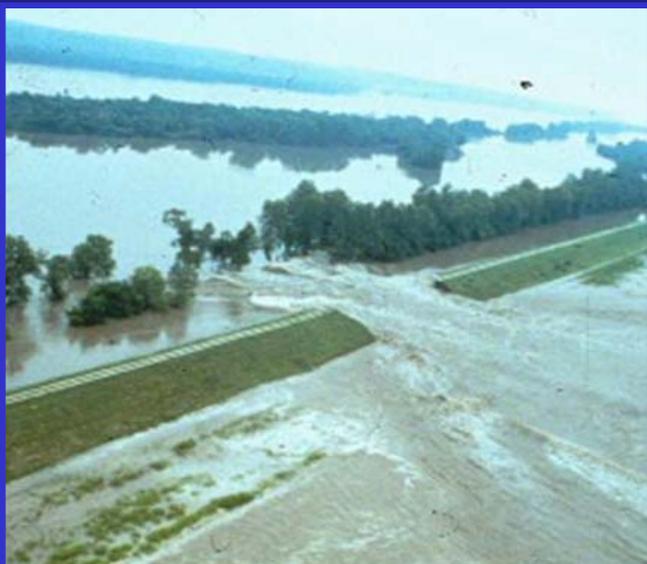
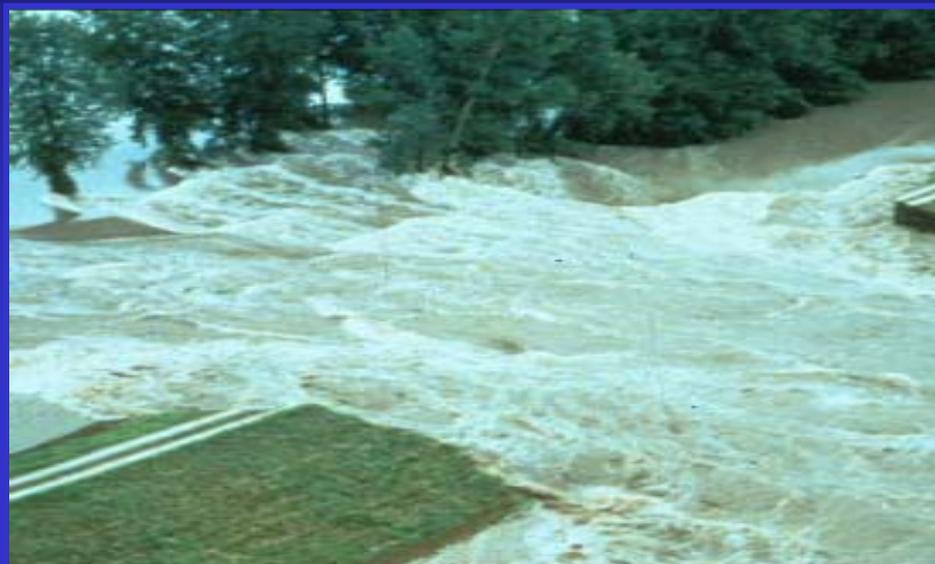
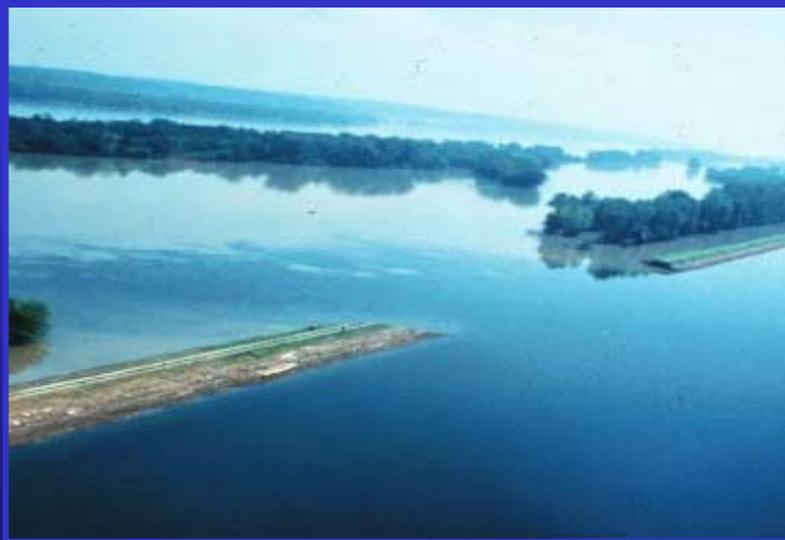
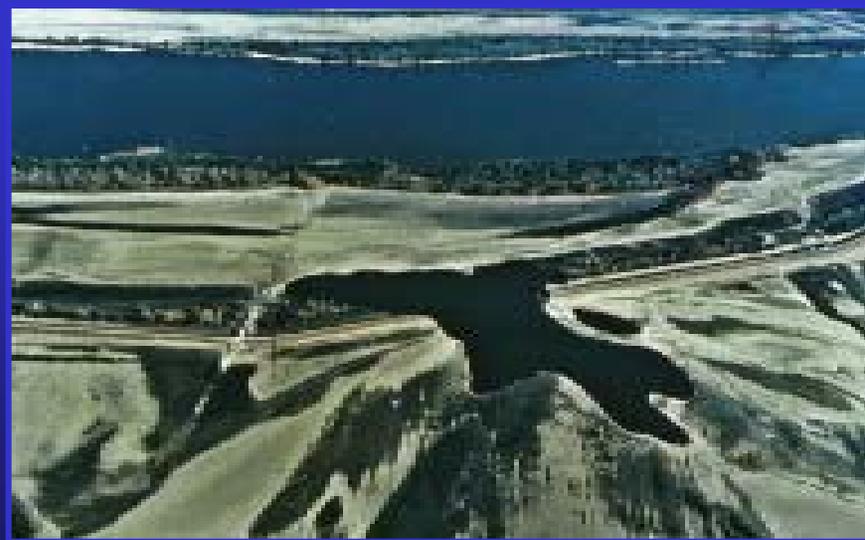
# Kaskaskia Island D&LD Failure

## Uncontrolled Seepage July 1993 Flood

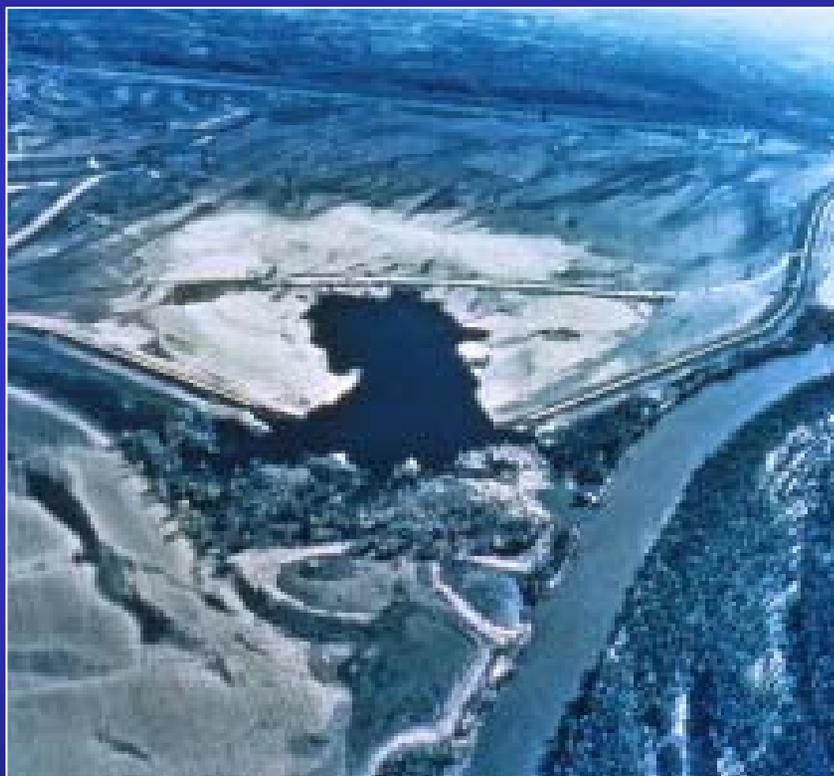
# Aerials of Bois Brule Levee Breach and Scour Hole

View toward levee district

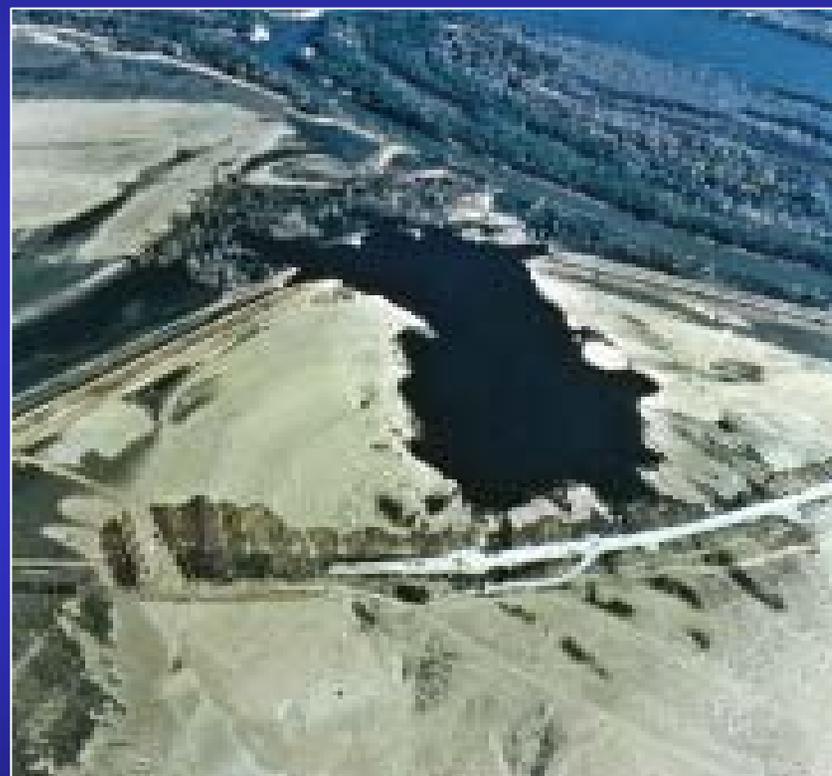
View toward Mississippi River

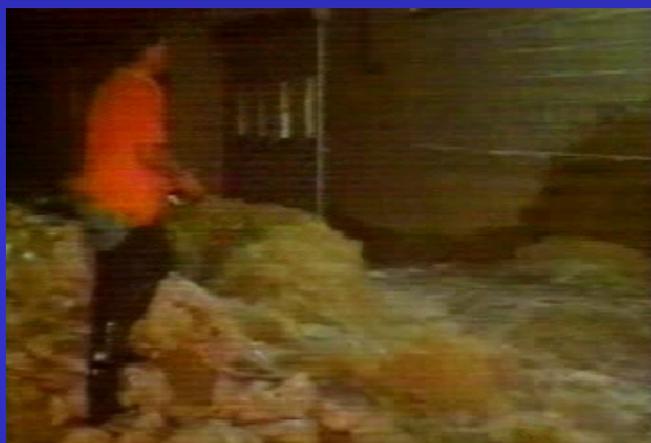
# St. Louis Flood Protection

## Uncontrolled Seepage Flows From Under The Floodwall

July 1993

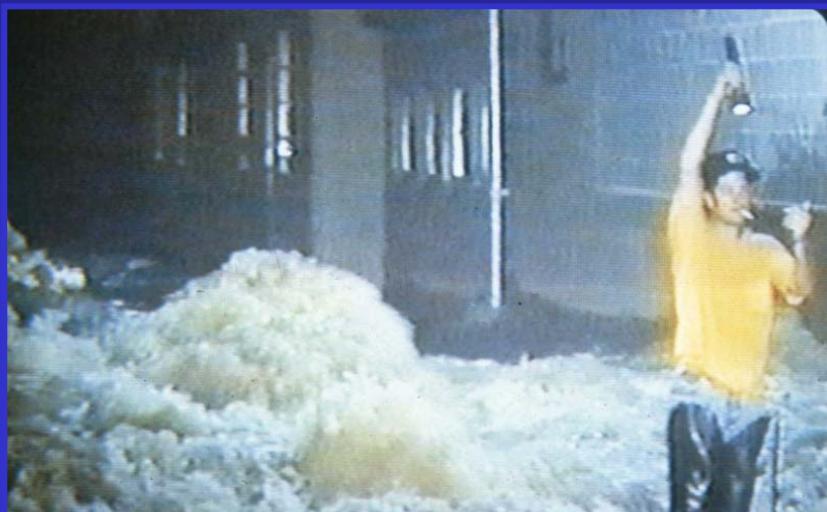
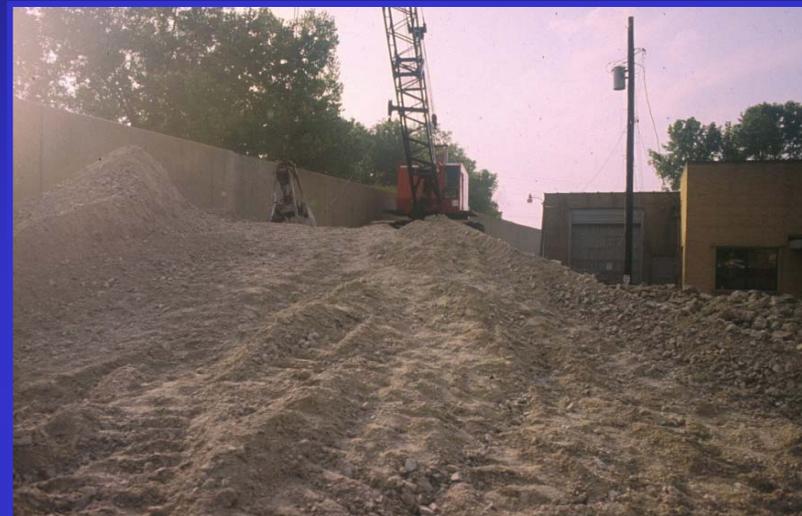
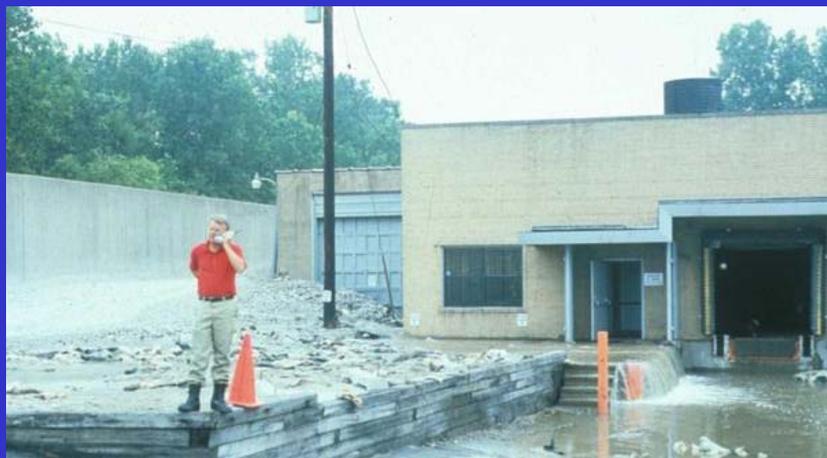
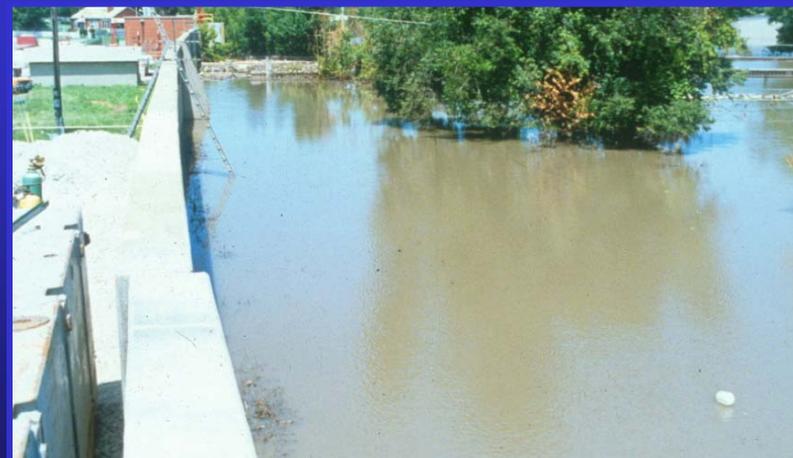
# St. Louis Flood Protection

## Uncontrolled Seepage Flows From Under The Floodwall

### July 1993

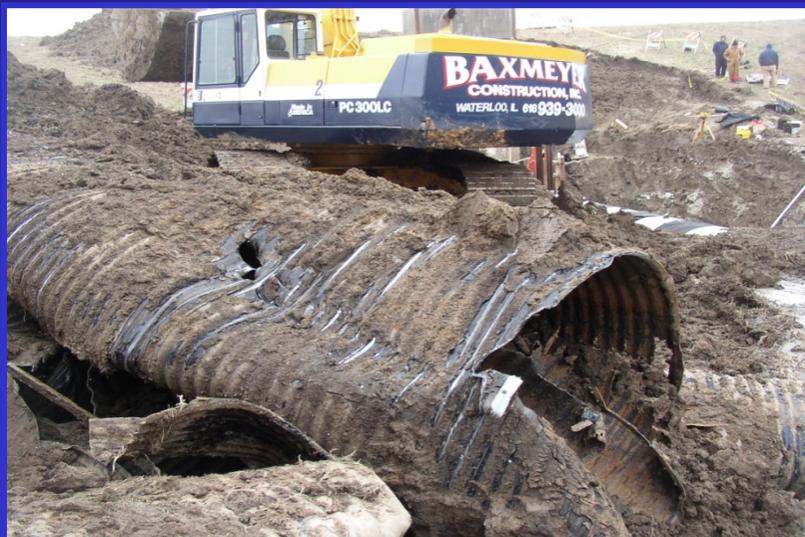
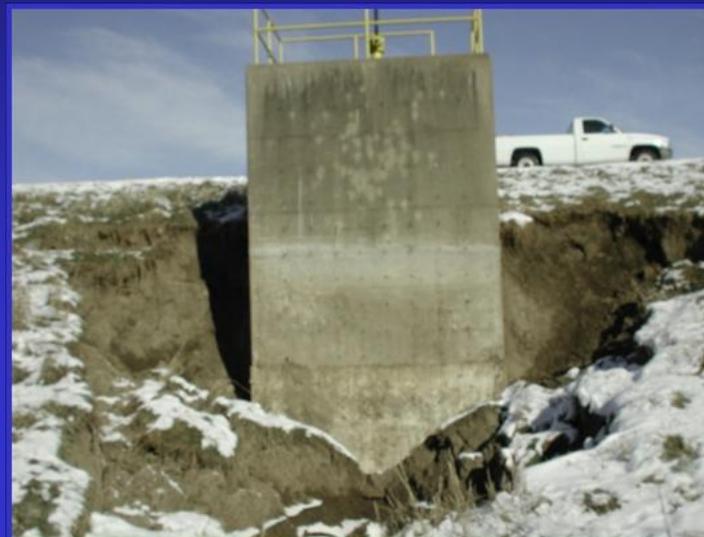
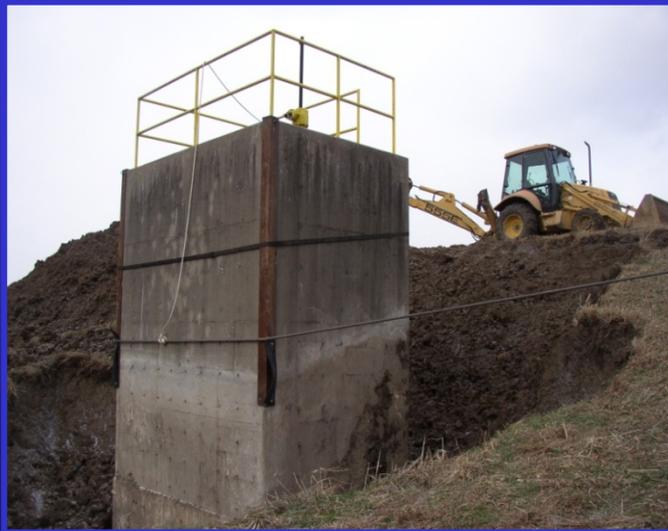
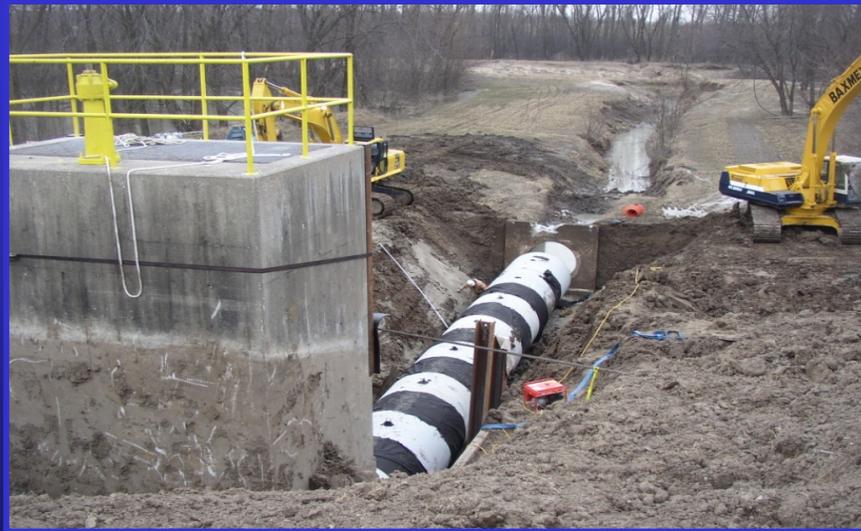
# Wood River D&LD

## Deteriorating Riverside CMP Gravity Drain, January 2005

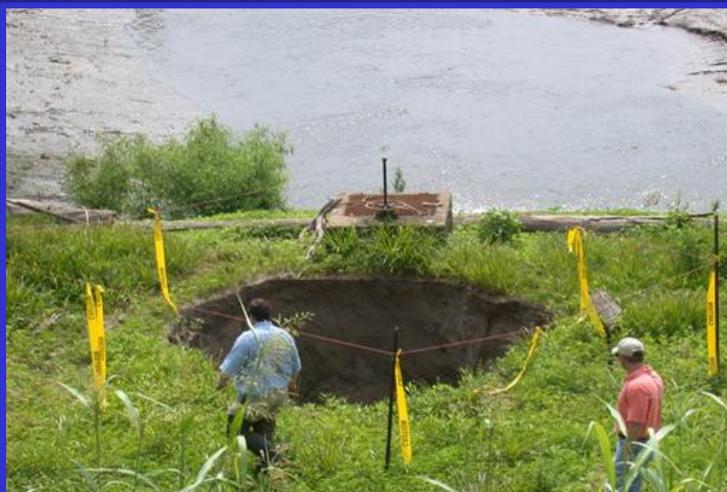
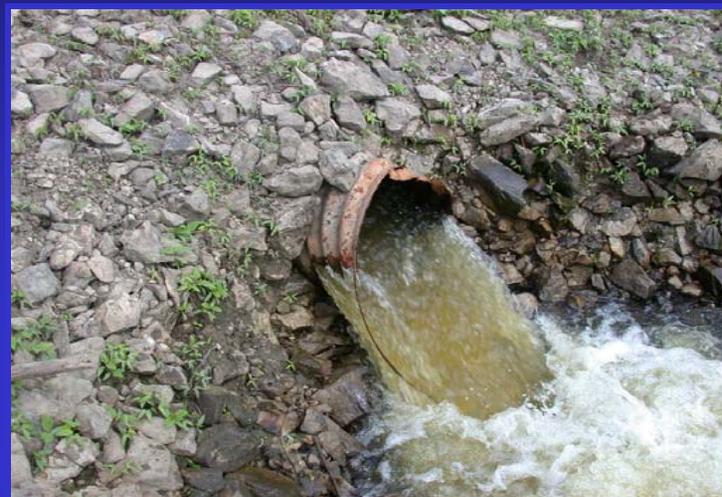
Top Photos  
Sta 473+12

## Two Deteriorating CMP Gravity Drains, July 2002

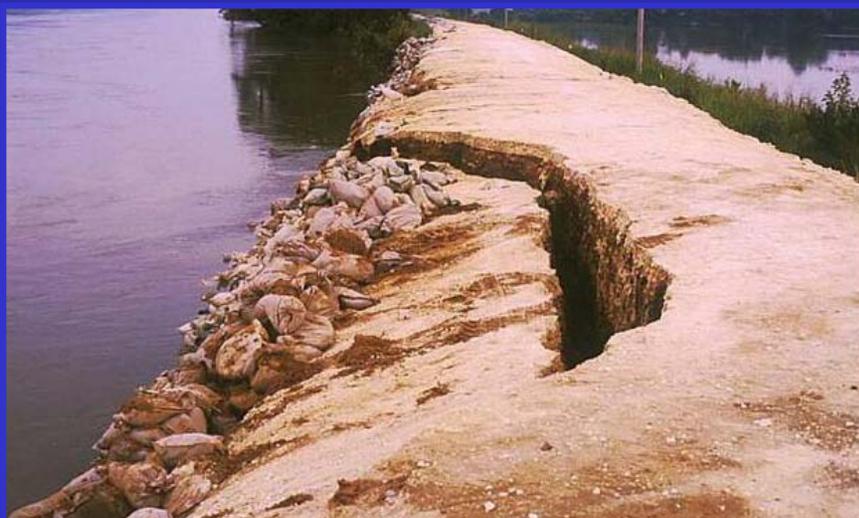
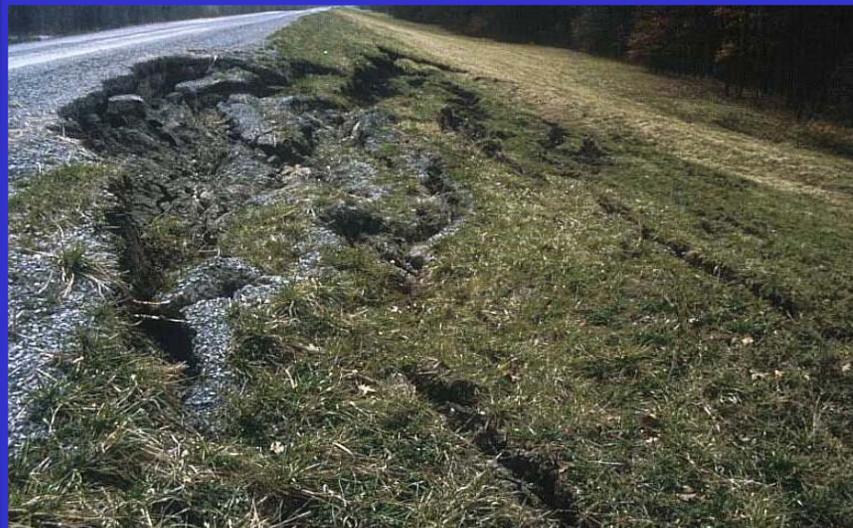
# Levee Instability from Scour and Uplift

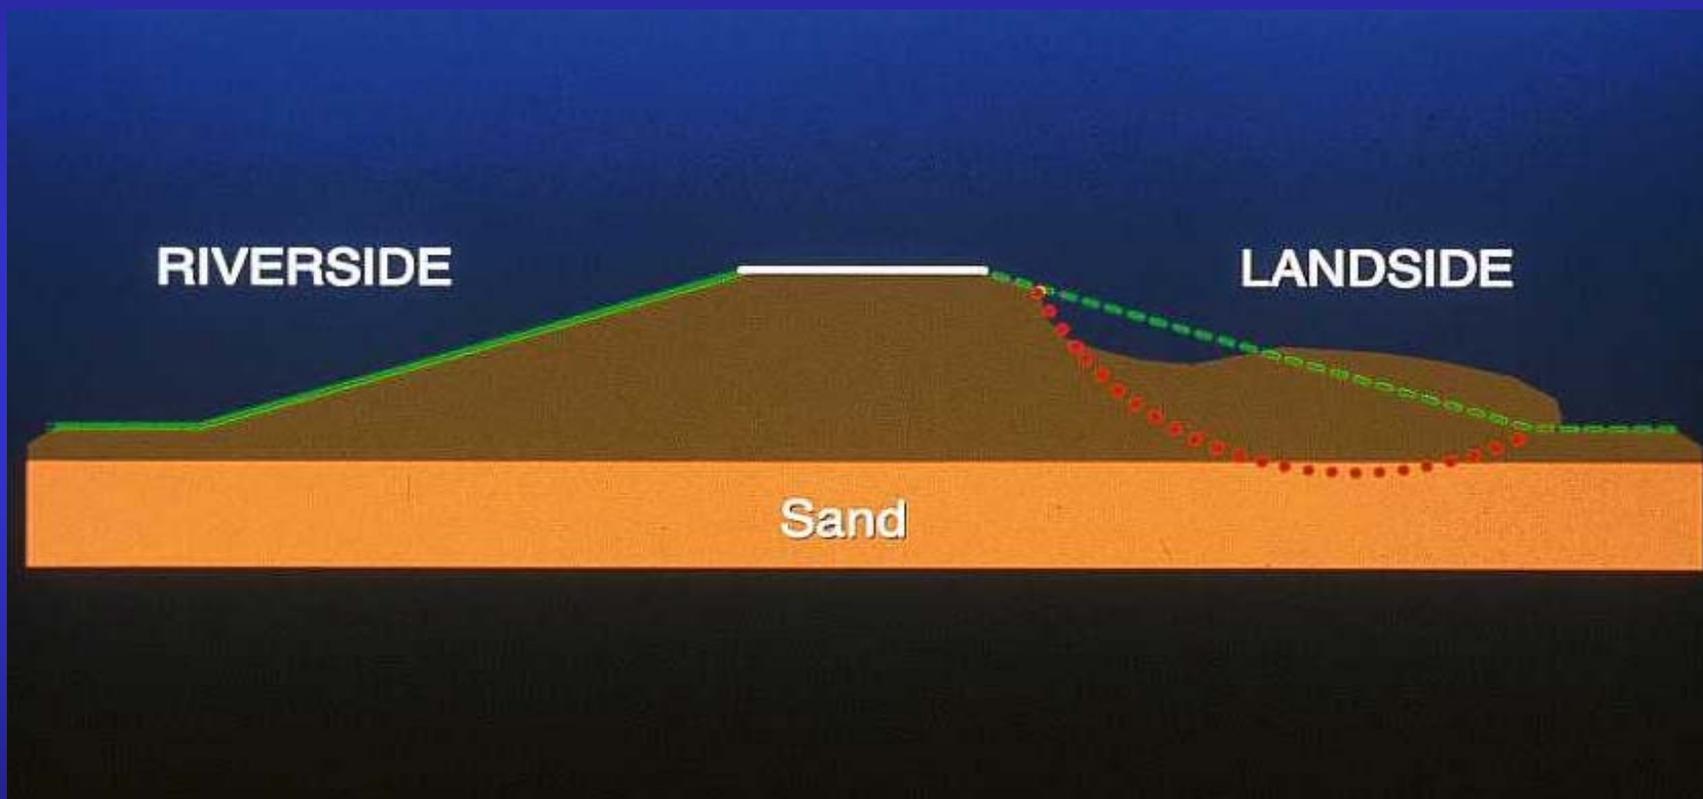
# Slope Instability Failures
