Conditions Affecting Missouri Levee Systems Reliability

***Mark Alvey, PE,
Chief, Geotechnical and HTRW Branch
St. Louis District***

November 26, 2007

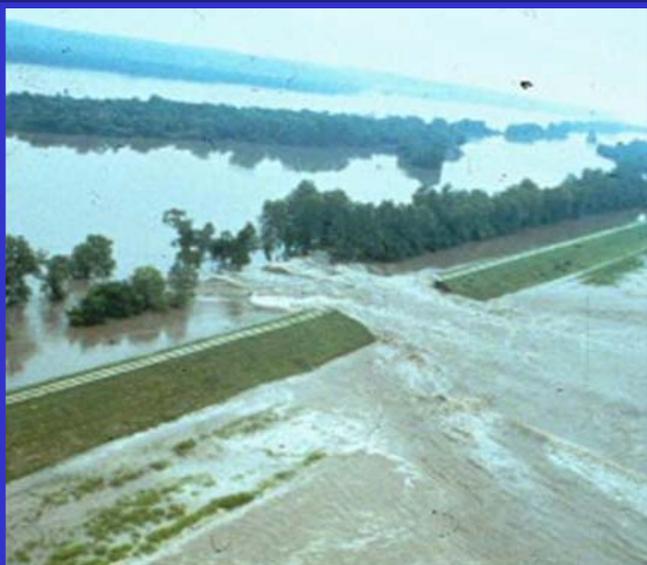
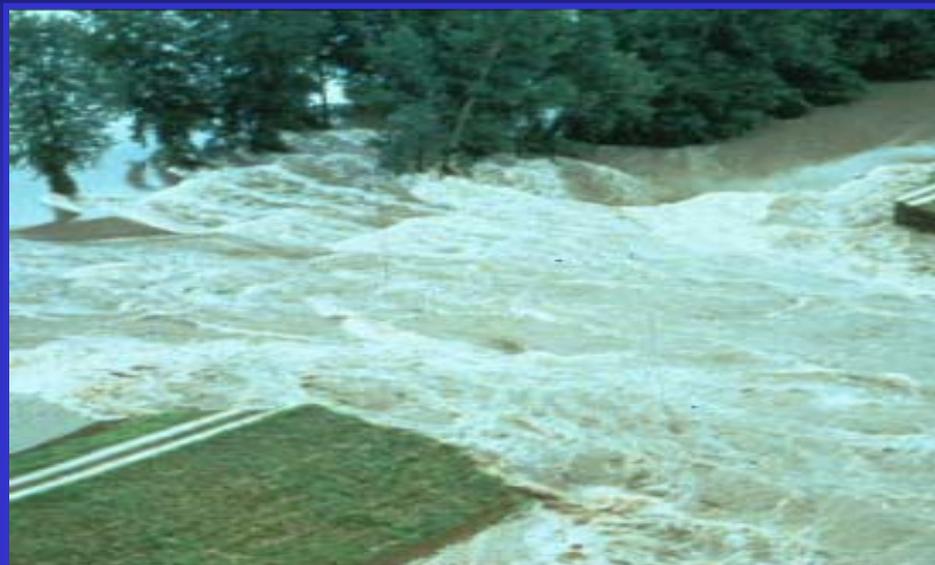
Kaskaskia Island D&LD Failure

Uncontrolled Seepage July 1993 Flood

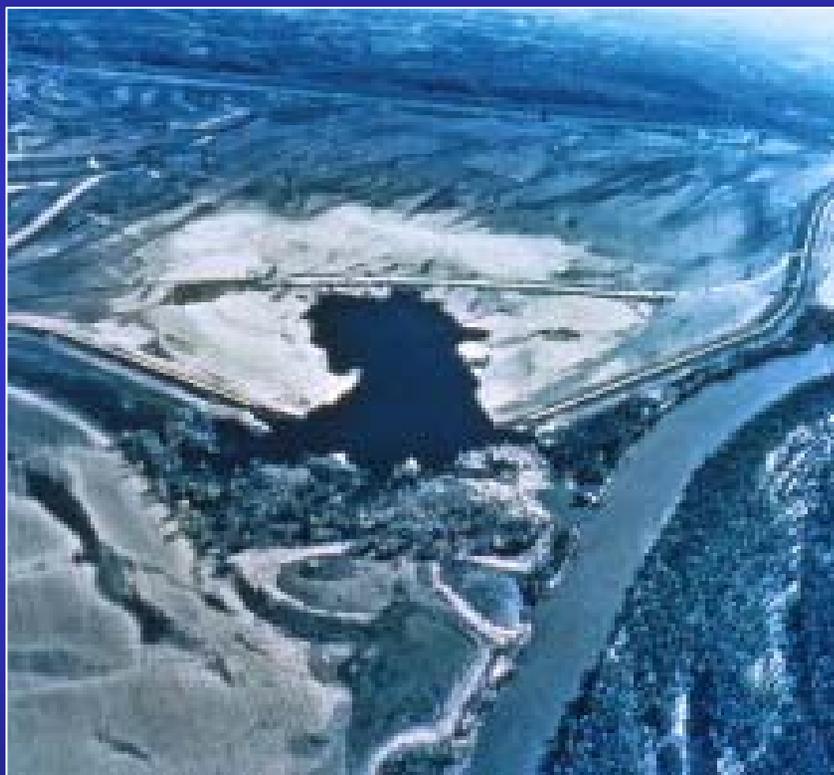
View toward levee district

Aerials of Bois Brule Levee Breach and Scour Hole

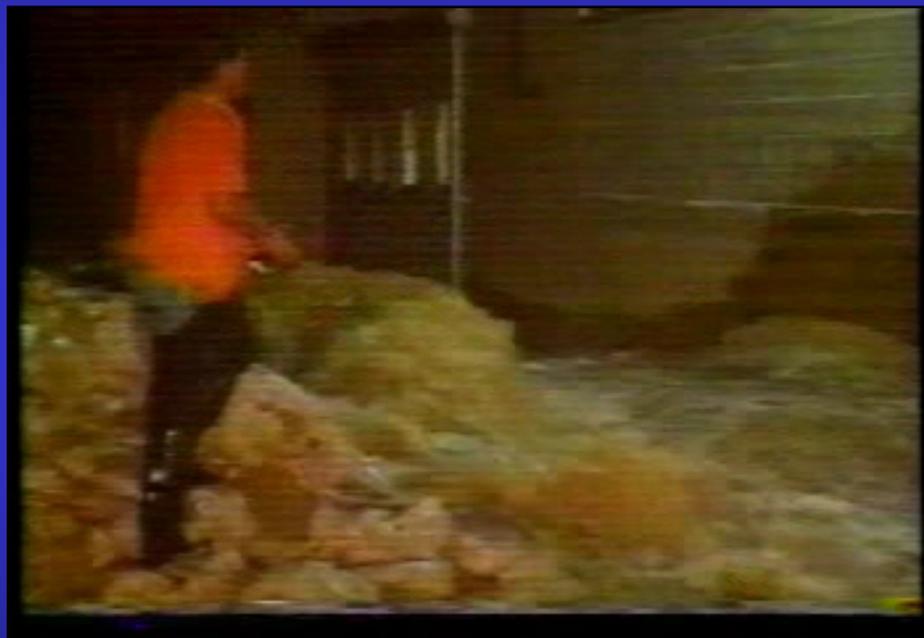
St. Louis Flood Protection

Uncontrolled Seepage Flows From Under The Floodwall

July 1993

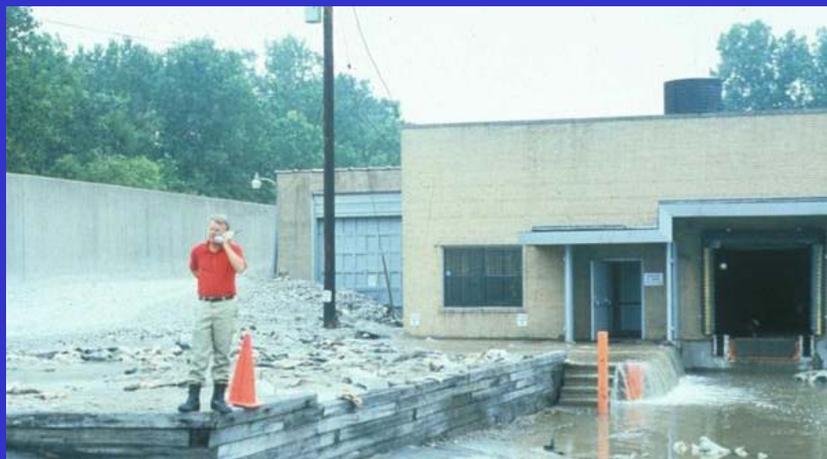
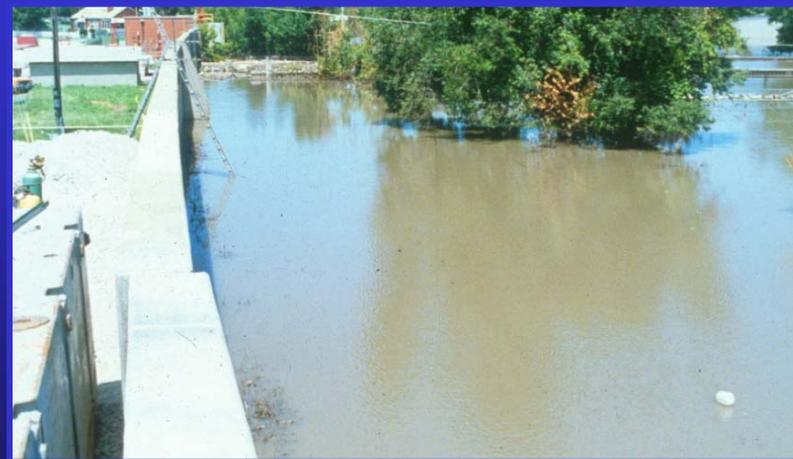
St. Louis Flood Protection

Uncontrolled Seepage Flows From Under The Floodwall

July 1993

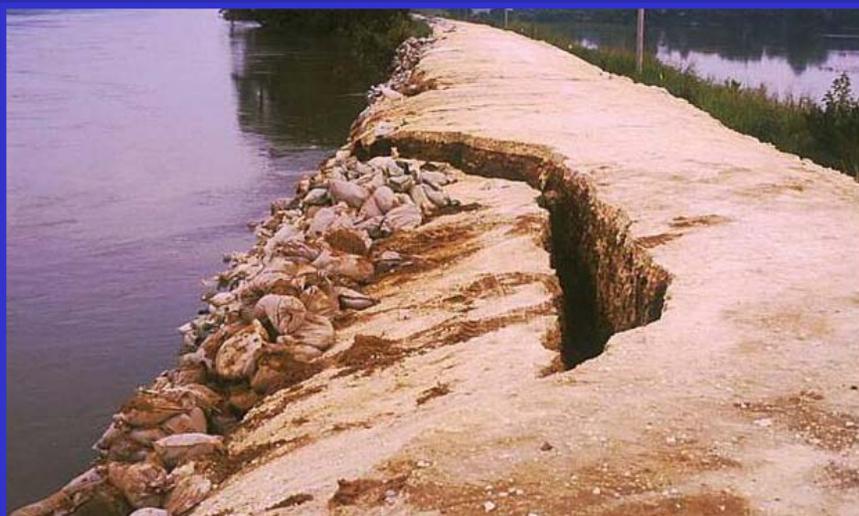
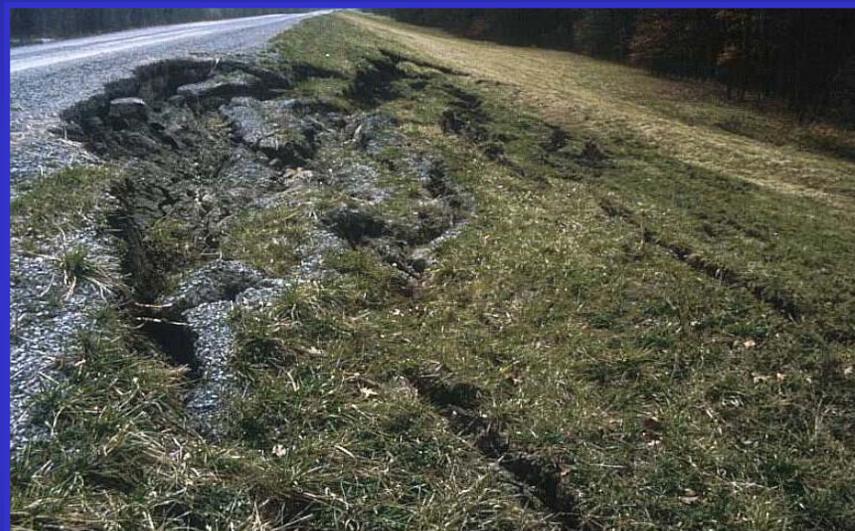
Levee Instability from Scour and Uplift
