EXAMPLES OF A WELL COMPLETED RFA (REQUEST FOR ASSISTANCE)

2015 PL84-99 - Ste. Genevieve Drainage and Levee District

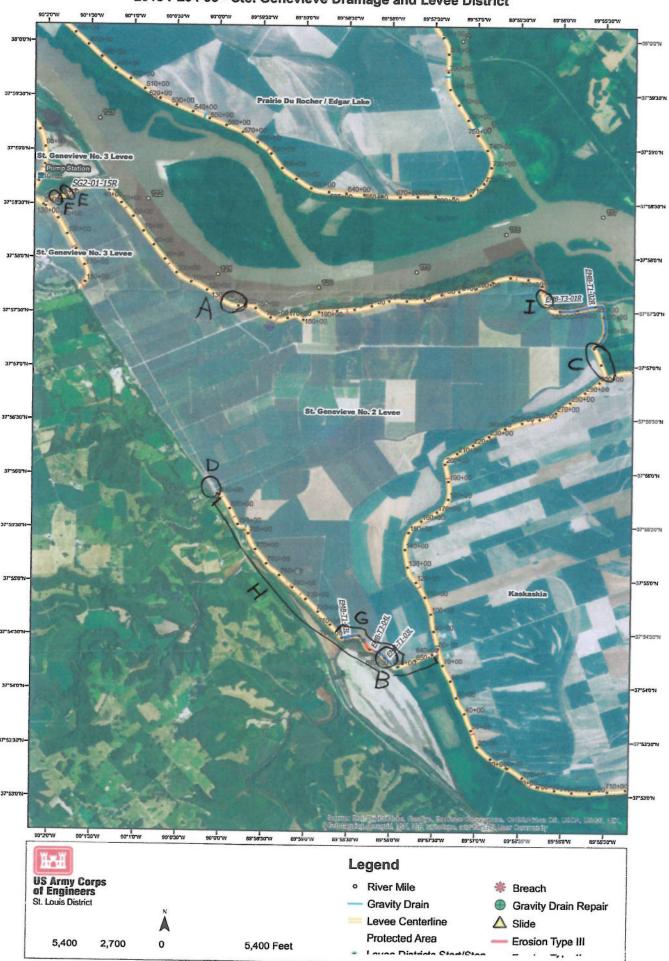
SECTION 36 TOWNSHIP 38 N RANGE 10 E

North Leroe by Port. 1900 of washed out Level with Large scour hole.

Lower Mitchell Level 400' of washedout Level with large scour hole.

Level connecting with Kaskaskia Level 1'To 3" of rock and dirt washed off Top of Level, 800'

Level along Hay 61 400' washed top 1'To 5' off. Shede on side of Level east of Maring bridge 200'

Shede on side of Levre east of Marina bridge 150'

G Ware wash on side of Level 3500'

H Road stone washed off top of Level 3.5 miles

I Erosion at tow of Levee 300

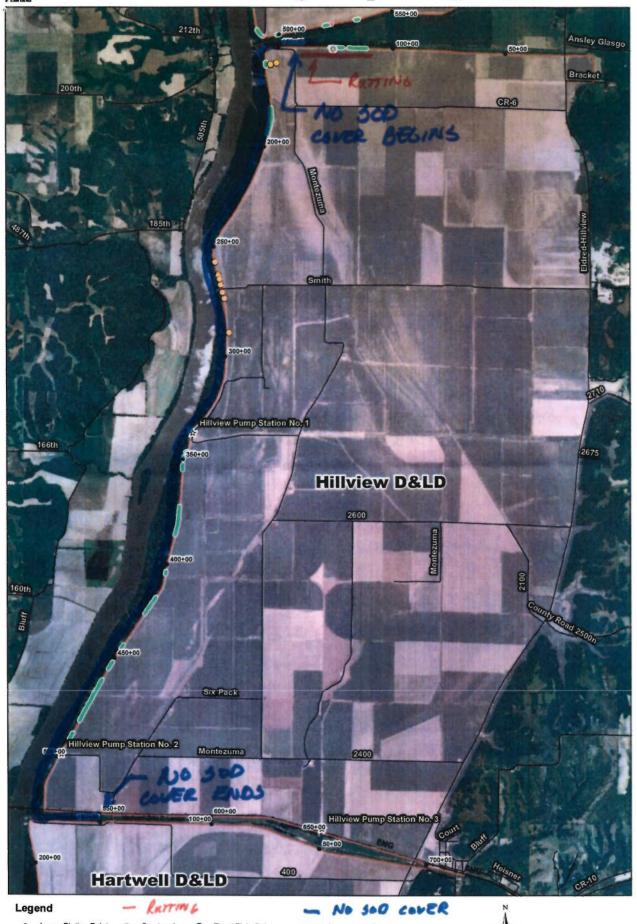
SECTION TOWNSHIP RANGE

A	. Riverside of Leve has thin or no sod cover
• • •	DETWEEN MAP STATTIONS 120+00 and 545+00
h,	Top of have is more entrep NEAR LEVER
	STATION 120 too FOR APPROXIMATELY 500 FT
	from SANDBAGGING EFFORTS
С.	SINKHOLE ABOVE PUMPSTATION DISCHARGE PIPE
