STATE OF MISSOURI  
**DEPARTMENT OF NATURAL RESOURCES**

04/20/01

Subject/Title: MDNR0 Certification of SLAPS Wells - Issues Requiring Resolution Prior to Certification

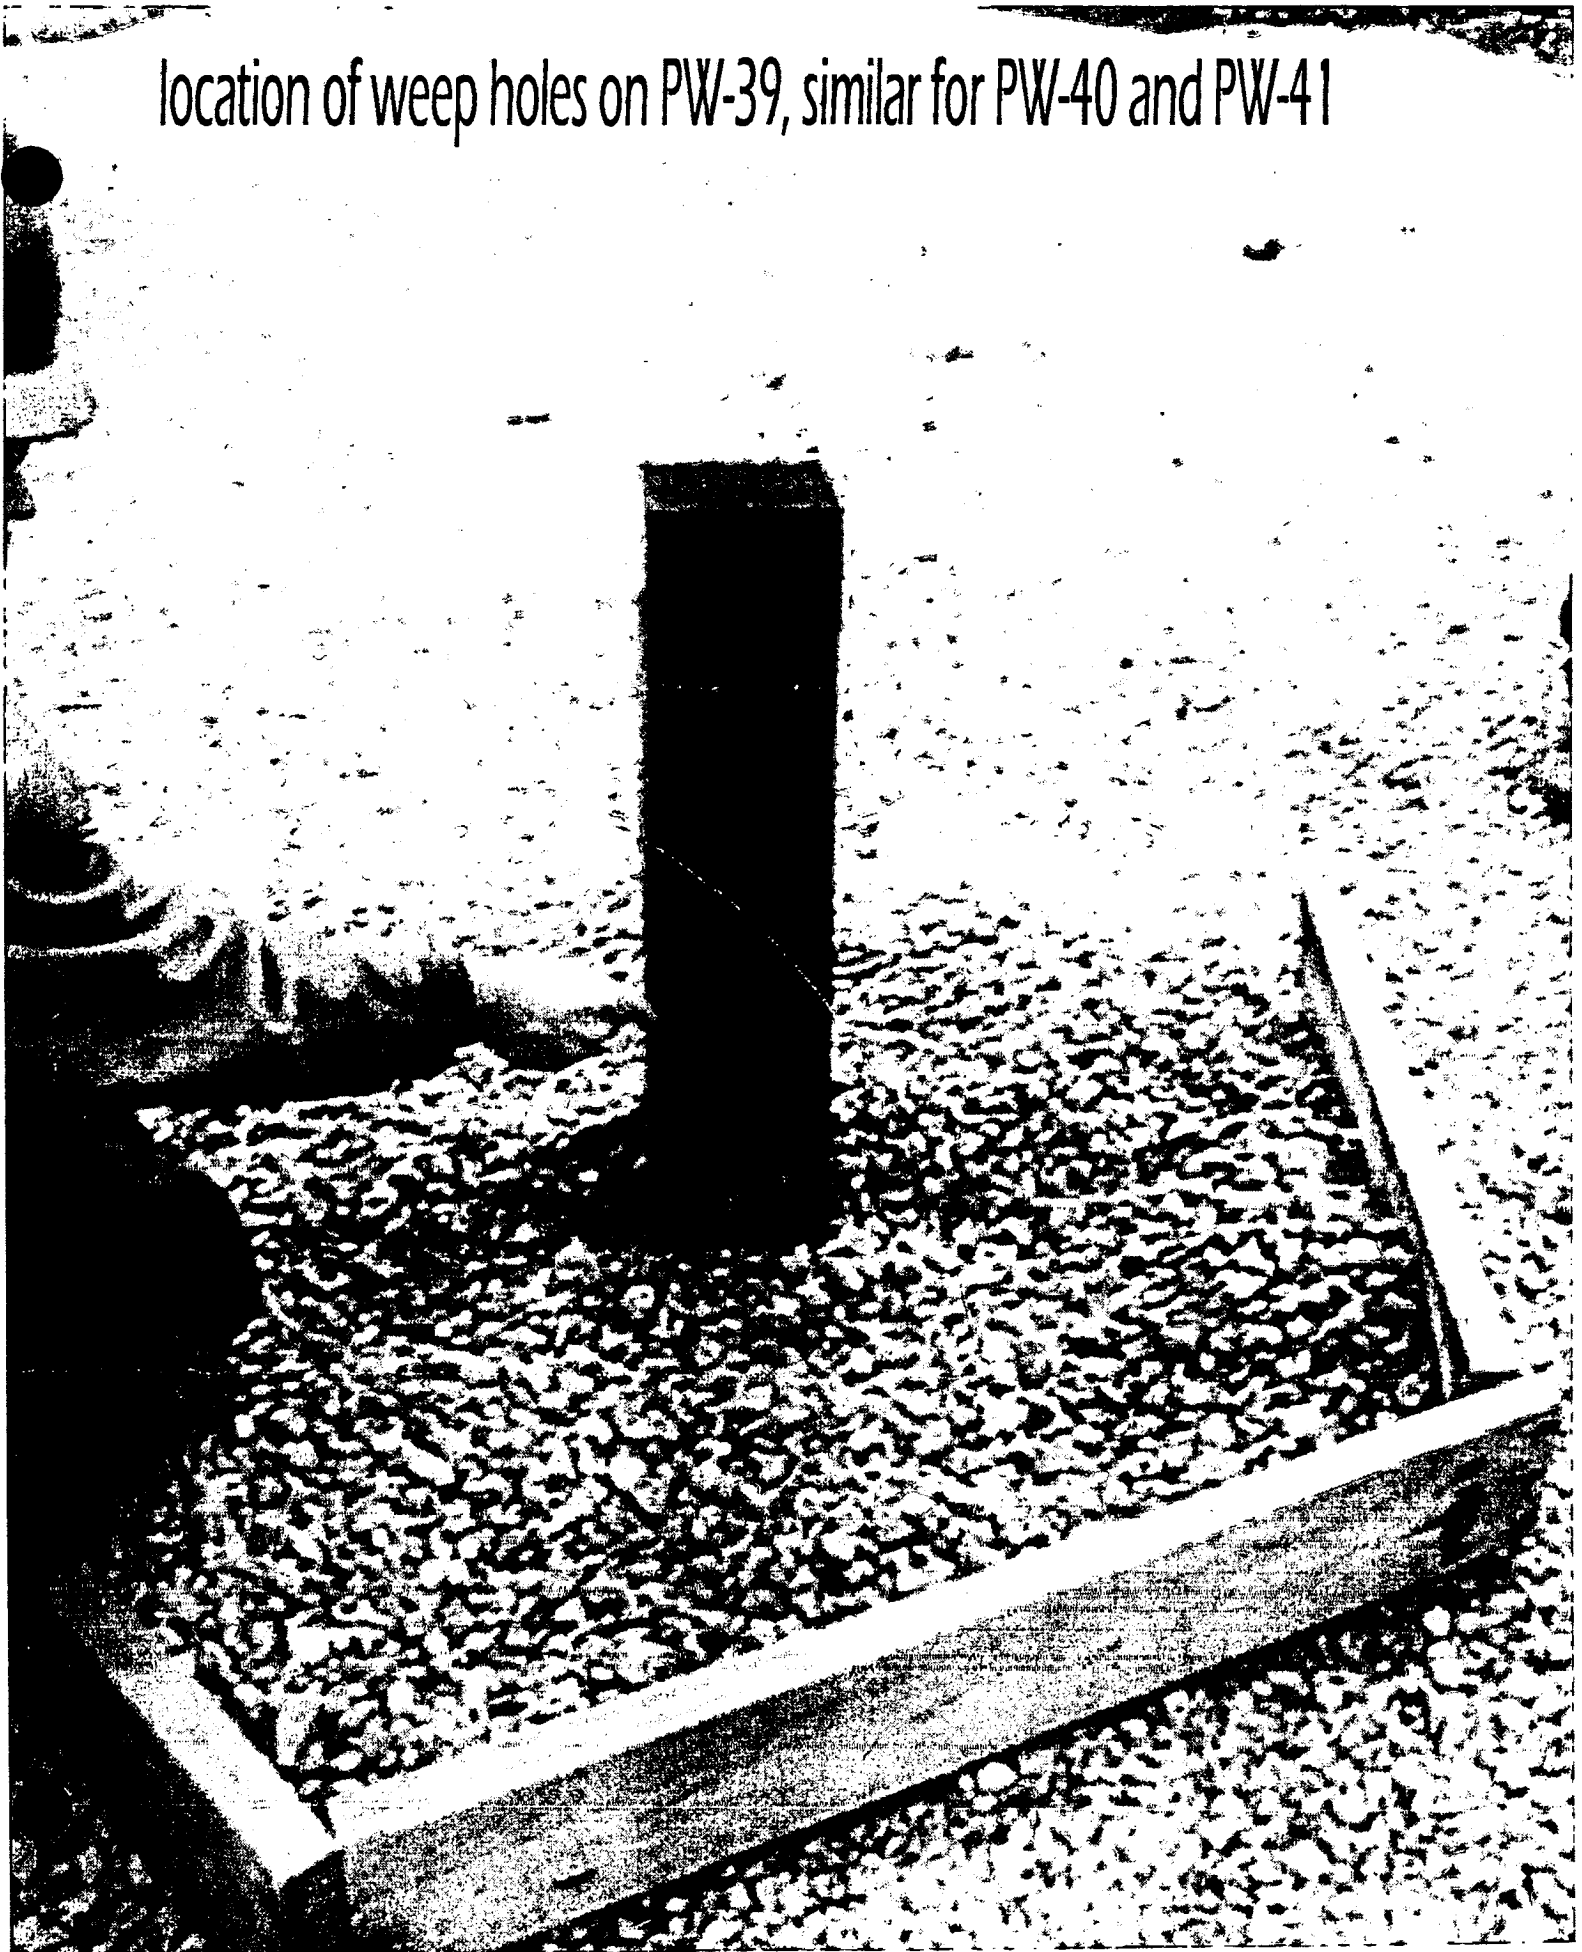
The concrete used in the surface completion of wells PW-39, PW-40 and PW-41 does not extend to the finished grade. I assume that the concrete for the surface completion and weep hole location were estimated as the finished grade apparently had not been placed at the completion point. The surface completion had been boxed in with lumber and large gravel was used to bring the area around the well to surface grade level (see accompanying photos).

location of weep holes on PW-39, similar for PW-40 and PW-41

For these three wells to be certified the concrete surface completion will have to be brought up to slightly above level with the current finished grade, with the concrete sloping slightly away from the protective casing. Also the current weep holes should be sealed with a waterproof sealant or welded over and new ones drilled in the proper location. Upon completion of the remediations, please contact this office and the wells will be certified.
