May 2013

# DRY BAYOU – THOMPSON BEND

# DRY BAYOU – THOMPSON BEND REPORT

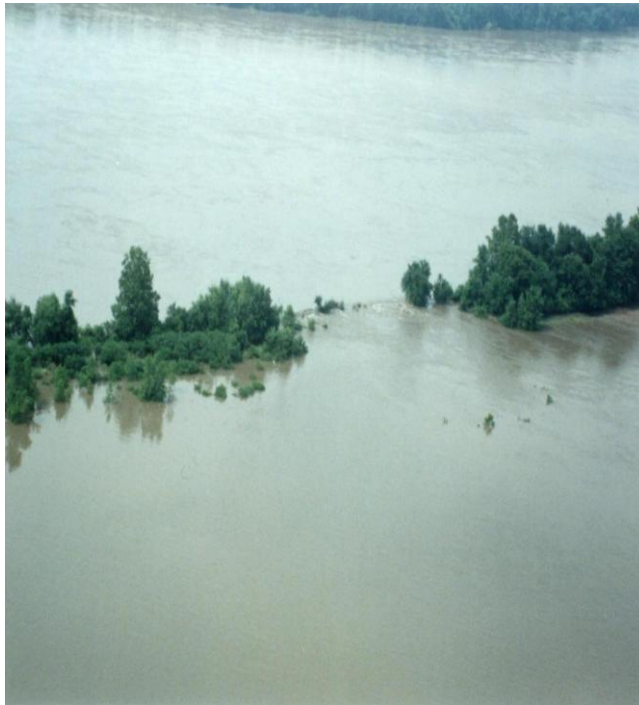
**Figure 13: Hillhouse Break 3 During 1993 Flood**

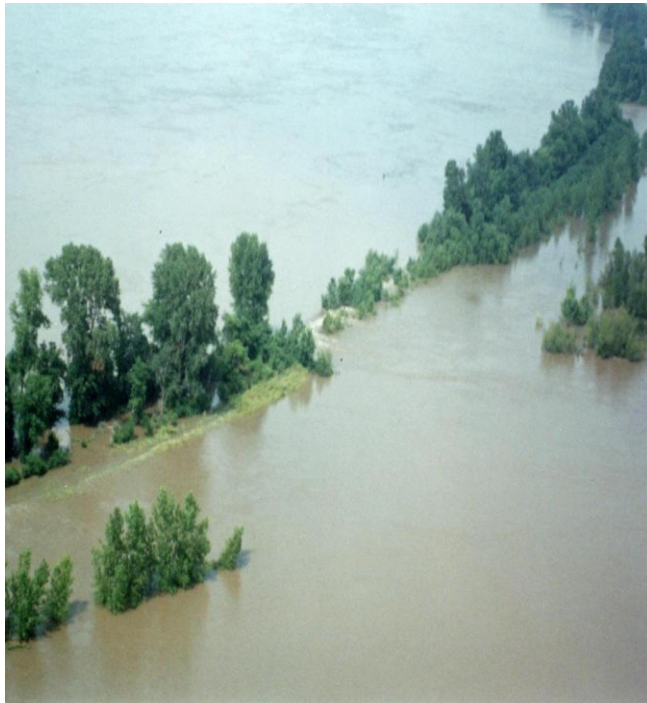
**Figure 14: Hillhouse Break 4 During 1993 Flood**

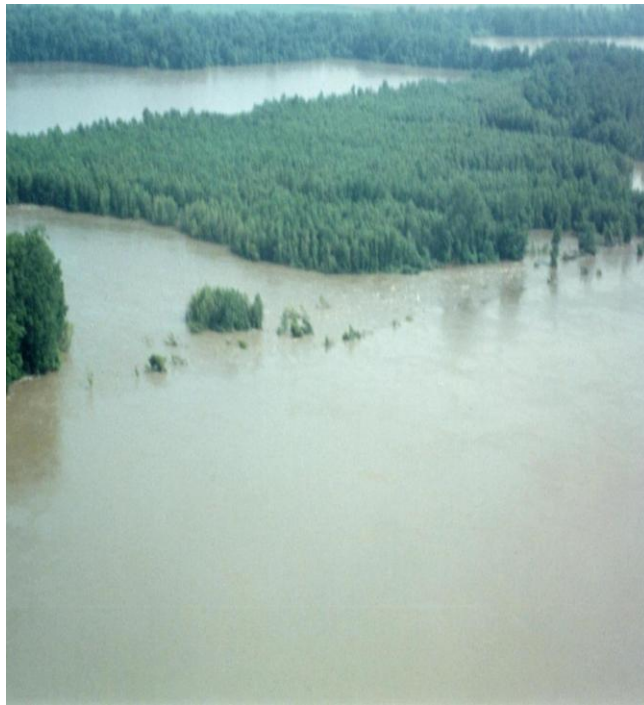
**Figure 15: Private Levee Breach at Original Dry Bayou During 1993 Flood**

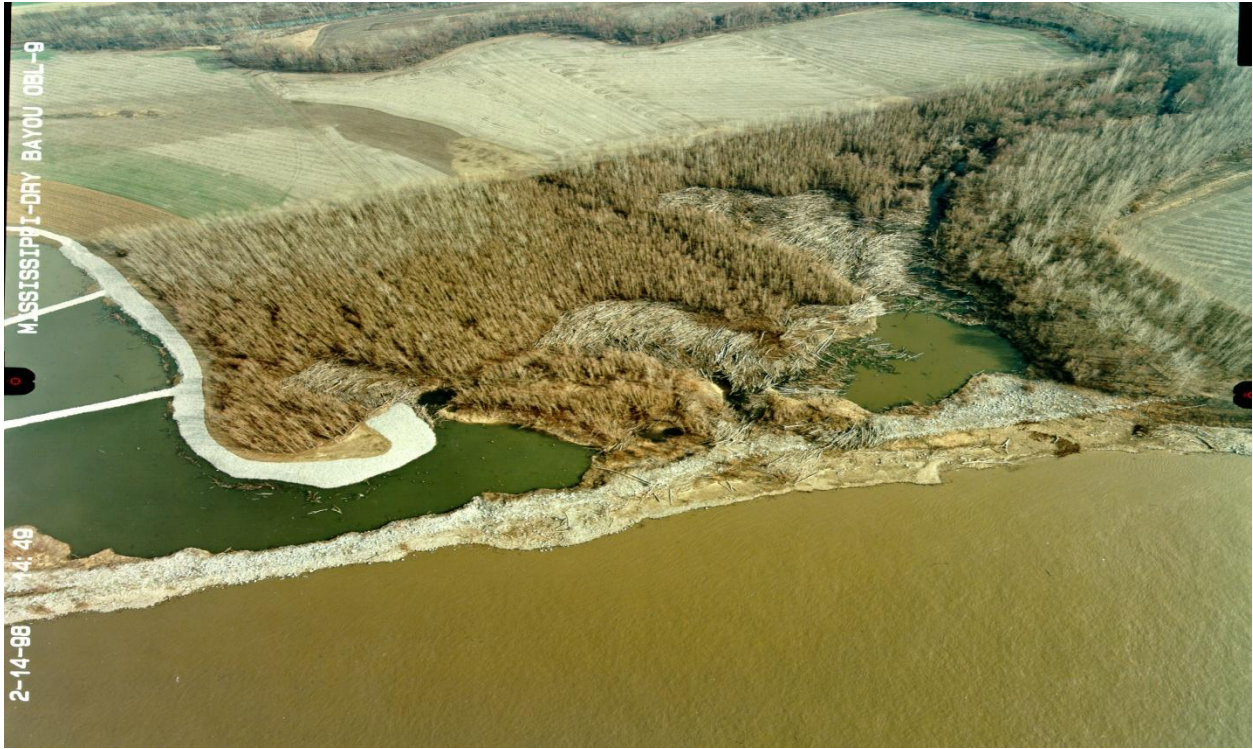
**Figure 25: Dry Bayou Revetment February 1998 (demonstrating effective tree screen reducing scour)**

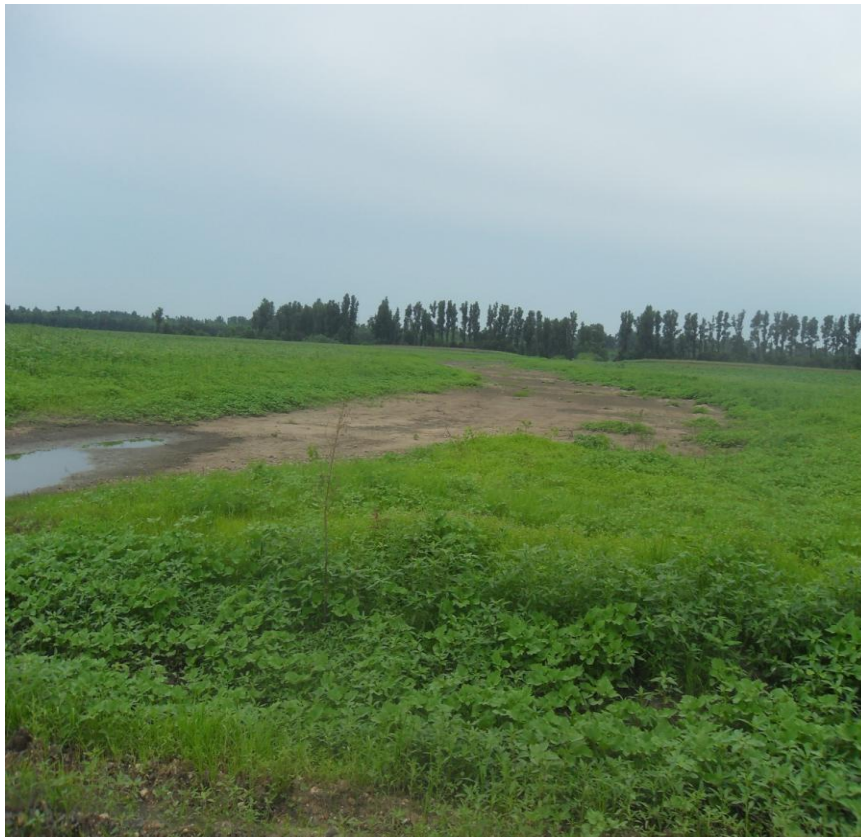
There were some damages noted after the flood event. Some additional scour was noted in low lying areas of the peninsula and there was some erosion on the bank line between RM 10 and RM 9. See Figure 35 and 36.

**Figure 35: Scour in Low Lying Area of Peninsula after 2011 Flood**

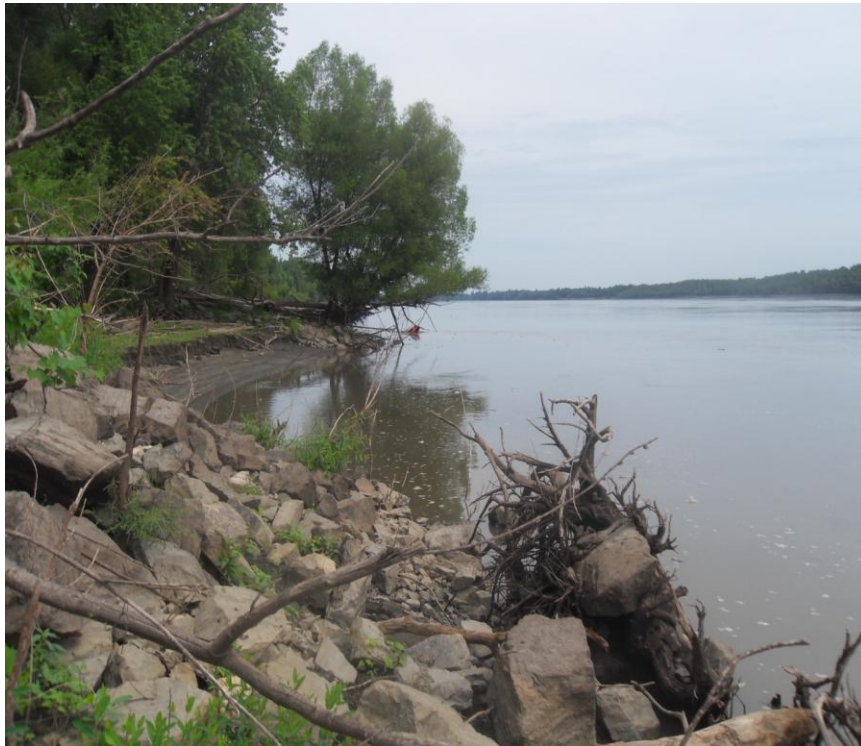
**Figure 36: Bank Erosion between RM 10 and RM 9 after 2011 Flood**
