Upper Joachim Creek

VALLE LAKE DAM
JEFFERSON COUNTY, MISSOURI
MO. 30438

PHASE I INSPECTION REPORT
NATIONAL DAM SAFETY PROGRAM

PREPARED BY: U. S. ARMY ENGINEER DISTRICT, ST. LOUIS

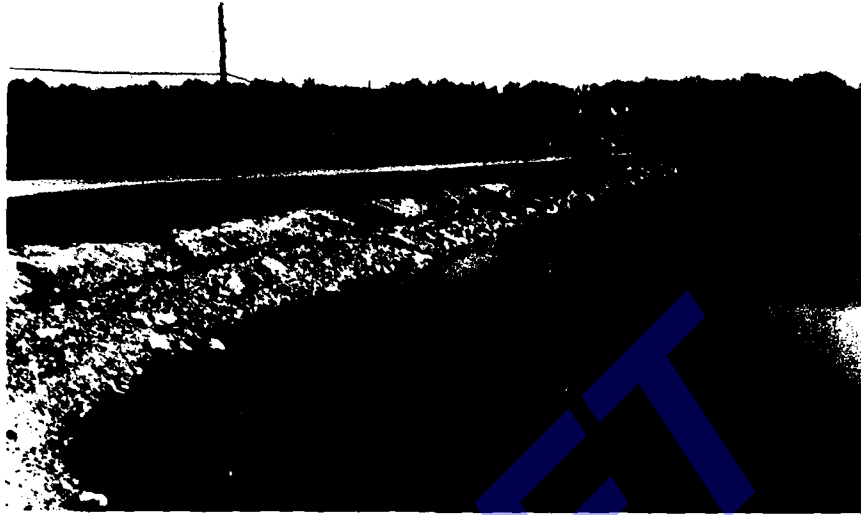
The upstream slope was protected from erosion due to wave action by riprap consisting of dolomite stones ranging in size from three inches to three feet in diameter. The riprap appeared to be providing adequate protection; however, some very minor wave erosion was observed above the riprap. No deterioration of the riprap was observed. The sand and gravel berm on the slope appears to have been added after the construction of the dam and has little or no effect on the stability or safety of the dam. The slope above the riprap supported a sparse growth of grass. The grass cover, however, did appear to provide adequate protection against erosion due to surface runoff for the slope for no erosion was observed. No bulges, depressions or cracks indicating an instability of the embankment or foundation were observed on the slope. The effect of drawing down the reservoir has had no apparent effect on the stability of the embankment.

Photo 1 - View of the upstream slope from the left abutment.

7. The minor wave erosion on the upstream slope should be monitored, and, if the erosion continues, protective measures should be employed to protect the slope from further damage.

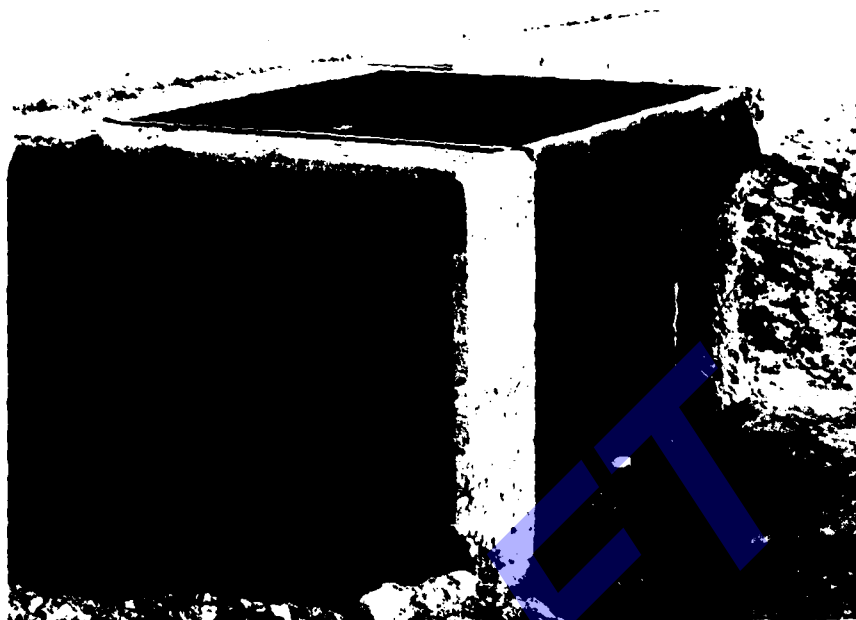
The front edge of the right sidewall has partially disintegrated into the stoplog slot (see Photo 7). No reinforcement was evident. The remaining concrete surfaces appeared stable with minor weathering observed. A small amount of debris was seen in the bottom of the drop inlet; however, the spillway was operating on the day of the inspection. It appears that some repair work was done

1. The disintegration of the principal spillway right sidewall does not presently affect the safety of the dam. Further deterioration will preclude the use of the stoplog slot and the reservoir regulation that the drop inlet provides will be lost. The complete failure of the wall could impair the functioning of the spillway and thus imperil the safety of the dam.

Photo 7 - Close-up view of the principal spillway drop inlet showing the concrete deterioration of the stoplog slot.

1. Further investigation of the three areas of seepage and possible seepage observed along the downstream slope should be undertaken to determine the seriousness of the condition. The investigation should be carried out under the direction of a qualified professional engineer and repairs made as required.
2. The damage to the principal spillway drop inlet sidewall should be repaired.
