APPENDIX E

North Main Street at De Soto, Missouri Interior Drainage

1.0 Background and Issues

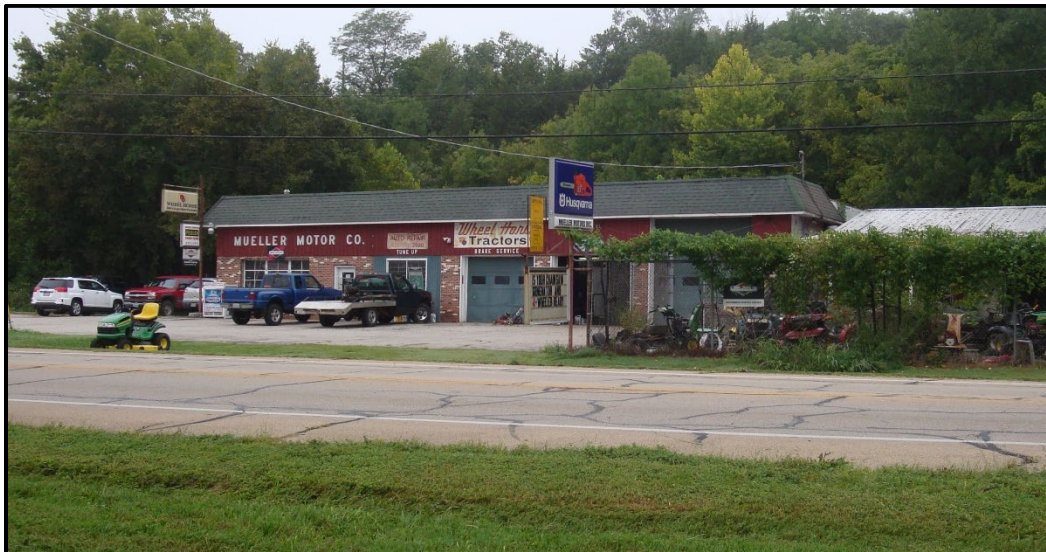
Figure 1
View of 1800 North Main Street, De Soto, MO

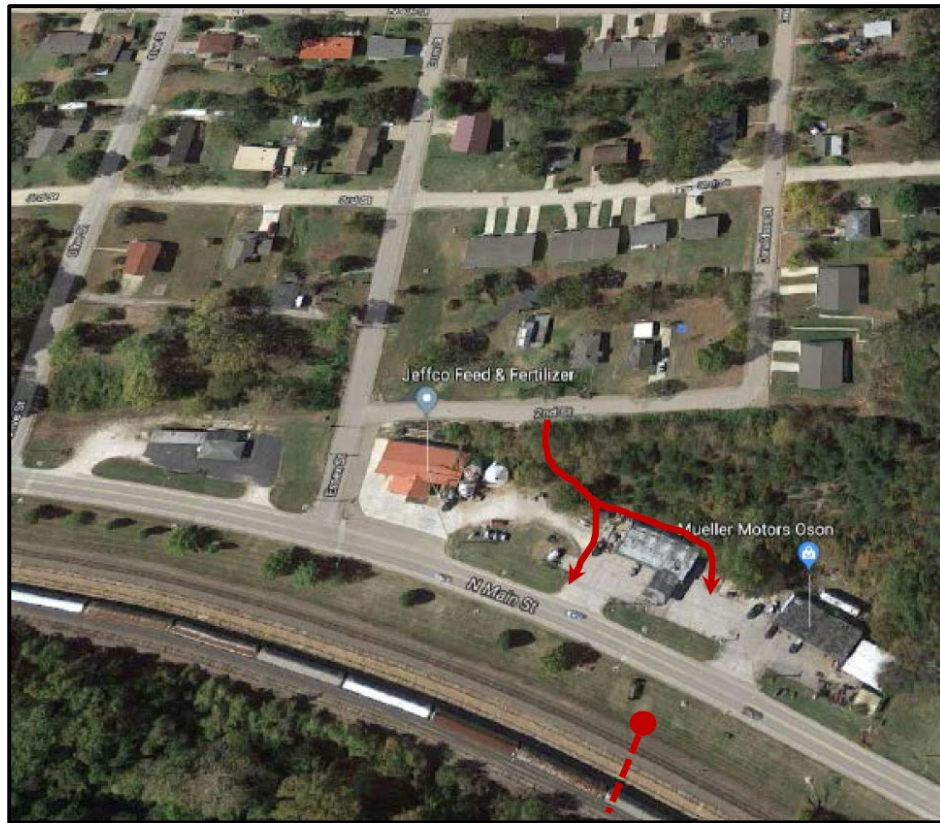
A portion of this residential development is shown in Figure 2. While there are many rooftops, driveways, and paved streets, there appears to be no storm water drainage system to collect and convey all of the runoff from the subdivision into Joachim Creek. According to the structure and business owners, runoff is conveyed overland, as depicted in Figure 2 with the “red” arrows, and impacts the structure during intense rainfall events. Additionally, some runoff near the southern side of this subdivision is collected by a storm water system and conveyed through and discharged out of a 36-inch corrugated plastic pipe between North Main Street and the railroad embankment, as shown in Figure 3. A concrete box culvert, located beneath the railroad embankment conveys flows from North Main Street area into Joachim Creek. The box culvert is shown on Figure 3 as the “red” circle and dashed line running beneath the embankment to Joachim Creek.

Figure 2
Aerial View of Subdivision and Overland Flow near 1800 North Main Street

Flood Source	Recommendation
Joachim Creek	Requires analysis of installation of flap gate or slide gate on outlet of concrete box culvert.
Storm Water System	Interior drainage issue. Requires analysis of system capacity at railroad box culvert.
Overland Flow	Interior drainage issue. Requires analysis of redirecting runoff into storm water system.

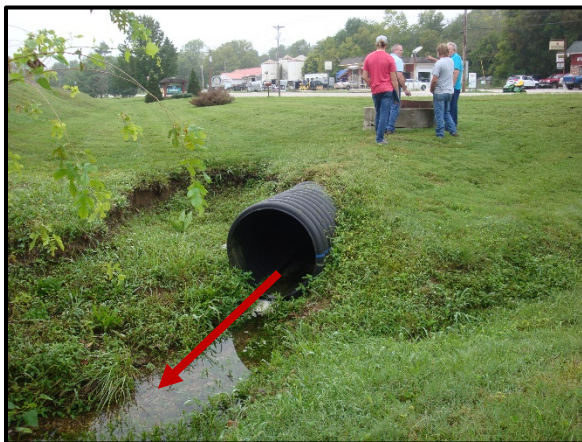
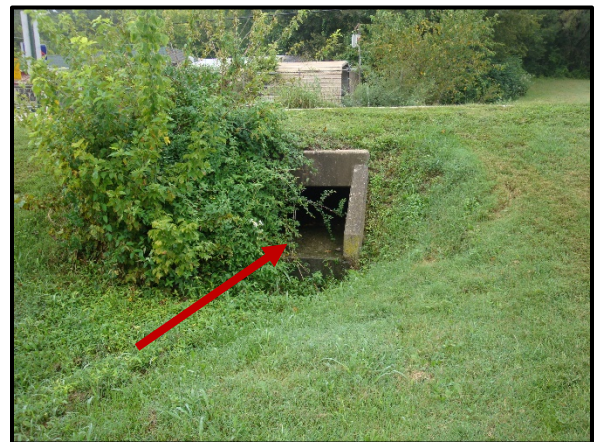
According to the owners, the interior drainage from the subdivision which is conveyed through the 36-inch pipe is directed at the box culvert, which is approximately 30-inch by 30-inch with vegetation located at the culvert entrance. During intense rainfall events, the discharge from the 36-inch pipe will back-up at the box

culvert, ponding water and eventually spreading across North Main Street to the structure. The situation is exacerbated as additional runoff from the subdivision flows overland in the vicinity of the structure.

Figure 3
View of Storm Water Drain Outlet and Box Culvert Entrance near 1800 North Main Street

It was also reported that on occasion, as Joachim Creek begins to flood, water from the creek will back through the box culvert and begin ponding in the vicinity of North Main Street. No flap gate or slide gate were identified at the box culvert to prevent Joachim Creek from flowing through the culvert during flood events.

The owners were adamant that the discharge of storm water from the subdivision combined with overland runoff in the vicinity of the structures was resulting in increased flood risk for their structures which was their primary concern. The storm water discharge is apparently exceeding the capacity of the box culvert to adequately convey flows into Joachim Creek. Their second concern was that Joachim Creek appeared to reach flood stage more frequently than it had in the past, and that some of the flows were being conveyed back through the box culvert, unimpeded, toward North Main Street and their structures.
