## GUIDANCE FOR CCTV AND SONAR INSPECTION PIPES PENETRATING LEVEES

FEBRUARY 2013

## Flood Wall / Inspection: Gate 150

Surveyor [REDACTED]	Contract [REDACTED]	Job No. 4867-2	Catchment Gate 150	Certificate Number [REDACTED]	
Date 11/5/2009	Time 12:36:53	Location DIXIE

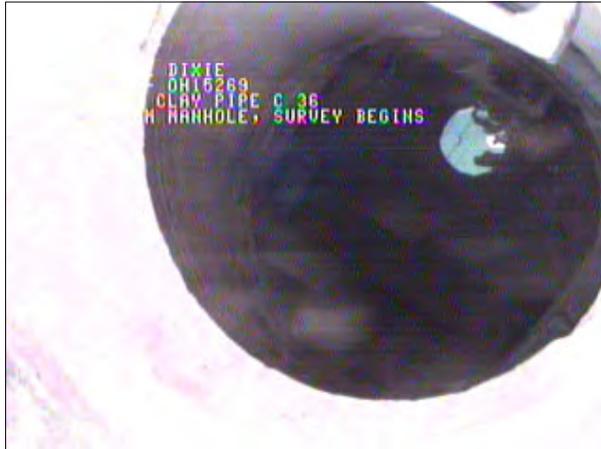
Photo: OH15269\_OH15266123825\_05112009\_A.JPG, VCR No.: FLOOD WALL#2, 01:42:22  
0FT, Downstream Manhole, Survey Begins

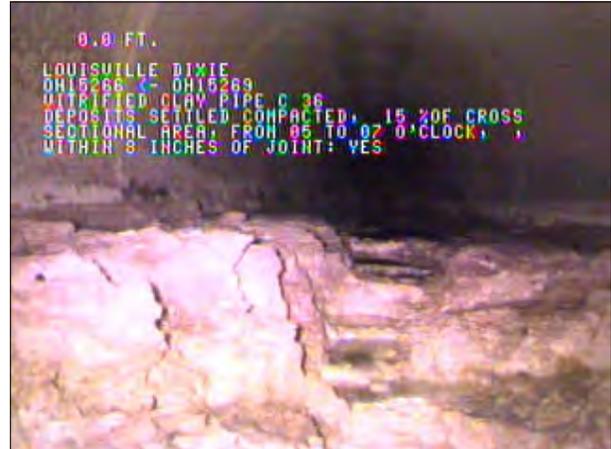
0.00	DSC	Deposits Settled Compacted, 15 %of cross sectional area, from 05 to 07 o'clock, , within 8 inches of joint: YES	00:01:06	65_3A	M 3
	28.80	MWLS	Water Level, Sag in pipe, 15 %of cross sectional area	00:02:29	65_4A	M 2

Photo: OH15269\_OH15266124326\_05112009\_A.JPG, VCR No.: FLOOD WALL#2, 01:42:36  
0FT, Deposits Settled Compacted, 15 %of cross sectional area, from 05 to 07 o'clock, , within 8 inches of joint: YES

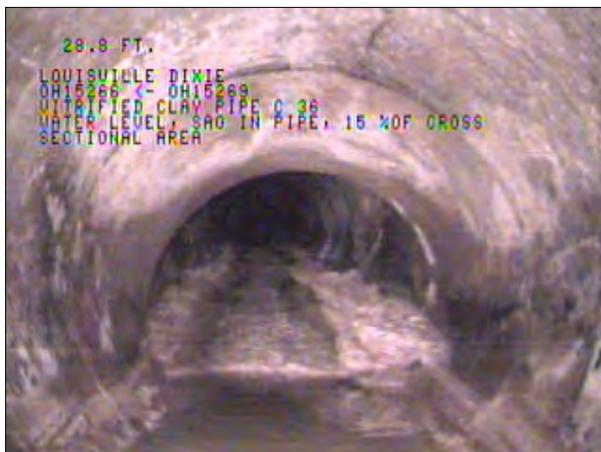
Photo: OH15269\_OH15266124455\_05112009\_A.JPG, VCR No.: FLOOD WALL#2, 01:43:58  
28.8FT, Water Level, Sag in pipe, 15 %of cross sectional area

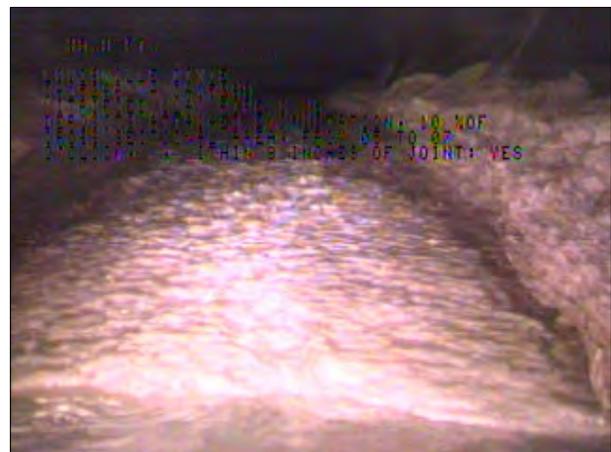
35.80	DAE	Deposits Attached Encrustation, 10 %of cross sectional area, from 05 to 07 o'clock, , within 8 inches of joint: YES	00:02:43	65_5A	M 2
	37.90	CM	Crack Multiple, from 09 to 03 o'clock, within 8 inches of joint: YES	00:02:55	65_6A	S 3

Photo: OH15269\_OH15266124520\_05112009\_A.JPG, VCR No.: FLOOD WALL#2, 01:44:10  
35.8FT, Deposits Attached Encrustation, 10 %of cross sectional area, from 05 to 07 o'clock, , within 8 inches of joint: YES

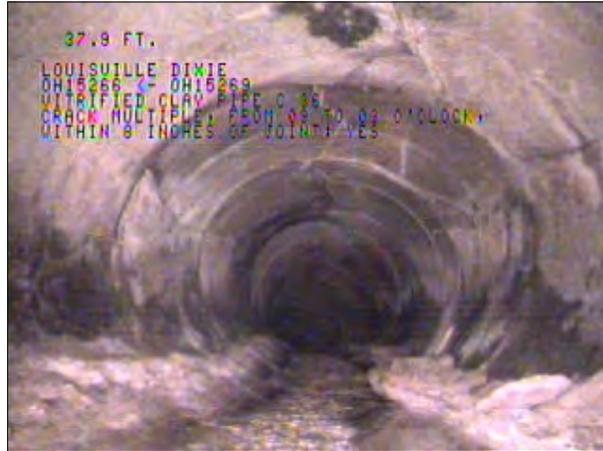
Photo: OH15269\_OH15266124541\_05112009\_A.JPG, VCR No.: FLOOD WALL#2, 01:44:21  
37.9FT, Crack Multiple, from 09 to 03 o'clock, within 8 inches of joint: YES

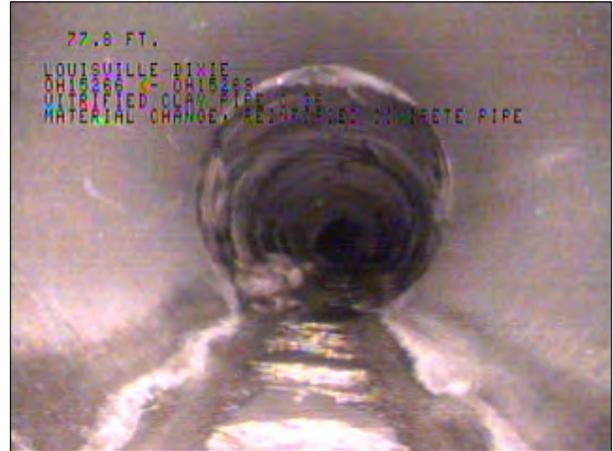
Photo: OH15269\_OH15266124720\_05112009\_A.JPG, VCR No.: FLOOD WALL#2, 01:45:49  
77.8FT, Material Change, Reinforced concrete pipe

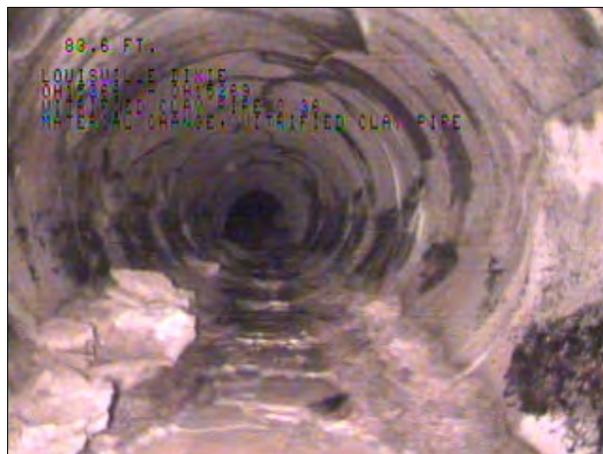
Photo: OH15269\_OH15266124748\_05112009\_A.JPG, VCR No.: FLOOD WALL#2, 01:46:07  
83.6FT, Material Change, Vitrified clay pipe

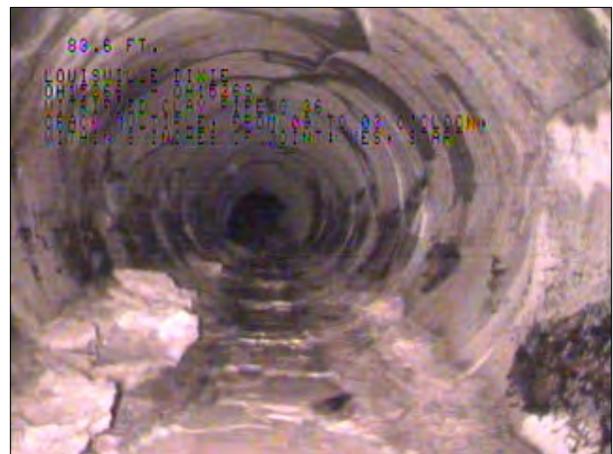
77.80	MMC	Material Change, Reinforced concrete pipe	00:04:24	65_7A	
	83.60	MMC	Material Change, Vitrified clay pipe	00:04:43	65_8A	
	83.60	S1 CM	Crack Multiple, from 09 to 03 o'clock, within 8 inches of joint: YES, Start	00:04:50	65_9A	S 3

Photo: OH15269\_OH15266124807\_05112009\_A.JPG, VCR No.: FLOOD WALL#2, 01:46:12  
83.6FT, Crack Multiple, from 09 to 03 o'clock, within 8 inches of joint: YES, Start

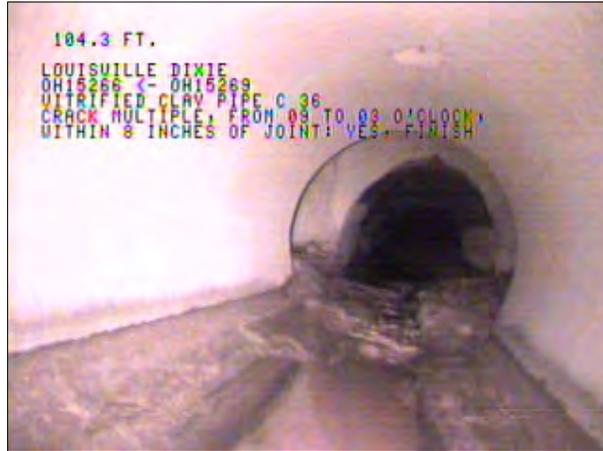
104.30	F1 CM	Crack Multiple, from 09 to 03 o'clock, within 8 inches of joint: YES, Finish	00:05:27	65_10A	S 3
	104.30	MMC	Material Change, Reinforced concrete pipe	00:05:34	65_11A

Photo: OH15269\_OH15266124848\_05112009\_A.JPG, VCR  
No.: FLOOD WALL#2, 01:46:48  
104.3FT, Crack Multiple, from 09 to 03 o'clock, within 8 inches of joint: YES, Finish

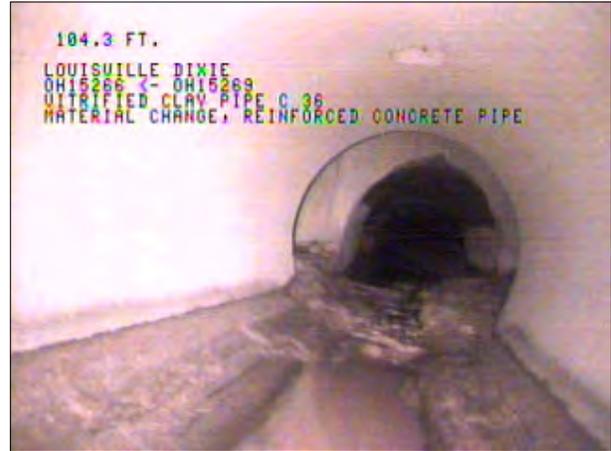
Photo: OH15269\_OH15266124907\_05112009\_A.JPG, VCR  
No.: FLOOD WALL#2, 01:46:54  
104.3FT, Material Change, Reinforced concrete pipe

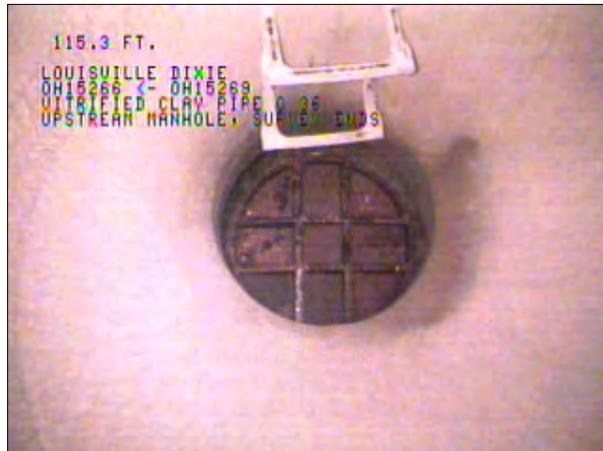
Photo: OH15269\_OH15266124956\_05112009\_A.JPG, VCR  
No.: FLOOD WALL#2, 01:47:25  
115.3FT, Upstream Manhole, Survey Ends
