**APPENDIX III  
DESIGN NARRATIVE FOR THE  
CARLYLE LAKE ADMINISTRATION BUILDING**

**APPENDIX III-A**  
**REPORT ON EXISTING ADMINISTRATION FACILITIES**

# CARLYLE ADMINISTRATION BUILDING

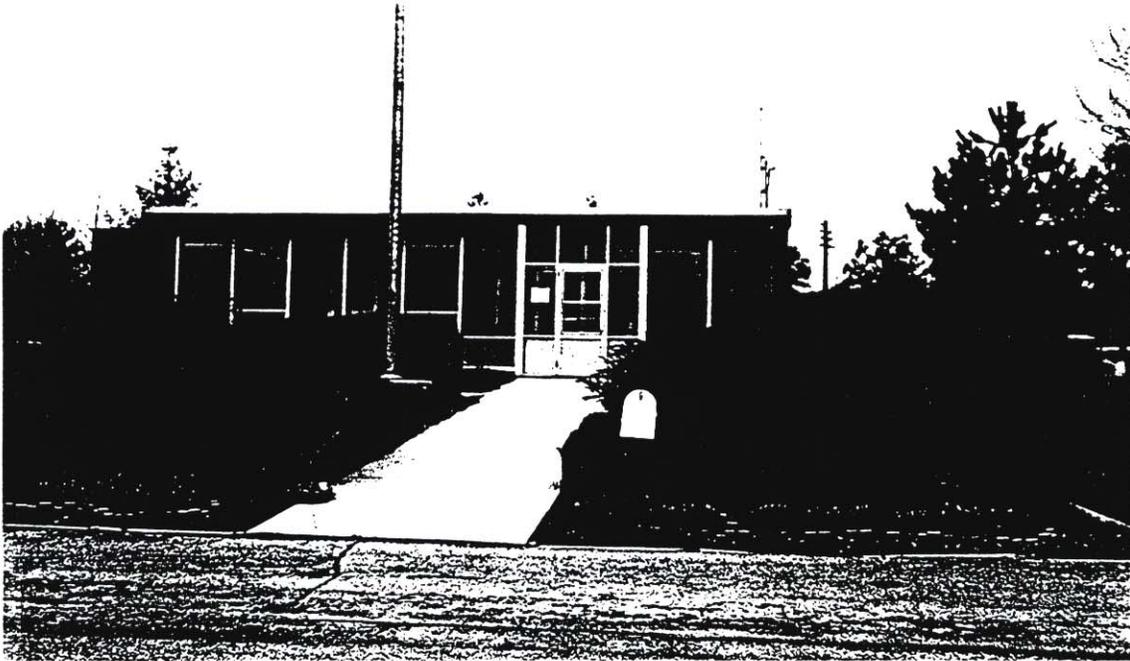
ADMINISTRATION BUILDING - East Side. The vestibule is approximately 8 feet wide by 4 feet deep. When the 3'-0" interior door is in the open position there is only 12 inches of clearance remaining between the end of the door and the outer wall. In addition, the two doors are offset.

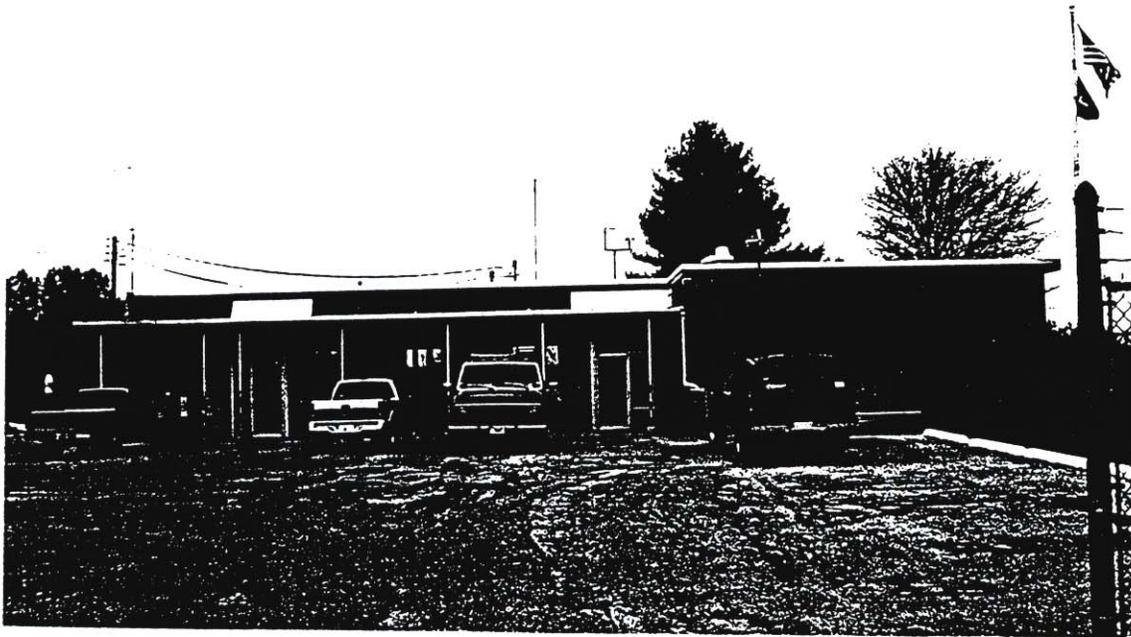
ADMINISTRATION BUILDING - South Side. Administration area at the right and original garage to the left. Note change in the ground line. The same elevation change occurs inside the building and the corridor is connected by a stair.

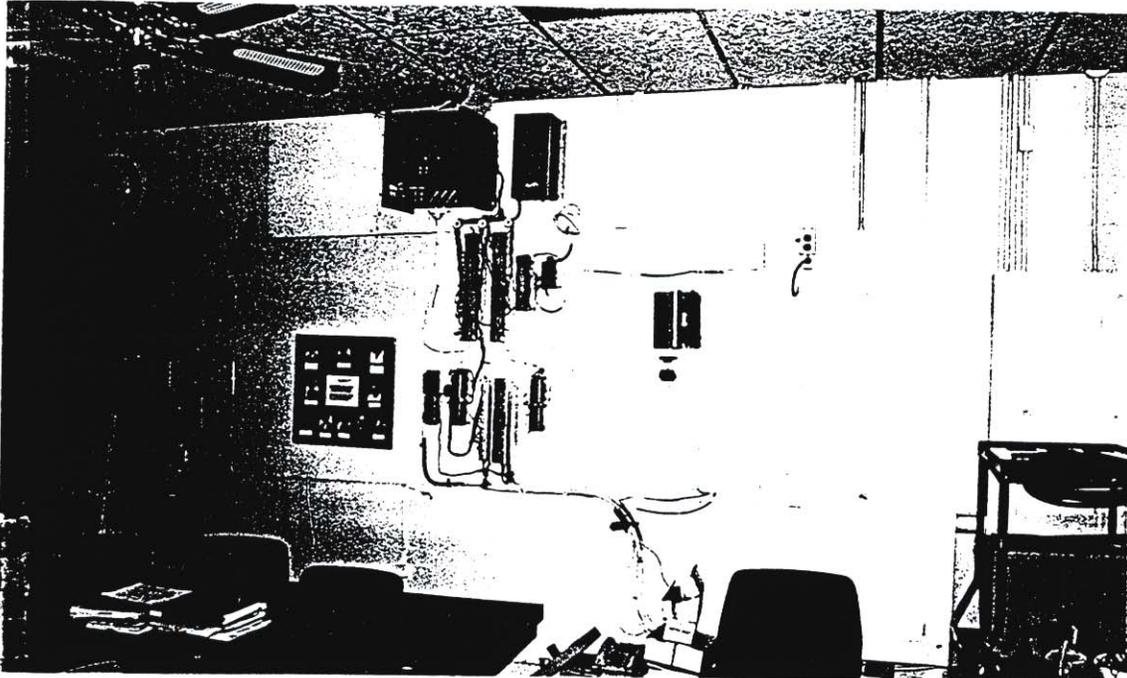
ADMINISTRATION BUILDING - Lower Level Meeting Area. Note the exposed telephone switches and the incoming electrical service panels on the wall behind the table. The meeting room is shared with two employee work areas. Note the ceiling fan for air circulation.

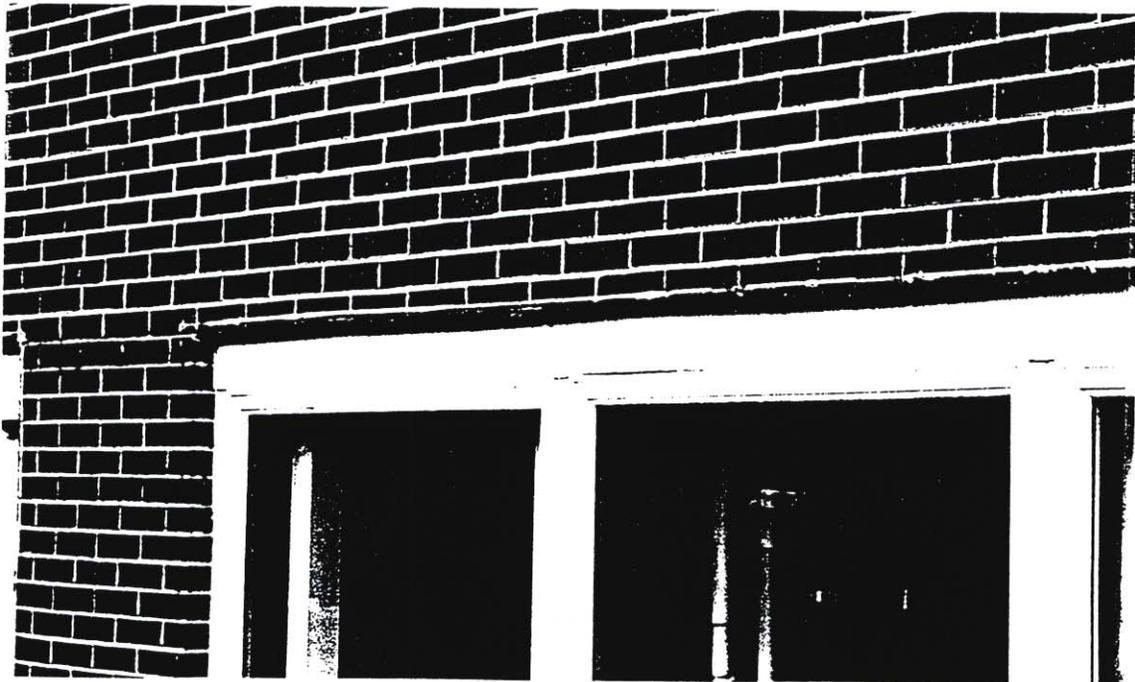
ADMINISTRATION BUILDING - North Side. Window head is a source of water penetration into the building.

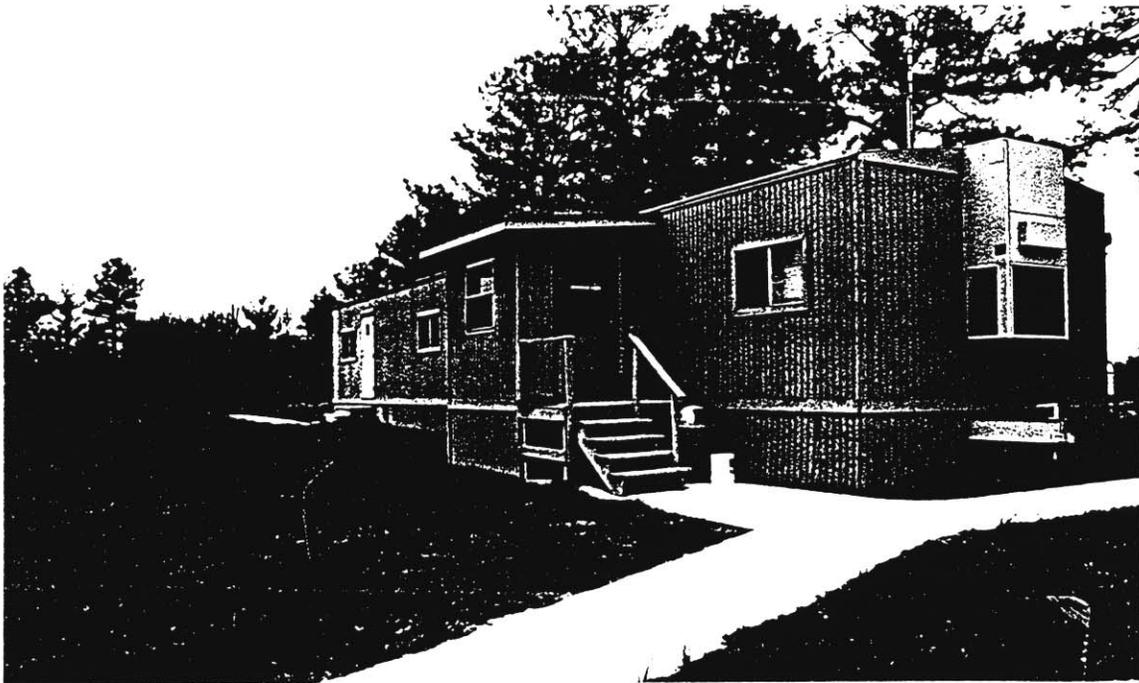
TRAILER - South Side. The floor of the trailer sits approximately 3 feet above the ground sidewalk. The elevated location requires one to climb steps. The unisex restroom inside is inaccessible.

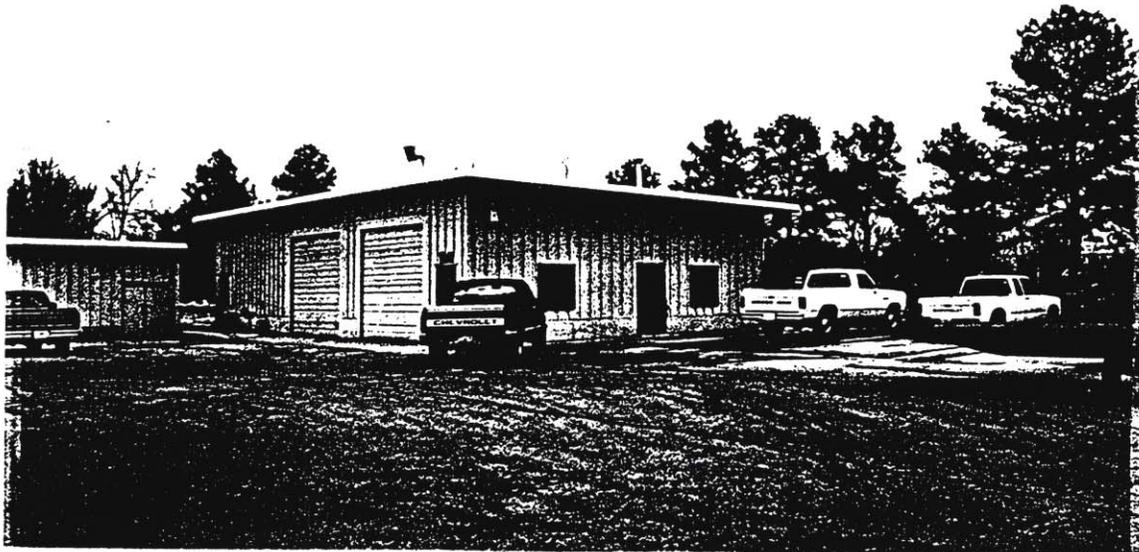
MAINTENANCE/GARAGE BUILDING - Office Area South Side. Overcrowded conditions at the administration headquarters require some office workers to be located in the Southern part of the building. The building does not have running water or toilet facilities.
