## GUIDANCE FOR CCTV AND SONAR INSPECTION PIPES PENETRATING LEVEES

FEBRUARY 2013

## Flood Wall / Inspection: Gate 150

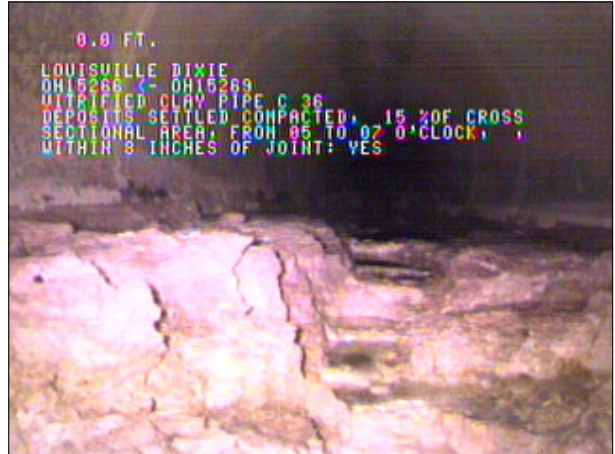
0.00	DSC	Deposits Settled Compacted, 15 %of cross sectional area, from 05 to 07 o'clock, , within 8 inches of joint: YES	00:01:06	65_3A	M 3
	28.80	MWLS	Water Level, Sag in pipe, 15 %of cross sectional area	00:02:29	65_4A	M 2

Photo: OH15269\_OH15266124326\_05112009\_A.JPG, VCR No.: FLOOD WALL#2, 01:42:36  
0FT, Deposits Settled Compacted, 15 %of cross sectional area, from 05 to 07 o'clock, , within 8 inches of joint: YES

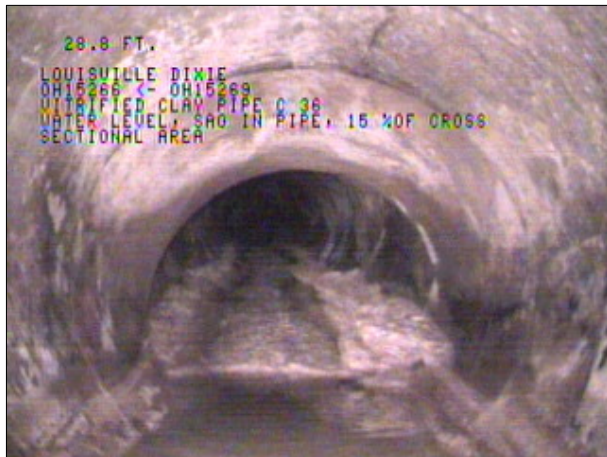
Photo: OH15269\_OH15266124455\_05112009\_A.JPG, VCR No.: FLOOD WALL#2, 01:43:58  
28.8FT, Water Level, Sag in pipe, 15 %of cross sectional area

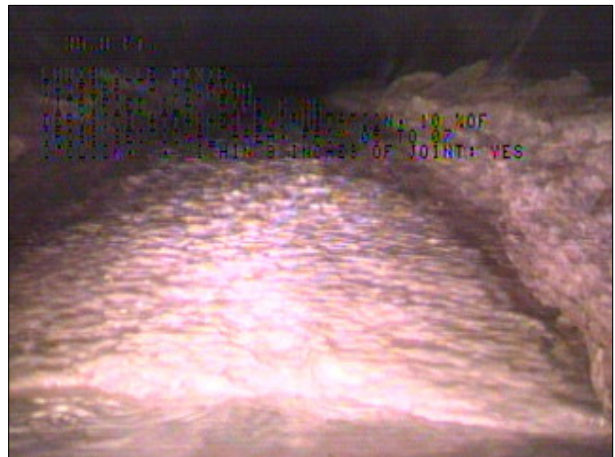
35.80	DAE	Deposits Attached Encrustation, 10 %of cross sectional area, from 05 to 07 o'clock, , within 8 inches of joint: YES	00:02:43	65_5A	M 2
	37.90	CM	Crack Multiple, from 09 to 03 o'clock, within 8 inches of joint: YES	00:02:55	65_6A	S 3

Photo: OH15269\_OH15266124520\_05112009\_A.JPG, VCR No.: FLOOD WALL#2, 01:44:10  
35.8FT, Deposits Attached Encrustation, 10 %of cross sectional area, from 05 to 07 o'clock, , within 8 inches of joint: YES

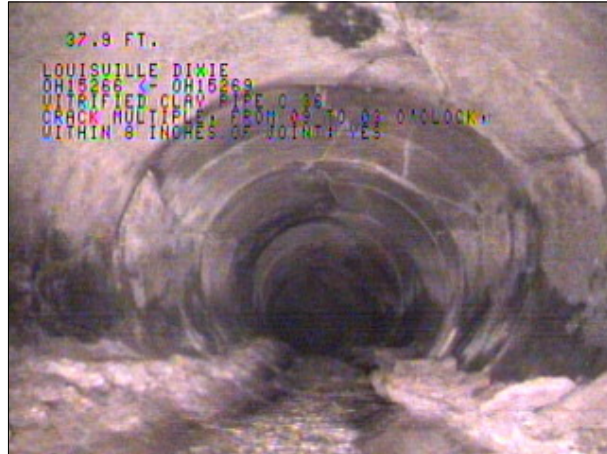
Photo: OH15269\_OH15266124541\_05112009\_A.JPG, VCR  
No.: FLOOD WALL#2, 01:44:21  
37.9FT, Crack Multiple, from 09 to 03 o'clock, within 8 inches of joint: YES

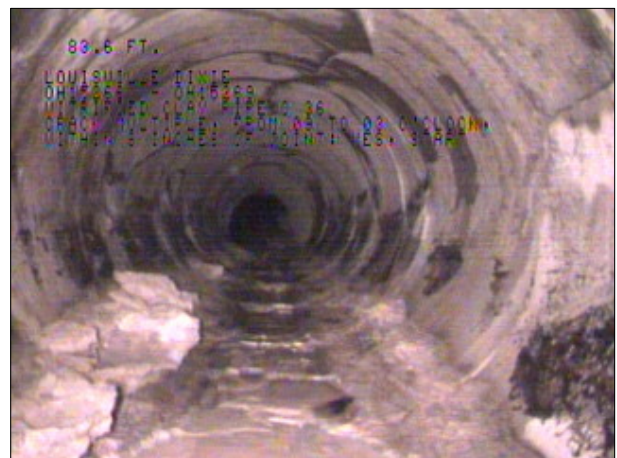
77.80	MMC	Material Change, Reinforced concrete pipe	00:04:24	65_7A	
	83.60	MMC	Material Change, Vitrified clay pipe	00:04:43	65_8A	
	83.60	S1 CM	Crack Multiple, from 09 to 03 o'clock, within 8 inches of joint: YES, Start	00:04:50	65_9A	S 3

Photo: OH15269\_OH15266124807\_05112009\_A.JPG, VCR  
No.: FLOOD WALL#2, 01:46:12  
83.6FT, Crack Multiple, from 09 to 03 o'clock, within 8 inches of joint: YES, Start

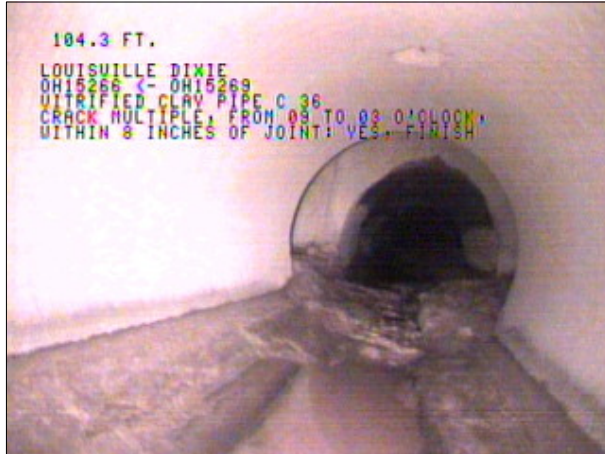
104.30	F1 CM	Crack Multiple, from 09 to 03 o'clock, within 8 inches of joint: YES, Finish	00:05:27	65_10A	S 3
	104.30	MMC	Material Change, Reinforced concrete pipe	00:05:34	65_11A

Photo: OH15269\_OH15266124848\_05112009\_A.JPG, VCR  
No.: FLOOD WALL#2, 01:46:48  
104.3FT, Crack Multiple, from 09 to 03 o'clock, within 8 inches of joint: YES, Finish
