Cahokia Heights & East St. Louis  
Flood Hazard Analysis  
(Floodplain Management Services -FPMS)

August 2023

Prepared by:  
U.S. Army Corps of Engineers  
St. Louis District  
1222 Spruce St  
St. Louis, MO 63103

## **Cahokia Heights & East St. Louis – Flood Hazard Analysis**

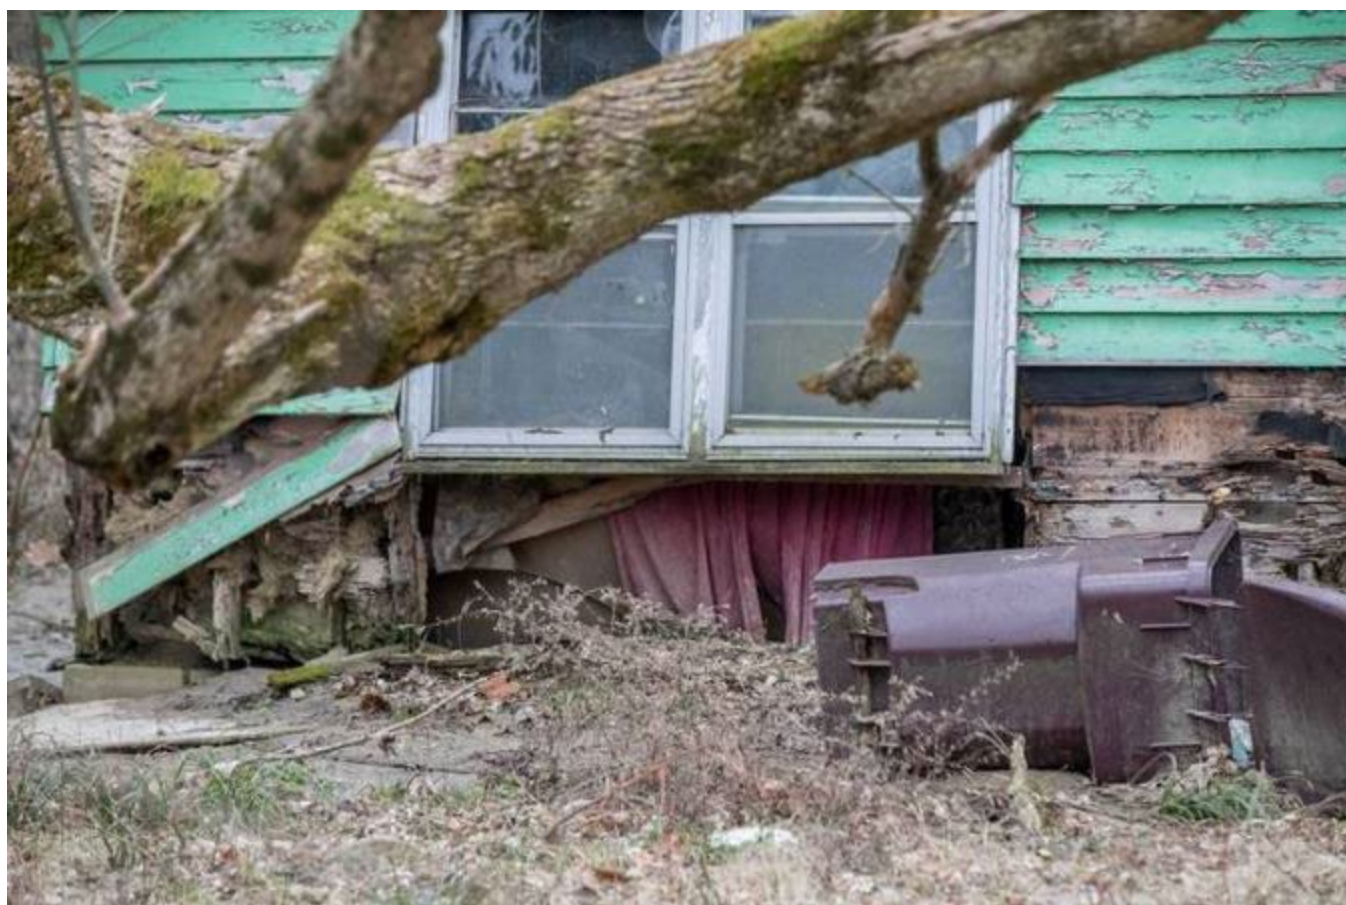
The impact of flooding to structures can be devastating. Repeated inundation can cause structures to develop mold and become structurally compromised.

*Figure 12: Water damage at a condemned home on Bellevue (Photo courtesy of Derik Holtmann - Belleville News Democrat)*

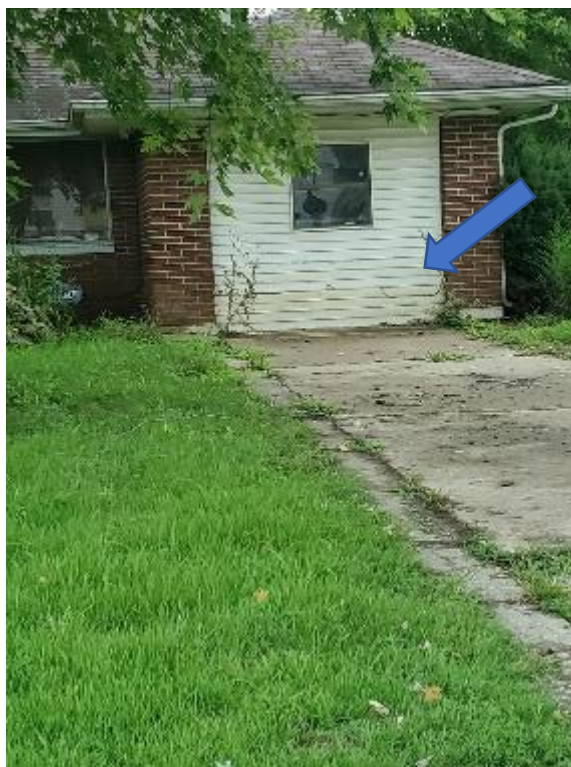
*Figure 13: Flood water mark on structure July 2022 (Photo courtesy of USACE)*

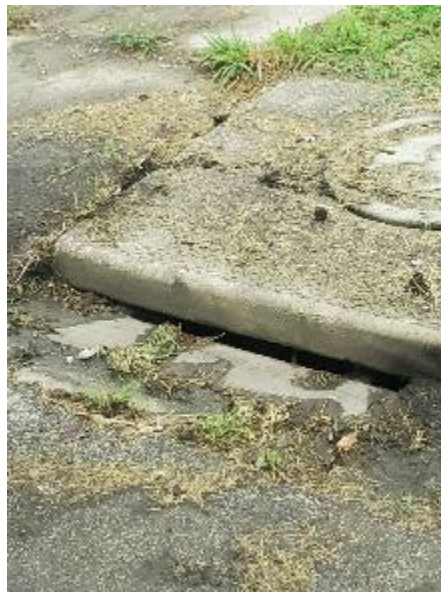
*Figure 16: Blocked storm sewer inlet July 2022 (Photo courtesy of USACE)*

While the storm sewer networks were likely adequate when initially designed and installed, continued development, in addition to more frequent and intense rain events, has made these undersized for current conditions.

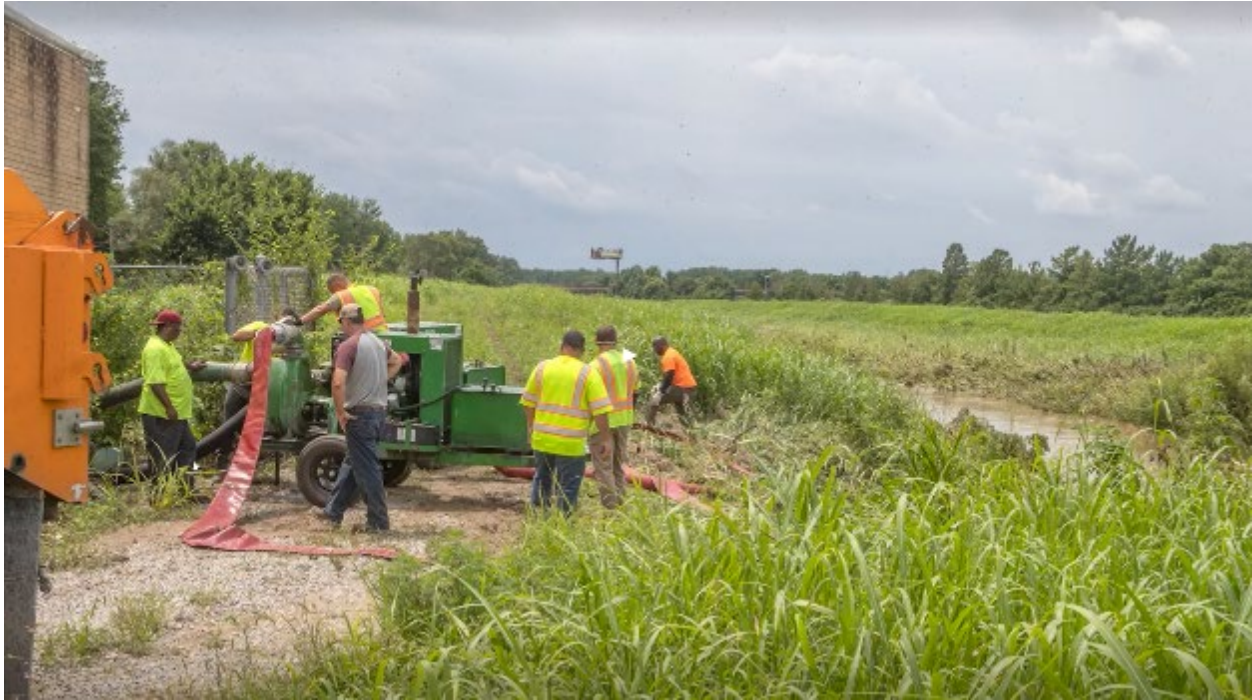
Parkside pump station does not currently operate at its fully designed capacity. During the July 2022 flood event it was noted by a pump station operator with the City of East St. Louis that the station was not keeping up with the incoming flows, and the pumps automatically shut off

*Figure 17: Parkside Pump Station- Crews Operating Portable Pumps Due to Pump Failure - July 2022 (Photo Courtesy of Belleville News Democrat)*

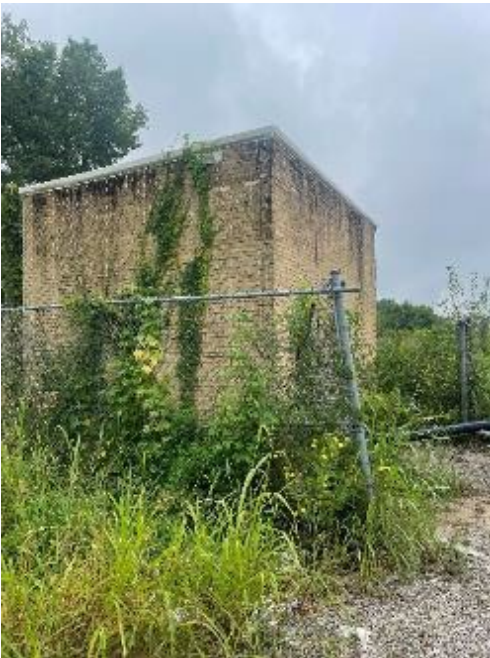
*Figure 18: Overgrown exterior of Parkside pump station. July 2022 (Photo courtesy of USACE)*

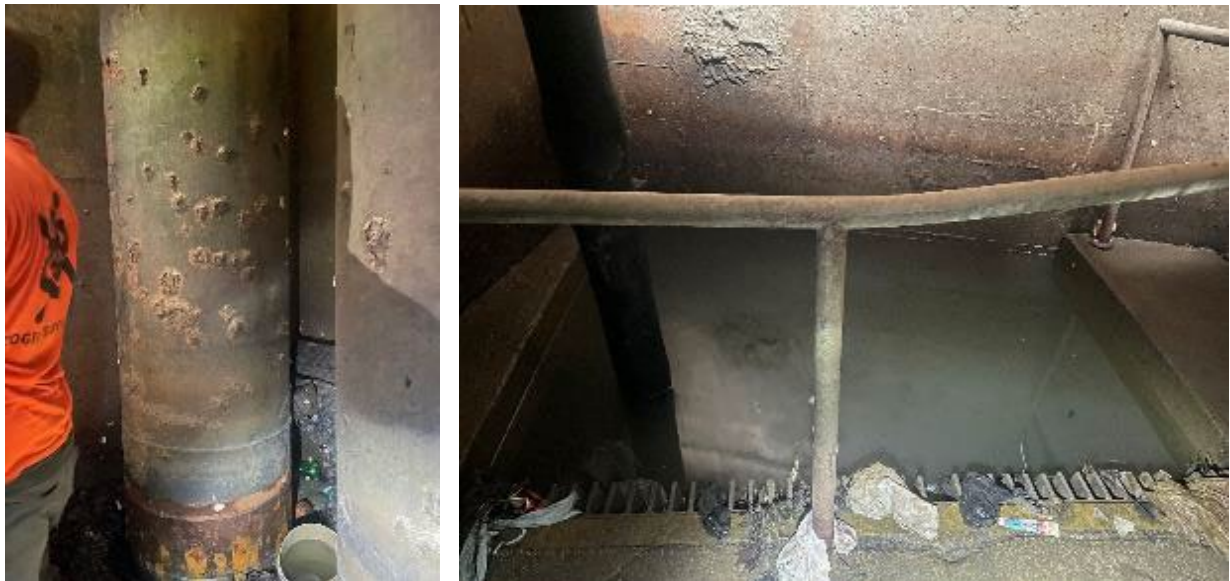
The sump of the station also features a trash rack to prevent large debris from entering and damaging the pump. During observation of the station, the trash rack was clogged with debris leading to an excessive amount of ponding in the sump. Clogged inlets can prevent proper flow to the pumps. It was also noted that two of the pumps have had debris clog their impeller, resulting in the need for rehab. Any type of damage to the pump impellers can lead to balancing and pumping issues and will affect the performance of the pumps. It is also assumed that the discharge system of the station does not include a mechanism to prevent backflow. The discharge culvert only features steel bars spaced apart to prevent debris from entering the outlet. It was also noted that when the water levels of Harding Ditch are high, water will recirculate within the ditch. Backflow into the pumps can cause damage to shaft and overall wear on the pump over time. Figure 17 -Figure 22 depict the current conditions at the pump station.

*Figure 20: Corroded pump tube and sump clogged with trash/debris at Parkside pump station. July 2022 (Photo courtesy of USACE)*

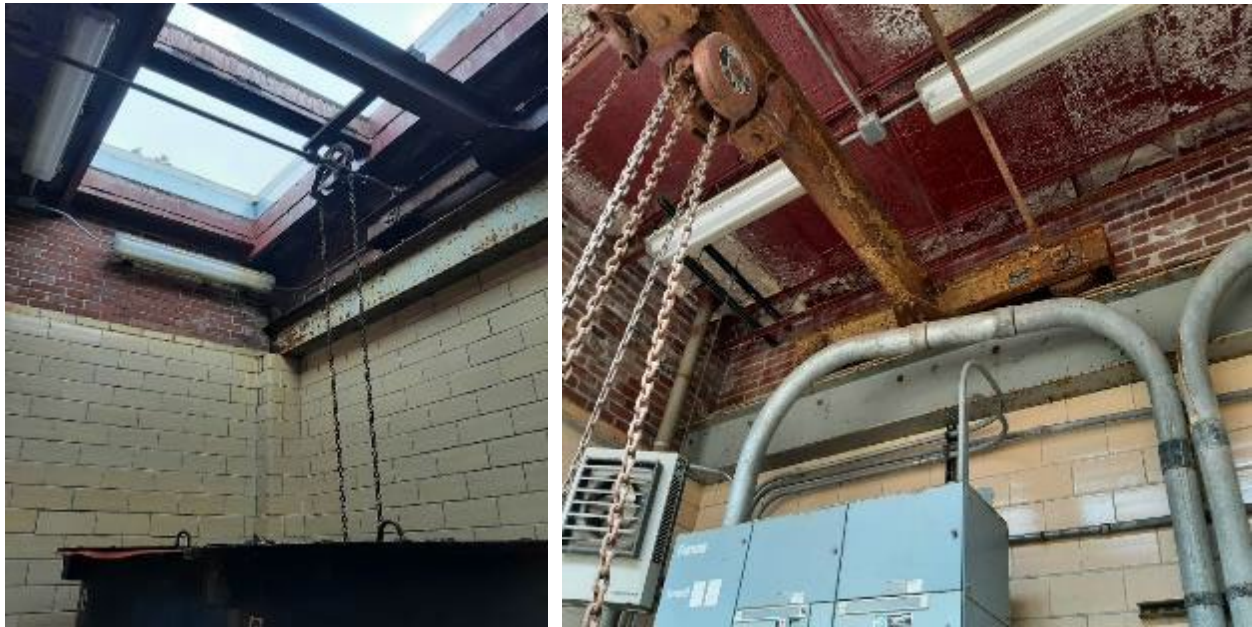
The station building also has a large opening in the roof due to a missing roof panel. This opening exposes the electrical boxes and motor control center (MCC) to the outside elements.

*Figure 22: Hole in roof of Parkside pump station and rusted equipment. July 2022 (Photo courtesy of USACE)*

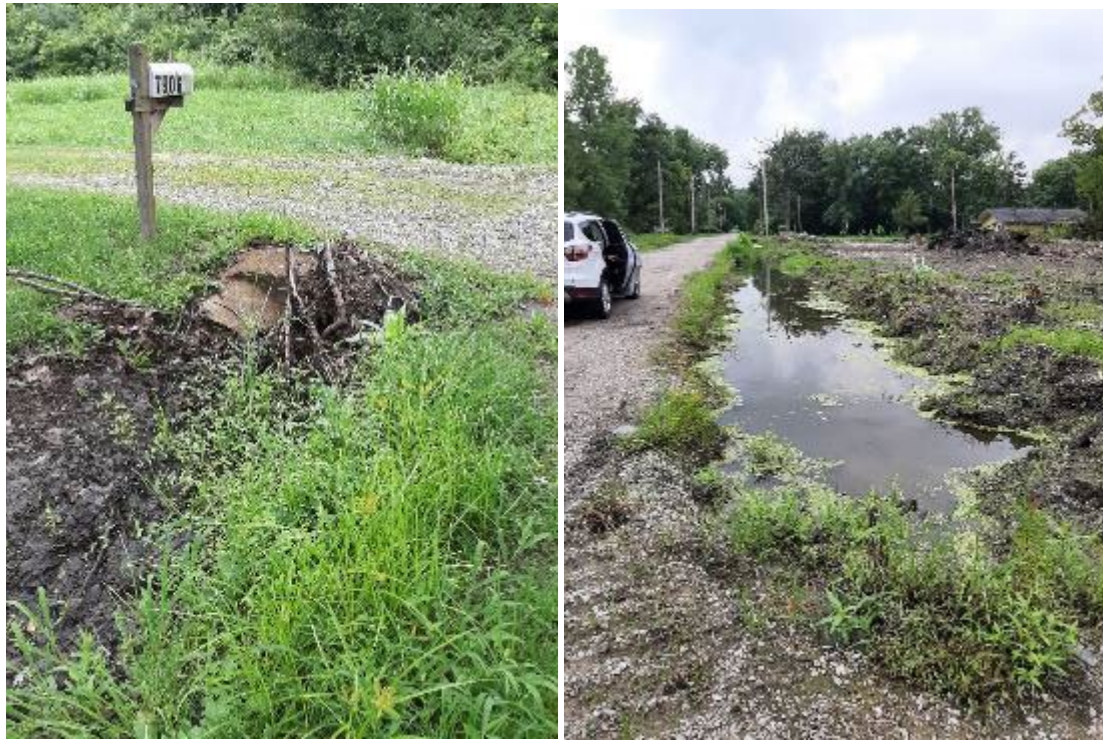
The current state of the drainage in the Ping Pong watershed is poor. In areas south of the Edgemont Ditch eastern fork, the stormwater ditches are discontinuous and do not provide adequate drainage. Culverts are insufficient, blocked, or crushed (Figure 24). Standing water can be seen after most storm events. In some areas, surface water ponds in yards and does not make it into the drainage ditches.

Figure 24: Damaged culvert and sedimented local drainage ditch. July 2022 (Photo courtesy of USACE)

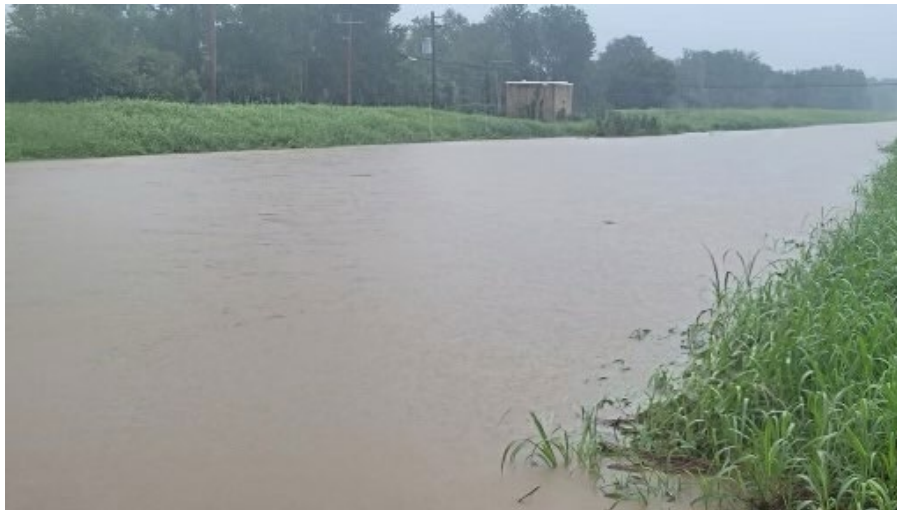
However, it should be noted that during a 1% AEP event, if the Mississippi River is at high elevations, Harding Ditch does adversely flood the Ping Pong and Parkside watersheds, preventing them from draining to the Mississippi River. Flood levels are increased during a 1% AEP event. Additional analysis and data collection would be needed to fully assess this condition.

*Figure 25: Harding Ditch Facing South (Parkside pump station seen on left bank) July 26, 2022 (Photo Courtesy of Cahokia Heights Mayor Curtis McCall)*

It should be noted that while an analysis of Harding Ditch (Figure 25) was outside the scope of this study, it is recommended that a full analysis be conducted to determine the impacts of the ditch to the study area. The limited analysis that was conducted showed that, when the Mississippi River is at normal or low elevations, Harding Ditch has minimal impact to interior drainage of the study area. During a modeled 72-hour duration storm event, interior drainage peaks and then recedes from the Parkside and Ping Pong areas before flooding in Harding Ditch develops. The same can be said for drainage through the Parkside pump station. Due to the size of the Harding Ditch watershed, it was necessary to model a 72-hour duration event in order to capture the effects of the ditch on the study area.
