Swan Lake Habitat Rehabilitation and Enhancement Project, Flood Damage Assessment Letter Report with Environmental Assessment

US Army Corps of Engineers 1222 Spruce St. St. Louis, MO 63103 December 2022

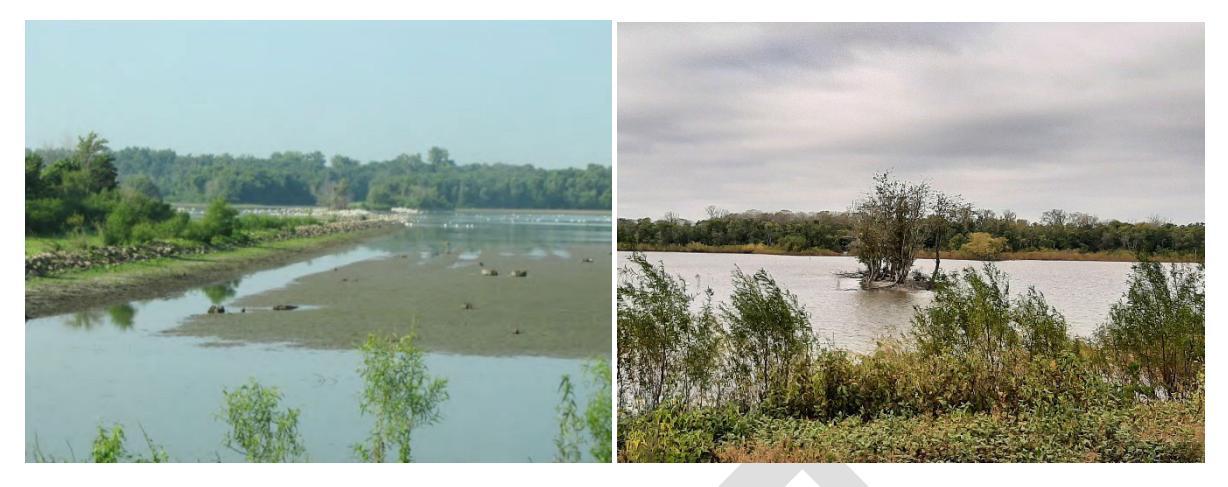
Figure 7: Island Erosion at Lower (left- 2013) and Middle (right- 2021) Swan Lake

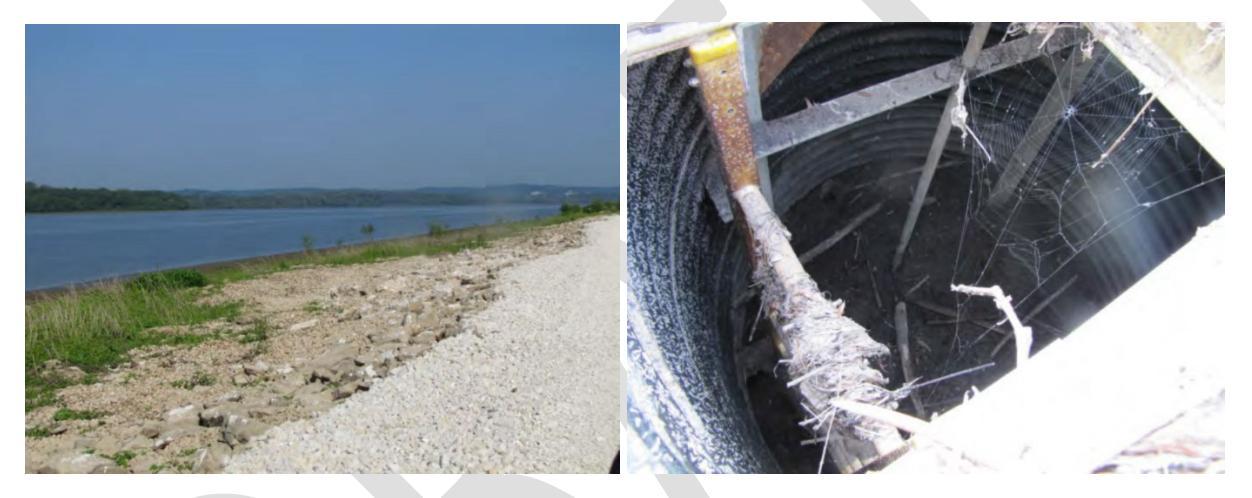
Figure 8: Examples of Erosion and Riprap Movement (left) and Sedimentation of Interior of Water Control Structure (right) (2020)

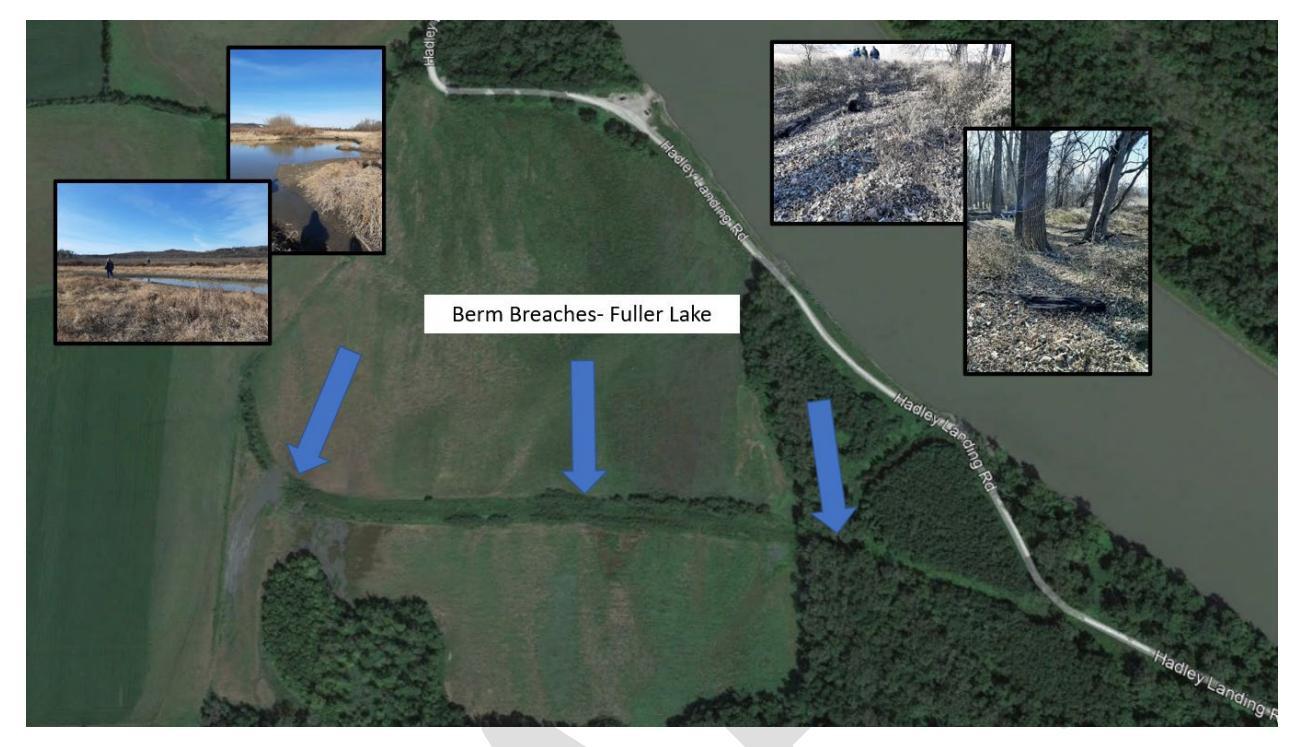
Figure 9: Approximate Locations of Fuller Lake Sediment Deflection Berm Breaches

(Post 2019 Flood)

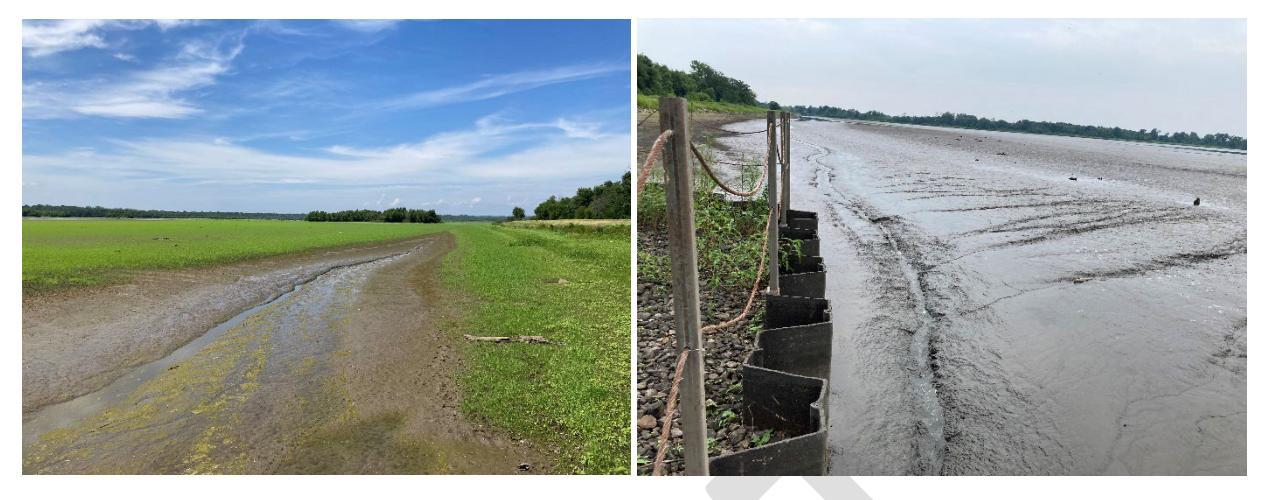
Figure 11: Lower Swan Channel Sedimentation (post 2019 flood- photos provided by USFWS)

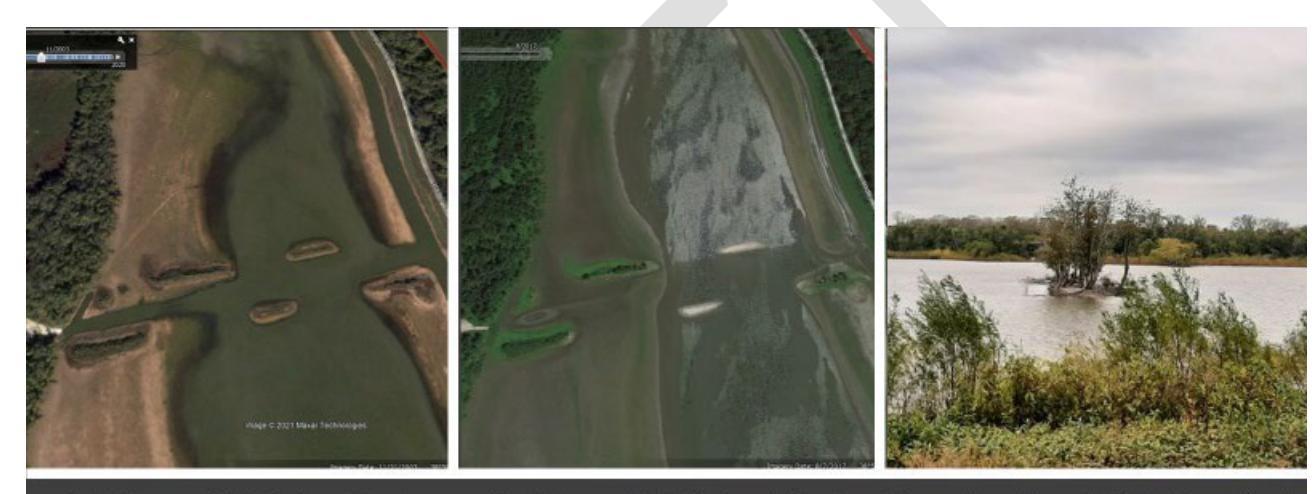
Figure 12: Island Erosion at Middle Swan Lake

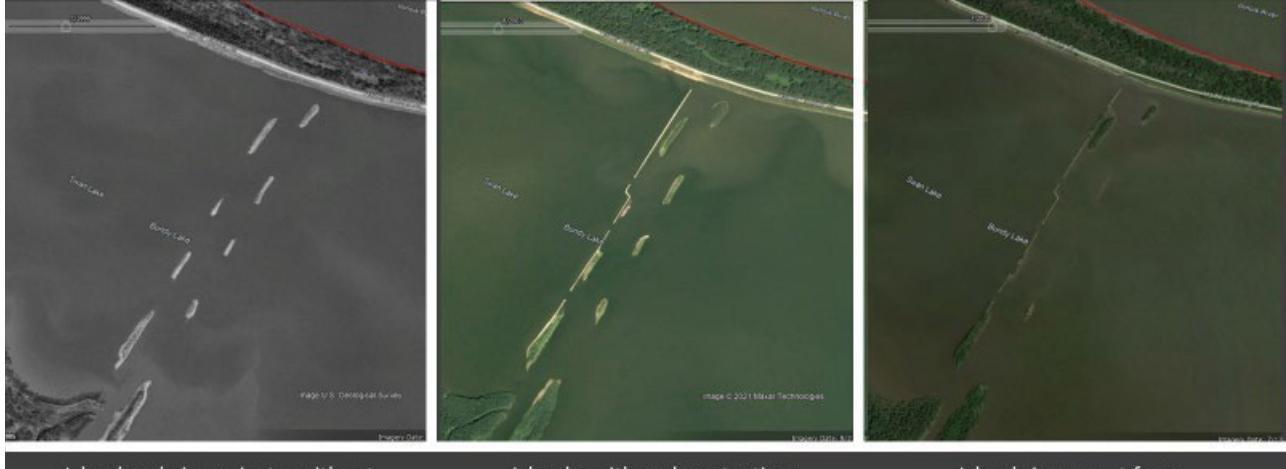
Island early in project – without additional rock protection (03-1999) Islands- with rock protection (08-2003) Islands in current form (07-2020)

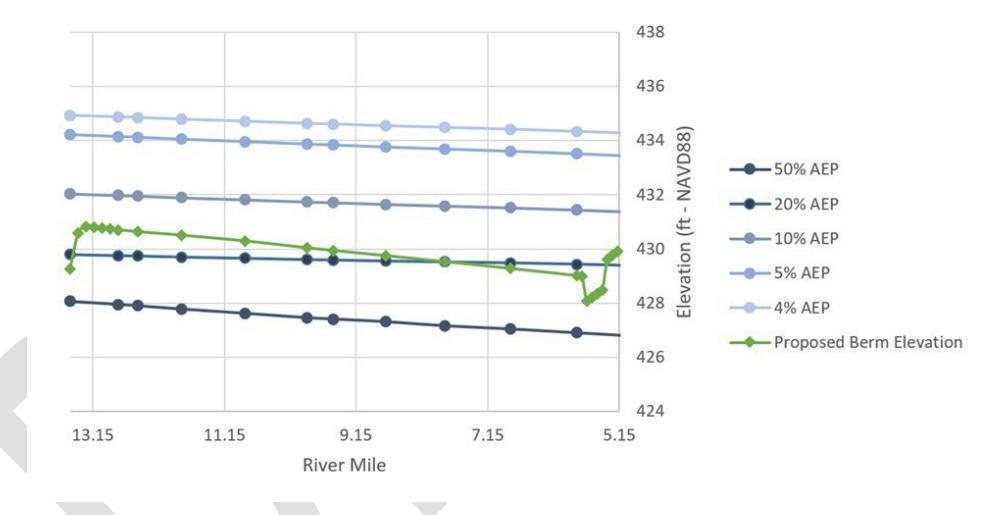
Figure 14: Comparison of Exterior Berm Elevation to Flood Elevation

The frequency of overtopping was determined by plotting the berm elevation against flood elevations. Fuller Lake and Swan Lake both have locations that are currently below the 50% AEP flood event level. Additionally, the vast majority of the sedimentation deflection berm is below the 20% AEP flood event level. The proposed berm realignment and restoration to as-built elevations result in the Fuller Lake portion of the berm being above the 20% AEP flood event level, specifically at a 16% AEP level, and the spillway on Lower Swan being between the 50% AEP and 20% AEP flood event levels, specifically at a 34% AEP level. Figure 14 shows plots of the berm elevation against flood elevations.

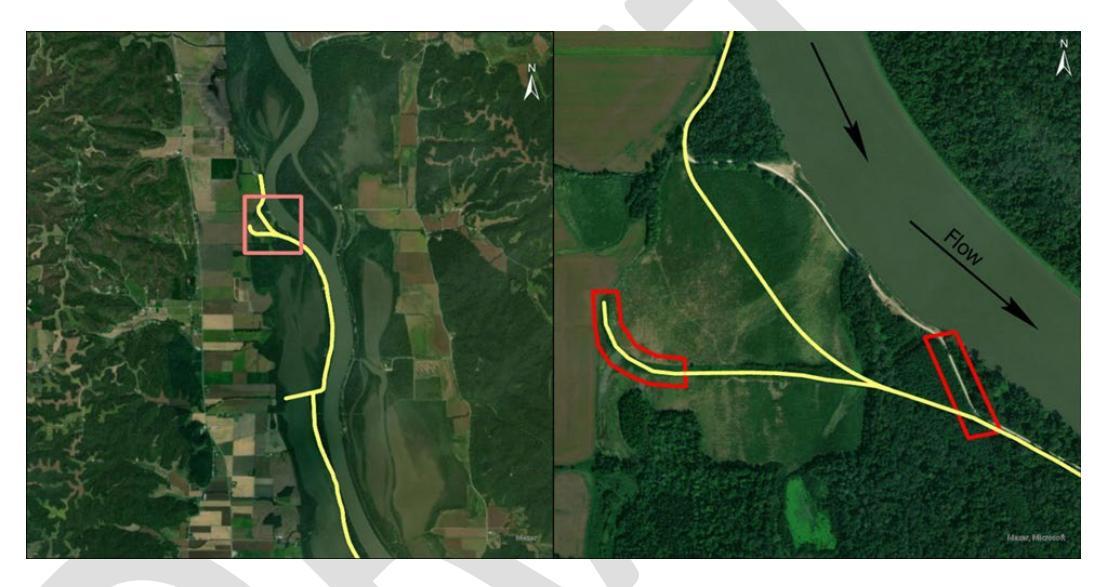
Figure 15: Locations of Elevated Velocities- Fuller Lake

A subsequent model was created to evaluate water velocities along the sediment deflection berm in order to identify locations that may experience elevated velocities. Higher velocities can indicate areas where scour is more likely. Such areas may require mitigation such as armoring, shallower slopes, or a vegetation buffer. Two portions of the berm were identified as having higher velocities than the surrounding areas and are shown in Figure 15. The western portion of the existing berm alignment experiences water channeling between the backside of the berm and the high ground to the west. Elevated velocities also occur due to water channeling down the clearing in the trees caused by the existing roadway to the east. Elevated velocities caused by the road clearing can be mitigated by planting trees in this area once the road has been relocated on top of the berm.

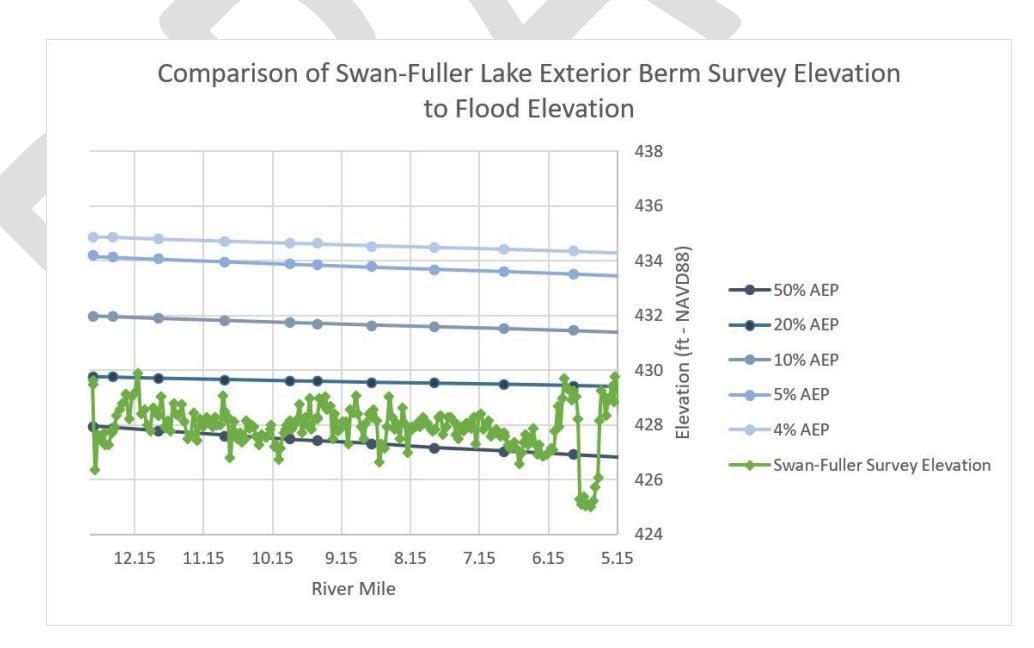
Figure E - 1: Comparison of Swan -Fuller Lake Survey to Flood Elevation Data

The frequency of overtopping was evaluated by plotting the Swan Lake / Fuller Lake berm elevation against the flood elevation. Figure E - 1 shows the existing berm elevation taken from survey data collected by the St. Louis District's survey team against various Illinois River frequency flood event elevations. The Illinois River frequency flood water-surface elevations were taken from a UNET model developed by USACE Rock Island District. This computer model is based upon the results of the report entitled "Upper Mississippi River System Flow Frequency Study" (January 2004). This report was developed by several agencies and stakeholders. Elevations were reported in NGVD29 and converted to NAVD88 when creating the profiles. The plot shows that the breach on the northwestern section of the berm and the uncontrolled spillway on the southern section of the berm are both below the 50% annual exceedance probability (AEP) flood event. Much of the rest of the berm lies between the 50% AEP and 20% AEP events.

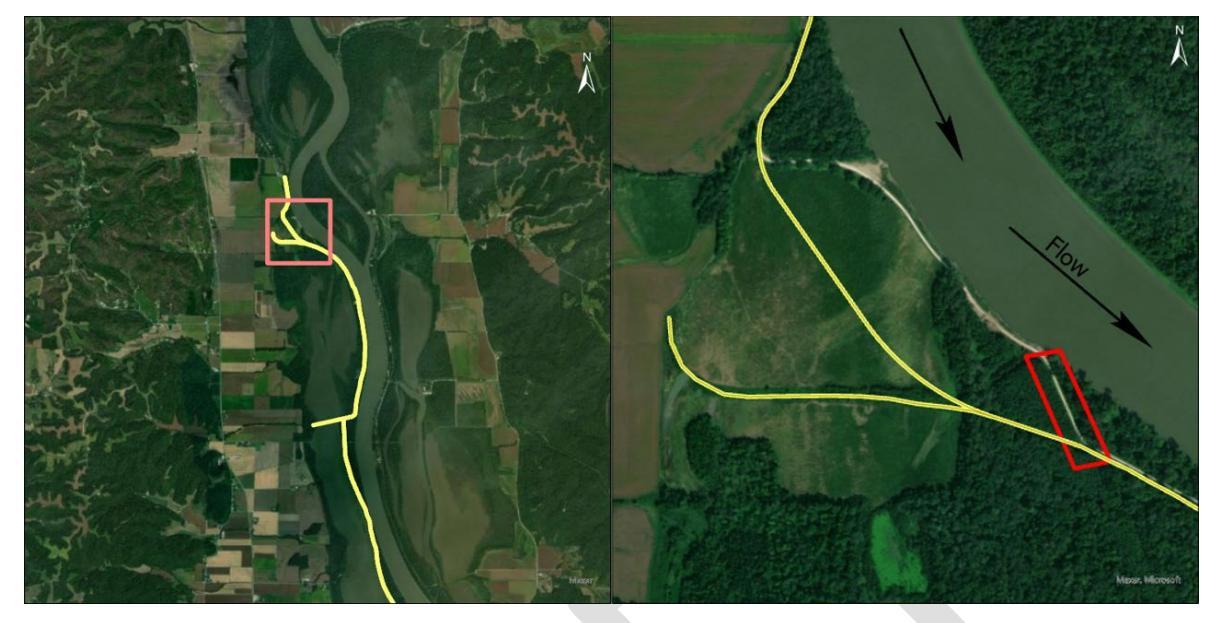
The model was run to identify areas of elevated velocities that may require additional attention. Based on the results of the model, two areas of interest were identified. The first area is located where the existing road meets the existing berm, as shown in Figure E - 11. Modeling indicated that this portion of the berm could experience elevated velocities due to water funneling down the clearing between the trees that is created by the road, as well as because of the direction of flow relative to the road. The risk of elevated velocities can be mitigated by reforesting the current roadway once the road is relocated on top of the berm. Further modeling with the current roadway simulated as being reforested resulted in the berm no longer experiencing elevated velocities at this location. The simulation of reforestation was achieved by altering the roughness value utilizing Manning's *n* calibration regions. Figure E - 12 shows the velocities of the recommended with reforestation, with arrows indicating the direction of flow.

Figure E - 11: Location of Existing Road Creating Elevated Velocities

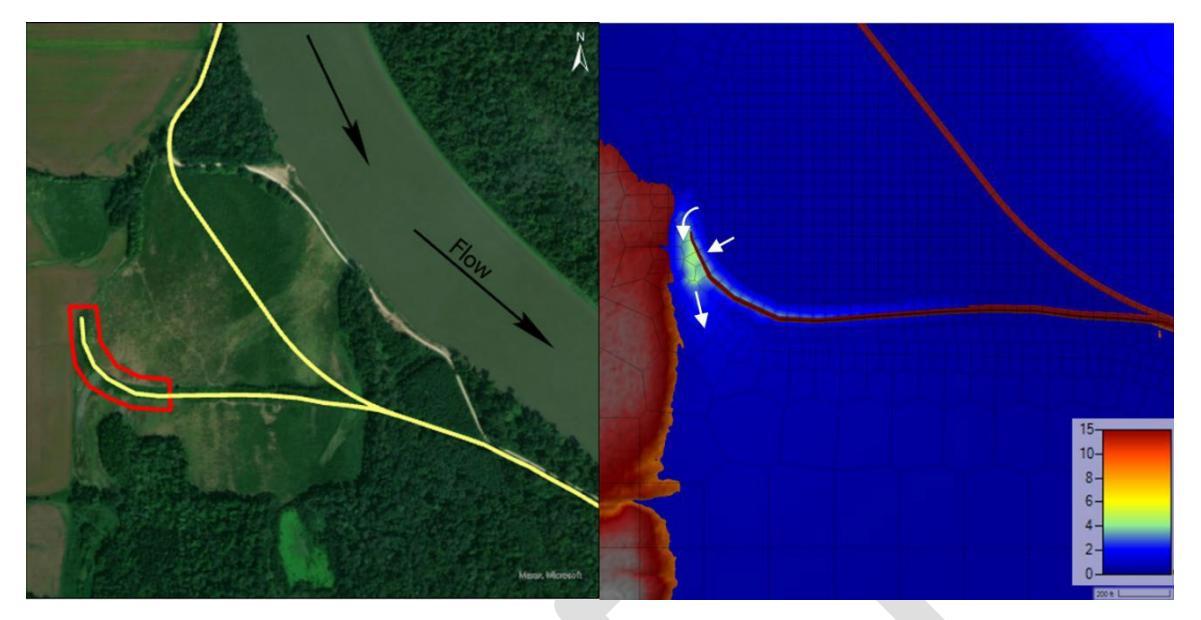
The second area of interest is located at the northwestern end of the existing berm alignment. Figure E - 7 shows the location as well as the velocities (in feet/second), with arrows indicating the direction of flow. Elevated velocities at this location are caused from water that overtops the berm being channeled between the backside of the berm and the relative high ground to the west.

Figure E - 13: Second Location and Velocity Results

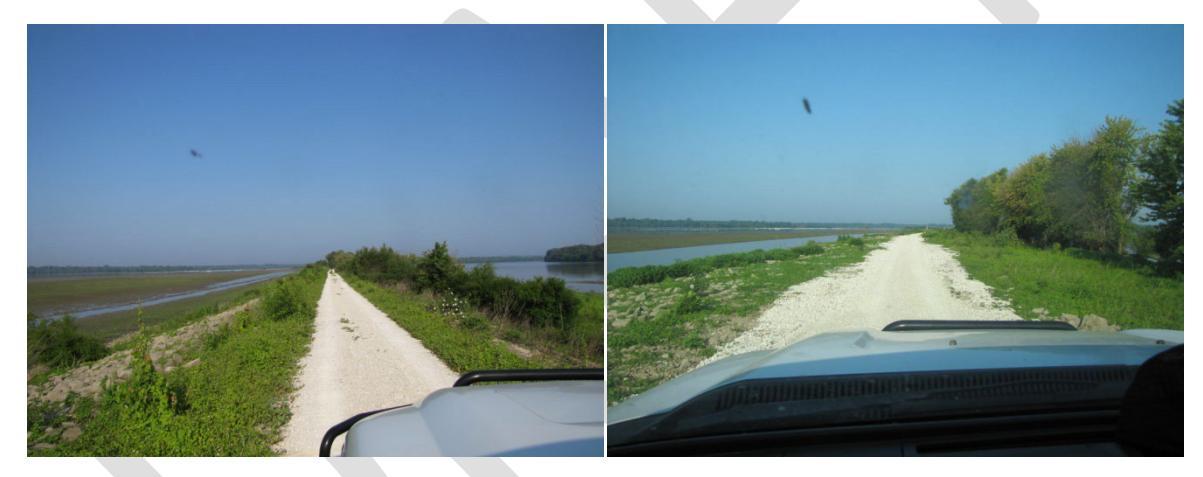
Figure G - 7: Exterior Sediment Deflection Berm at Lower Swan Lake (South of the Pump Station)

Finally, the upper end of this berm is oriented perpendicular to the flow of the Illinois River. While this may have been the right design choice to avoid sedimentation from upland flows or real estate issues, the orientation does lead to an increase in the scouring energy and a higher risk of berm failure. Whenever possible, exterior berms should be aligned with the flows of the adjacent river channel. If this is not possible, a wider cross section and gentle slopes (suggest a slope greater than the as-built slope of 1V:6H) on the protected side of the berm will help reduce the risk of a scour failure.

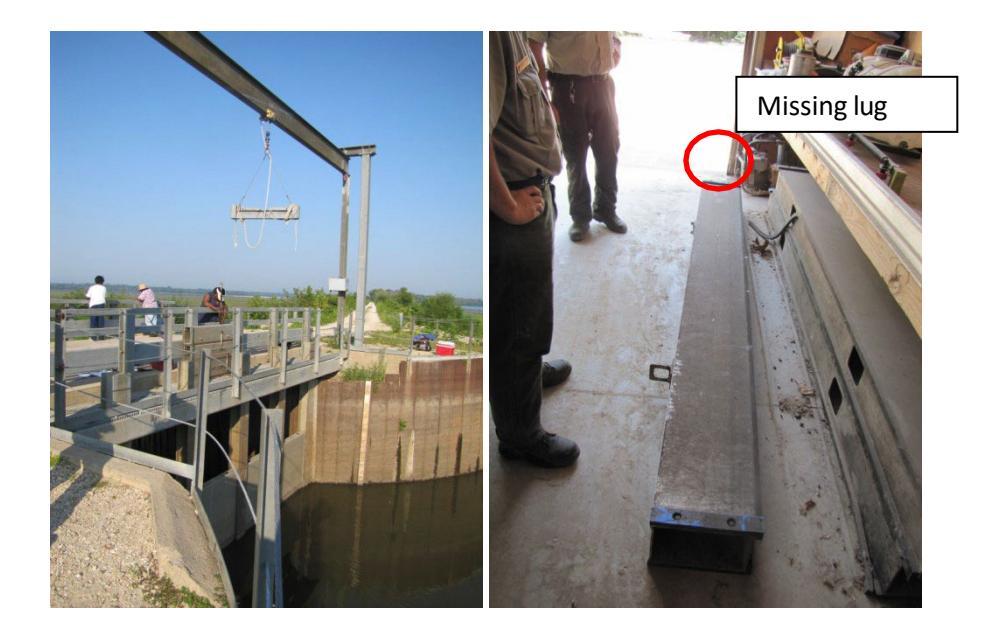
Figure G - 15: Lower Swan Lake Gravity Control Structure and Trolley Beam (Aluminum stoplogs had some problems with the lifting lugs being ripped off during lifting.)

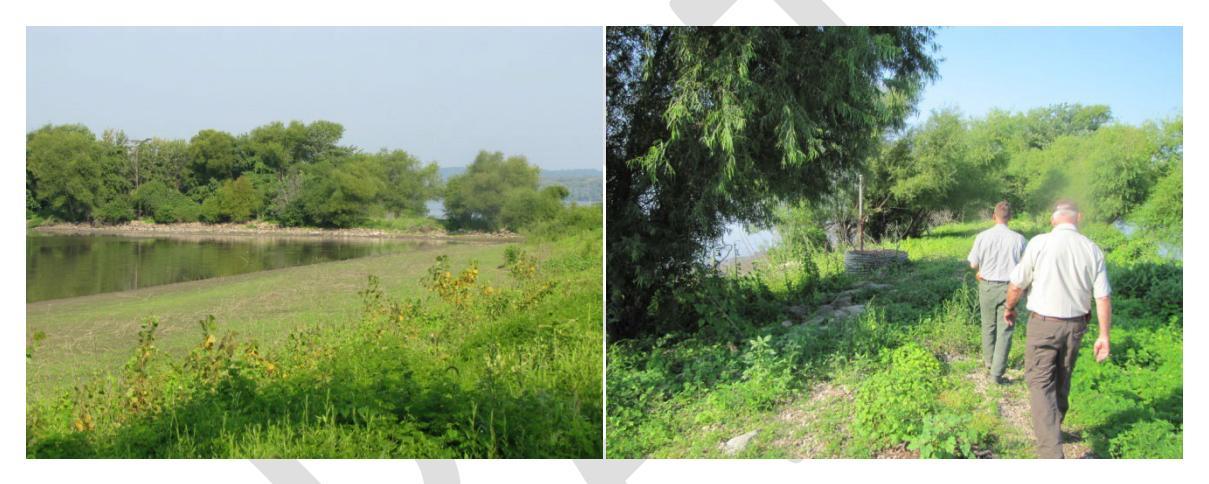
Figure G - 28: The Cross Dike Between Middle and Lower Swan Lake is Currently Covered in Woody Vegetation
