Upper Joachim Creek Floodplain Management Plan for the City of De Soto & Jefferson County, Mo September 2019

VALLE LAKE DAM JEFFERSON COUNTY, MISSOURI MO. 30438

PHASE I INSPECTION REPORT NATIONAL DAM SAFETY PROGRAM

SUBJECT: Valle Lake Dam (Mo. 30438) Phase I Inspection Report

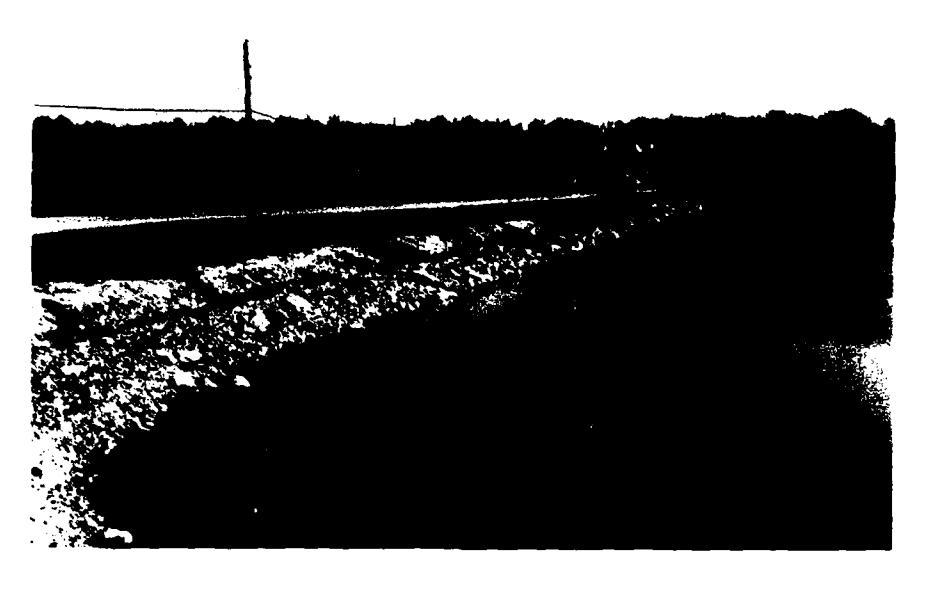
The upstream slope was protected from erosion due to wave action by riprap consisting of dolomite stones ranging in size from three inches to three feet in diameter. The riprap appeared to be providing adequate protection; however, some very minor wave erosion was observed above the rigrap. No deterioration of the rigrap was The sand and gravel berm on the slope appears to have observed. been added after the construction of the dam and has little or no effect on the stability or safety of the dam. The slope above the riprap supported a sparse growth of grass. The grass cover, however, did appear to provide adequate protection against erosion due to surface runoff for the slope for no erosion was observed. No bulges, depressions or cracks indicating an instability of the embankment or foundation were observed on the slope. The effect of drawing down the reservoir has had no apparent effect on the stability of the embankment.

Photo 1 - View of the upstream slope from the left abutment.

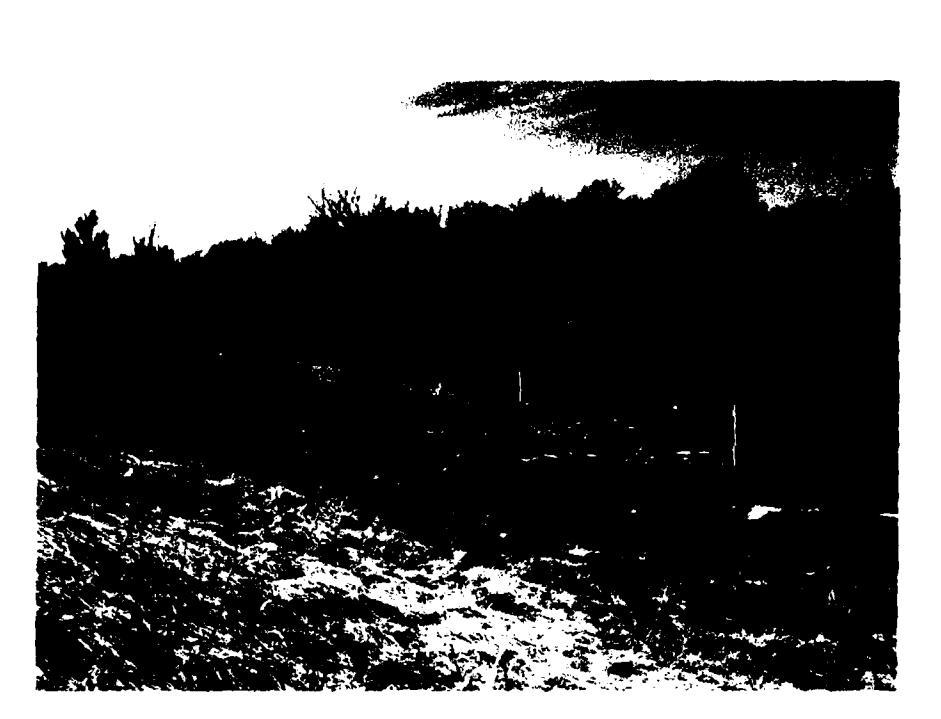
One of the areas of possible seepage was observed just downstream of the embankment along the left abutment/embankment contact (see Photo 5). No measurable flow of water was observed in the area; however, the ground was boggy and standing water was observed in the area. It was unknown whether the source of the moisture in this area is due to seepage through the embankment or the foundation bedrock or due to recent rainstorms in the area. Bedrock was also exposed in this area.

Photo 5 - View of the area of possible seepage on the left abutment. Note the spillway training berm in the background and the outcropping of bedrock.

- 3. A combination of 1 and 2 above.
- b. 0 & M Procedures
 - I. Further investigation of the three areas of seepage and possible seepage observed along the downstream slope should be undertaken to determine the seriousness of the condition. The investigation should be carried out under the direction of a qualified professional engineer and repairs made as required.

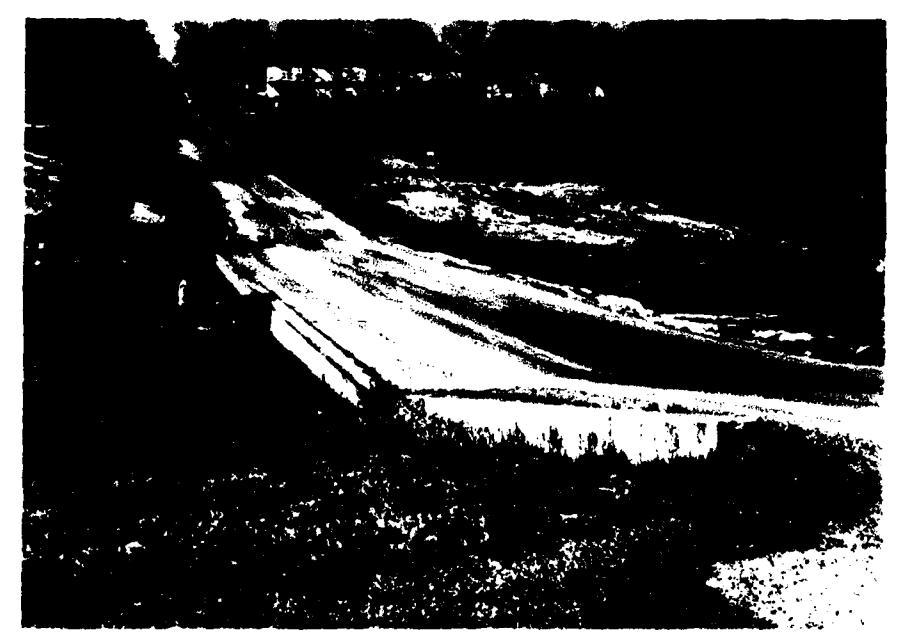
Photo 6 - View of the principal spillway drop inlet and emergency spillway broad-crested weir looking toward the left abutment.

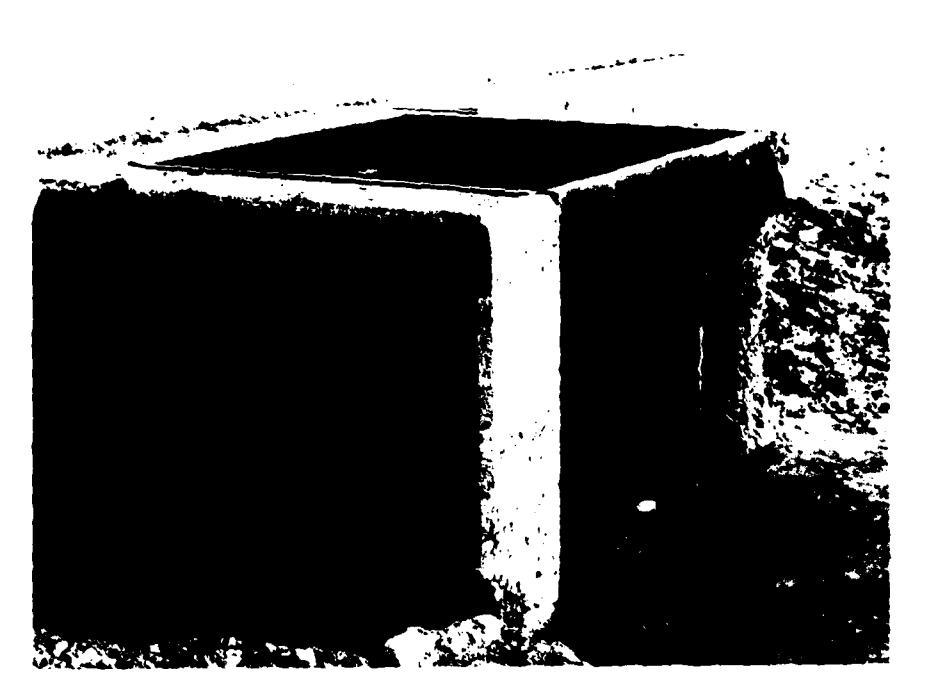
The front edge of the right sidewall has partially disintegrated into the stoplog slot (see Photo 7). No reinforcement was evident. The remaining concrete surfaces appeared stable with minor weathering observed. A small amount of debris was seen in the bottom of the drop inlet; however, the spillway was operating on the day of the inspection. It appears that some repair work was done around the inlet of the outlet pipe. The concrete surface was rough and the edge of the pipe was bent and rusting in places. There were several minor deformation of the pipe observed along the length of the conduit, which were probably caused by vehicular traffic during construction before sufficient backfill was placed over the pipe. There was some undermining around the edges of the outlet pad and a slight amount of differential settlement has taken place at the transverse joint in the middle of the pad. The discharge channel appeared stable resembling a natural stream with a series of pools, riffles and falls over the in situ bedrock.

1. The disintegration of the principal spillway right sidewall does not presently affect the safety of the dam. Further deterioration will preclude the use of the stoplog slot and the reservoir regulation that the drop inlet provides will be lost. The complete failure of the wall could impair the functioning of the spillway and thus imperil the safety of the dam.

The structural stability of the principal spillway appears to be questionable due to the disintegration of the drop inlet wall. However, this damage does not constitute an unsafe condition at this time. The emergency spillway appeared to be structurally stable with the exception of the voids on the back slope caused by erosion. The principal spillway was partially obstructed by debris on the day of the inspection, however, it was operating. The emergency spillway was unobstructed and appeared to be able to function properly.

Photo 7 - Close-up view of the principal spillway drop inlet showing the concrete deterioration of the stoplog slot.

- The damage to the principal spillway drop inlet sidewall should be repaired.
