**NATURAL SYSTEMS ASSESSMENT:
WATERS OF THE UNITED STATES DELINEATION
RIVER'S EDGE SOUTH HARBOR
MADISON, ILLINOIS**

TRI-CITY REGIONAL PORT DISTRICT
Granite City, Illinois

GEOTECHNOLOGY, INC.
Collinsville, Illinois

Geotechnology, Inc. Report No. 0734009.85TA

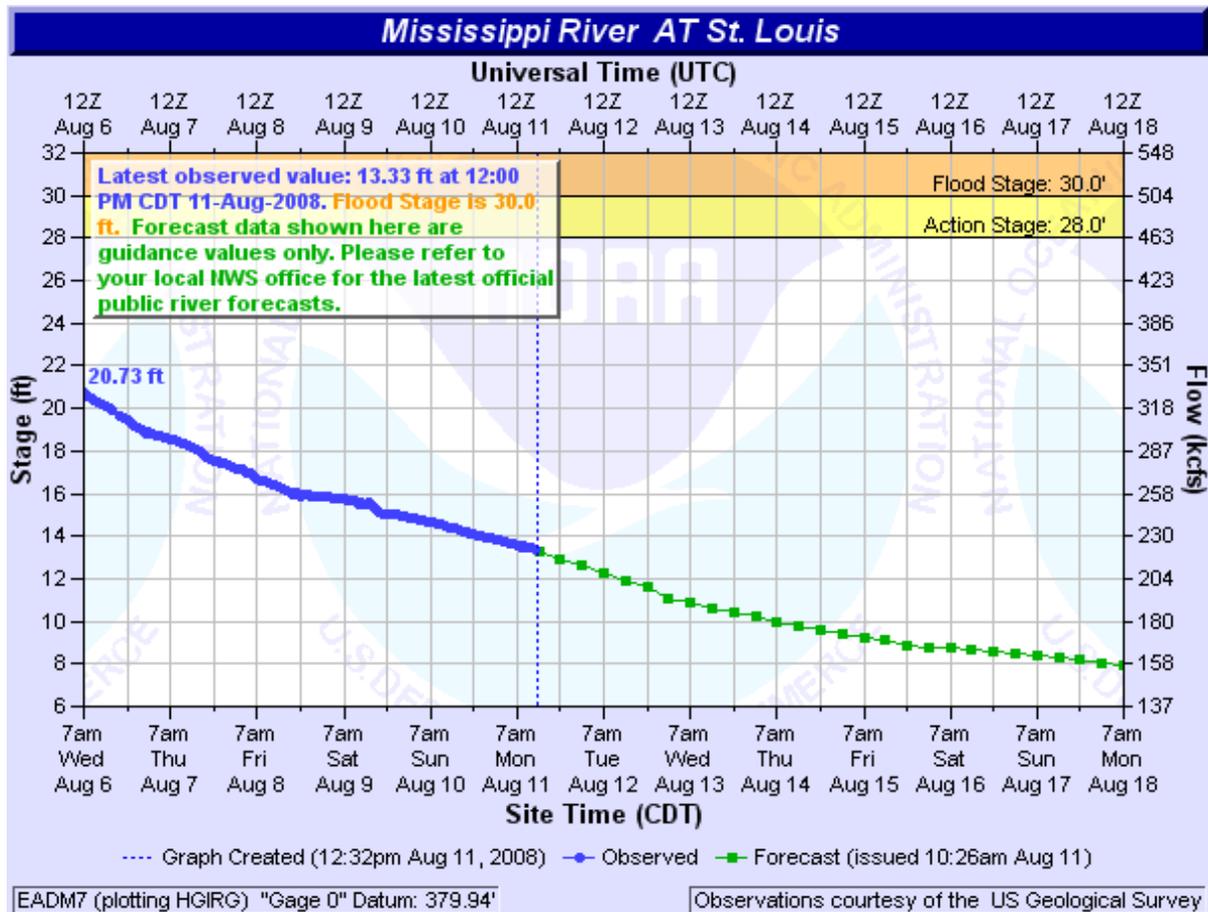
RIVER GAGE INFORMATION

**National Weather Service
Advanced Hydrologic Prediction Service**
www.weather.gov/ahps/

NOTE: River forecasts for this location take into account past precipitation and the precipitation amounts expected approximately 24 hours into the future from the forecast issuance time.

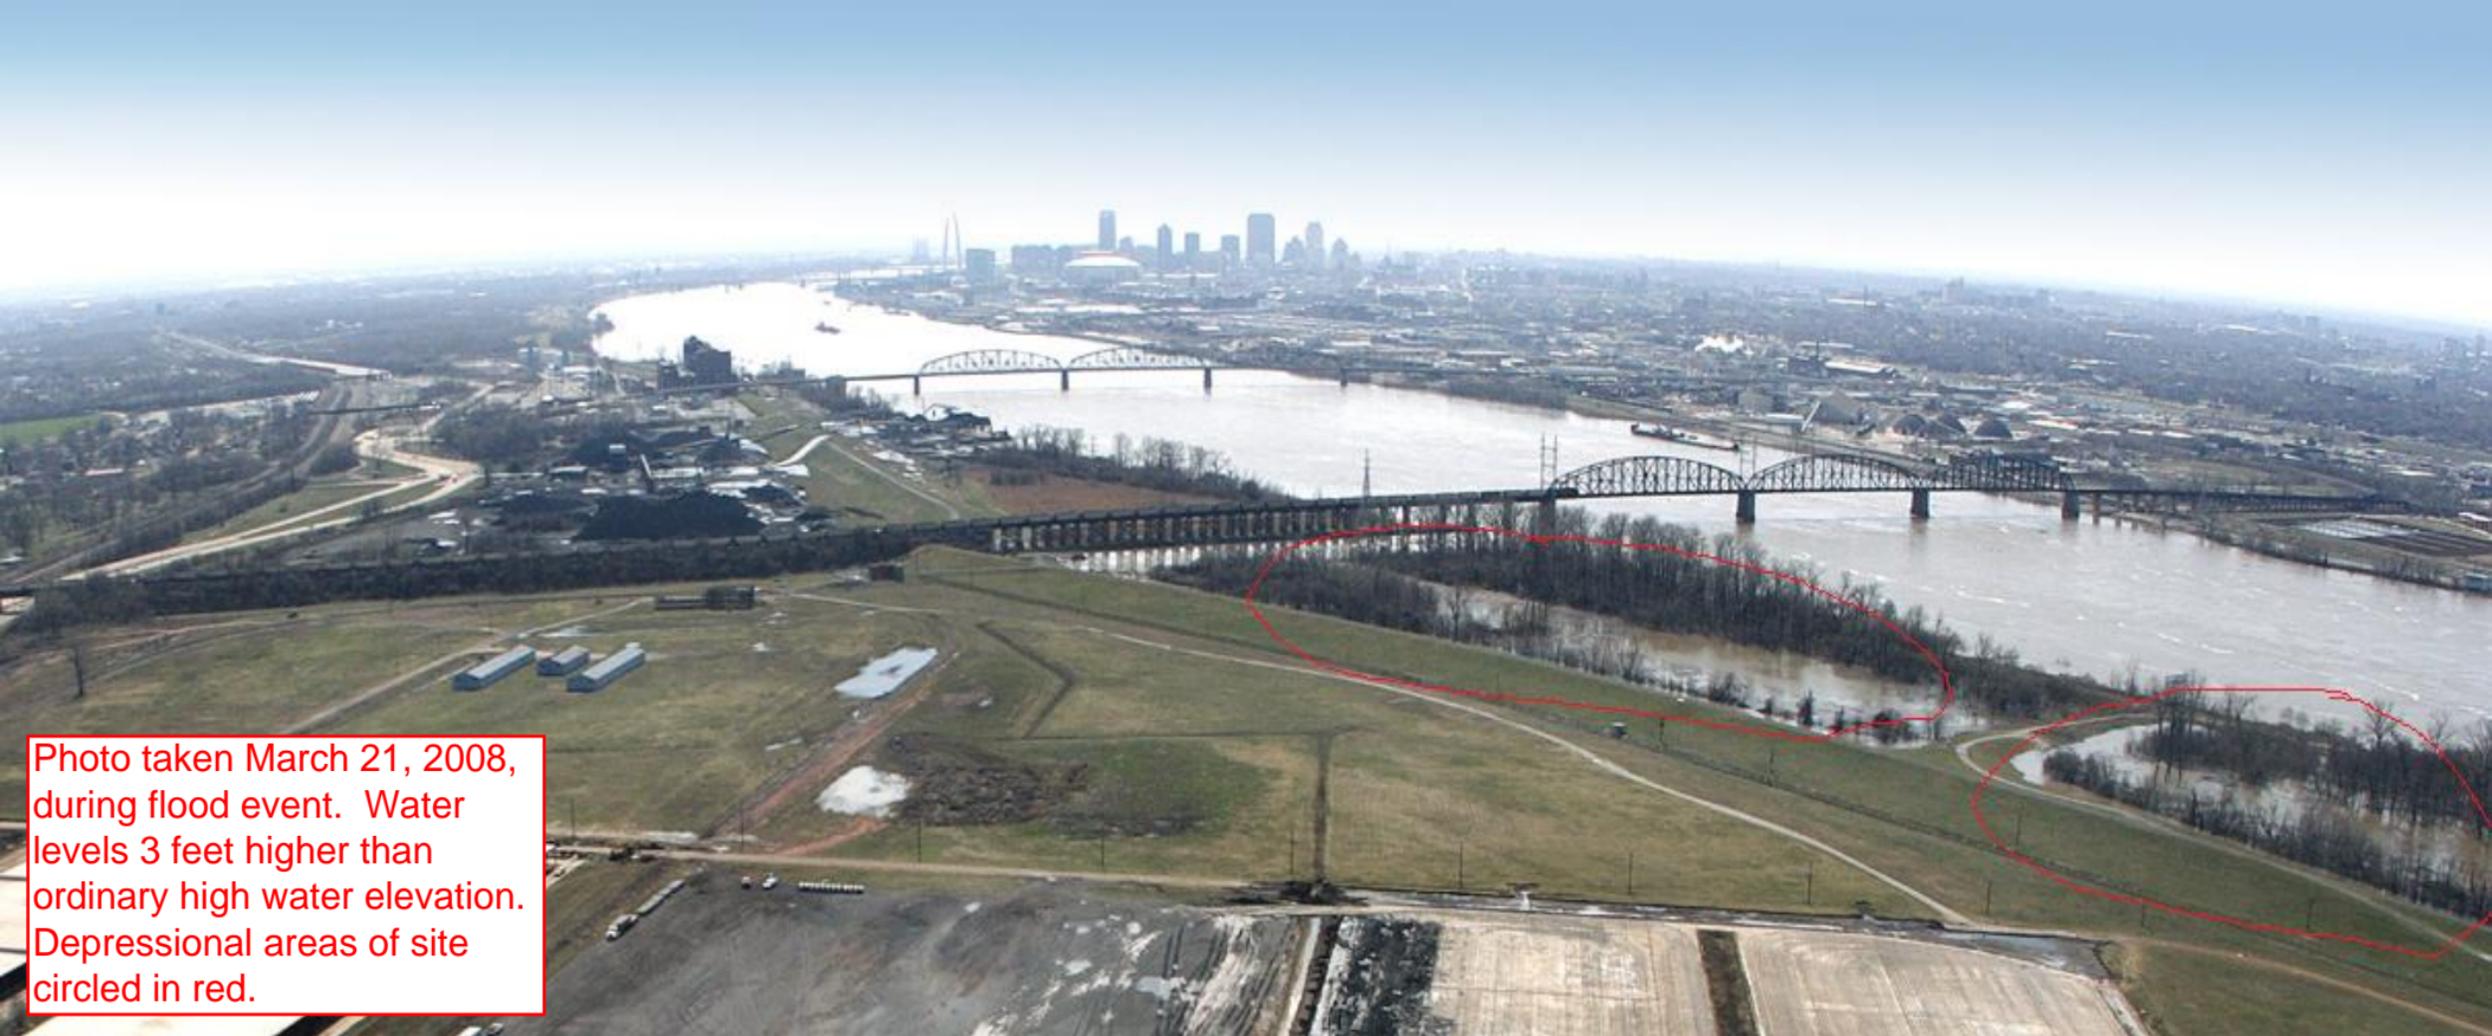
Photo taken March 21, 2008, during flood event. Water levels 3 feet higher than ordinary high water elevation. Depressional areas of site circled in red.

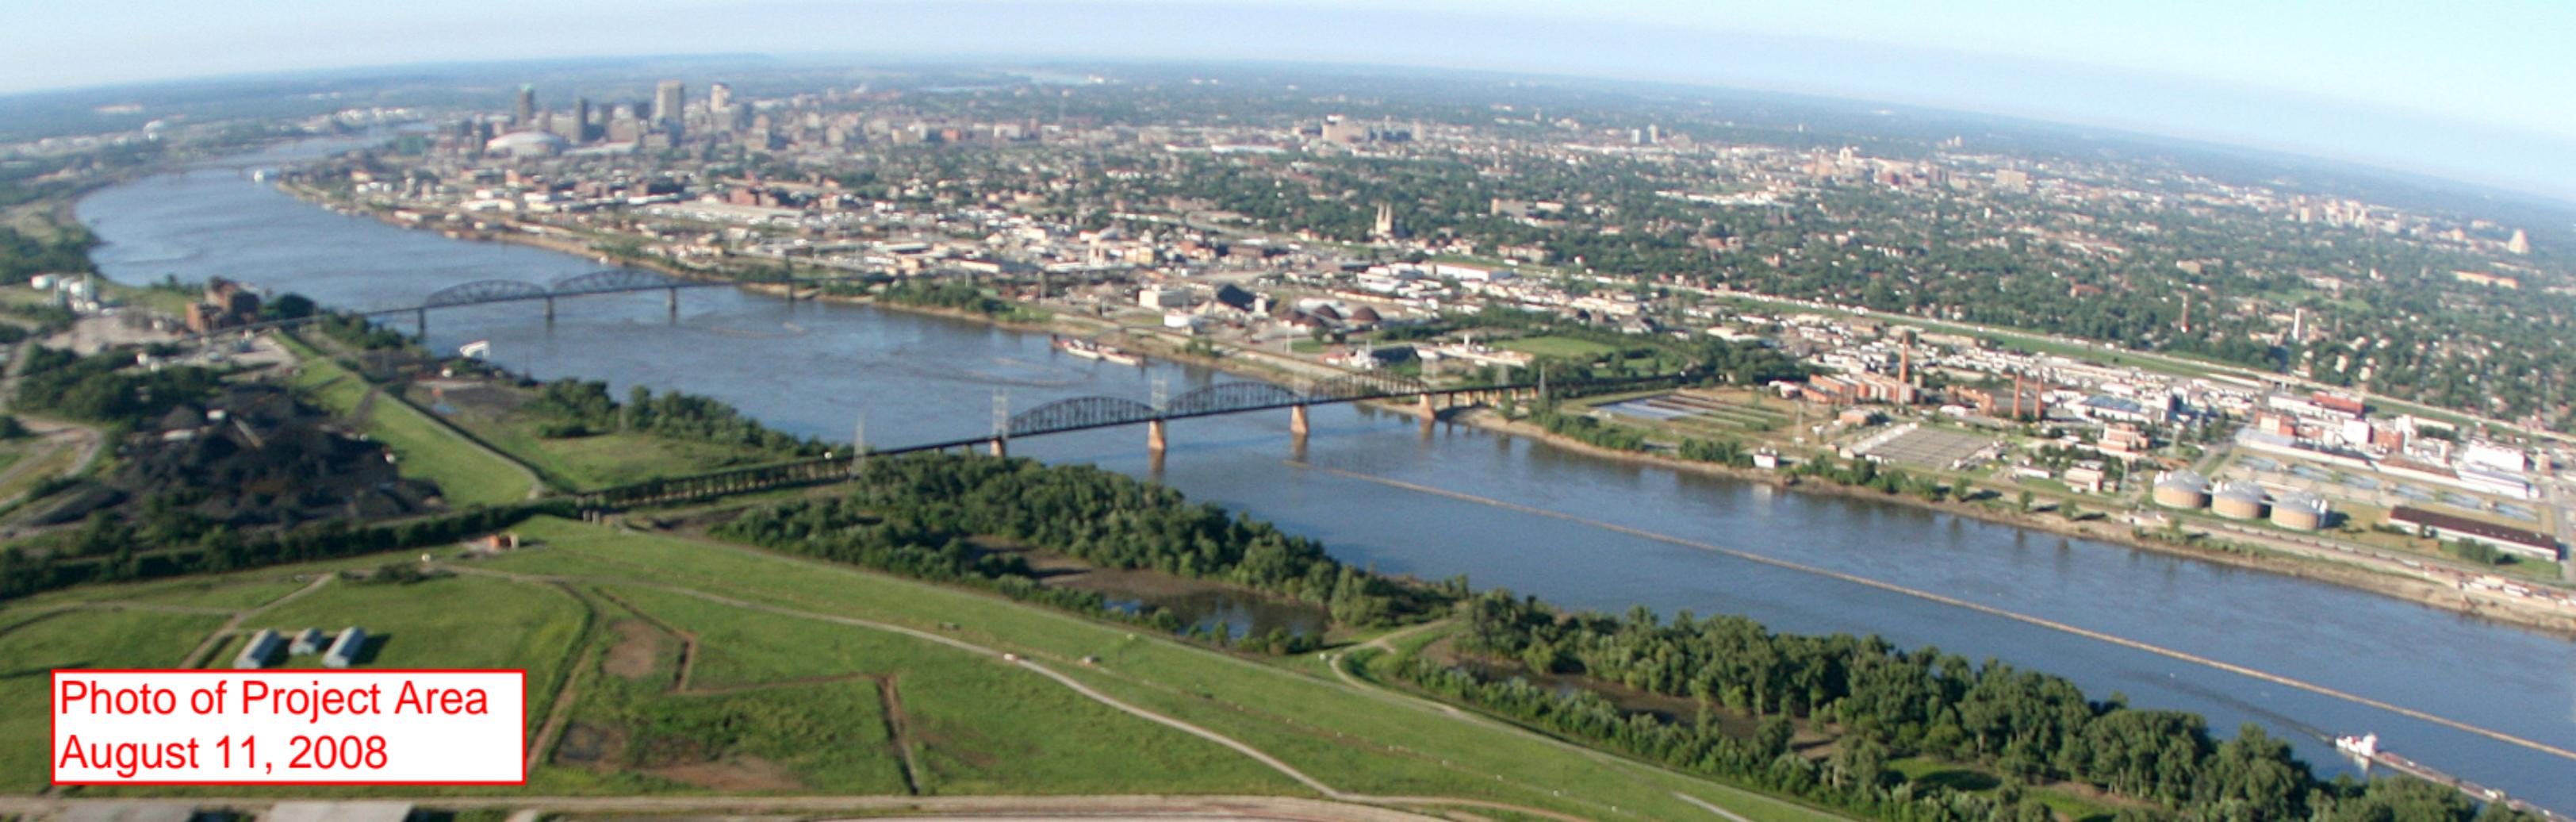
Photo of Project Area
August 11, 2008

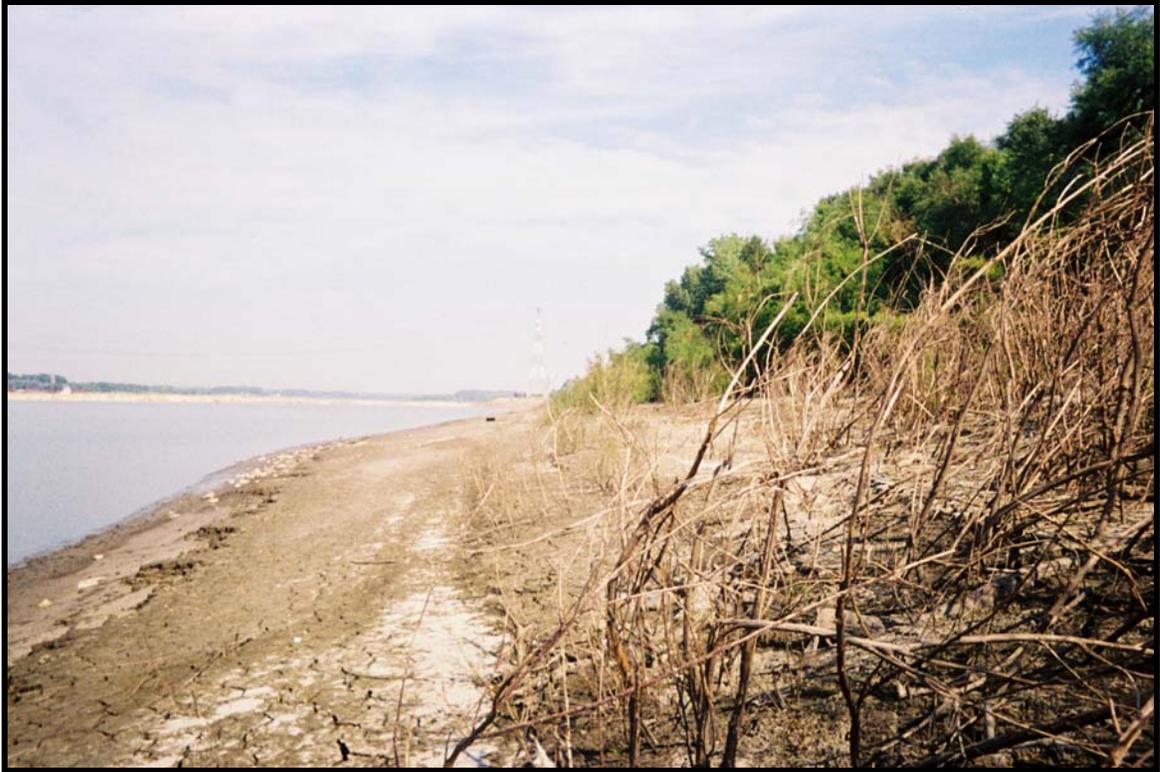
Photograph 1 ↑ - View of Mississippi River, facing upstream. Confluence with Chain of Rocks Canal, visible in background. Photo taken 8-19-08.

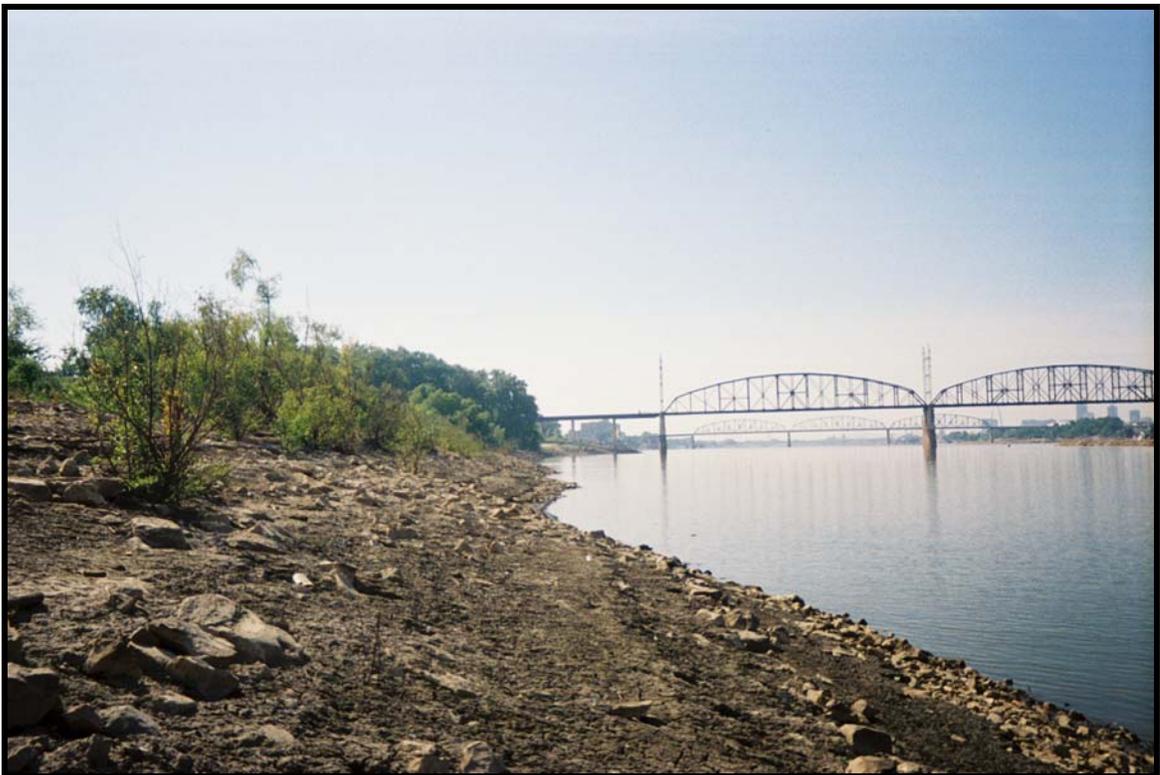
Photograph 2 ↑ - View of Mississippi River, facing downstream. Merchant's Bridge in background. Photo taken 8-19-08

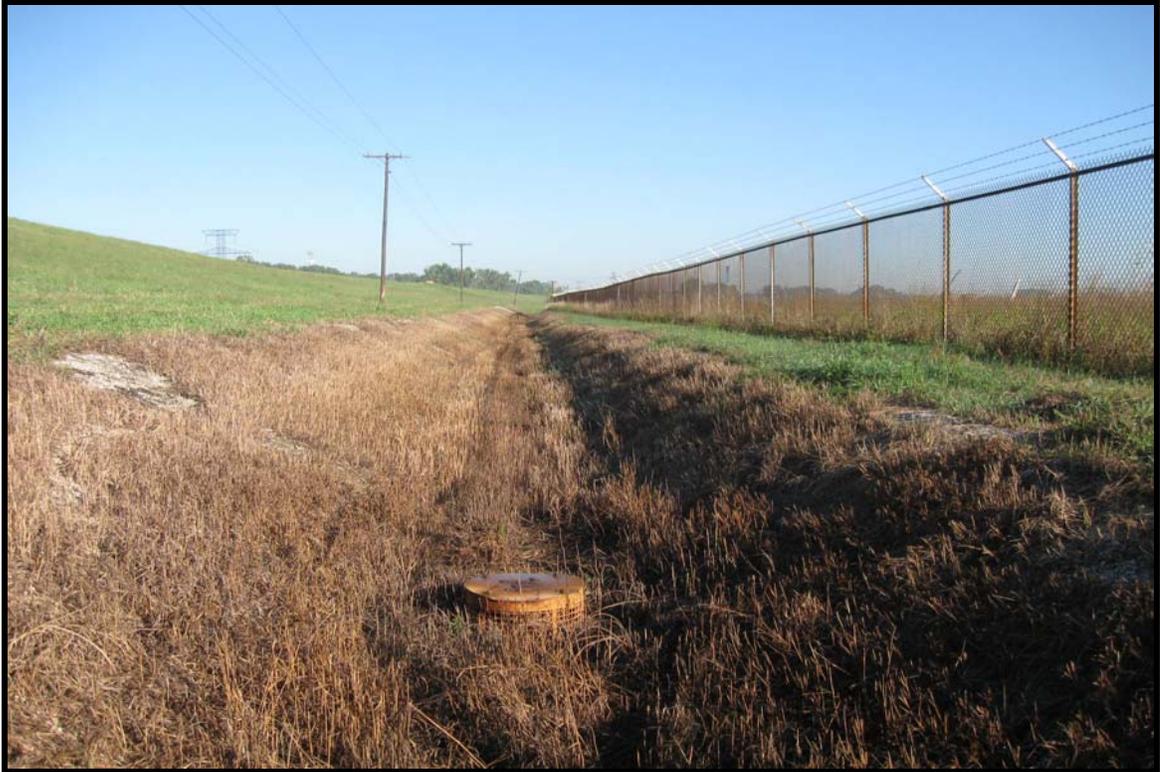
Photograph 3 ↑ - View of U.S. Army Corps of Engineers' (USACE) Relief Well Drainageway, facing north, levee to left. River's Edge development to right. Relief well cap is visible in foreground. Photo taken 9-17-08.

5.1.2 USACE Relief Well Drainageway. A man-made drainageway that connects levee relief wells was observed at the eastern toe of the levee. Wells within the drainageway are approximately 150 LF apart. The ephemeral drainageway has a gravel and sediment bed and is approximately 2 to 3 feet wide. Banks of the USACE Relief Well Drainageway range from 3 to 6 feet high and were observed to be lined with

grouted riprap and gravel. Upland vegetation [fescue (*Festuca arundinacea*) and johnsongrass (*Sorghum halepense*)] was observed to be growing in a large portion of the drainageway bed. Vegetation in the drainageway appears to be well maintained in conjunction with levee vegetation. Within the project area, the drainageway drains from the north and from the south to a pump station within the project boundaries. Approximately 3,386 LF of the drainageway exists within the project boundaries; however, 855 LF of the drainageway is piped. As the drainageway and relief wells are directly connected to the Mississippi River, impacts to the drainageway and/or relief wells will require approval by regulatory agencies.

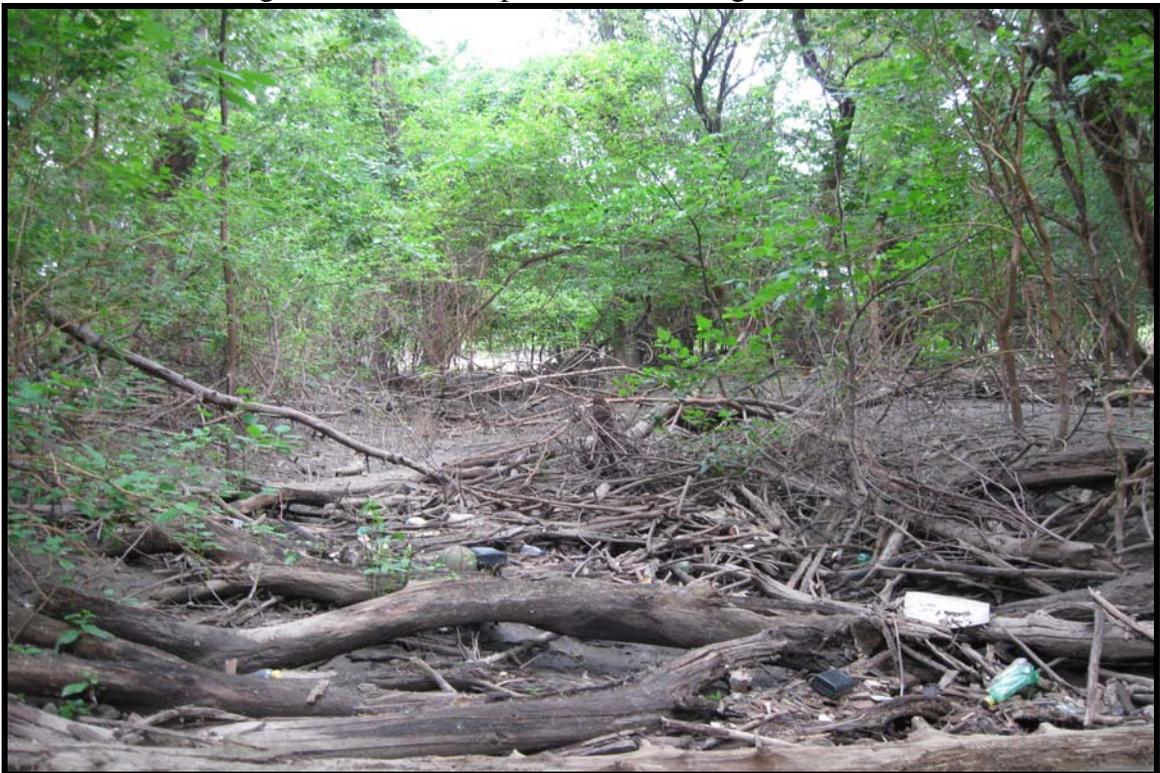
Photograph 4 ↑ - View of Drainageway, facing east. Emergent Wetland 1 (out of boundaries) is visible in background. Photo taken 8-19-08.

5.1.3 Drainageway. A man-made drainageway exists along the southern boundary of the project site. The drainageway was observed to be approximately 10 to 12 feet wide with 2 to 3 feet high banks. The drainageway was observed to have a sediment bottom and contain large amounts of flood debris. The drainageway appears to have been constructed to drain Emergent Wetland 1 and discharges to the Mississippi River. Approximately 70 LF of the drainageway exist within the project boundaries. Since the drainageway is a primary tributary to the Mississippi River, impacts to the drainageway will require approval by regulatory agencies.

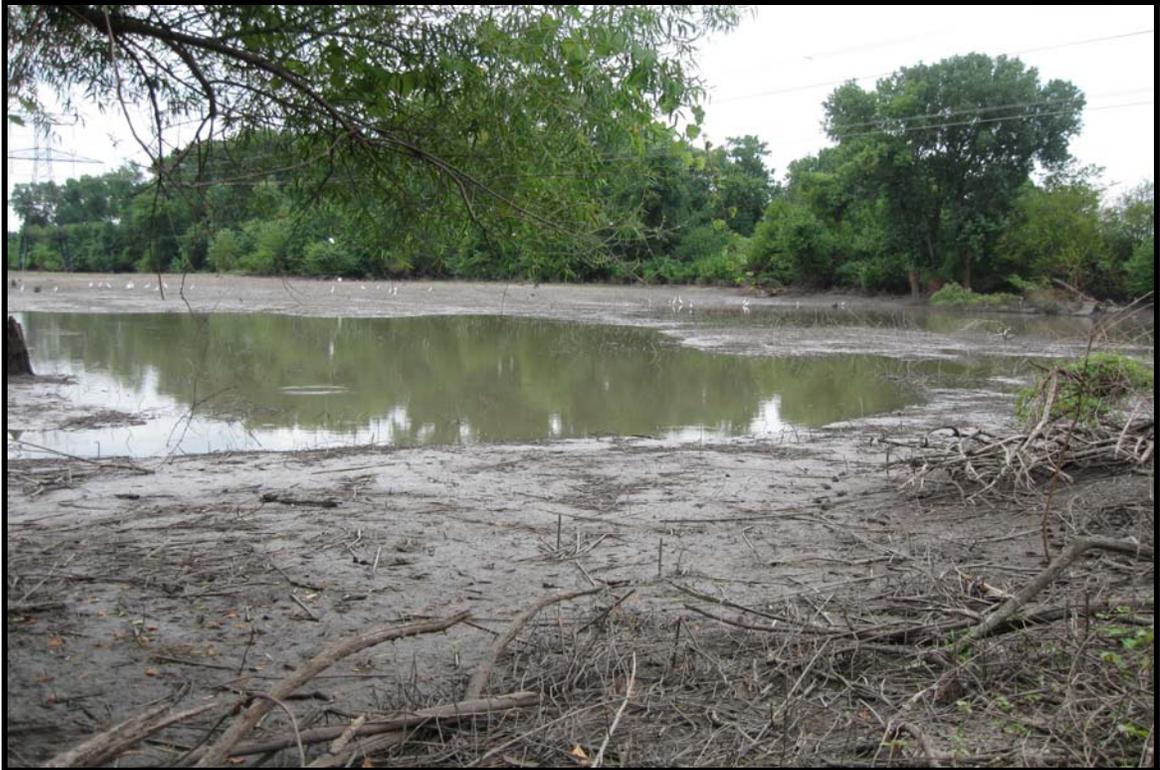
Photograph 5 ↑ - View of Emergent Wetland 1, facing southwest along southern boundary. Photo taken 8-14-08.

5.2.1 Emergent Wetland 1. Emergent Wetland 1 exists in the overhead electrical easement south of Wharf Road. The wetland is bound by a scrub-shrub wetland (not in the project boundaries) to the east, Wharf Road to the north, and Forested Wetland 1 to the west. The wetland extends south of the project boundary; approximately 0.84 acres of the emergent wetland exist on site. During site reconnaissance, Emergent Wetland 1 was observed to be inundated in areas and appeared to have been inundated just days prior to field work. Due to recent and current inundation, the wetland was not observed to support hydric vegetation; however, adjacent vegetation observed included swamp smartweed (*Polygonum hydropiperoides*) and buttonbush (*Cephalanthus occidentalis*). Each of these plants is classified as an obligate wetland species.

Emergent Wetland 1 was observed to support hydric soils. Soils exhibited mottling and mineral concretions. Additionally, the area has been mapped as an emergent wetland on NWI maps. See data forms S1 and S8.

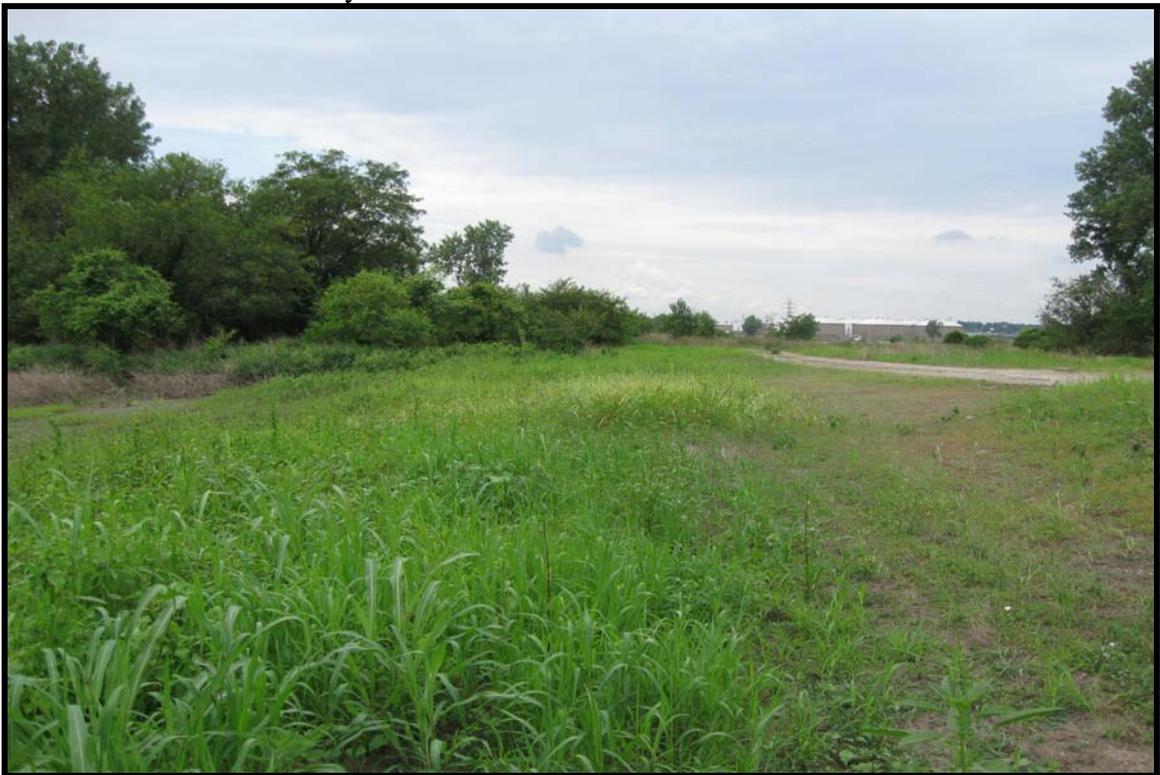
Photograph 6 ↑ - View along southern slope of Wharf Road, facing west. Emergent Wetland 1 to left. Forested Wetland 1 top left. CMPSC wharf in open area of background. Photo taken 8-14-08.

5.3.2 Wharf Road. Wharf Road is an access road to the CMPSC Wharf that crosses the levee. Constructed in the early 1940s, the road was observed to have retained much of its original integrity. Specifically, although the road has been unmaintained and exposed to flooding, its alignment and underlying building materials have not eroded or washed away. Herbaceous and woody vegetation was observed to be slowly migrating upward from either toe of the road's slopes. Upland herbaceous vegetation was observed on the toe of slope of the road through the area of the overhead electrical easement, including common sunflower (*Helianthus annuus*), wild potato vine (*Ipomoea pandurata*), pigweed (*Amaranthus albus*), and trumpetvine (*Campsis radicans*). Riverside of the overhead electrical easement, woody vegetation appears to be spreading. Shrubby mulberry (*Morus alba*) and honeylocust (*Gledistia triacanthos*) dominate the toe of the slope outside of the easement and provide a woody transition buffer to adjacent forested wetlands.

Due to near record flooding, sediment deposits were observed on the Wharf Road below the elevation of 420 feet; however, other wetland hydrological indicators were not observed. Generally, the top elevation of Wharf Road in the floodplain is 415 feet. Soil borings taken near the toe of the slope of the road exhibited refusal at 4 to 6 inches. Concrete and gravel building materials were observed on the top of the road. See data forms S2, S3, S18, and S33.

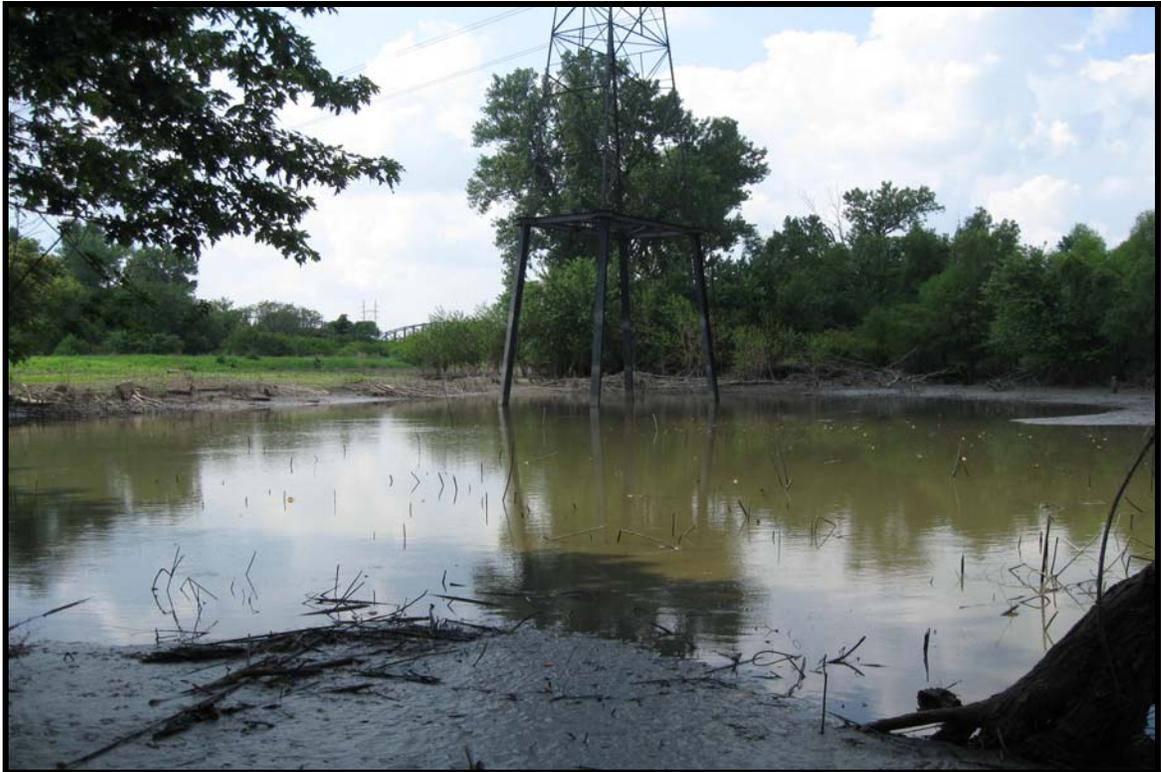
Photograph 7 ↑ - View of Emergent Wetland 2 near S21, facing southwest. Wharf Road visible in background to left. Forested Wetland 3 in background to right. Photo taken 8-15-08.

The lower elevated portions of Emergent Wetland 2 exist in an overhead electrical easement and were observed to be partially inundated. Saturated soils were observed throughout the boundaries of the wetland. Emergent Wetland 2 was observed to support hydrophytic plant species, including swamp smartweed (*Polygonum hydropiperoides*), fogfruit (*Phyla lanceolata*), and strawcolored flatsedge (*Cyperus strigosus*). A large portion of Emergent Wetland 2 did not exhibit existing vegetation due to recent flooding and inundation.

Emergent Wetland 2 was observed to support hydric soils, however, soils were observed to be varied between heavy clay and hydric sand. Mottling, mineral concretions, and/or oxidized root channels were observed in soil borings taken in the wetland. A portion of the soils of Emergent Wetland 2 have been mapped as Beaucoup silty clay loam, a hydric soil. Additionally, a large portion of the wetland has been mapped as an emergent wetland on NWI maps. See data forms S17, S19, S23, S25, S27, and S30.

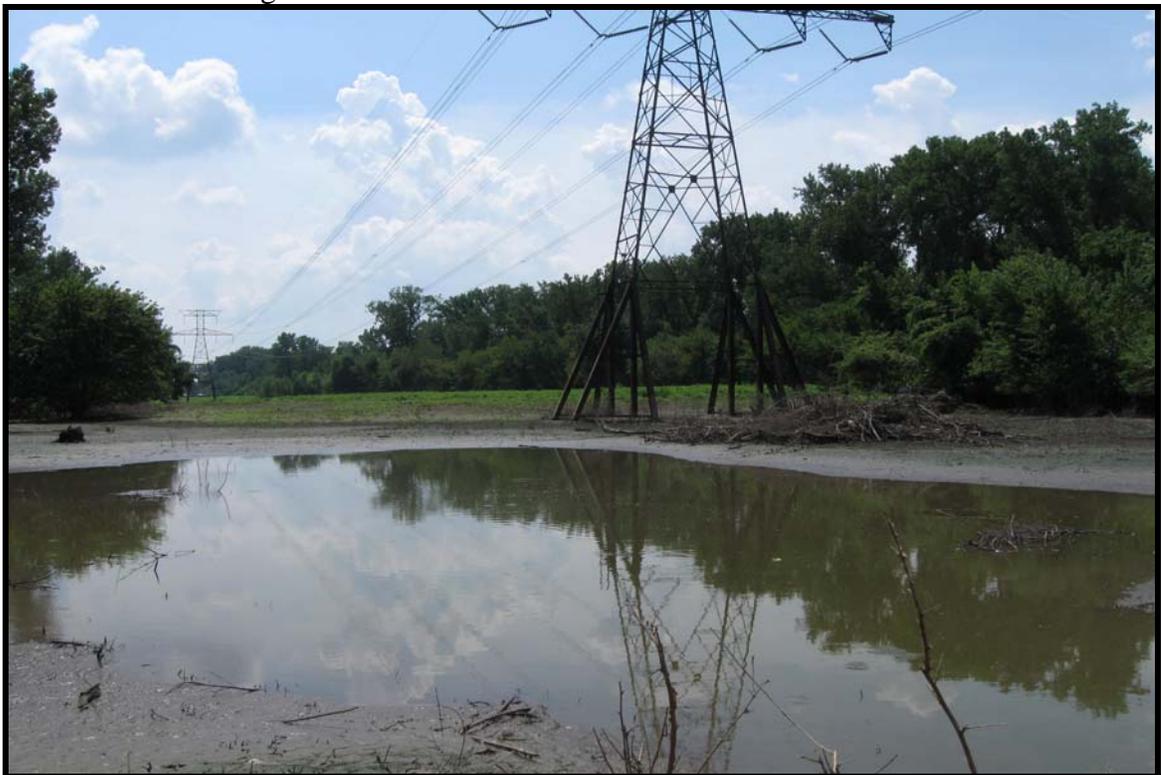
Photograph 8 ↑ - View of Emergent Wetland 2, facing south. Forested Wetland 2 to left and Forested Wetland 3 in top right background. Photo taken 8-15-08.

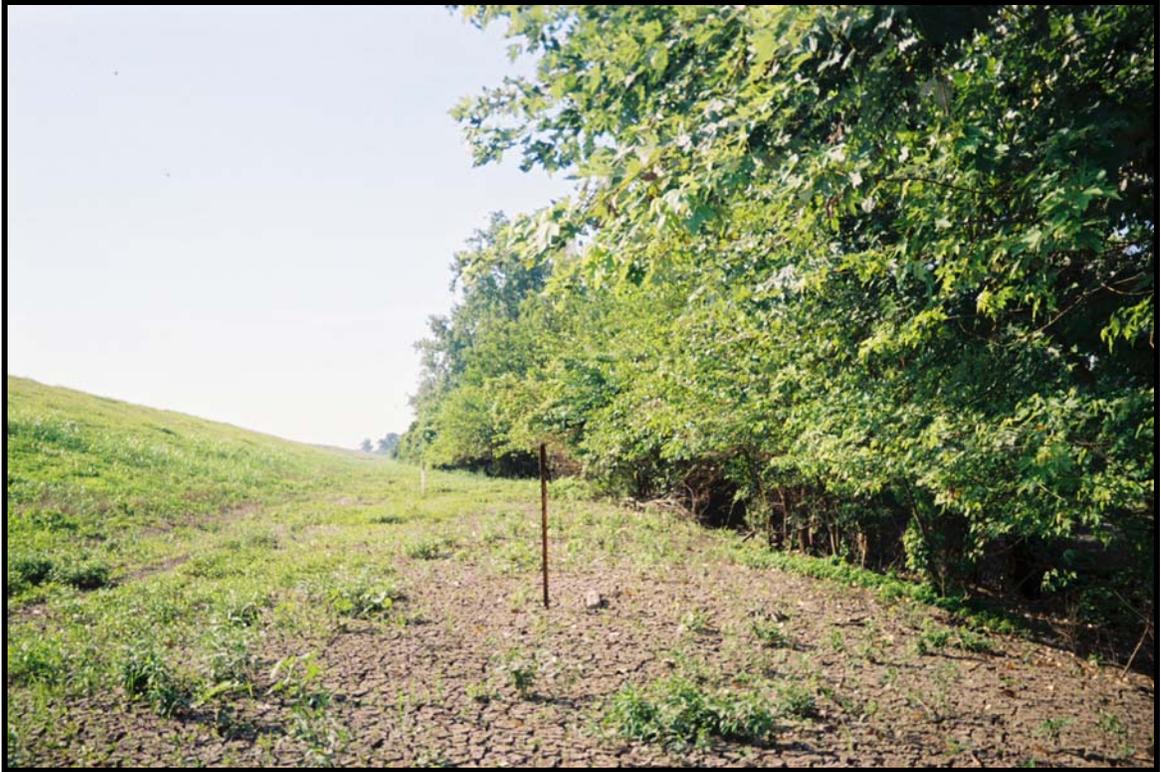
Photograph 9 ↑ - View of Emergent Wetland 2 (center) and Forested Wetland 2 (right), facing south. Levee to left. Photo taken 8-19-08.

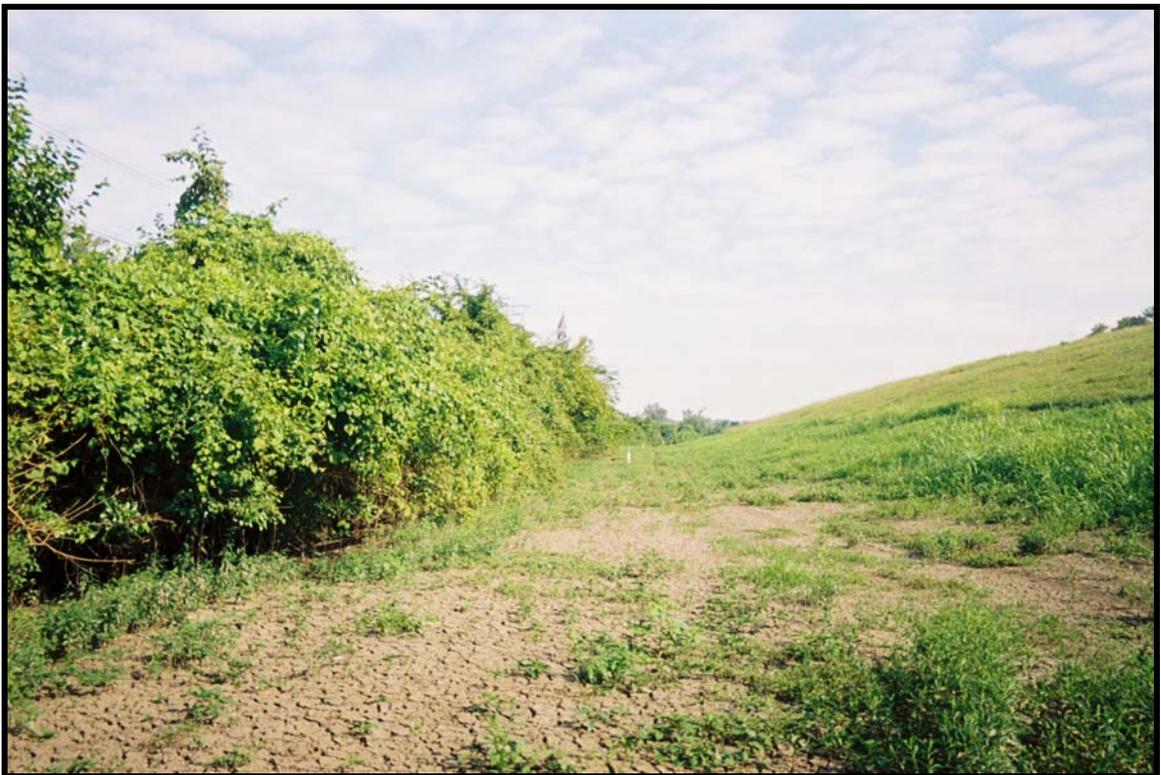
Photograph 10 ↑ - View of Emergent Wetland 2 (center) and Scrub-Shrub Wetland (left), facing north. Levee to right. Photo taken 8-19-08.

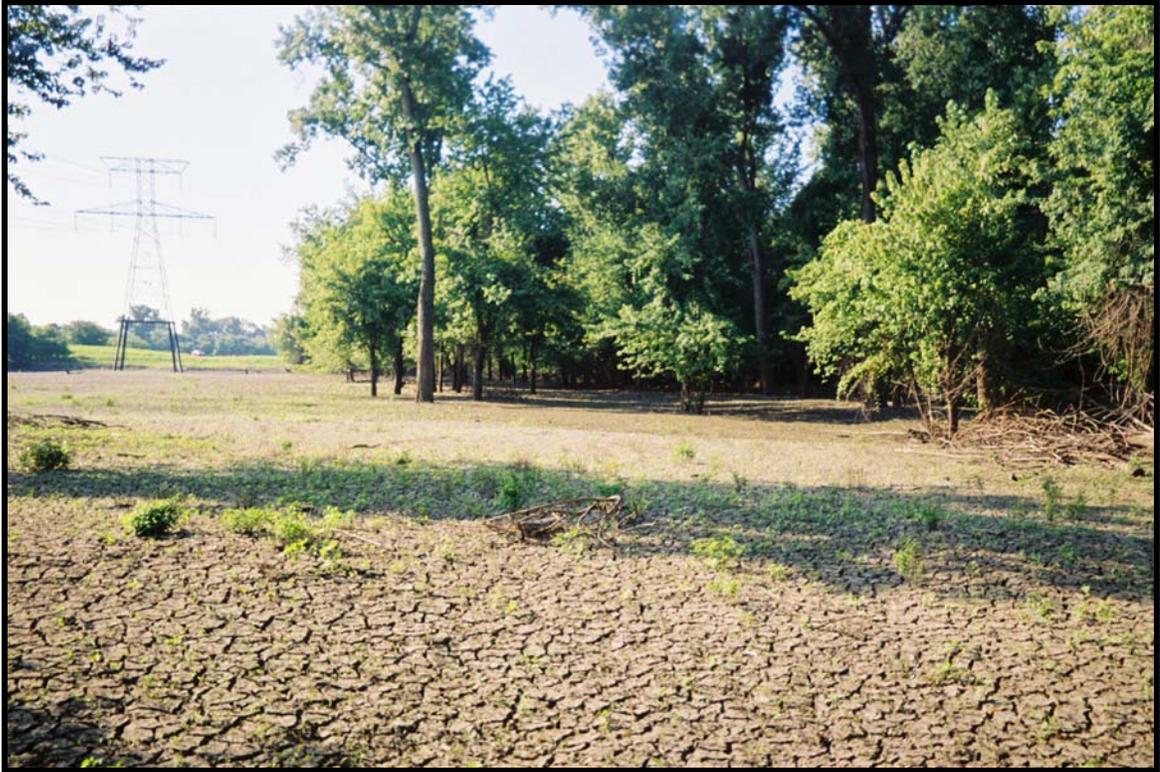
Photograph 11 ↑ - View of Emergent Wetland 2 (left) and Forested Wetland 3 (right) boundary between, facing south. Wharf Road visible in background. Photo taken 8-19-08.

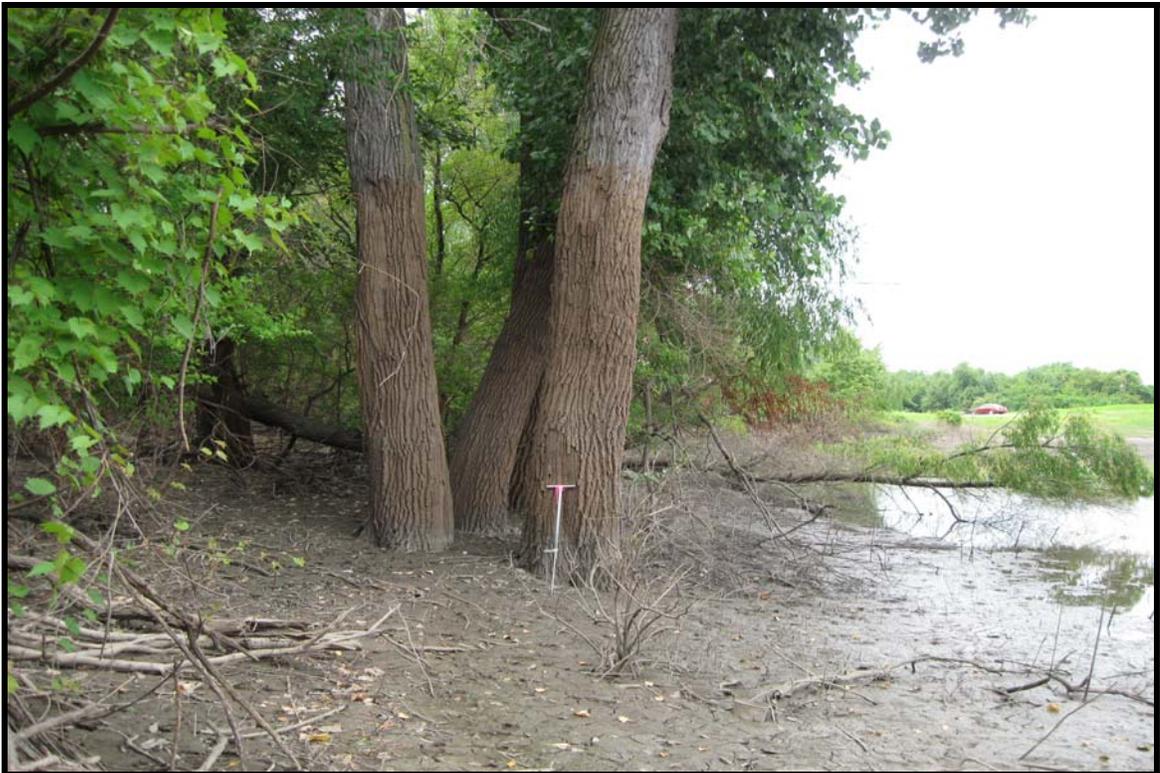
Photograph 12 ↑ - View of sediment marks on cottonwood approximately 15-16 feet high in Forested Wetland 1, facing north along boundary with Emergent Wetland 1 (right). Vehicle in background on Wharf Road. Photo taken 8-14-08.

5.2.3 Forested Wetland 1. Forested Wetland 1 exists along the southern boundary of the project site. The wetland extends south of the project area; approximately 1.41 acres of Forested Wetland 1 exist within the project boundaries. Forested Wetland 1 is bound by Emergent Wetland 1 to the east, CMPSC Wharf to the north, and the Mississippi River to the west. Little herbaceous vegetation was observed in the wetland due to recent flooding; however, the area was not observed to be inundated. Evidence of recent flooding, including flood debris and sediment marks approximately 15 to 16 feet high were observed.

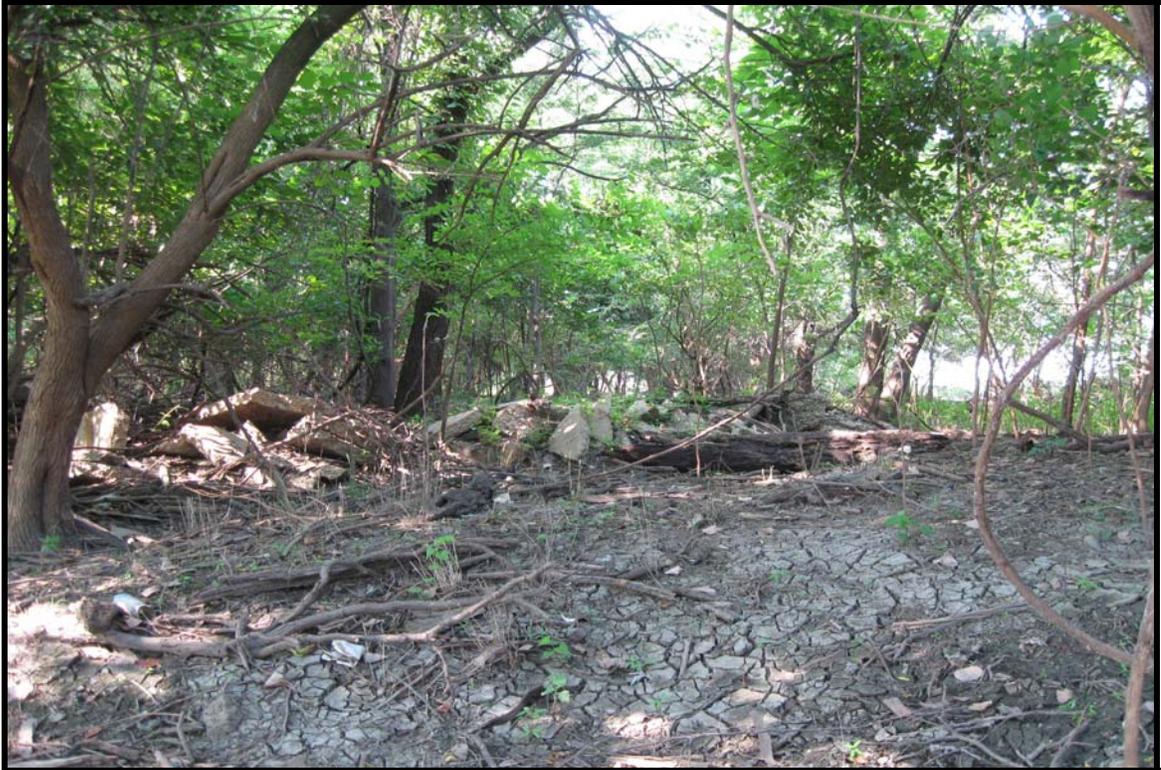
Photograph 13 ↑ - View of concrete rubble and fill piles on slope of CMPSC wharf near boundary of wharf and Forested Wetland 1, facing south. Photo taken 8-15-08.

5.3.3 CMPSC Wharf. Built in the early 1940s, many of the original building materials of the CMPSC Wharf remain today. These materials include concrete remnants, riprap, gravel, and cobblestone. Herbaceous vegetation of the top of the wharf was observed to be dominated by johnsongrass (*Sorghum halepense*) and switchgrass (*Panicum virgatum*). Perimeter areas of the wharf to the north and south were observed to be dominated by mulberry (*Morus alba*), honeylocust (*Gleditsia triacanthos*), and river birch (*Betula nigra*). Silver maple (*Acer saccharinum*) and cottonwood (*Populus deltoides*) were observed to grow near the boundaries of the wharf and adjacent forested wetlands. Sparse vegetation was observed on the banks of the Mississippi River which exists as the western boundary of the wharf, however, scattered bush honeysuckle (*Lonicera maackii*) and black willow (*Salix nigra*) were observed. While some hydrophytic species were observed to be growing on the wharf; upland vegetation appeared to dominate the relative cover.

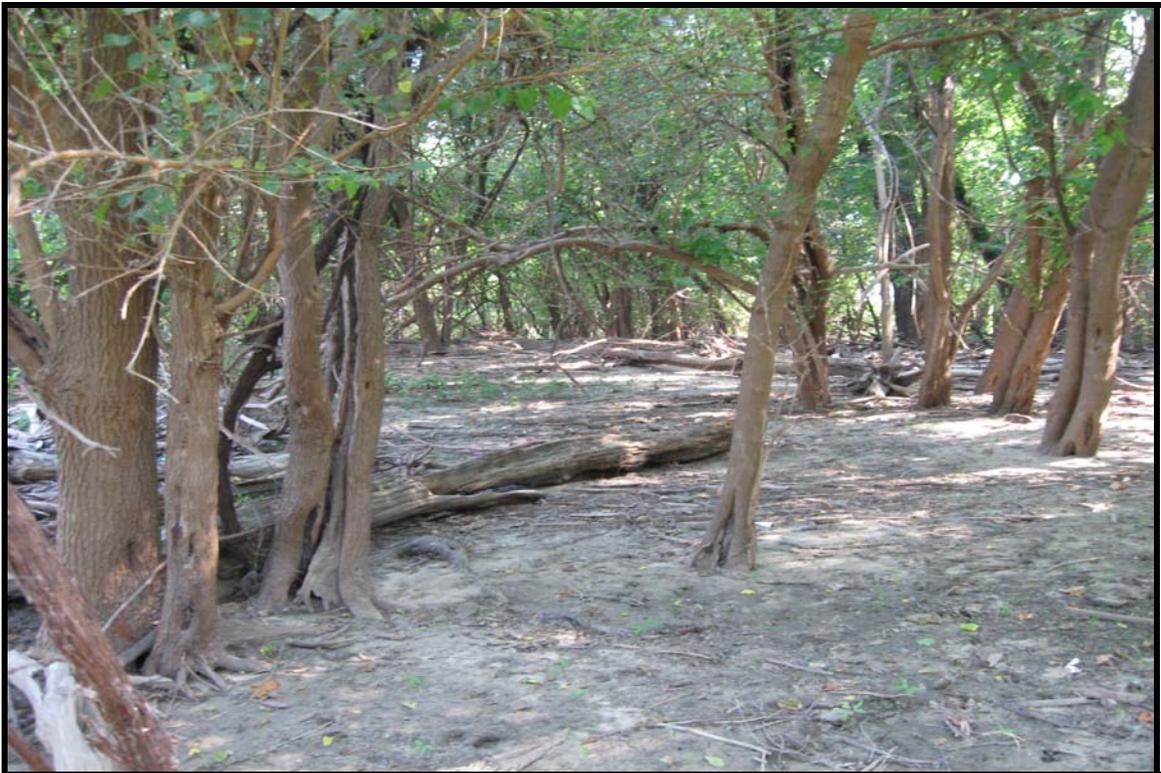
Photograph 14 ↑ - View of Forested Wetland 1, near its boundary with CMPSC wharf, facing east. Photo taken 8-15-08.

Forested Wetland 1 was observed to support mature cottonwoods (*Populus deltoides*), and silver maples (*Acer saccharinum*). Smaller tree species within the wetland include mulberry (*Morus alba*), river birch (*Betula nigra*), and black willow (*Salix nigra*). Each of these tree species is classified as a hydrophytic or "water-loving" plant species. Hydric soils were observed in Forested Wetland 1; however, soil textures and structures were varied from heavy clays to hydric sands. Mottling and/or mineral concretions were observed in soil borings. A large portion of Forested Wetland 1 has been mapped as Beaucoup silty clay loam, a hydric soil. See data forms S4, S6, S7, S12, S13, S14, and S15.

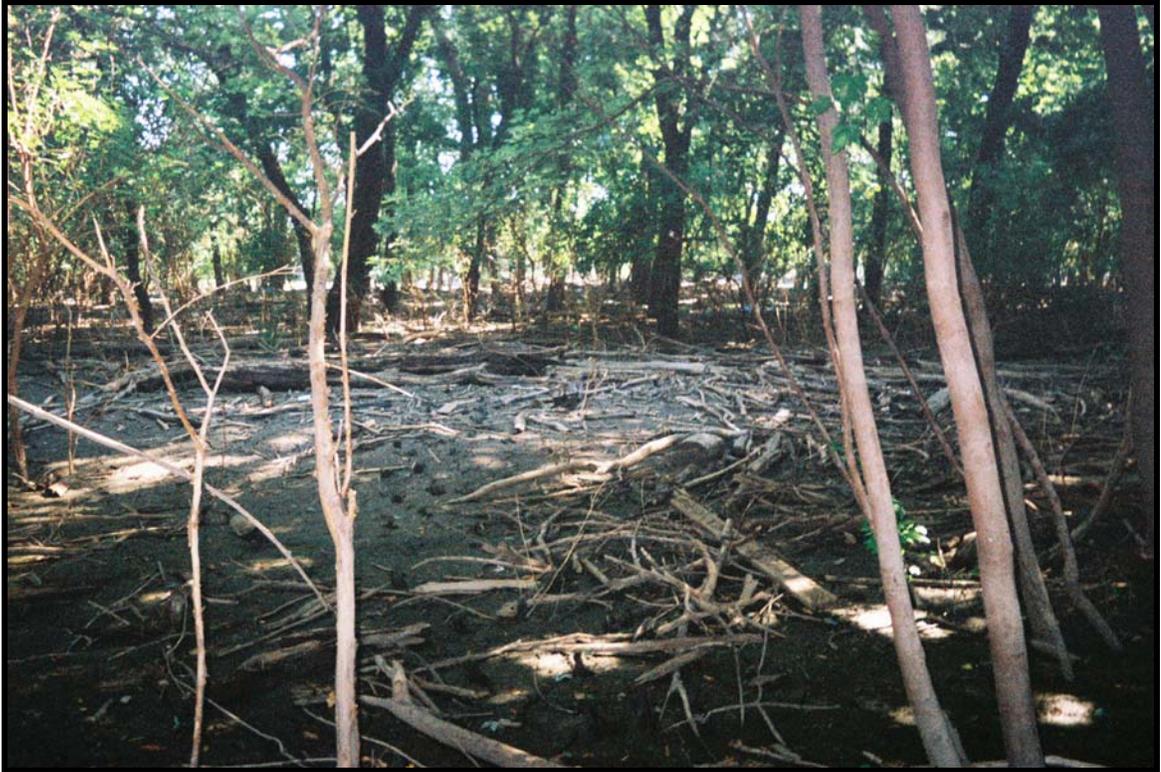
Photograph 15 ↑ - View of Forested Wetland 3 near S39, facing east. Photo taken 8-19-08.

5.2.5 Forested Wetland 3. Forested Wetland 3 is the largest of the three on-site forested wetlands. The forested wetland extends north of the project area; approximately 14.62 acres of Forested Wetland 3 exist within the project boundaries. Forested Wetland 3 is bound by Emergent Wetland 2 to the east, CMPS Wharf to the south, and the Mississippi River to the west. The wetland was observed to be dominated by mature cottonwoods (*Populus deltoides*) and silver maples (*Acer saccharinum*). In addition, smaller mulberry (*Morus alba*), river birch (*Betula nigra*), and black willow (*Salix nigra*) trees were observed. Each of these trees is classified as a hydrophytic species. Little herbaceous vegetation was observed due to recent flooding. Forested Wetland 3 was observed to be inundated in areas and highly saturated.

Forested Wetland 3 was observed to support hydric soils, with a heavy influence of hydric sands. Mottling and mineral concretions were observed. A large portion of Forested Wetland 3 has been mapped as Beaucoup silty clay loam, a hydric soil. Additionally, the wetland has been mapped as forested wetlands on NWI maps. See data forms S34, S35, S37, S39, and S40.
