**NATURAL SYSTEMS ASSESSMENT:
WATERS OF THE UNITED STATES DELINEATION
RIVER'S EDGE SOUTH HARBOR
MADISON, ILLINOIS**

TRI-CITY REGIONAL PORT DISTRICT
Granite City, Illinois

GEOTECHNOLOGY, INC.
Collinsville, Illinois

Geotechnology, Inc. Report No. 0734009.85TA

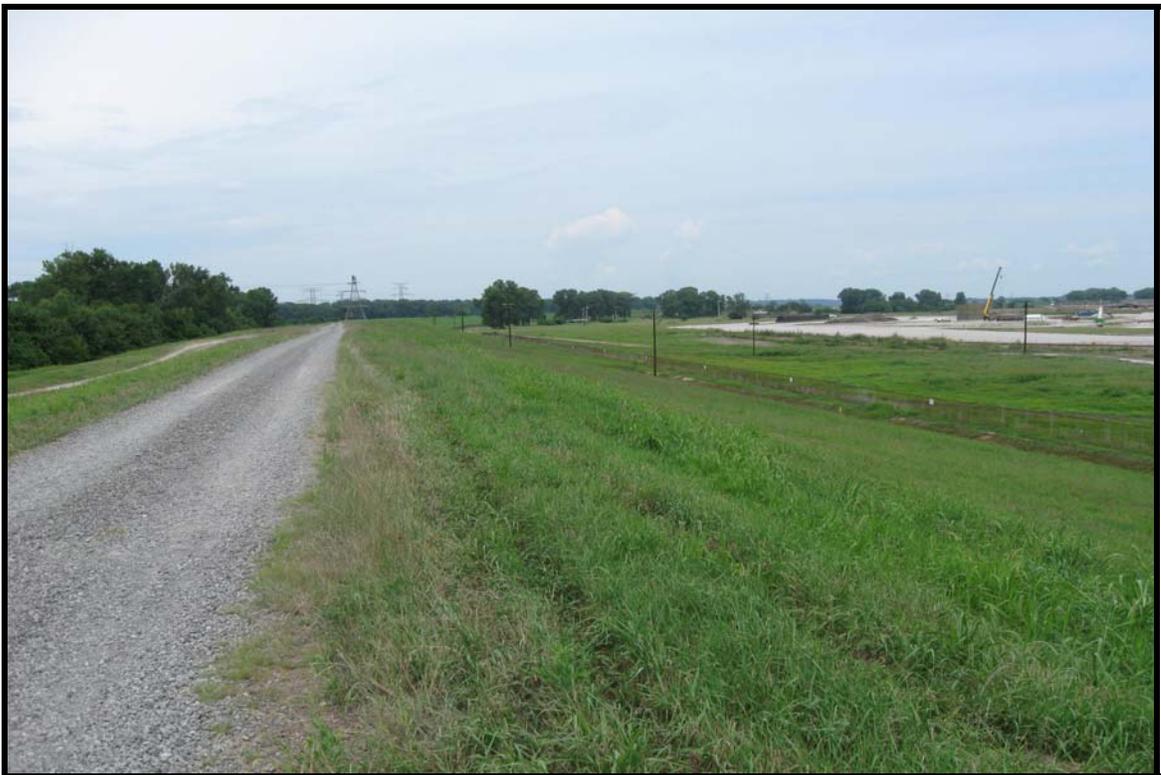
Photograph 16 ↑ - View along top of levee facing north. USACE Relief Well Drainageway is visible to the right. Photo taken 8-14-08.

5.3.1 Levee. The levee, currently owned by the Metro East Levee District, is part of an extensive levee system that protects Metro East, Illinois, from flooding of the Mississippi River. The levee transverses the eastern portion of the project area. The constructed levee is approximately 250 feet wide and peaks at an elevation of 440 feet. Vegetation on the levee was observed to be well maintained and primarily comprised of the upland species, fescue (*Festuca arundinacea*) and johnsongrass (*Sorghum halepense*). Other upland species observed include toothed spurge (*Euphorbia dentata*), wholly croton (*Croton capitatus*), wild potato vine (*Ipomoea pandurata*), camphorweed (*Heterotheca subaxillaris*), field bindweed (*Convolvulus arvensis*), and nodding foxtail (*Setaria faberi*).

Sediment marks were observed near the elevation of 420 feet on the river (west) side of the levee. This is consistent with USACE flood data obtained at <http://www2.mvr.usace.army.mil/WaterControl/shefdata2.cfm?sid=CE626E20&d=237&dt=E>. Although sediment marks were observed at higher than normal levels, other wetland hydrological indicators were not observed. Soil borings taken closer to the toe of the levee exhibited refusal between 2 and 6 inches. See data forms S20, S22, S26, and S29.

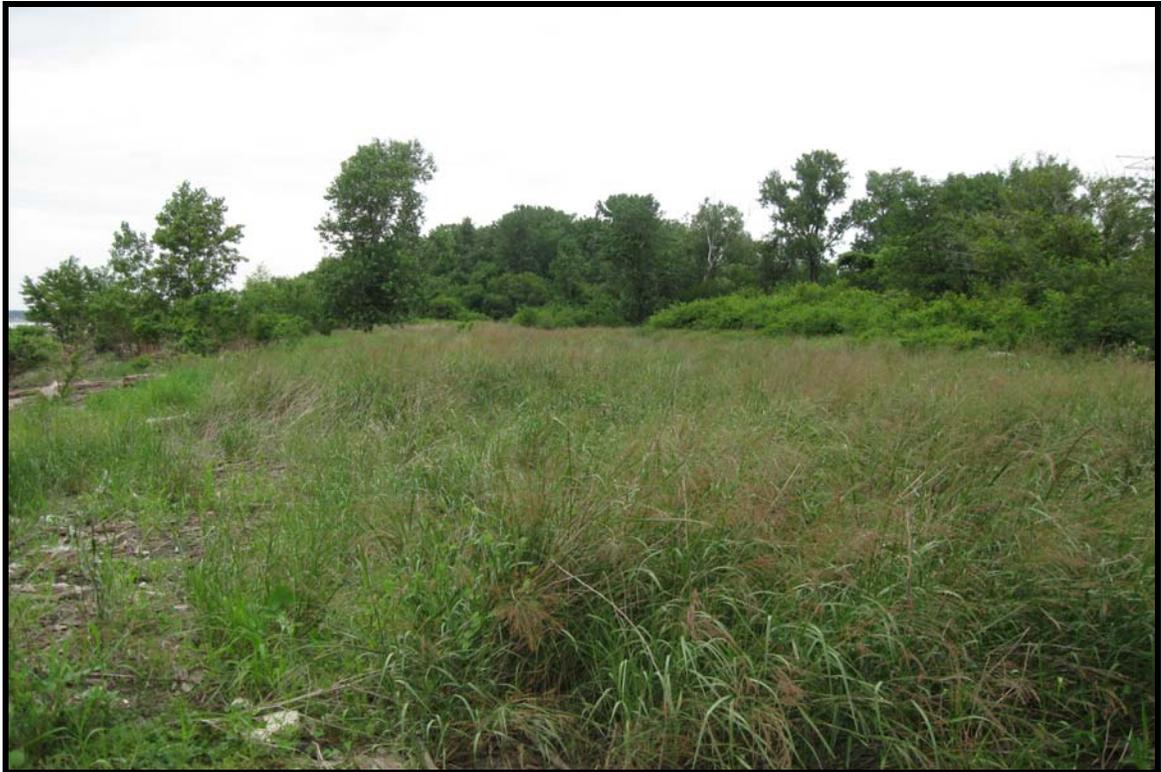
Photograph 17 ↑ - View of CMPSC Wharf, facing north. Photo taken 8-14-08.

5.3.3 CMPSC Wharf. Built in the early 1940s, many of the original building materials of the CMPSC Wharf remain today. These materials include concrete remnants, riprap, gravel, and cobblestone. Herbaceous vegetation of the top of the wharf was observed to be dominated by johnsongrass (*Sorghum halepense*) and switchgrass (*Panicum virgatum*). Perimeter areas of the wharf to the north and south were observed to be dominated by mulberry (*Morus alba*), honeylocust (*Gleditsia triacanthos*), and river birch (*Betula nigra*). Silver maple (*Acer saccharinum*) and cottonwood (*Populus deltoides*) were observed to grow near the boundaries of the wharf and adjacent forested wetlands. Sparse vegetation was observed on the banks of the Mississippi River which exists as the western boundary of the wharf, however, scattered bush honeysuckle (*Lonicera maackii*) and black willow (*Salix nigra*) were observed. While some hydrophytic species were observed to be growing on the wharf; upland vegetation appeared to dominate the relative cover.

Where exposed rock was not observed, soil borings were taken. Soil borings exhibited refusal between 3 to 6 inches. Surficial soils were observed to be highly variable. Based upon sampling areas in the field, our findings illustrated a consistency in the boundary of the wharf with the OHW elevation of 410.5 feet. Impacts to the bank of the wharf up to and including the 410.5 feet elevation will be considered river impacts and require approval by regulatory agencies. See data forms S5, S9, S10, S11, S16, S36, S38, and S41.

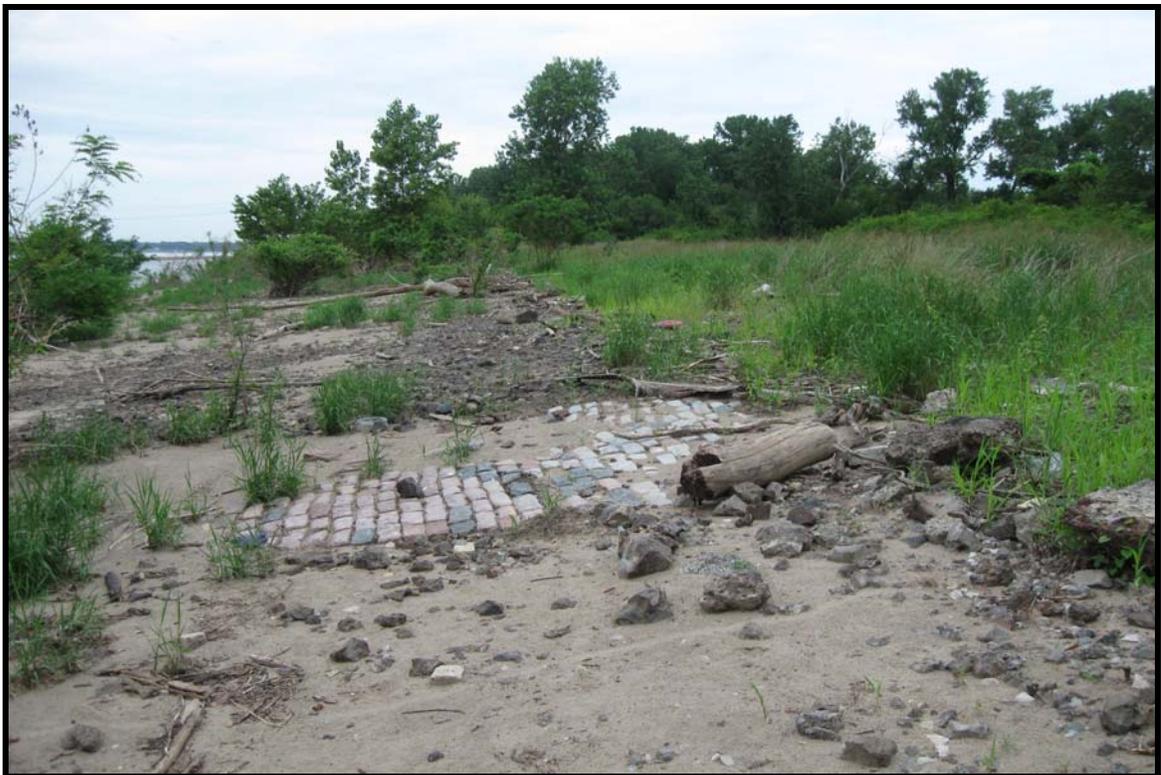
Photograph 18 ↑ - View of cobblestone remnants on CMPSC Wharf, facing north. Photo taken 8-14-08.

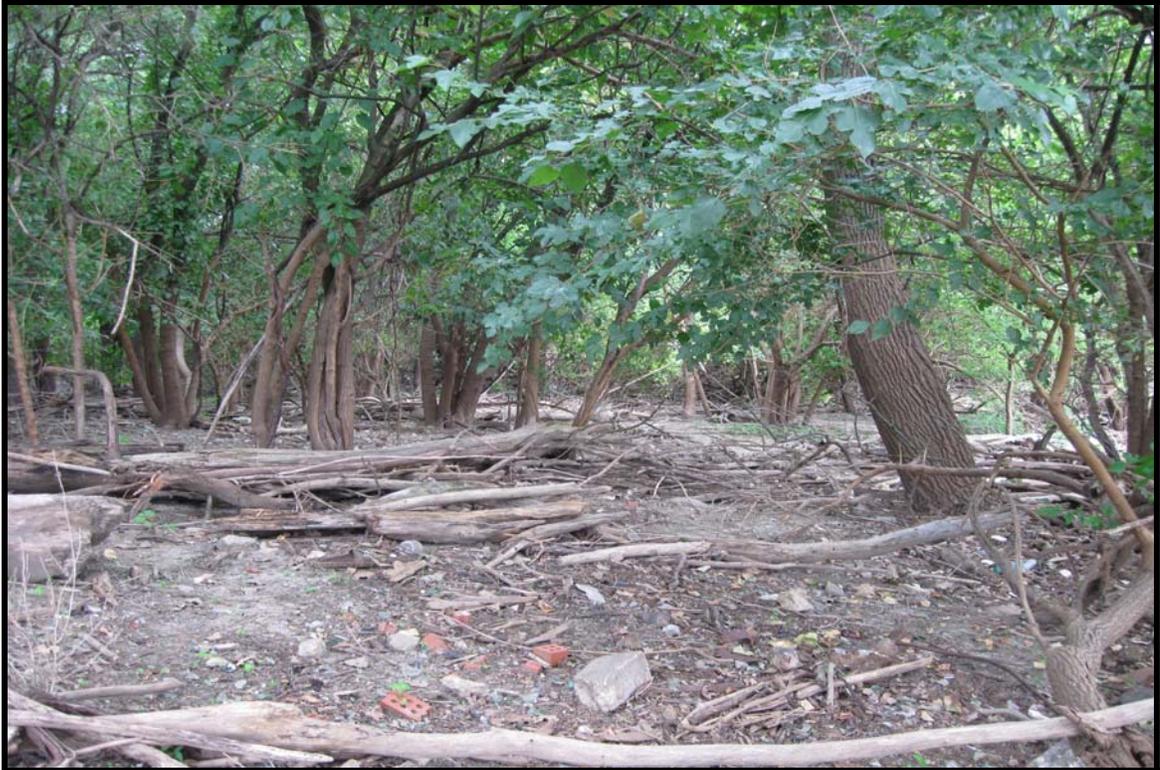
Photograph 19 ↑ - View of boundary of CMPSC Wharf (foreground) and Forested Wetland 1 (background), facing south. Photo taken 8-14-08.

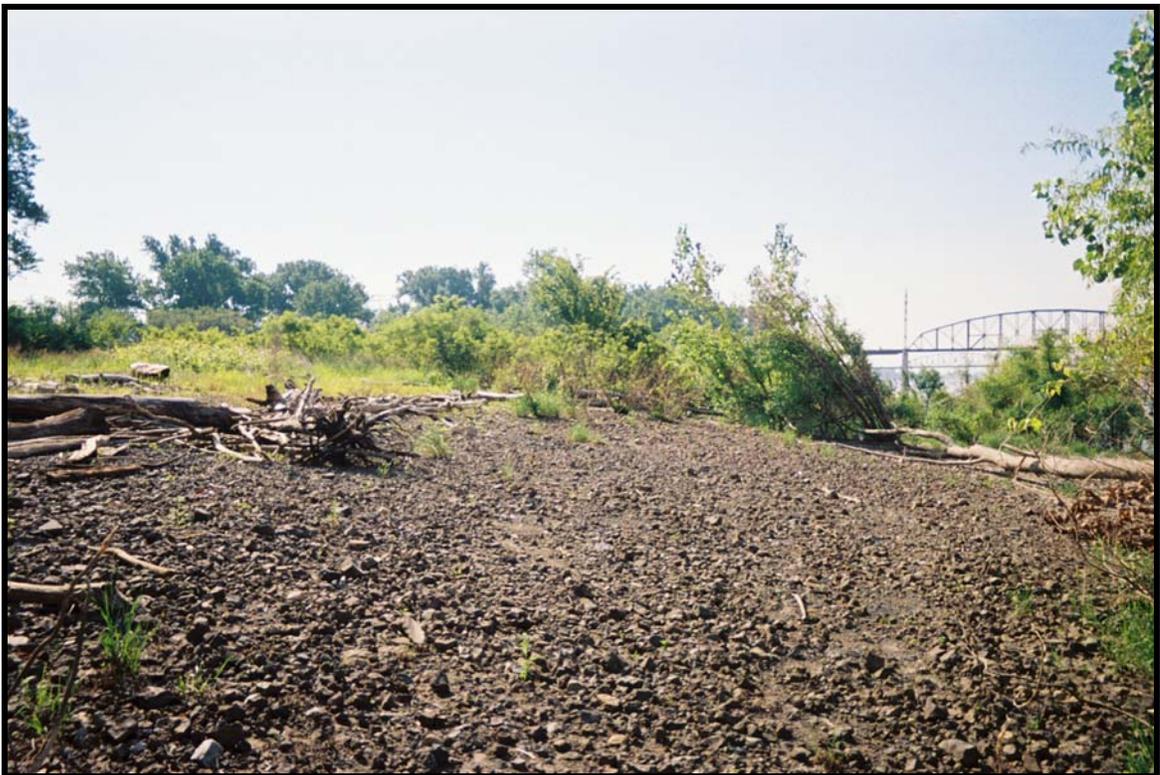
Photograph 20 ↑ - View of remaining gravel on CMPSC Wharf, facing south. Photo taken 8-19-08.
