Sweet Water Mitigation Bank

Addendum No. 5 to the
WFI-B Umbrella Mitigation Banking Instrument
LKS-SW-2022-002

April 19, 2023

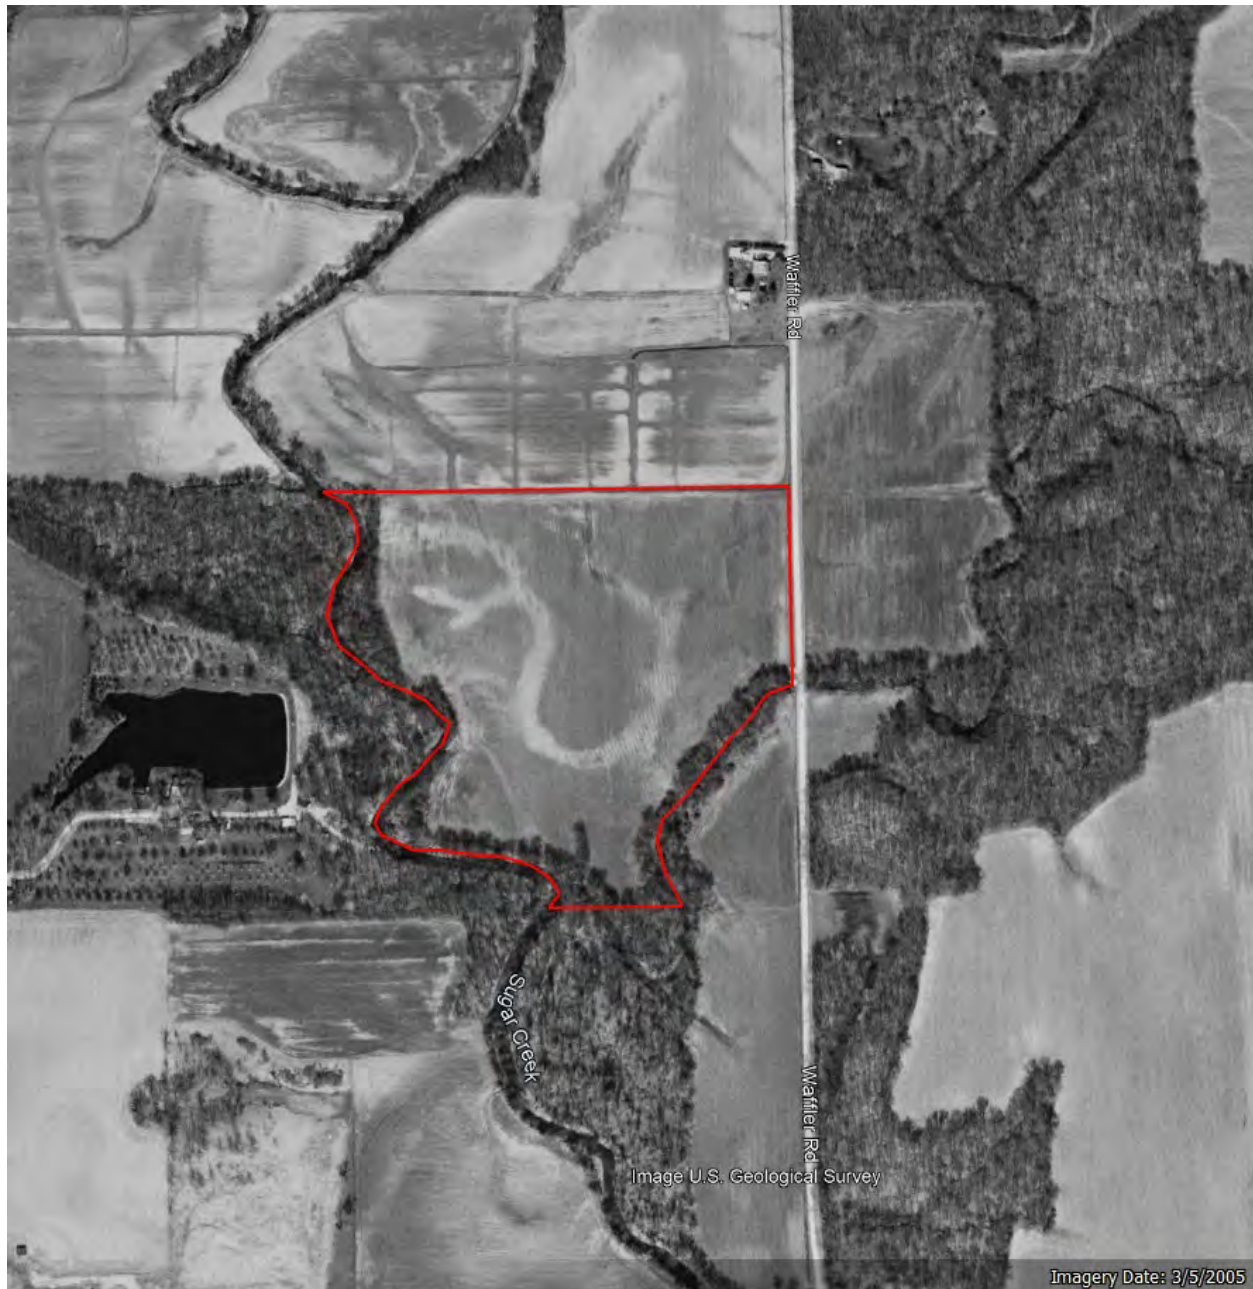
Aerial: 2005 (historic meander scar very visible)

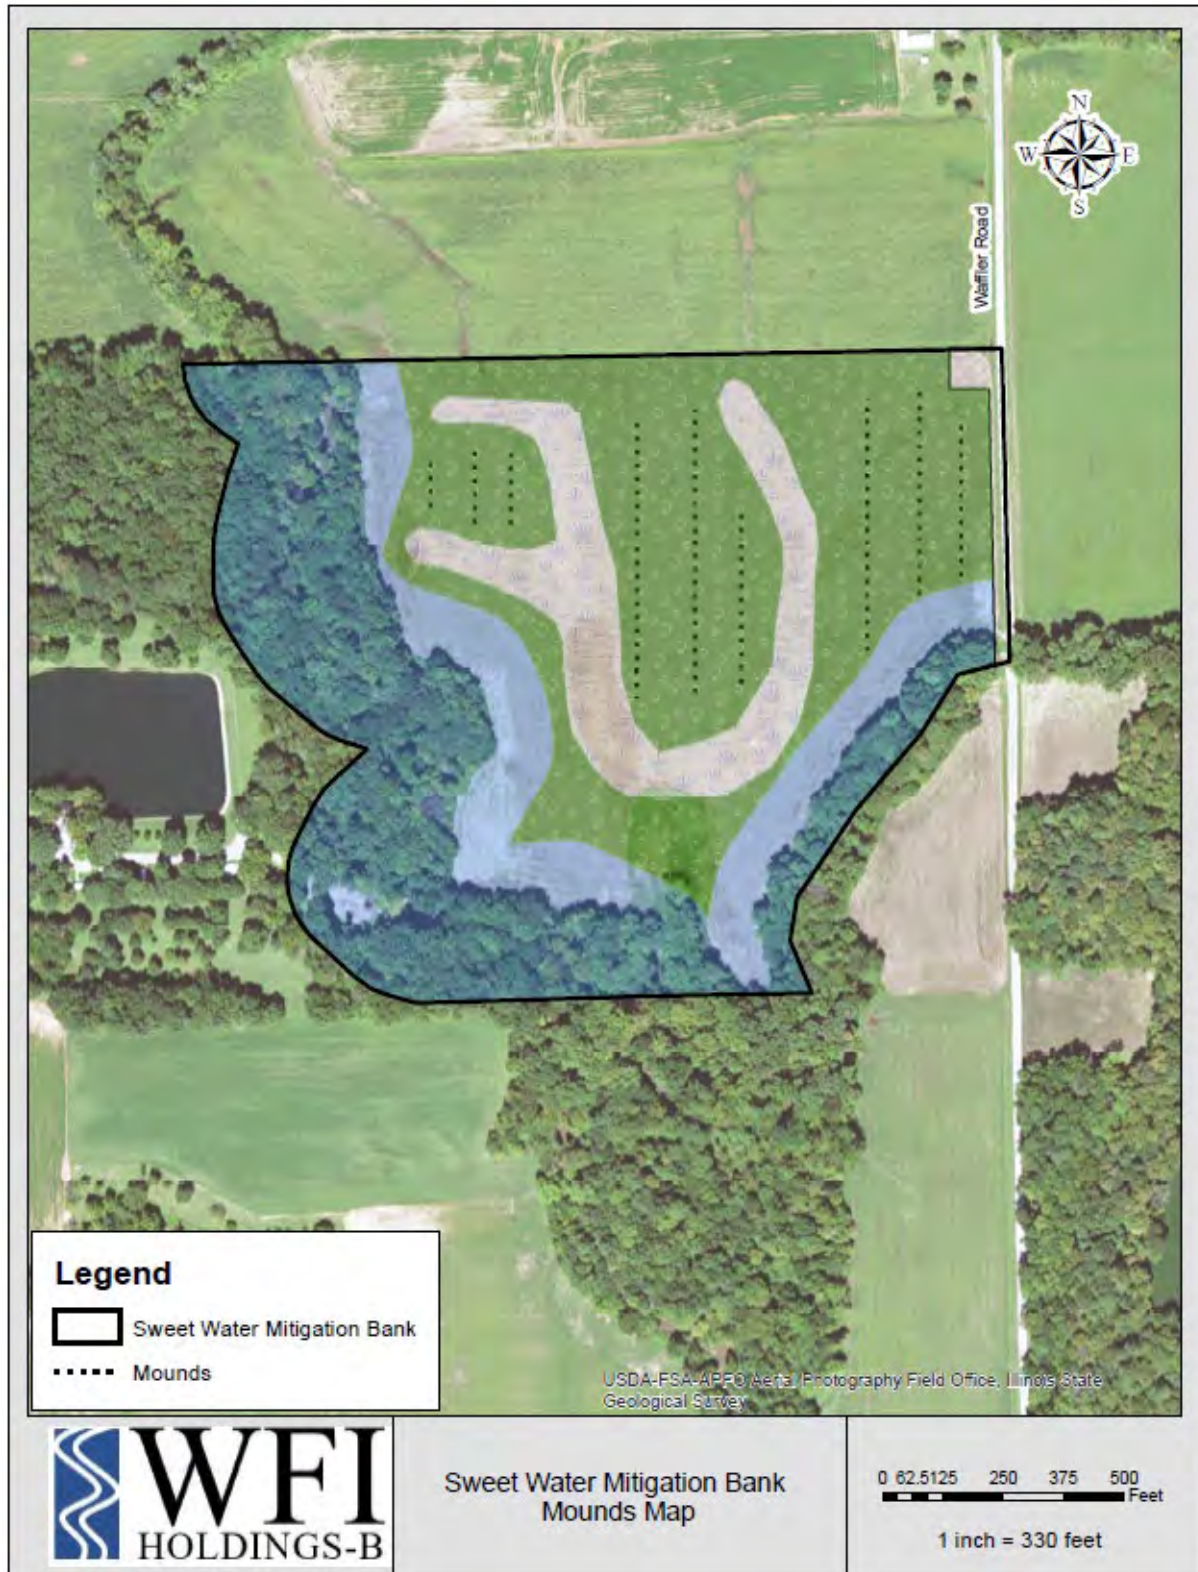
Figure 8 – Mound Construction

Rows of mounds @ 40' center

The tree planting will incorporate the construction of mounds that trees will be planted upon specifically to promote the growth of hard mast species. Planting on mounds will increase survivability of container trees by promoting root development due to air space created by the mounds. Secondly, it may reduce mechanical damage caused by major precipitation events and freezing. Using container trees (app. 4 feet in height) planted on mounds will reduce the frequency and duration of seedlings being overtopped during the growing season.

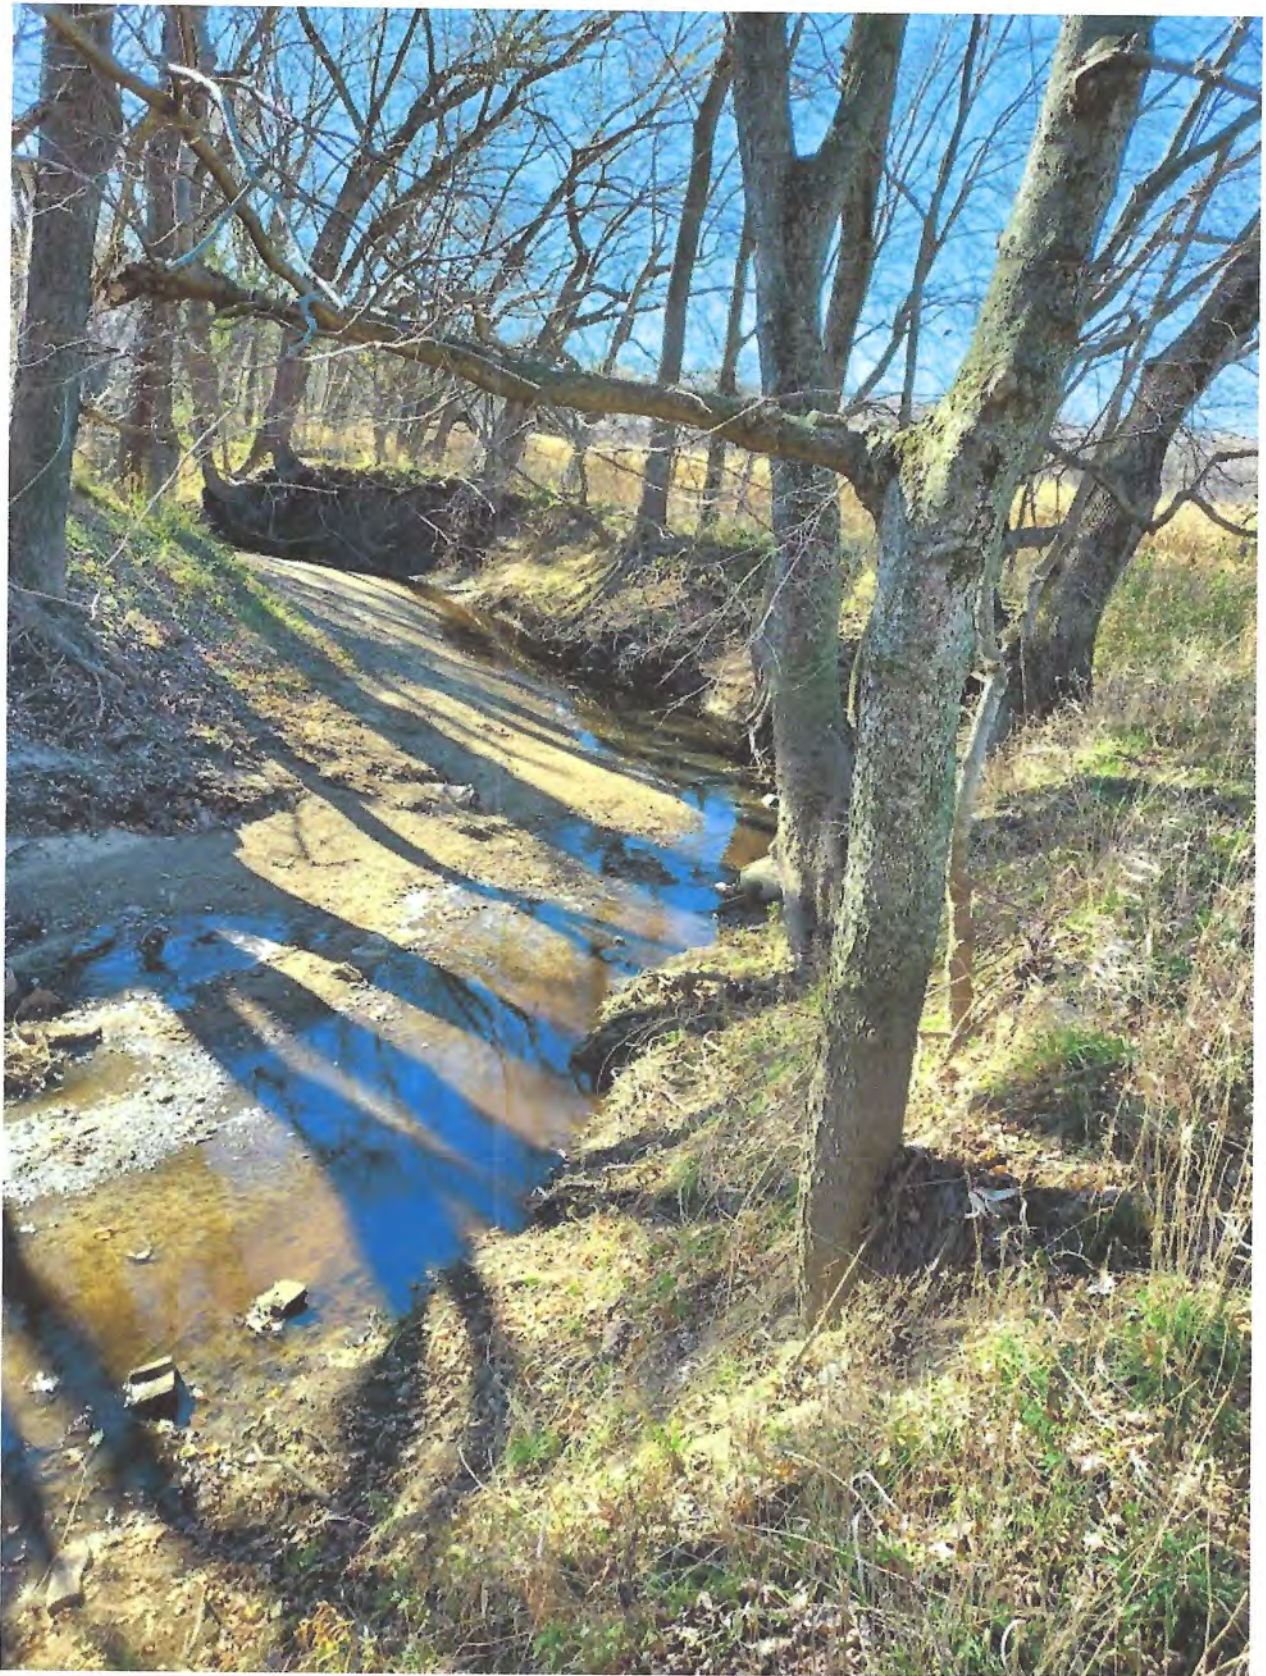
Site of 200 ft. STP Reach 1 –Spanker Branch (Looking Downstream)

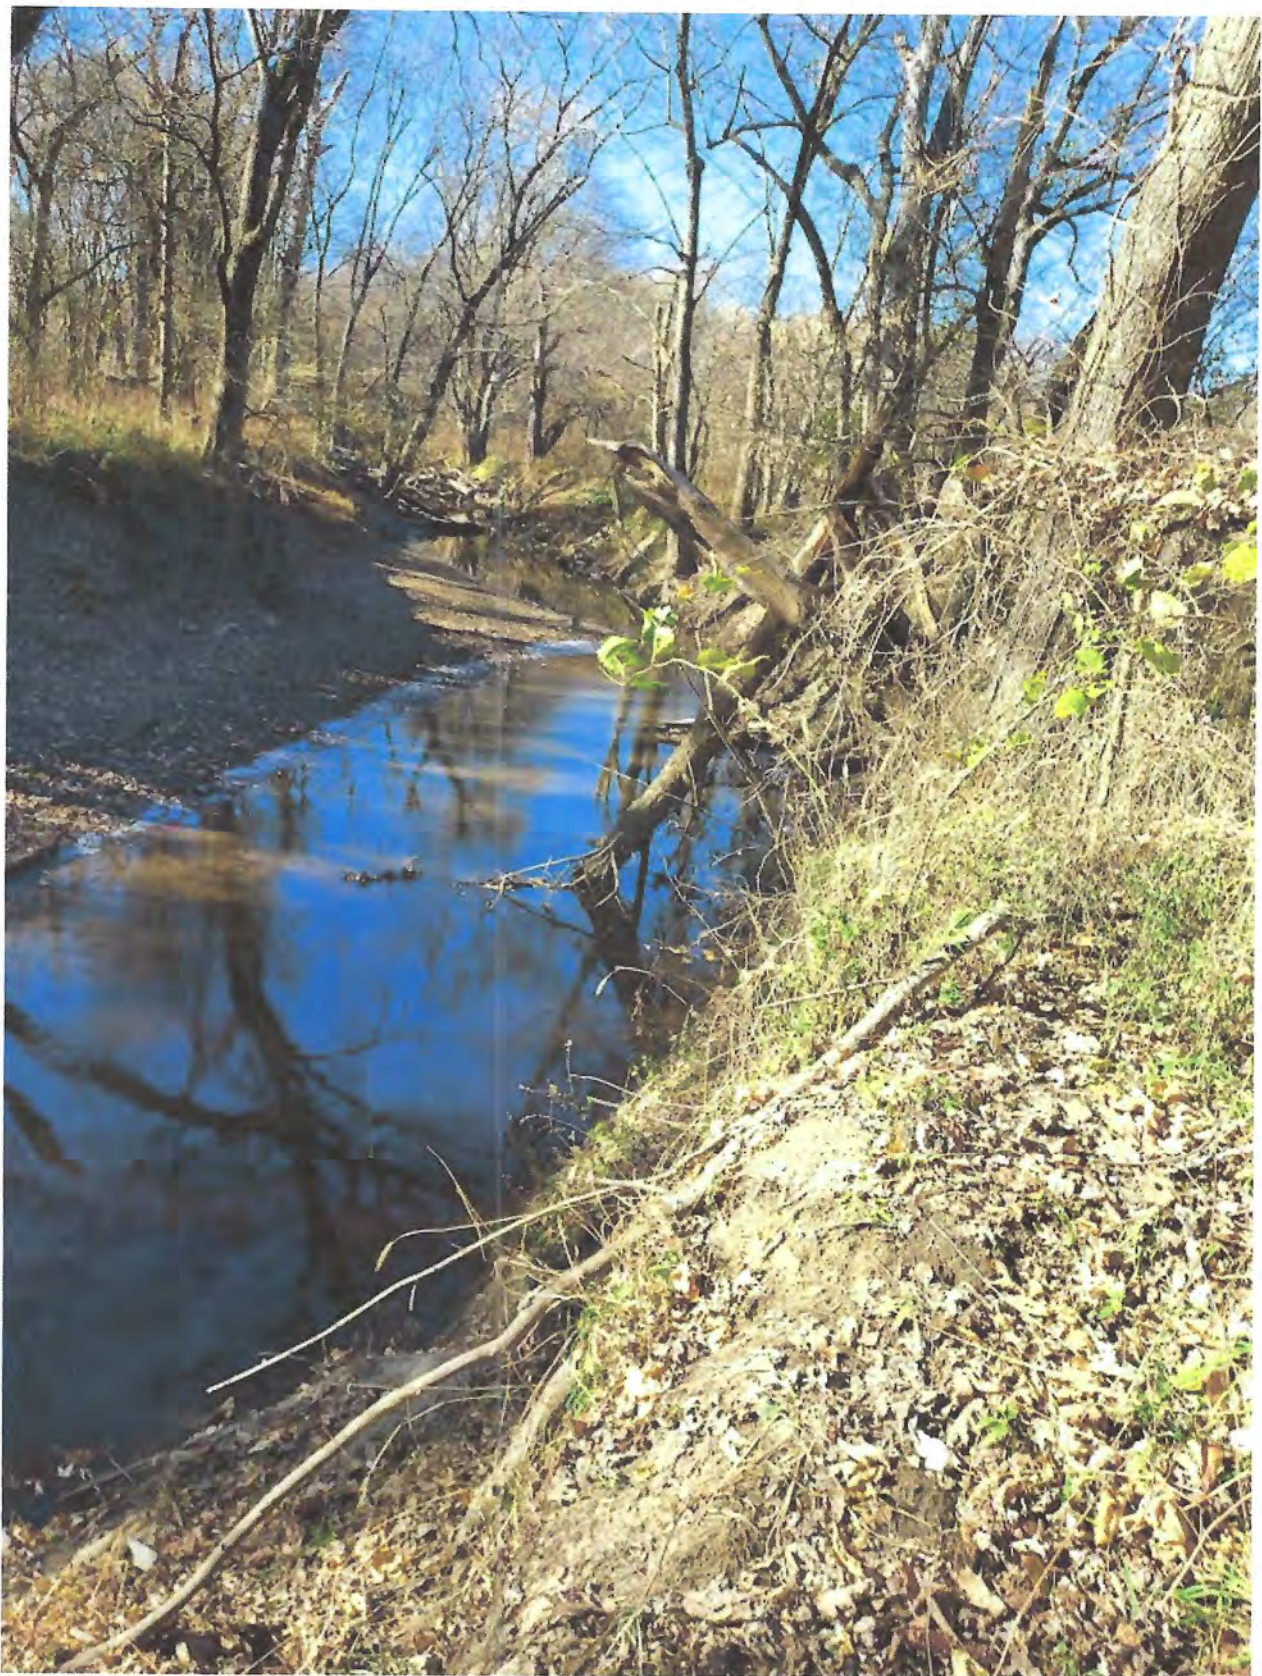
Site of 300 ft. STP Sugar Creek: Reach 2 (Looking Upstream)

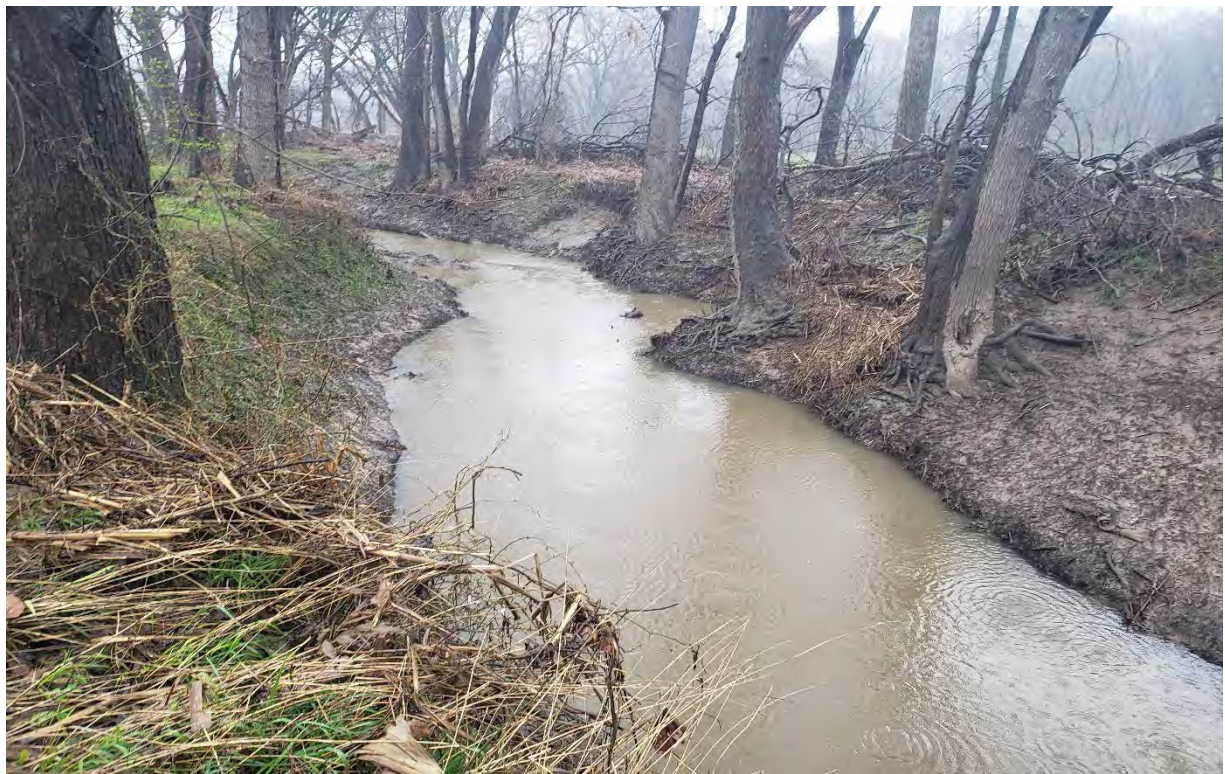
Photo 2. Upstream view of Spanker Branch with eroding banks, facing northeast
