1. AGENCY USE ONLY (Leave blank)		2. REPORT DATE 1999	3. REPORT TYPE AND DATES COVERED Final Report	
4. TITLE AND SUBTITLE An Archaeological Curation-Needs Assessment for the Legacy Resource Management Program			5. FUNDING NUMBERS

7. PERFORMING ORGANIZATION NAME(S) AND ADDRESS(ES) U.S. Army Corps of Engineers, St. Louis District 1222 Spruce Street (CEMVS-ED-Z) St. Louis, Missouri 63103-2833			8. PERFORMING ORGANIZATION REPORT NUMBER Archaeological Curation-Needs Assessment Technical Report No. 15

# **An Archaeological Curation-Needs Assessment for the Legacy Resource Management Program**

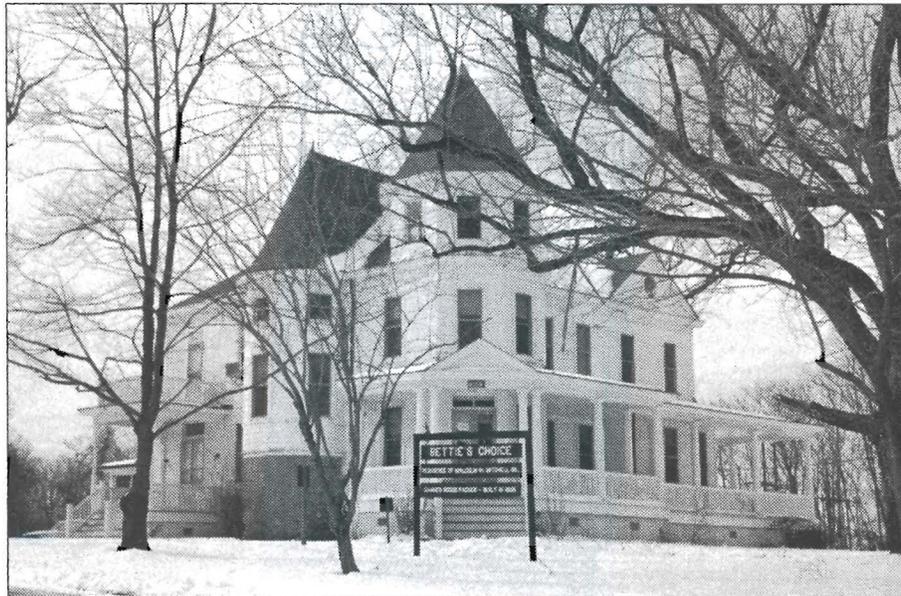
The Malcolm Mitchell House has been renovated to contain offices and exhibit areas managed by the Directorate of Safety, Health, and Environment. The foundation of the building is granite, the roof is imitation-slate tile, and exterior walls are Victorian-style wood clapboard. There are three floors aboveground and one belowground. Interior and exterior renovations are numerous. Walls and ceilings have been repaired and repainted. The gutter system, front porch ceiling, front porch pillars, and floor joints are all either additions or major modifications. The current roof is 15 years old. Overall, the structure is solid, with no cracks or leaks. There are multiple windows in the structure,

**Figure 1. Exterior of the repository on Aberdeen.**

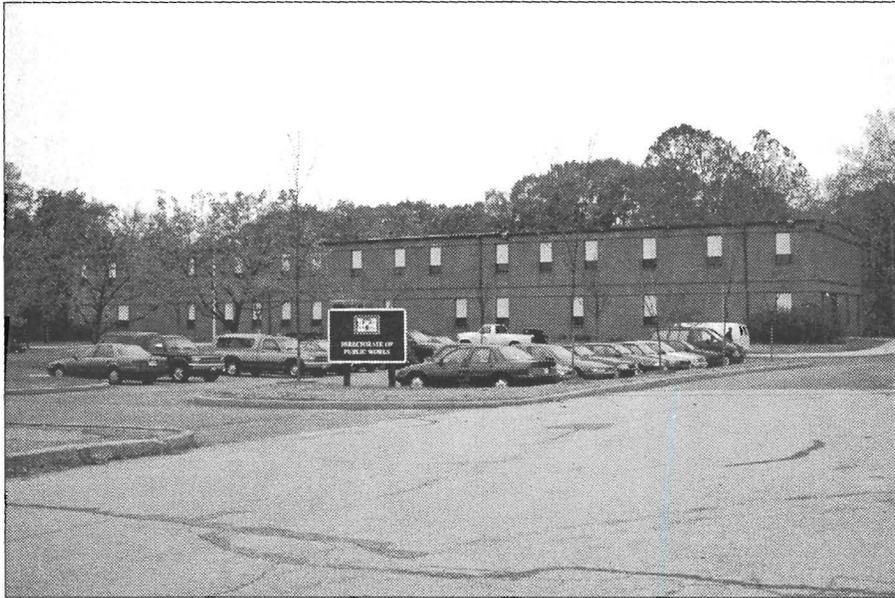
**Figure 5. View of the DPW building that houses associated records and reports from Fort Belvoir.**

The Directorate of Public Works (DPW) on Fort Belvoir is located in an administrative office building on the Fort Belvoir military installation (Figure 5). Only associated records and reports are stored in the offices of the DPW.

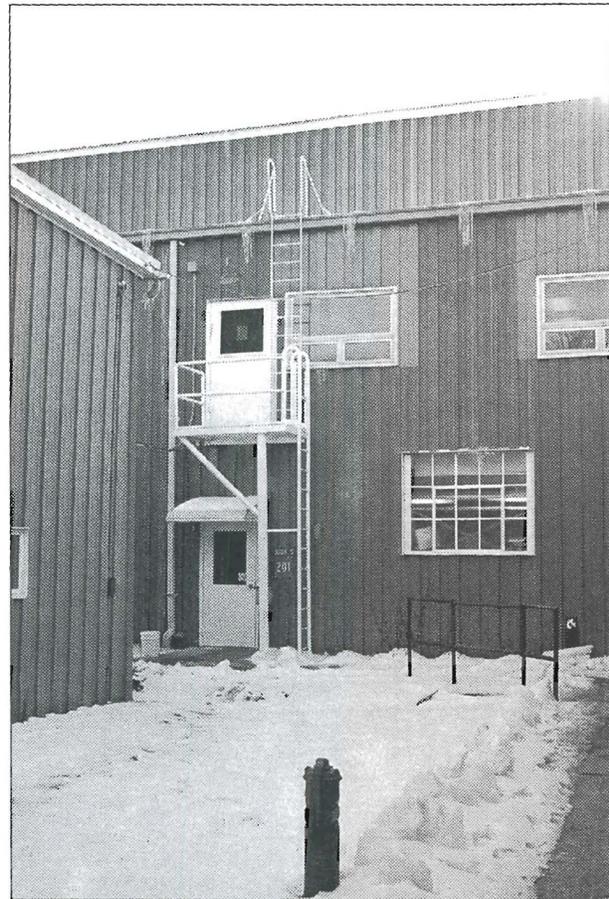
**Figure 8. Entrance to repository on Fort Detrick.**

with metal support beams. The interior walls are concrete block. There are no windows, and only one metal-panel door to the repository. The collections storage area, filled to approximately 80 percent capacity, is used primarily for the storage of records and maps. For the most part, it contains metal file cabinets and metal map cabinets. Archaeological collections encompass less than 5 percent of the storage space.

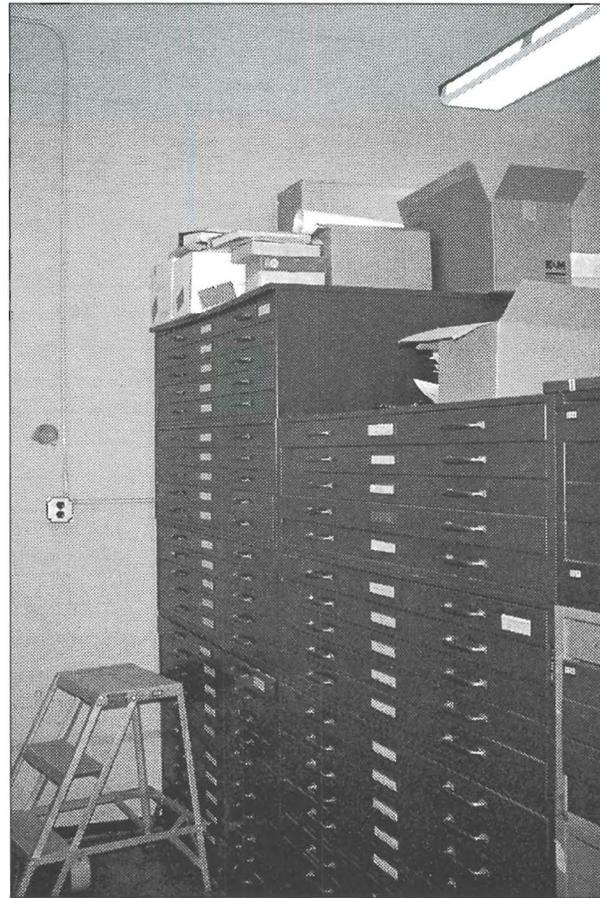
Archaeological collections are stored in a cardboard box located on the top of several 7-foot-tall, metal file cabinets in the rear of the collections storage area (Figure 9).

Artifacts are stored in one acidic-cardboard box with a volume of 1 ft<sup>3</sup>. The box has folded flaps, and is directly labeled "archaeological survey" in marker.

**Figure 9. Collections are stored in a box on top of the highest of the flat map cabinets.**

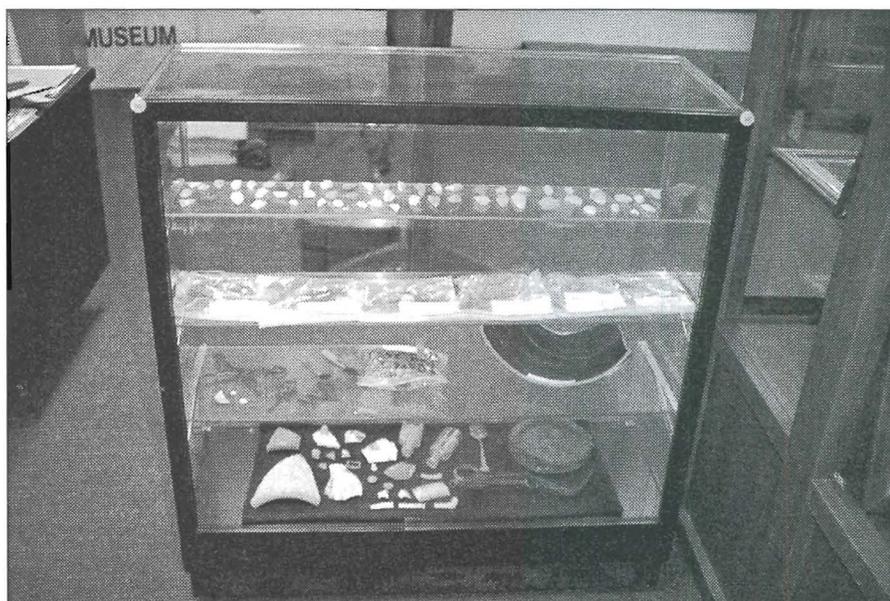
**Figure 14. Prehistoric and historical-period artifacts are on display in the Fort A. P. Hill Museum.**

There is one floor and two exterior doors. There are four exterior windows, two on the north side of the structure and two on the south side. The museum has multiple exhibits and display cabinets, with one cabinet containing archaeological materials (Figure 14).

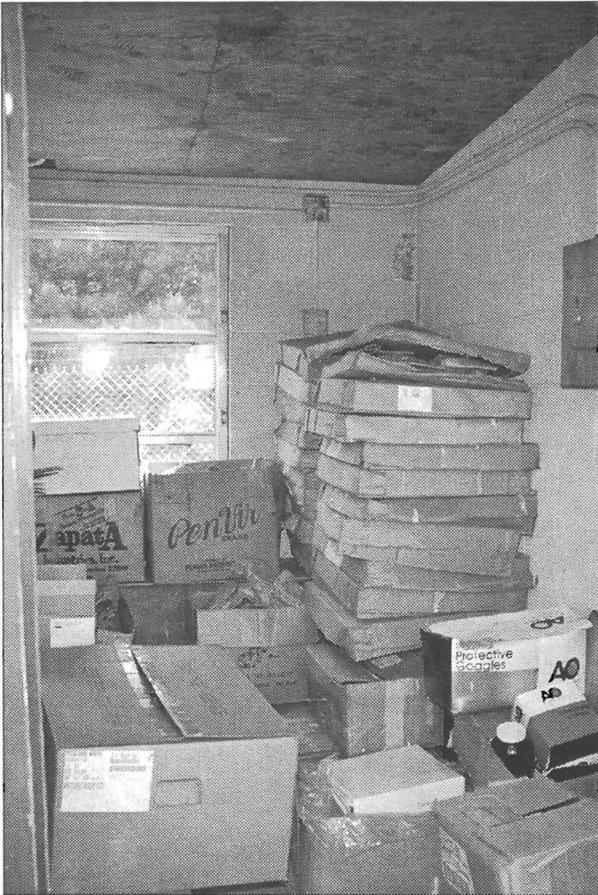
Boxes of artifacts are stacked on the concrete floor of Storage Location 1 (Figure 15). In Storage Location 3, artifacts are exhibited in a wood-and-glass storage case measuring 3.1 × 1.1 × 3.4 feet (w × d × h).

**Figure 15.** Damaged artifact boxes are stacked against the wall in Storage Location 1.

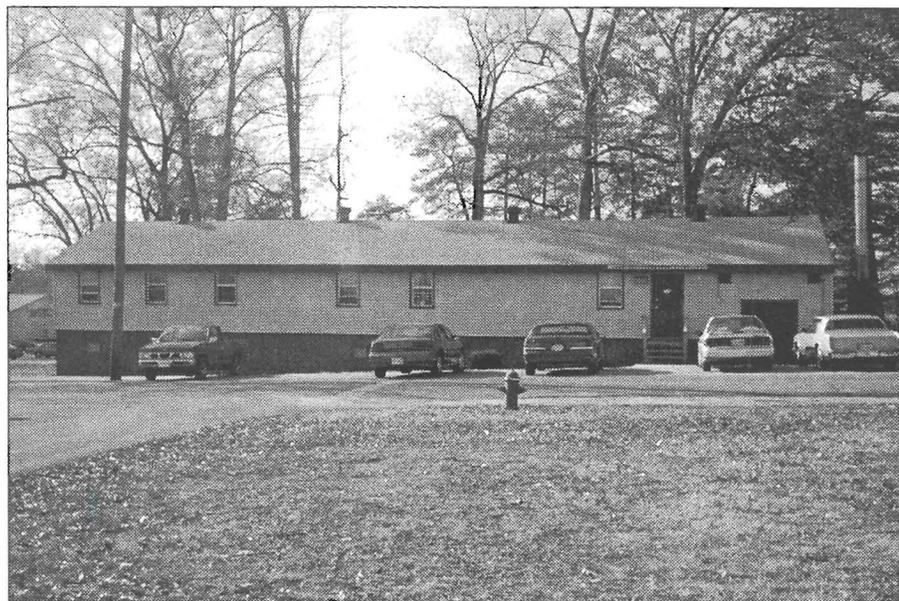
Building 239, which encompasses approximately 2,125 ft<sup>2</sup>, is not an official repository (Figure 17). Activity areas in the structure include offices, a reception area, a conference area, and rest rooms. Collections are currently being stored in the closet within one of the offices.

**Figure 17. Exterior of Building 239, Fort Meade's environmental offices, where collections are stored.**

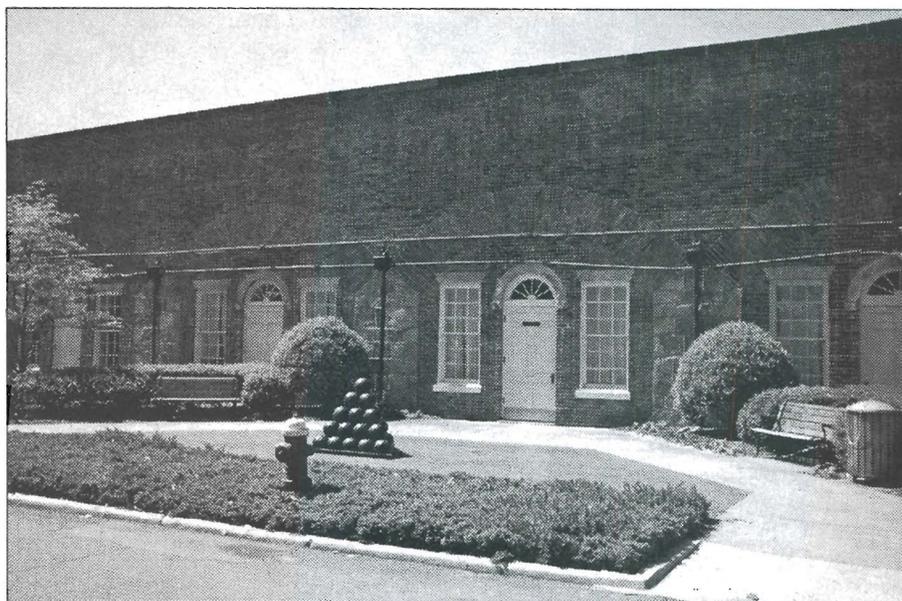
The original fortification dates to the period 1818–1834. The foundation and exterior walls are primarily composed of brick and stone. Bricks have been removed from several sections of the fortification roof and been replaced with poured concrete. On many original sections, however, roofing remains composed of bricks that are covered with earth. The museum has had multiple renovations and expansions since 1951, the latest during 1982–1983 when several rooms were added. There is only one floor for the entire fortification. Multiple windows are present in the inward-facing walls of the museum, and approximately one-third as many face outward to the fort's exterior. Windows and their frames were replaced approximately two years prior to the assessment team's site visit. The structure is solid, but there are multiple cracks in the brick walls and roofs. In addition, there is some water seepage from the brick roof, where it is overlain by earth.

**Figure 20. Exterior of the Casemate Museum, Fort Monroe.**

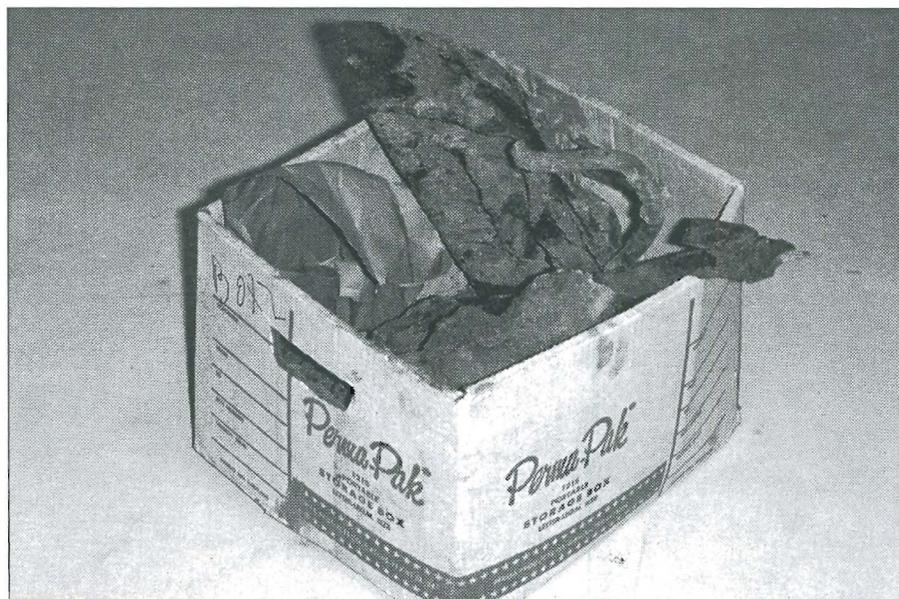
All of the artifacts have been cleaned, but none have been labeled. Ninety-five percent of the artifacts are sorted by material class.

**Figure 25. Oversized metal artifacts are stored loose within a cardboard box.**

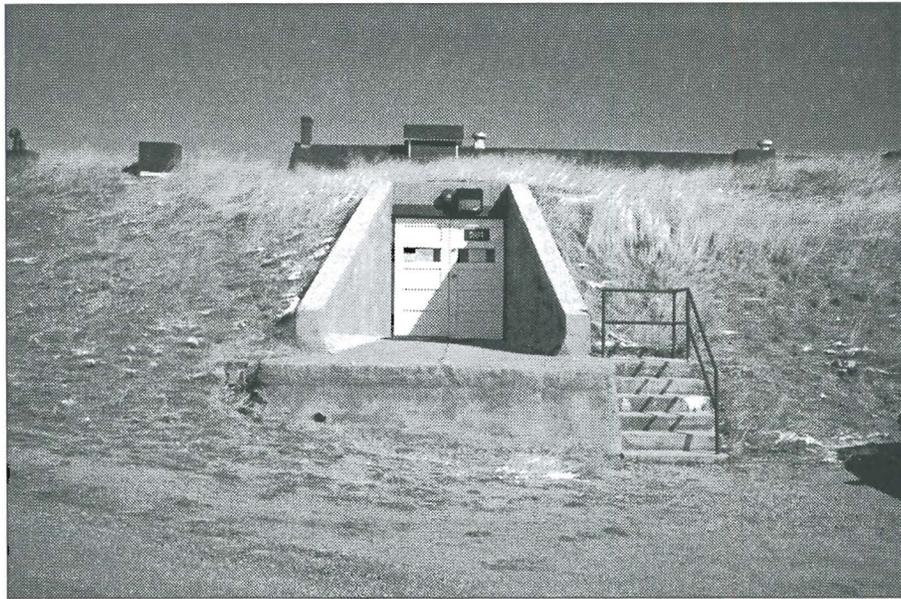
Building 261, the curation facility, encompasses approximately 3,077 ft<sup>2</sup> and was completely renovated in 1992 to be used as a curation facility. The structure has a poured-concrete-slab foundation, exterior walls, and roof. The entire structure is covered with approximately 3 feet of dirt and is within an earthen mound (Figure 29).

**Figure 27.** The entrance to Building 261, the curation facility on Warren AFB, appears to lead into a hill. Approximately 3 feet of earth cover this facility.

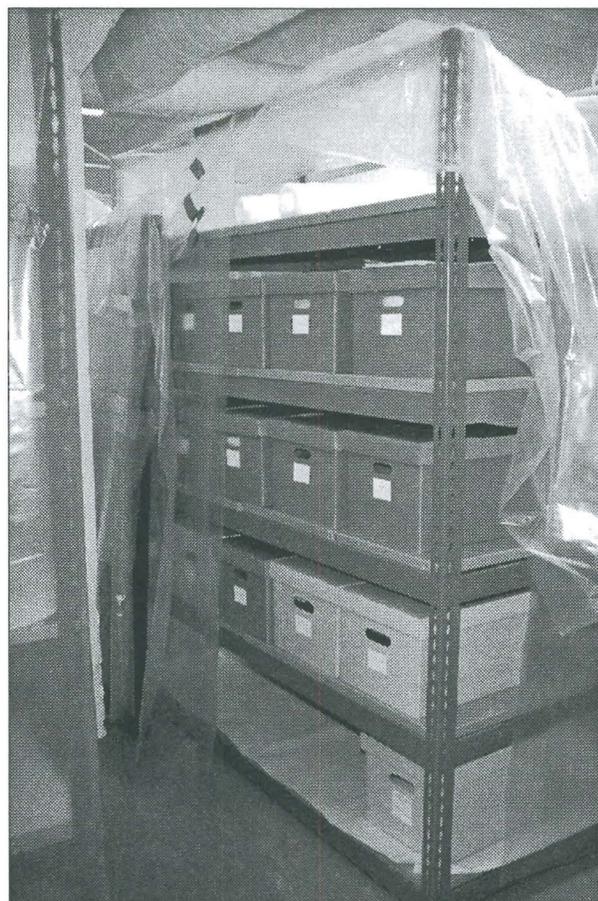
(w x d x h). One of these units is located in Collections Storage Area 4, where boxes are temporarily placed while being processed. All of the shelving units are draped with heavy sheets of plastic that are taped together at the seams to protect the collections from dust (Figure 30). A glass case in Collections Storage Area 1 displays glass and ceramic bottles that were recovered from sites on base (Figure 31).

**Figure 30. Collections are stored in cardboard boxes on metal shelving units in Collections Storage Area 2. Note that some of the shelves are lined with sheets of ethafoam and covered with heavy sheets of plastic to protect against dust.**

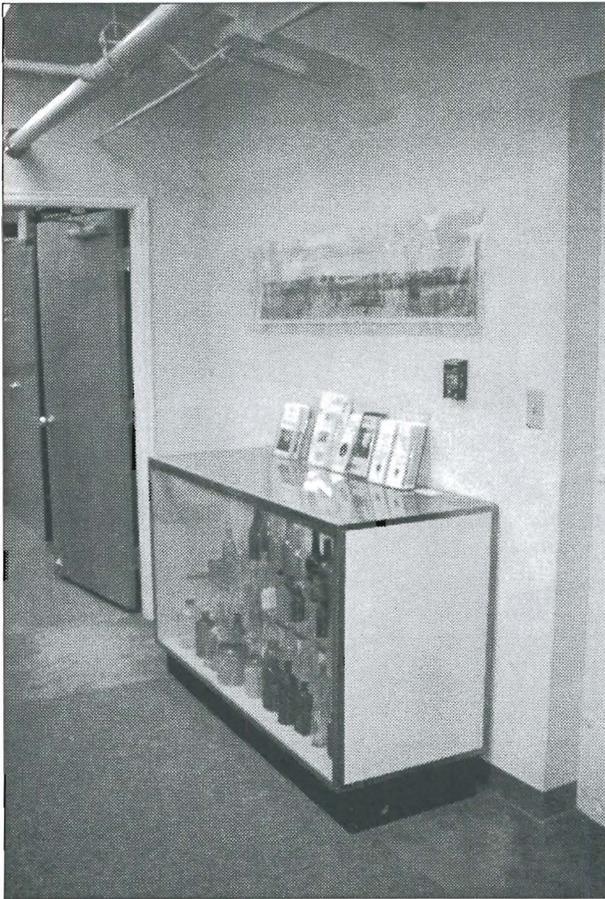
**Figure 31. A display case in Collections Storage Area 1 houses historical-period glass and ceramic bottles.**

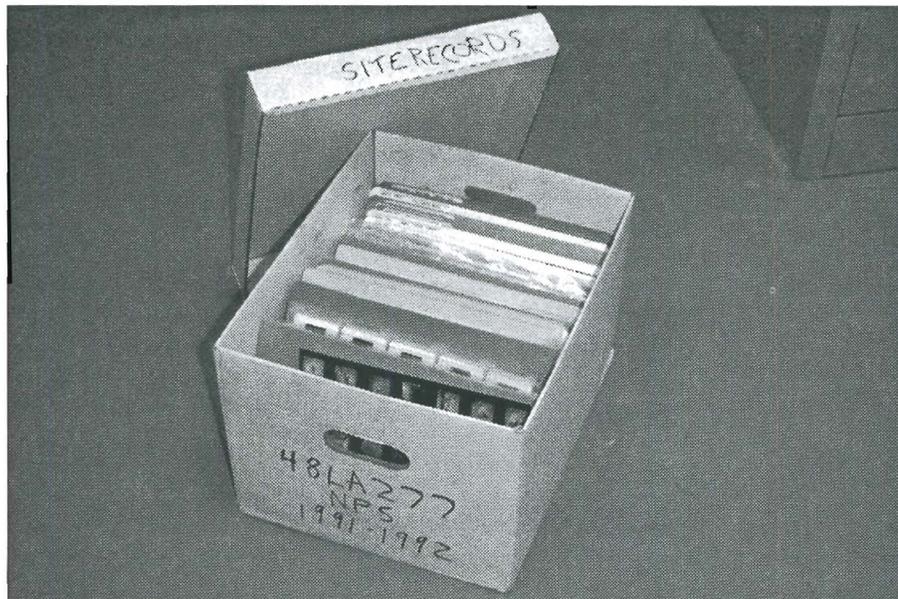
records, and field notes. Paper records are stored in acid-free boxes in Collections Storage Area 2 (Figure 32) and on wood shelves in Collections Storage Area 1. Boxed records are generally stored in manila files labeled with adhesive tags written on in marker. Some of the records not in files are bound together with rubber bands. Records in Collections Storage Area 1 are kept in plastic-covered, three-ring binders (Figure 33). Different types of records are separated with tabbed, labeled pages. Binders stand upright and are labeled and arranged by project. Artifact catalogs are filed in a standard, four-drawer, metal file cabinet. The acid-free files are labeled directly in red pencil.

**Figure 32.** Some of the associated records for Warren AFB have been placed in cardboard boxes and are stored on metal shelving units in Collections Storage Area 2.

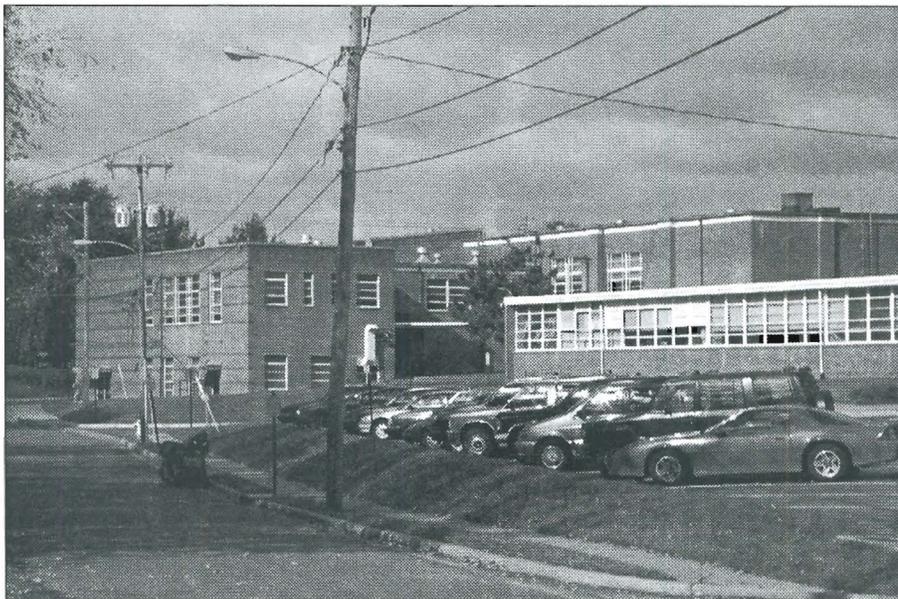
FCAS encompasses approximately 5,000 ft<sup>2</sup> of the 15,000-ft<sup>2</sup> structure (Figure 34). The FCAS research section consists of a receiving and loading area, an artifact-holding and -washing area, a processing lab, and a temporary artifact storage area. Archaeological artifacts and associated documentation are stored in three collections storage areas. Collections Storage Area 1 houses both artifacts and records. It is adjacent to the downstairs laboratory, which measures approximately 600 ft<sup>2</sup>. Collections Storage Area 2, located within the archaeology laboratory, contains prehistoric-site records and measures approximately 300 ft<sup>2</sup>. Collections Storage Area 3, located on the second floor within a historical-

**Figure 34. Exterior view of FCAS, which is located in the left portion of this building.**

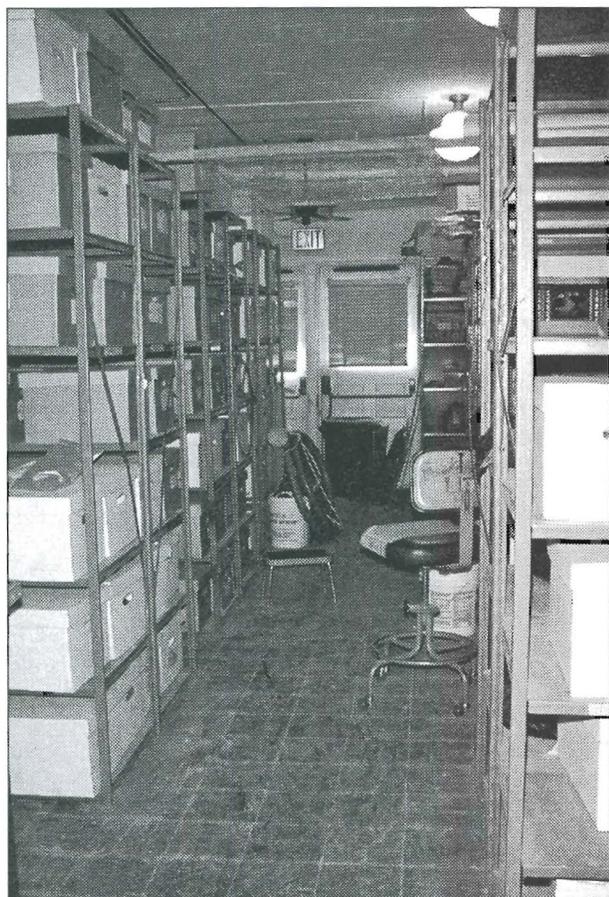
**Figure 35. Collections Storage Area 1 is crowded with boxed collections and field equipment. A significant amount of dust covers the peeling asbestos floor tiles. The back, exterior door is kept locked.**

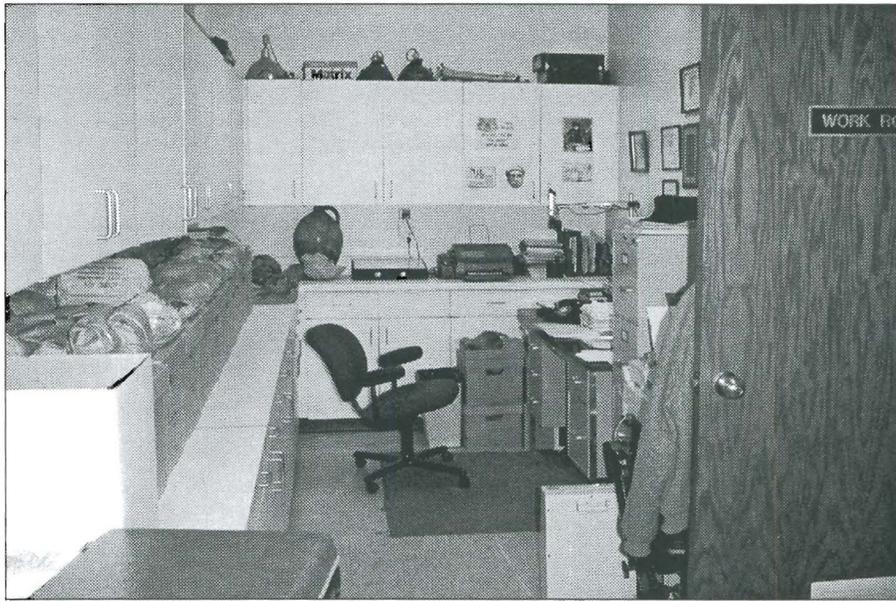
The room that functions as a laboratory and kitchen is also used for processing artifacts and storing collections (Figure 39). Small amounts of acetone and hydrochloric acid are used without any means of ventilation. The only window in the facility is in the park manager's office. The window has a metal frame and does not have a shade. Park personnel clean the structure daily.

**Figure 39. Office and collections storage area in Storage Location 1 at FLSHA.**

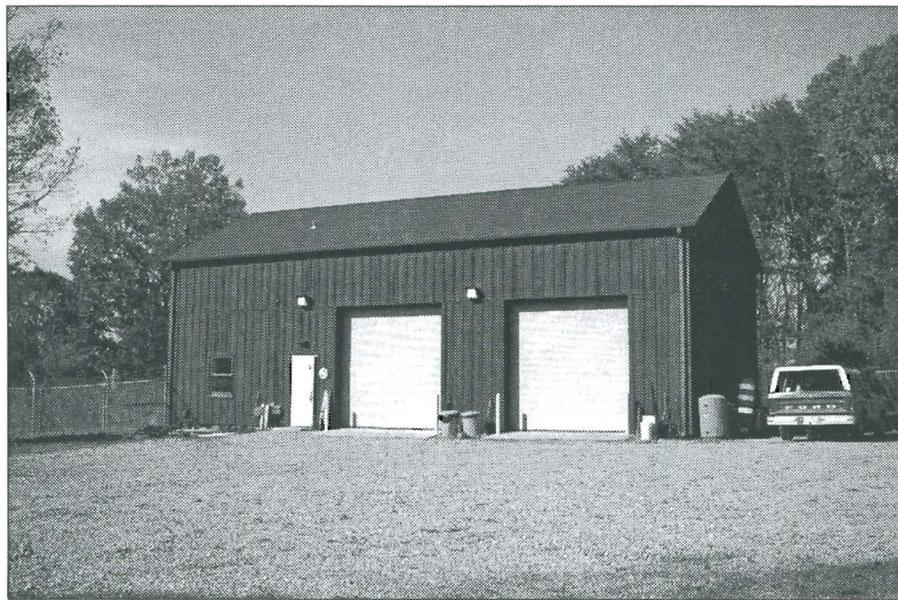
Storage Location 2, the maintenance building, was built in 1985 and encompasses approximately 2,500 ft<sup>2</sup> (Figure 42). The foundation is

**Figure 42. Exterior view of Storage Location 2, the maintenance building, at FLSHA.**

concrete block; the exterior walls are cinder block with wood siding. The shingled roof is original to the structure. No problems with water leakage through the roof have been reported.

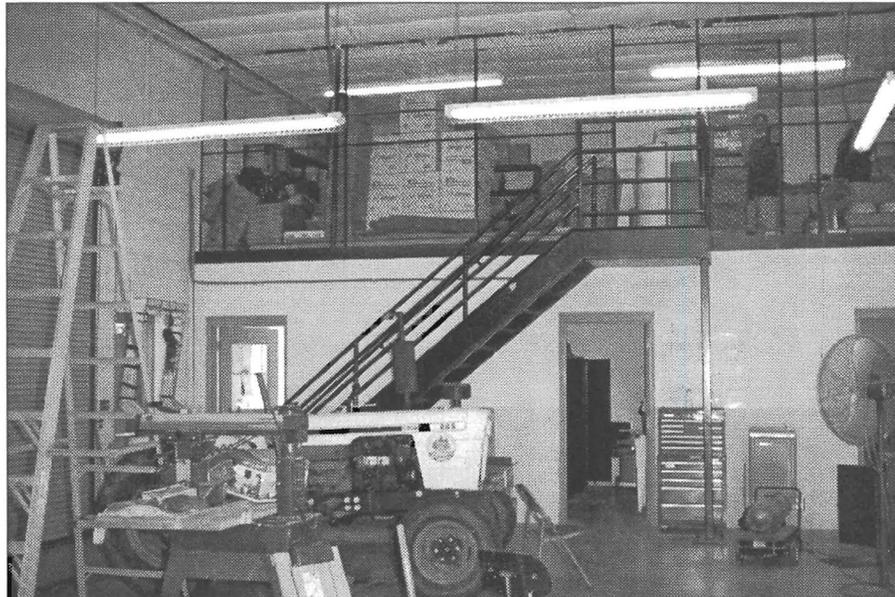
The single-story structure has a metal, caged-in loft that contains the collections storage area. The floor of the 125-ft<sup>2</sup> loft consists of steel beams with poured concrete. The ceiling is

**Figure 43. Artifact collections are stored on shelves in the loft of Storage Location 2.**

exposed insulation. Approximately 40 ft<sup>2</sup> of the loft is used for collections storage; the remainder of the loft is used for the storage of field equipment.

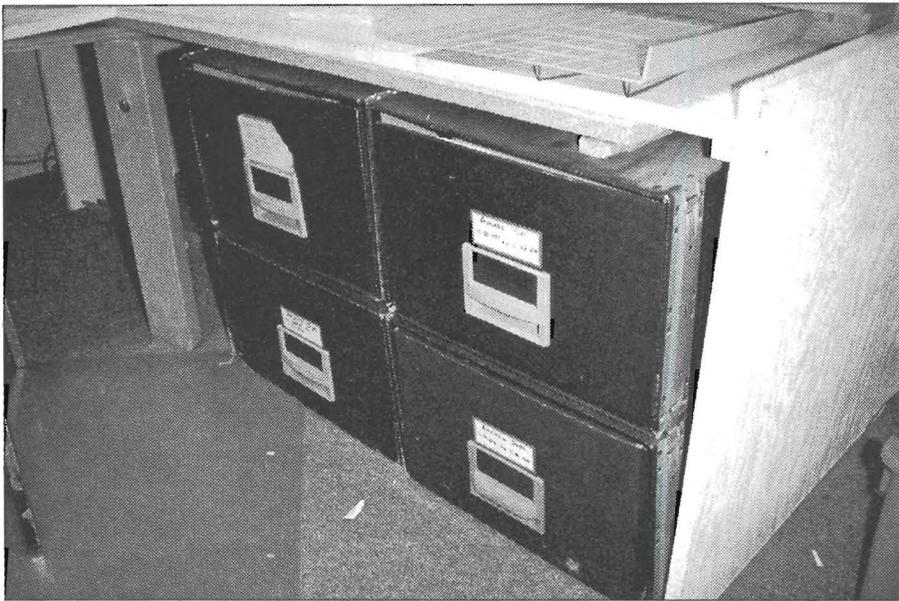
**Figure 53.** Cardboard storage units are used to house associated documentation at GRI.

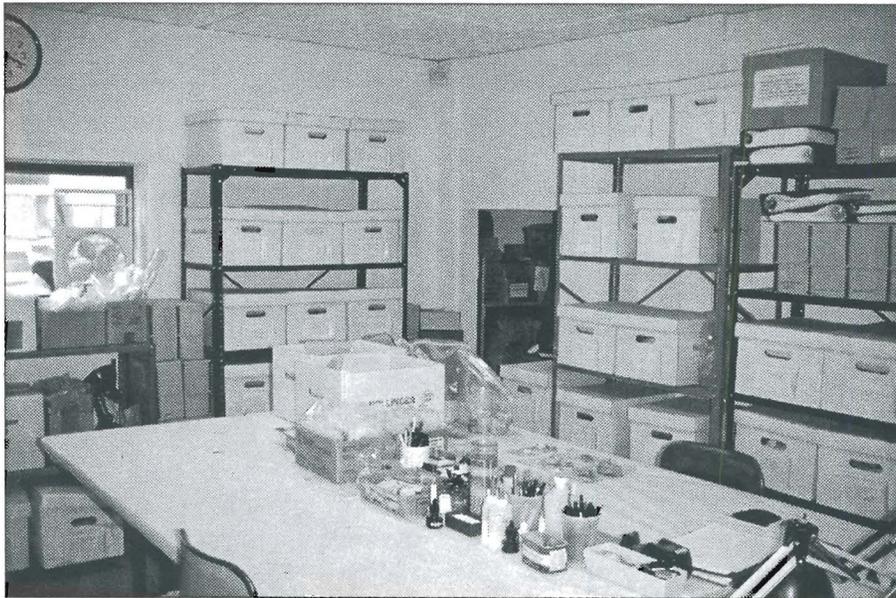
Archaeological collections and associated documentation are stored on standard enameled-metal shelving units (Figure 57) measuring approximately  $3 \times 1.3 \times 5.8$  feet (w  $\times$  d  $\times$  h). Each unit is five shelves high, and boxes are stacked one to two high.

**Figure 57. View of the collections storage area and laboratory at Goodwin. Boxed collections are stored temporarily on metal shelving units until they are sent to a permanent repository.**

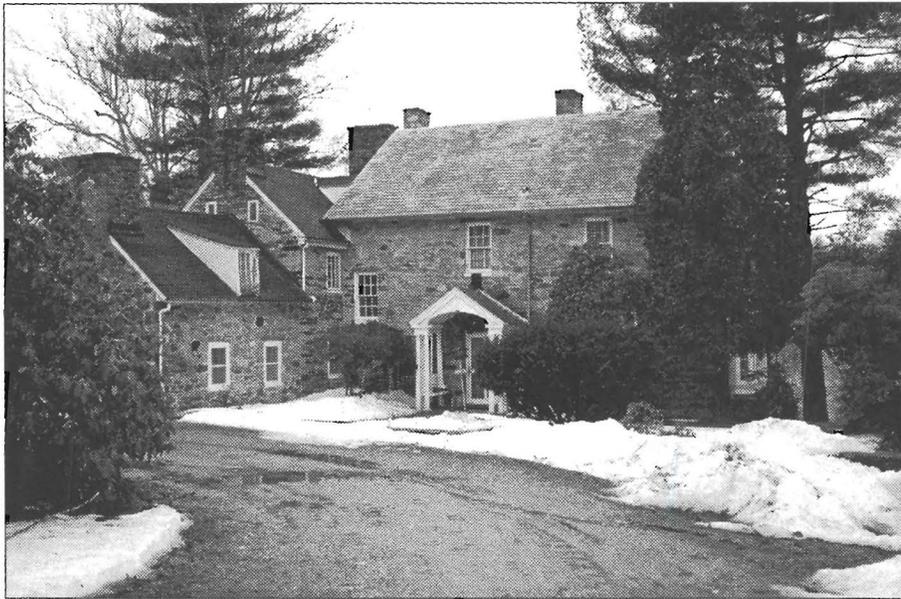
**Figure 63. View of the Harford Glen Mansion.  
HCAS uses the attic as a collections storage area.**

The Harford Glen Mansion was originally a stone farm house dating to approximately 1827 with a wing added in the 1930s (Figure 63). There have been extensive internal renovations converting the farm house into classrooms, offices, and meeting rooms. The house, land, and out buildings are now used by the county school system as an environmental education center.

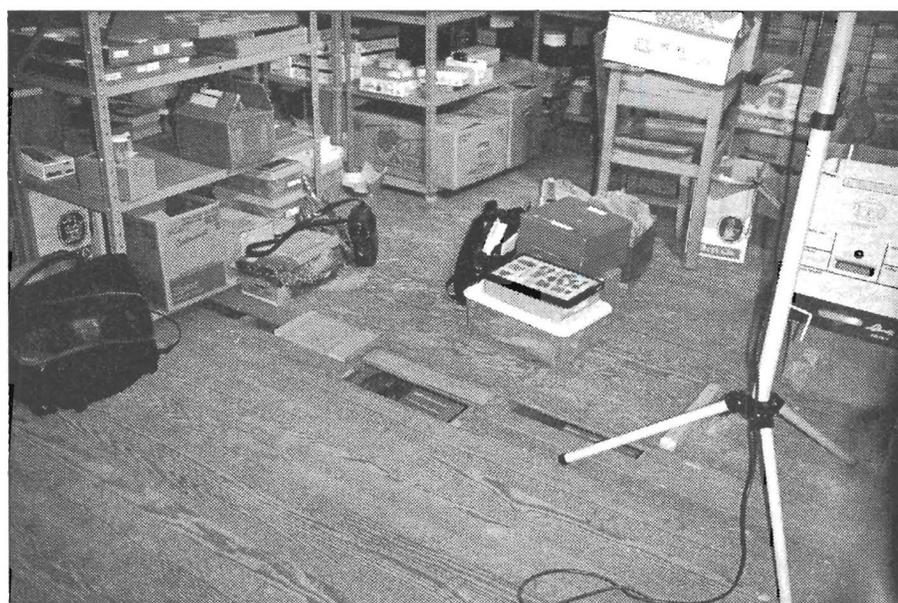
**Figure 65.** Missing floor boards are a safety hazard and the result of current repair work on the electrical system.

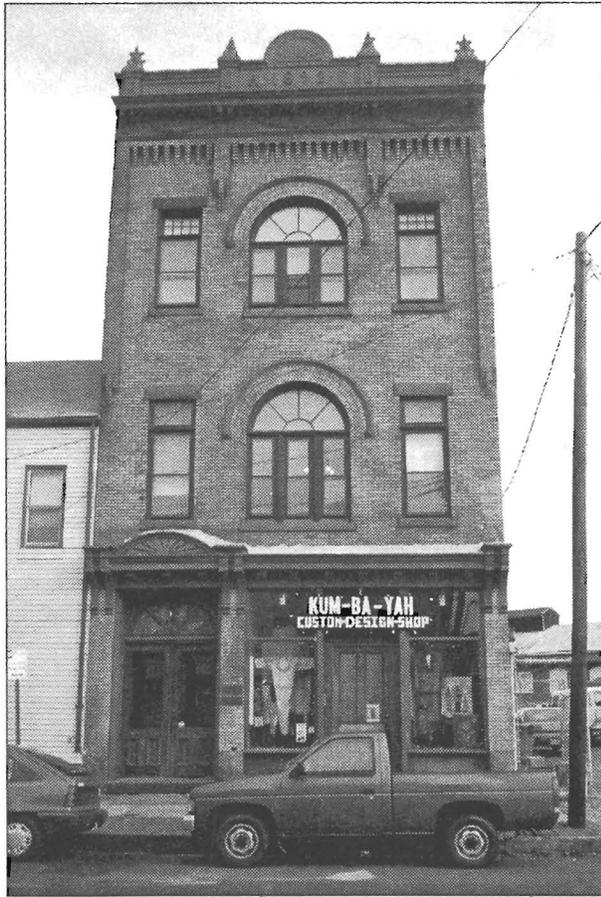
HRA occupies the majority of a 6,000-ft<sup>2</sup> building (Figure 68) that was built in 1892 and was originally used for the German-American Social Club. The firm shares the building with a small store on the first floor. Records are currently stored in four separate collections storage areas.

The building has a stone foundation and brick exterior walls. The type of roof is unknown. It has not been replaced during the seven years that HRA has been there. The building has a total of four floors, three are above grade and one below grade basement. Windows of various shapes and sizes are on all sides of the building and most of them do not have shades. The wood frames have never been replaced; however, personnel have never experienced any drafts or water leaks.

**Figure 68. Exterior of building where HRA offices are located.**

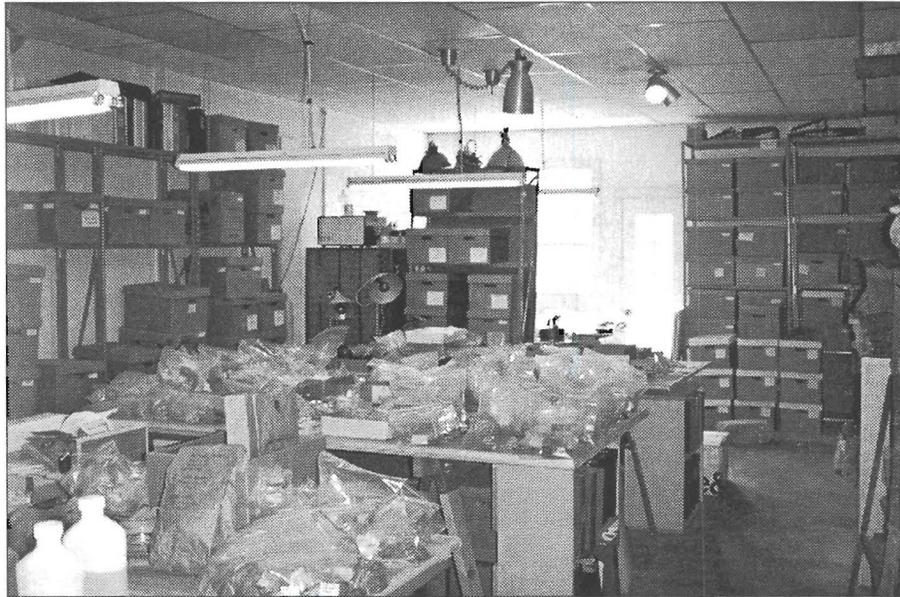
**Figure 72. View of the laboratory and collections storage area at JRIA.**

air-conditioning. In addition to these controls, there are floor fans, space heaters, and radiators in the collections storage area. There are no dust filters on these systems. Humidity is not monitored, but regulation is attempted through placement of silica gel in select type collection artifact storage drawers. Building maintenance is conducted by the landlord on an as-needed basis; however, the collections storage area is cleaned regularly by the curatorial staff. At the time of the St. Louis District visit, a leaking air-conditioning unit had caused water damage to carpet and tile in the doorway between the collections storage area and the office space. Lighting is from fluorescent and incandescent fixtures, and natural light, without UV filters. There is noticeable water damage in the collections storage area ceiling around light fixtures.

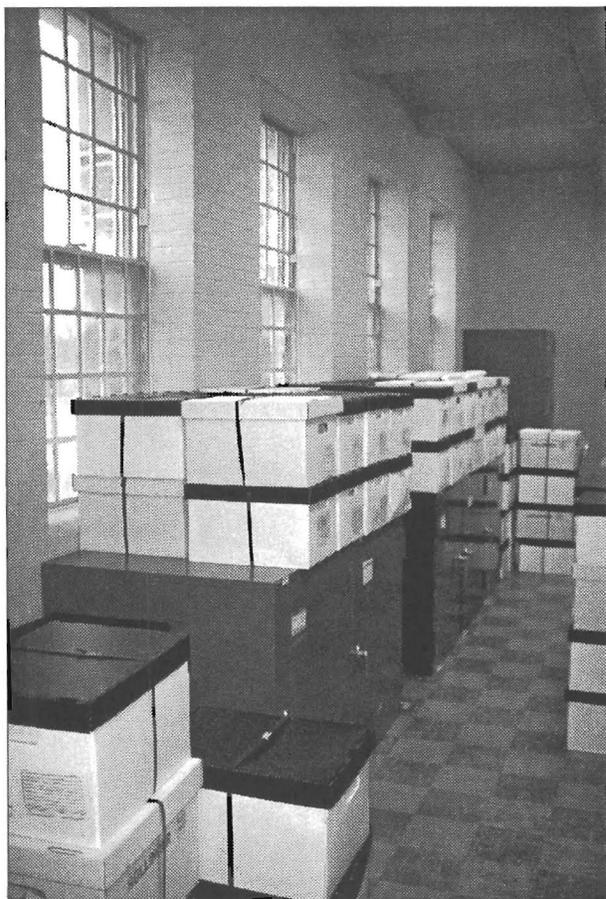
**Figure 75. This collections storage area in Storage Location 1 is used for select artifact collections and overflow storage of collections.**

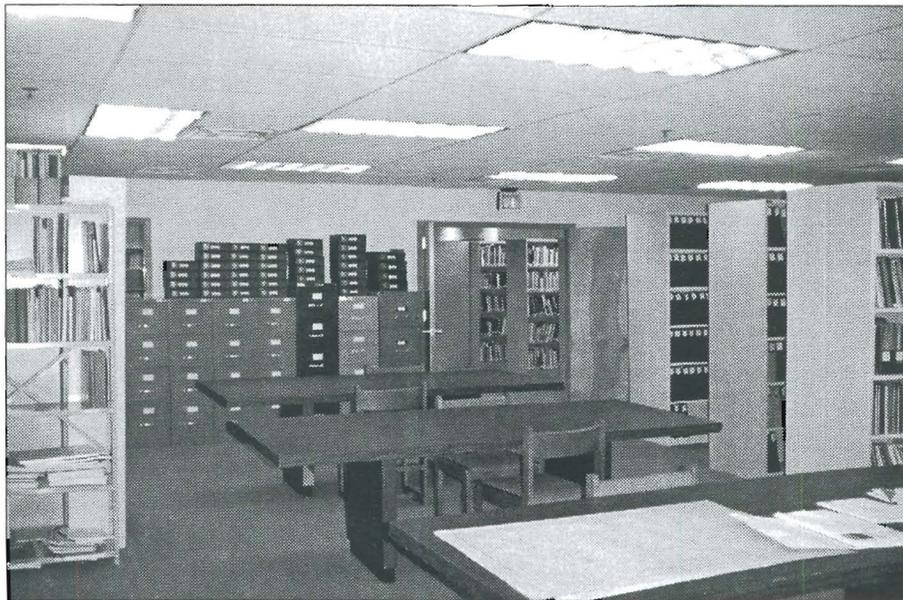
**Figure 77. View of the records storage room and study area in Storage Location 2.**

study (Figure 77), and library areas. The Maryland site files are located in this area. The floor is concrete overlain with carpet. Interior walls are wallboard/Sheetrock, and the ceiling has suspended acoustical tiles. There are no exterior

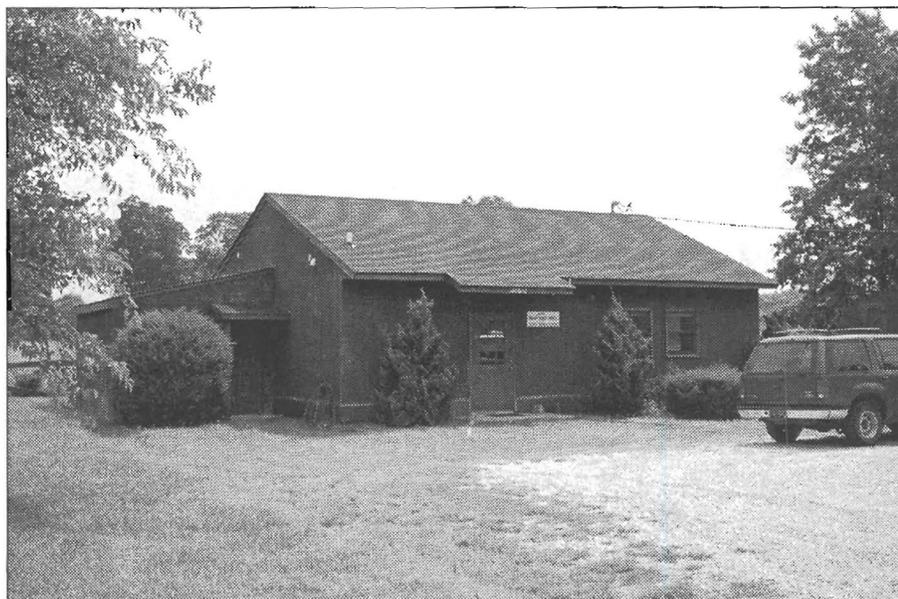
**Figure 78. Exterior view of MAAR.**

It is composed of a concrete foundation and wood siding, with Sheetrock interior walls. The roof is original asphalt shingle. The building appears to be structurally solid. There are six windows in the building, all having blinds and wood frames. The frames and windows appear to be free of cracks and leaks. The most recent renovation is a 5-year-old interior wall that was constructed to separate two laboratory areas in the south section of the facility. Utilities are original to the facility.

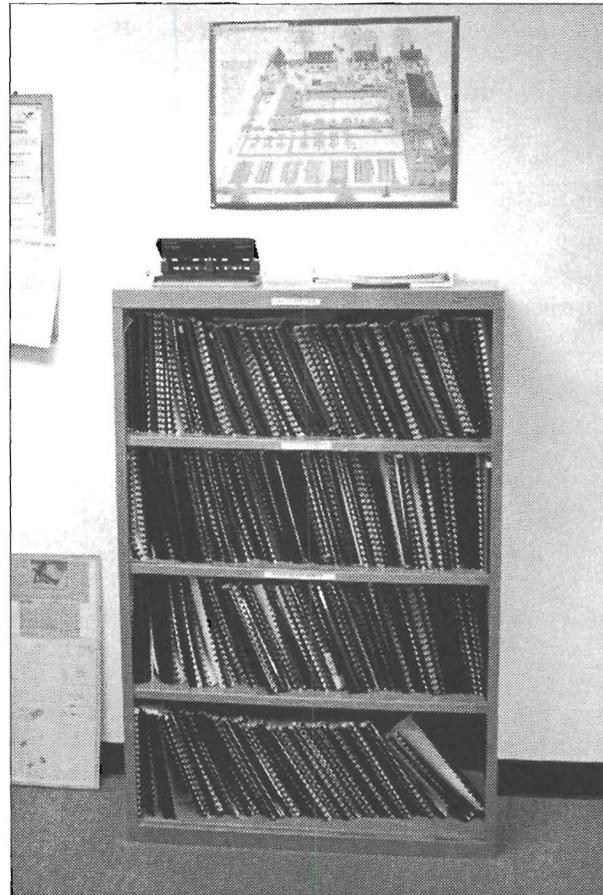
Five linear inches of reports from military installations are stored in acidic hanging file folders in two file cabinets. These are organized by the MAAR code, which is typed on nonarchival paper and placed within a nonarchival clear plastic tag. Final reports that MAAR has produced are stored in a report library on metal bookshelves (Figure 80). The library collections are organized by state.

Figure 80. Metal shelving units are used to store the spiral-bound reports at MAAR.

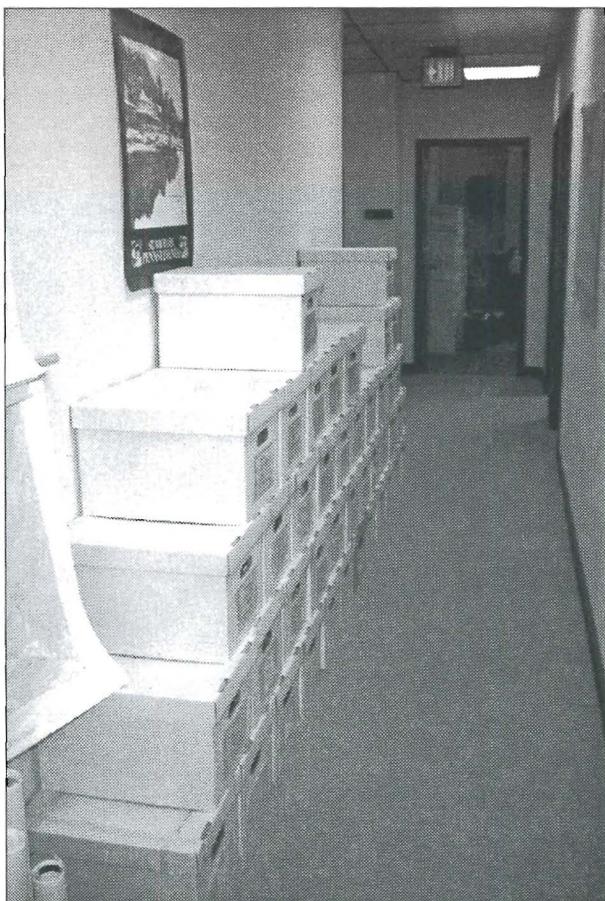
Archaeological collections are stored in boxes stacked three or four high along a wall in the hallway of Collections Storage Area 1 (Figure 82). Table 27 outlines the percentages of material classes present in the Fort Belvoir collections.

**Figure 82. Boxed artifact collections are stacked along the wall in the hallway at Milner.**

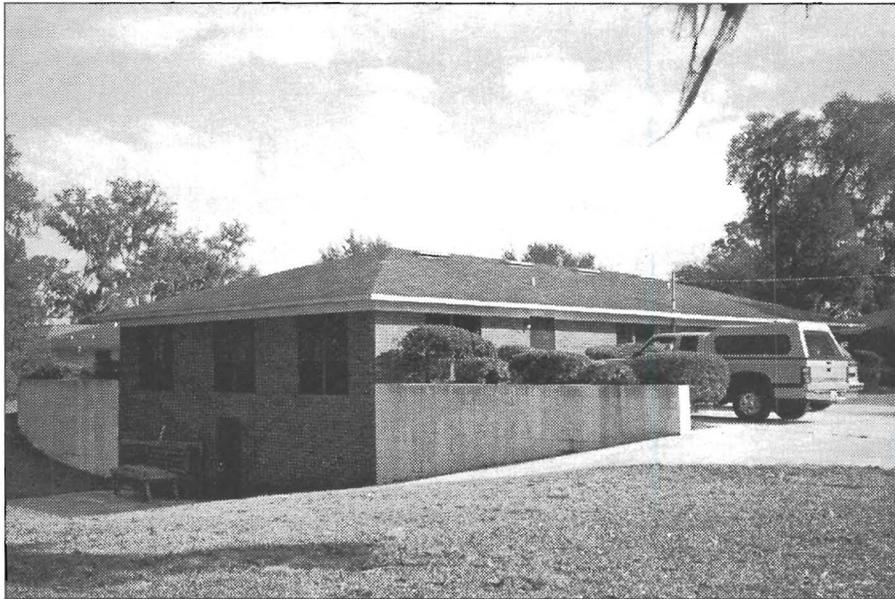
The building is approximately 10 years old, with a slab concrete foundation and brick over frame exterior walls. The roof is composed of asbestos shingles; it is the original roof of the building. No cracks or leaks are present in the roof or foundation, and although tornadoes and hurricanes are common to the area, weather has not affected the building. The repository has one floor above grade and a basement under one half of the building that has an exposed wood-beam ceiling, concrete floor, and cinder block walls. Interior dividing walls in the collections storage area are made of plywood. The windows in the upper level offices have aluminum frames. One window pane has been replaced. No major renovations have been performed on the building since it was built.

**Figure 85. View of the shared office building where the SouthArc offices are located. Note the partially below-grade level that is used by SouthArc for the temporary storage of artifact and unassociated records collections.**

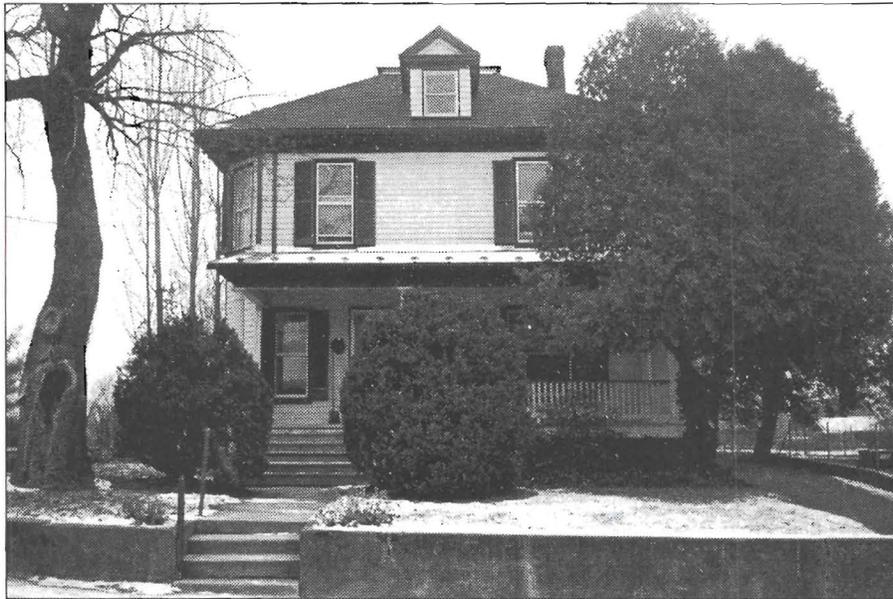
The building has a stone foundation with a concrete basement floor. Exterior walls have wood siding and the roof has shingles that were replaced in 1994. The building has a total of four floors—three above grade and one below-grade basement. Windows of various shapes and sizes are on all sides of the building, most without shades. Some of the windows and wood frames

**Figure 87. Exterior view of the house where TAA offices are located.**

have been replaced. Personnel have occasionally experienced draftiness and water leaks.

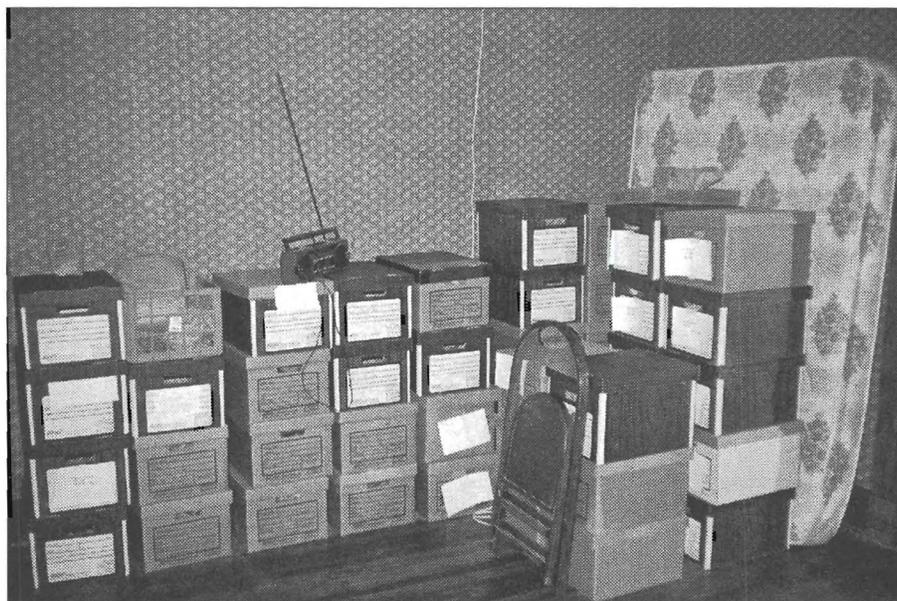
**Figure 88. Boxed collections are stacked on the floor in an upstairs bedroom at TAA.**

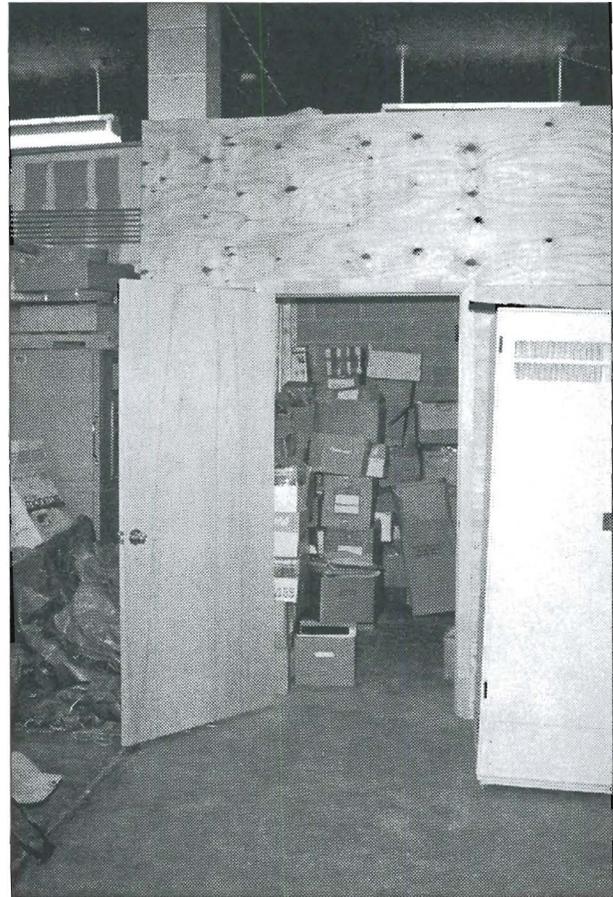
**Figure 91.** View of the collections storage area in Storage Location 2. Note that the walls do not extend to the ceiling and the boxes of collections are stacked haphazardly, causing damage.

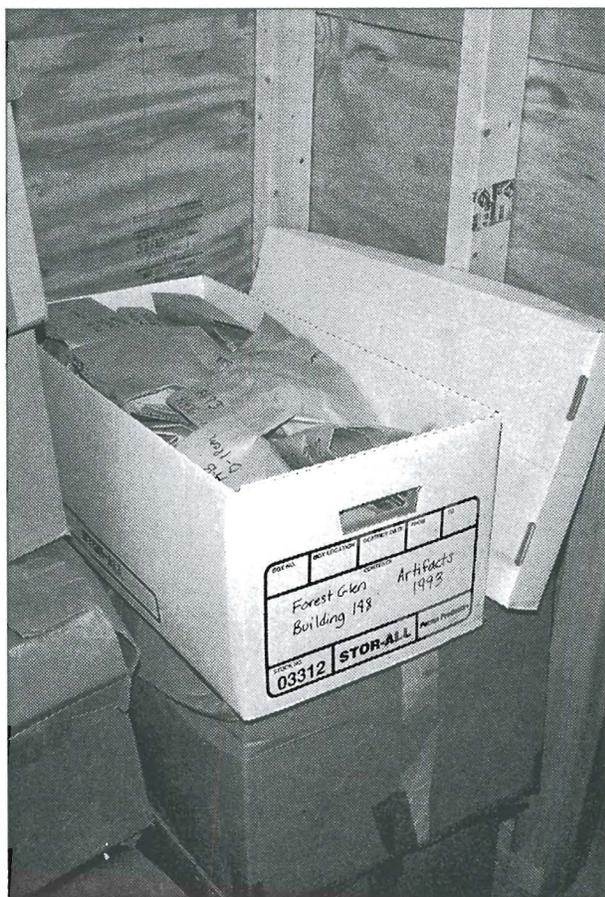
**Figure 92. Acidic-paper bags are used as secondary containers for artifacts in Storage Location 2.**
