1. AGENCY USE ONLY (Leave blank)		2. REPORT DATE 1999	3. REPORT TYPE AND DATES COVERED Final Report	
4. TITLE AND SUBTITLE An Archaeological Curation-Needs Assessment for the Legacy Resource Management Program			5. FUNDING NUMBERS

7. PERFORMING ORGANIZATION NAME(S) AND ADDRESS(ES) U.S. Army Corps of Engineers, St. Louis District 1222 Spruce Street (CEMVS-ED-Z) St. Louis, Missouri 63103-2833			8. PERFORMING ORGANIZATION REPORT NUMBER Archaeological Curation-Needs Assessment Technical Report No. 15

# **An Archaeological Curation-Needs Assessment for the Legacy Resource Management Program**

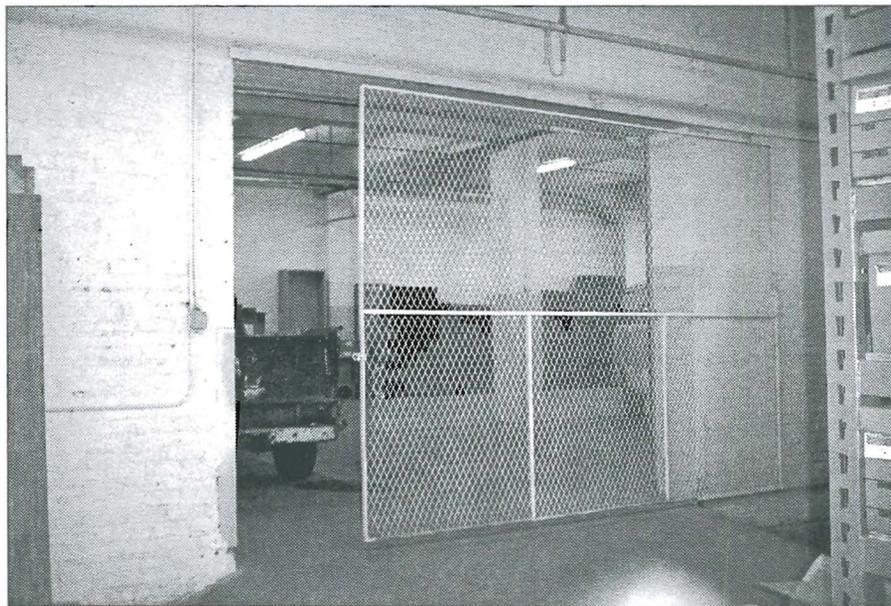
Figure 96. The collections storage area is separated from the rest of the facility by a sliding gate.

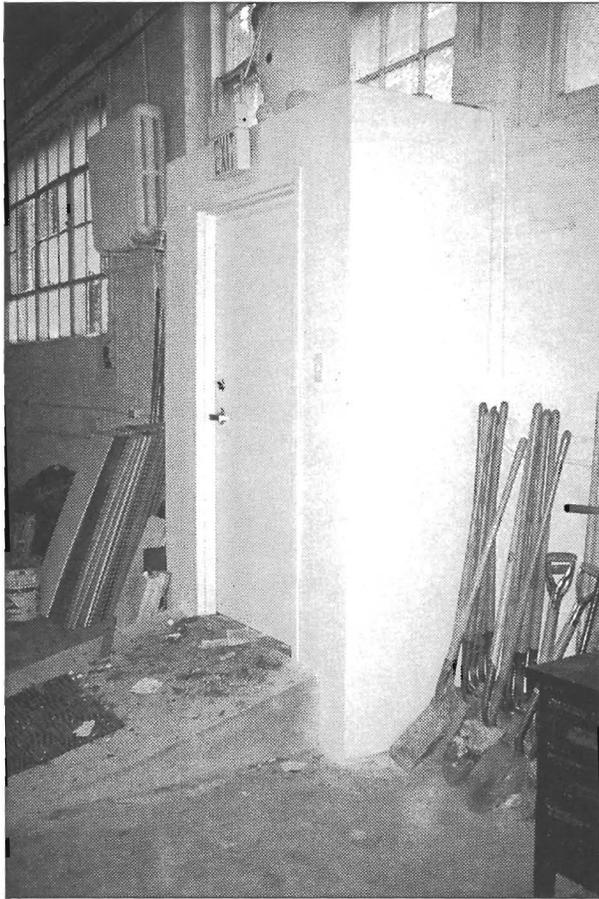
**Figure 97. Exterior door in the collections storage area. Note the amount of dirt and leaves in front of the doorway.**

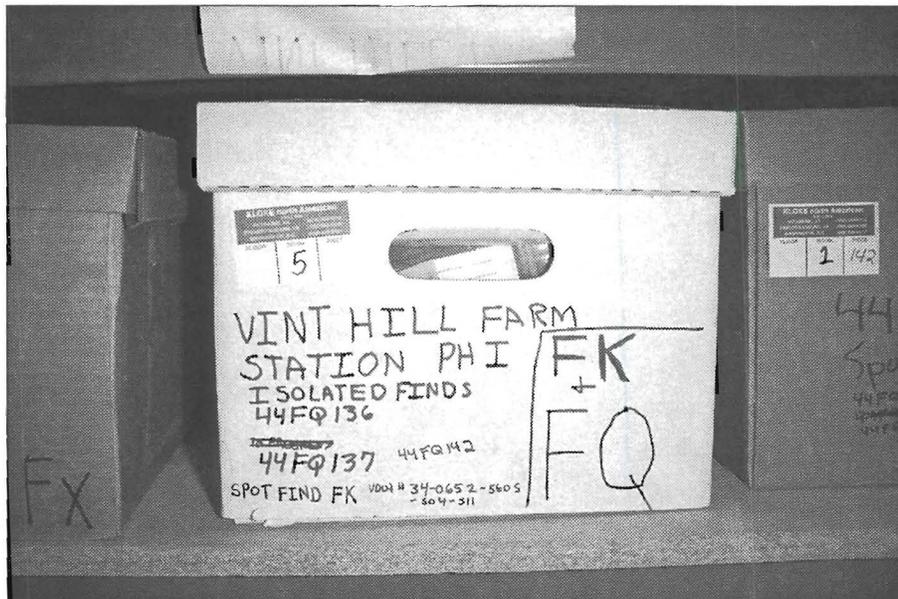
Two primary containers, each measuring 1.1 ft<sup>3</sup>, house the military collections (Figure 99). One box contains artifacts from Vint Hill and the other contains artifacts from Fort Belvoir. Both primary containers are acid-free Hollinger boxes. Labeling is in marker, directly on the side of the container. Information consists of county, site number, and project.

Figure 99. Example of the primary containers used to store collections. Cardboard boxes are labeled directly with black marker and stored on metal shelving units with particleboard shelves.

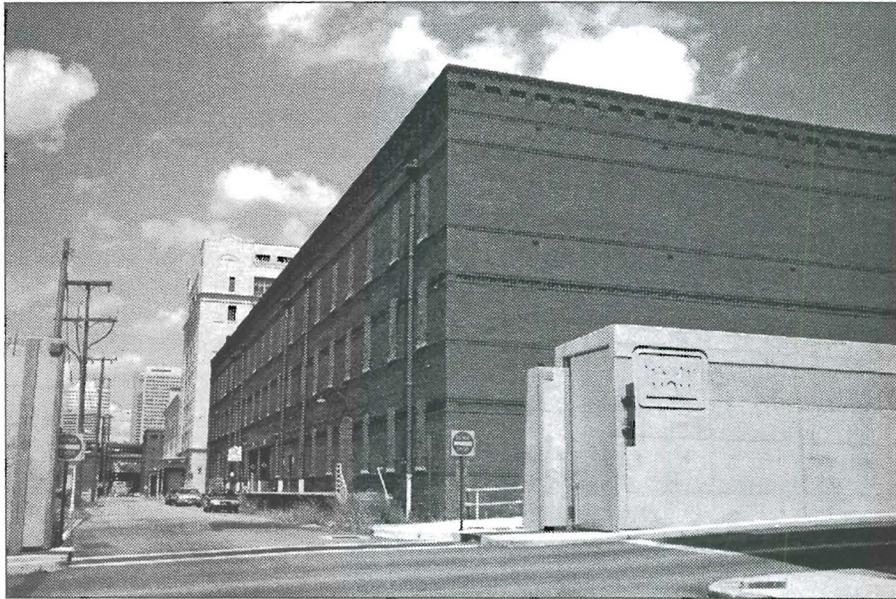
Originally constructed in 1899 and used in the tobacco distribution industry, this three-story building is currently used as a state storage facility. It is located approximately 1 mile east of the VDHR offices in what is known locally as Tobacco Row. It has a concrete foundation, brick exterior walls, and a built-up tar and asphalt roof. The collections storage area is located on the second floor of the facility. Interior walls are constructed of brick, and the ceiling is composed of closely spaced 4-x-12-inch wood beams. The floors on the second and third stories are wood and have a maximum-load capacity of 200 pounds per square foot. There are multiple windows in the facility, all of which have been covered on the interior with plywood, and on the exterior with metal shutters. The assessment team entered the building by one of two large, rolling overhead, metal garage doors on the south side of the facility. Two interior doors lead to the collections storage area, both on the southeast wall. One is a single metal-panel door, and the other is a standard-sized, rolling overhead, metal garage door. A double-wide door frame separates the main collections storage area from a smaller area housing field equipment and supplies.

**Figure 100. Exterior view of Storage Location 1, the Extra Attic building, used by VDHR.**

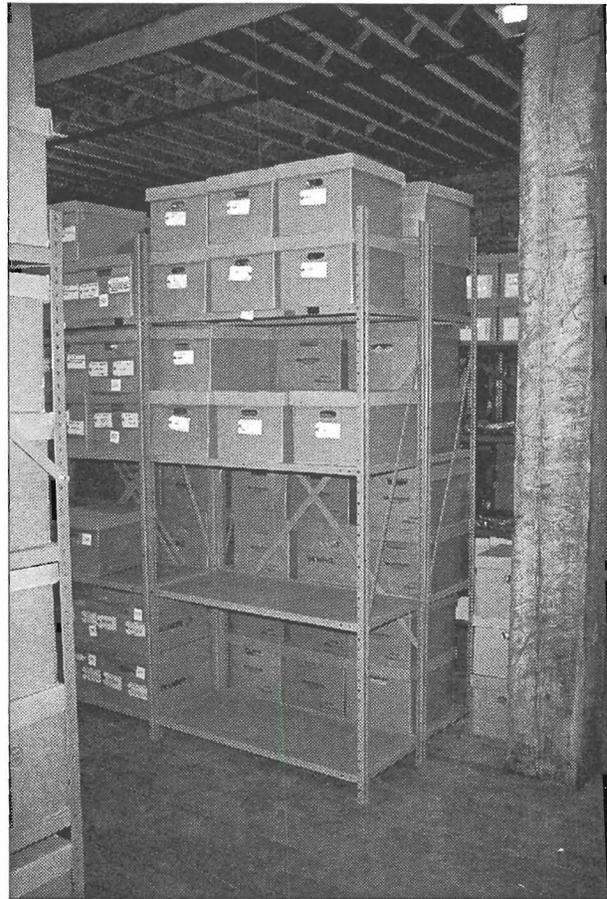
Artifact storage units in Storage Location 1 consist of open, enameled-metal shelving units that measure 3.5 × 1.5 × 7 feet (w × d × h) (Figure 101). Shelving units are numbered consecutively with adhesive tags attached to the top shelf of each unit. Artifact boxes are stacked two high on the shelves.

**Figure 101. Metal shelving units, with boxes stacked two high, are used in Storage Location 1 for collections storage units.**

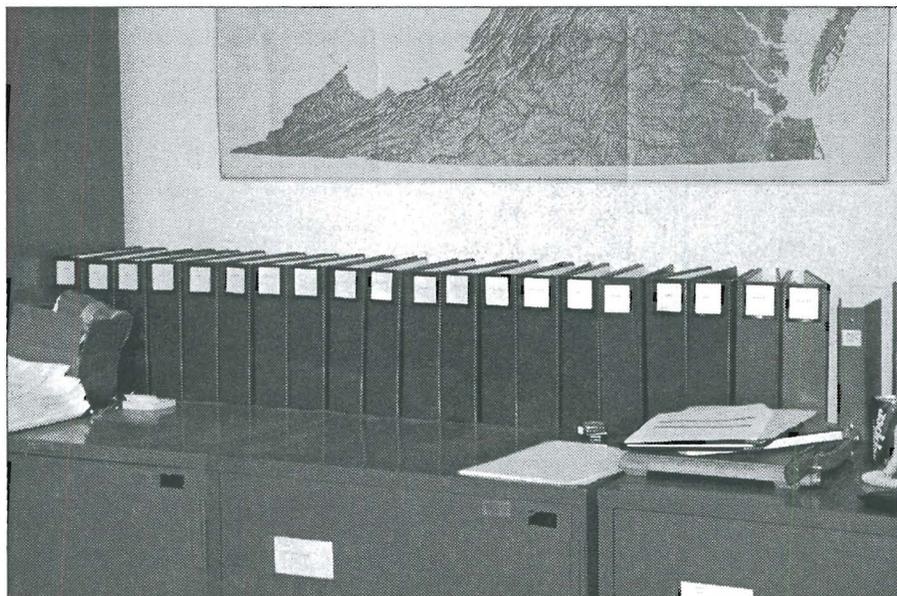
**Figure 106. Artifact inventories are stored in three-ring binders arranged on top of metal file cabinets in the aluminum building.**

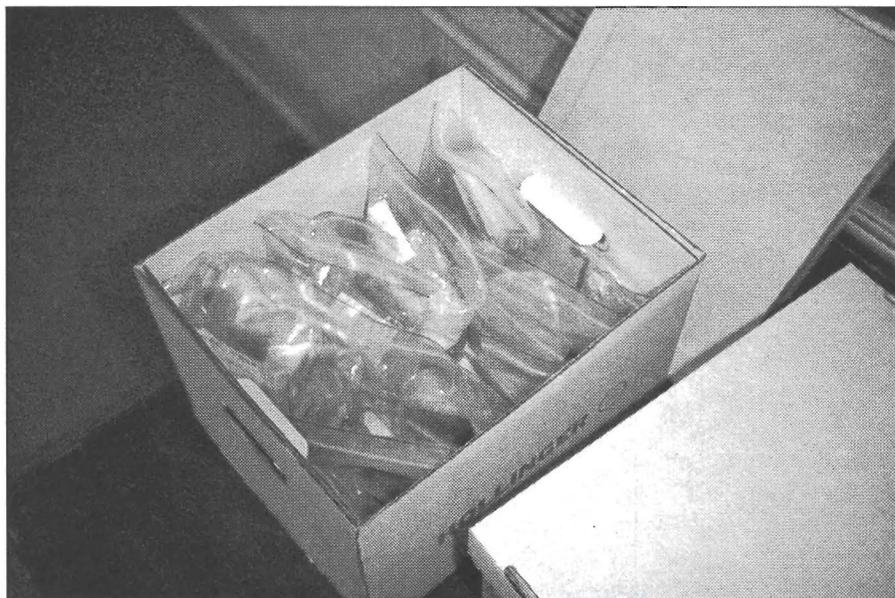
All of the artifacts are curated in small, zip-lock, 2-mil polyethylene bags nested within larger ones (Figure 109). The larger, exterior bags are not labeled. There is, however, a preprinted label on acid-free paper inserted inside the smaller, interior bags. Label information is written in marker and consists of project name, site number, bag number, provenience, date, comments, and excavator's initials.

Figure 109. Zip-lock plastic bags inside cardboard boxes house artifacts at WMCAR.

8. Apply adhesive, plastic label holders containing acid-free labels to the fronts of artifact boxes (or adhere small, zip-lock plastic bags). This way, if the label information or box contents changes, the old label can be replaced without damaging the box.

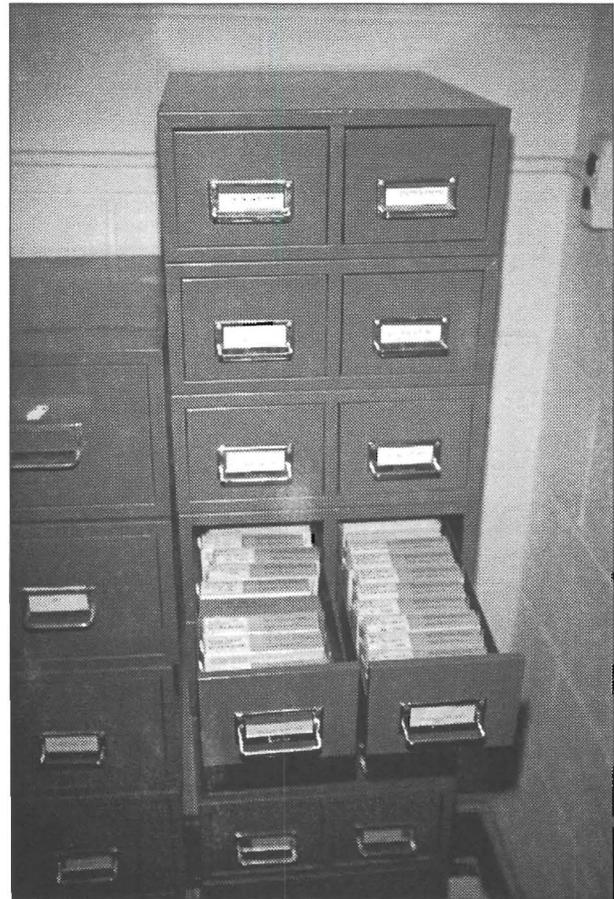
Slides are stored in a series of 10 enameled-metal file-drawer units stacked on top of each other (Figure 110). Each unit measures 1 × 1.3 × 0.4 feet (w × d × h), making the total height of the unit 4 feet. Drawers have metal tag holders with computer-printed paper tags that list the range of slides included in each drawer. Within the unit, slides are stored in their original cardboard slide boxes. These boxes have adhesive labels listing slide numbers. There is also movement toward transferring slides to archival sleeves within three-ring binders to facilitate viewing. The slides themselves are directly labeled with slide number in pen.

**Figure 110. Slide collections are arranged in metal file cabinets in Collections Storage Area 1, Room 51, the archives storage area.**
