An Assessment of Potential Curation Facilities at the Hanford Site, Department of Energy

Technical Report No. 26

13. ABSTRACT (Maximum 200 words) In March and June 2000, St. Louis District personnel examined ten facilities that are located on the Hanford Nuclear Test Site in order to determine their potential as curation repositories for Hanford Cultural Resources. The facilities examined ranged from abandoned buildings associated with the NIKE missile complex to nuclear research reactors. All buildings would require substantial rehabilitation to comply with existing regulations for the curation and management of cultural resources (36 CFR Part 79).

Archaeological Curation-Needs Assessments
Technical Report No. 26

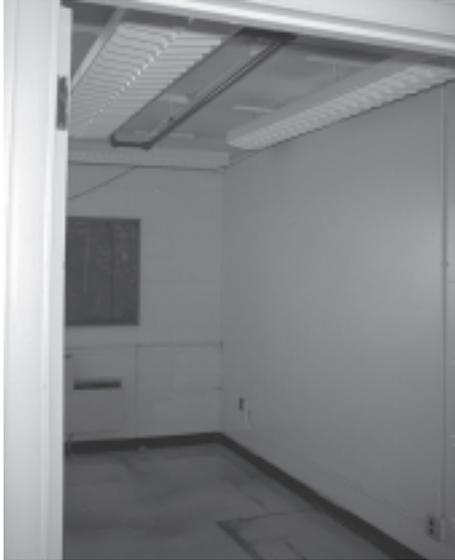
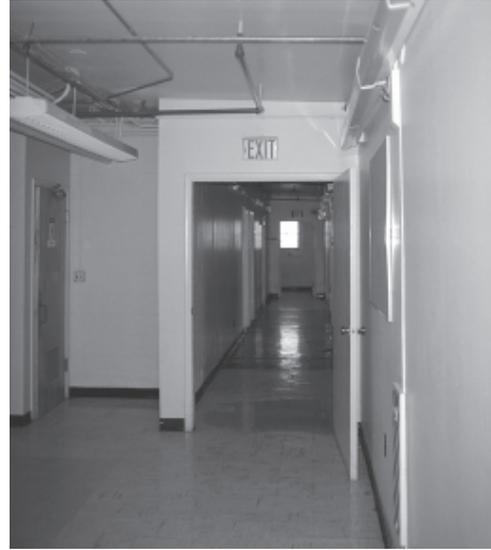
Building 6652I

The building was built in 1955 and served as an administrative and storage facility for the missile base. After closure of the base it served as a laboratory for the ALE. It has a concrete slab foundation, concrete block exterior walls and a built-up asphalt roof. The roof has experienced several leaks over the years that has led to some severe water damage (e.g., standing water was noted throughout the building). All windows in the building have wooden window frames and are locked with simple window locks. Some air was

noted coming through the window frames. The ceilings are plaster in some parts of the building and suspended acoustical tile in others. Interior walls are wallboard, lighting is fluorescent, and floors are concrete with tile atop. Asbestos is present throughout the facility. It is not friable however and has not presented a problem to date.

The building is currently abandoned and as such all environmental controls have been suspended. There is no heat or air conditioning in the facility, although these systems were present and should still function if restarted. Pest management and janitorial services have likewise been suspended and all fire-detection and -suppression devices have been shut down. Security for the building consists of a locked gate located at the entrance to the ALE and controlled access into the building.

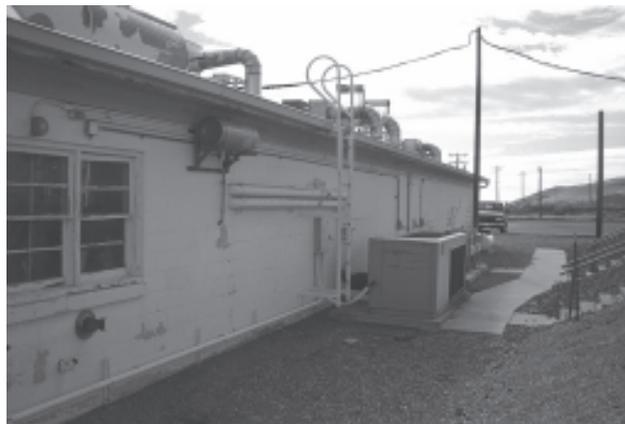
Building 6652H

The building was built in 1956 and served as a mess hall for the missile base. After closure of the base it served as a laboratory for the ALE. It has a concrete slab foundation, concrete block exterior walls and a built-up asphalt roof. The roof has experienced several leaks over the years that has led to some moderate water damage. All windows in the building have wooden window frames and are locked with simple window locks. Some air was noted coming through the window frames. The ceilings are plaster in some parts of the building and suspended acoustical tile in others. Interior walls are wallboard, lighting is fluorescent, and floors are concrete with tile atop. Asbestos is present throughout the facility. It is not friable, however, and has not presented a problem to date.

The building is currently abandoned and as such all environmental controls have been suspended. There is no heat or air conditioning in the facility, although these systems were present and should still function if restarted. Pest management and janitorial services have likewise been suspended and all fire-detection and -suppression devices have been shut down. Security for the building consists of a locked gate located at the entrance to the ALE and controlled access into the building.

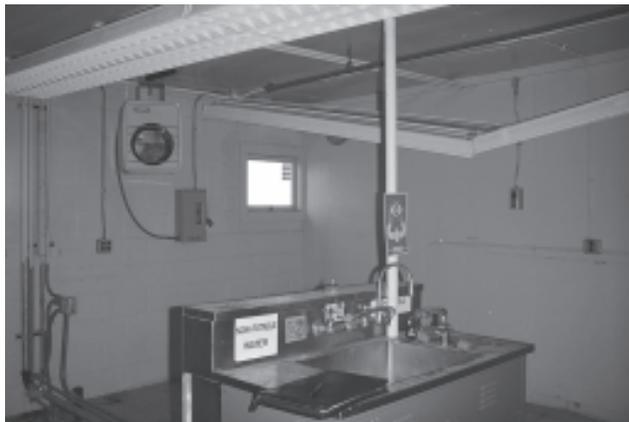
Building 6652M

The building was built in 1955 and served as a lavatory, shower, and change room for military personnel at the missile base. After closure of the base it served as a laboratory for the ALE. It has a concrete slab foundation, concrete block exterior walls and a built-up asphalt roof. The roof of this building has experienced major leaks that have caused the ceiling to begin to fall. All windows in the building have wooden window frames and are locked with simple window locks. Some air was noted coming through the window frames. The ceilings are plaster. Interior walls are wallboard, lighting is fluorescent, and floors are concrete with tile atop. Asbestos is present throughout the facility. It is not friable however and has not presented a problem to date.

The building is currently abandoned and as such all environmental controls have been suspended. There is no heat or air conditioning in the facility, although these systems were present and should still function if restarted. Pest management and janitorial services have likewise been suspended and all fire-detection and -suppression devices have been shut down. Security for the building consists of a locked gate located at the entrance to the ALE and controlled access into the building.

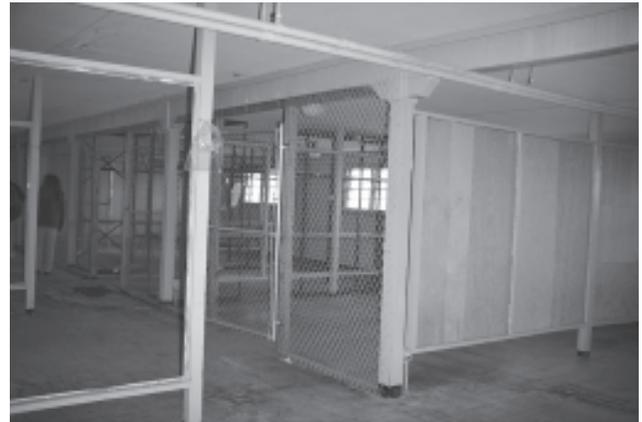
Building 6652G

The building was built in 1956 and served as a barracks building for personnel at the missile base and as storage for nonradioactive materials. It has a concrete slab foundation, concrete block exterior walls and a built-up asphalt roof, none of which have been observed leaking. All windows in the building have wooden frames and are locked with simple window locks. Some air was noted coming through the window frames. The ceilings are plaster in some parts of the building and suspended acoustical tile in others. Interior walls are wallboard, lighting is incandescent, and floors are concrete with tile atop. Asbestos is present throughout the facility. It is

The building is currently abandoned and as such all environmental controls have been suspended. There is no heat or air conditioning in the facility, although these systems were present and should still function if restarted. Pest management and janitorial services have likewise been suspended and all fire-detection and -suppression devices have been shut down. Security for the building consists of a locked gate located at the entrance to the ALE and controlled access into the building.

The building would need to undergo extensive rehabilitation before it could be effectively used as a collections repository. All environmental controls would have to be reinitiated or replaced completely and pest management and janitorial services would have to be reactivated. All asbestos would need to be removed or more fully encapsulated throughout the building. Fire-detection and -suppression systems would have to be completely upgraded to fit current building codes and to comply with 36 CFR Part 79. Security would likewise need to be upgraded to include both

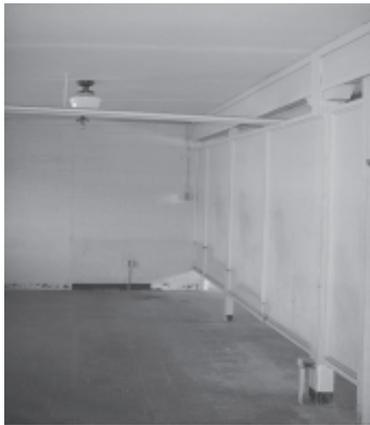
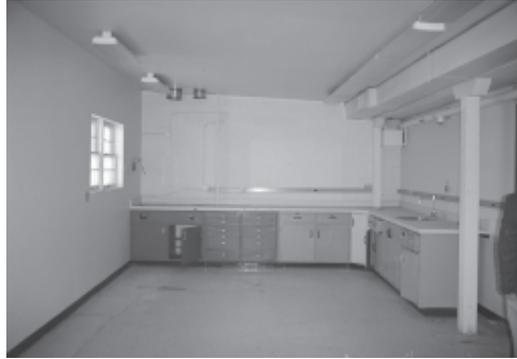
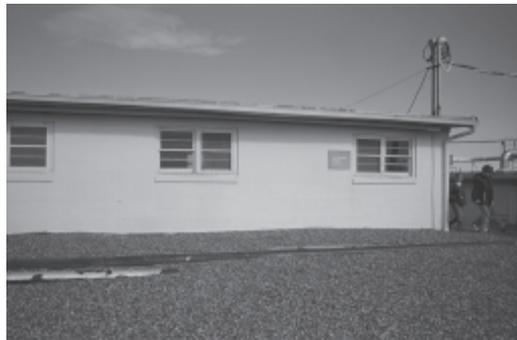
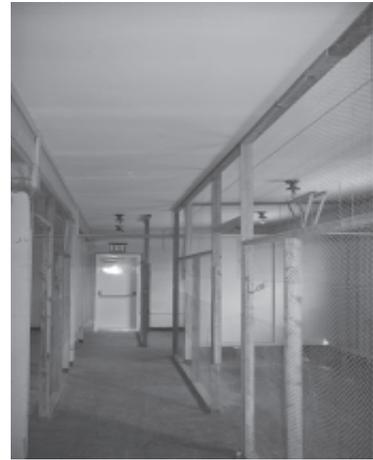
Building 6652J

The building was built in 1955 and served as a barracks for military personnel at the missile base. After closure of the base it served for laboratory and storage purposes for the ALE. It has a concrete slab foundation, concrete block exterior walls and a built-up asphalt roof. Some minor water stains were noted on the ceiling. All windows in the building have wooden window frames and are locked with simple window locks. Some air was noted coming through the window frames. The ceilings are plaster in some parts of the building and suspended acoustical tile in others. Interior walls are wallboard, lighting is incandescent and fluorescent, and floors are concrete with tile atop. Asbestos is present throughout the facility. It is not friable however and has not presented a problem to date.

is no heat or air conditioning in the facility, although these systems were present and should still function if restarted. Pest management and janitorial services have likewise been suspended and all fire-detection and -suppression devices have been shut down. Security for the building consists of a locked gate located at the entrance to the ALE and controlled access into the building.

This 7,400 ft² facility has several large areas that once served as sleeping quarters for base personnel. These areas are similar to those noted in 6652G and could be easily modified to accommodate storage units for artifacts or records. Additionally, the large size and floor plan of this building also possess adequate space for offices and laboratories.

However, all environmental controls would have to be reinitiated or replaced completely and

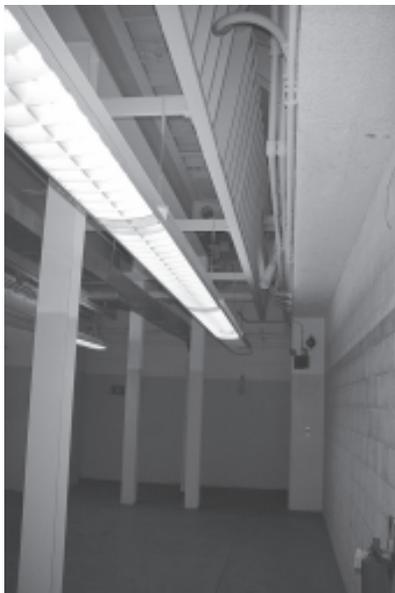
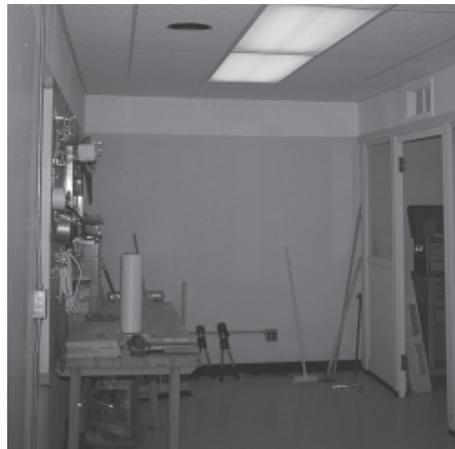
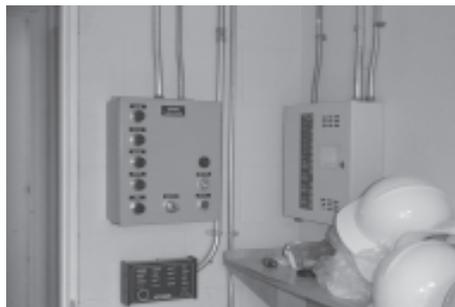
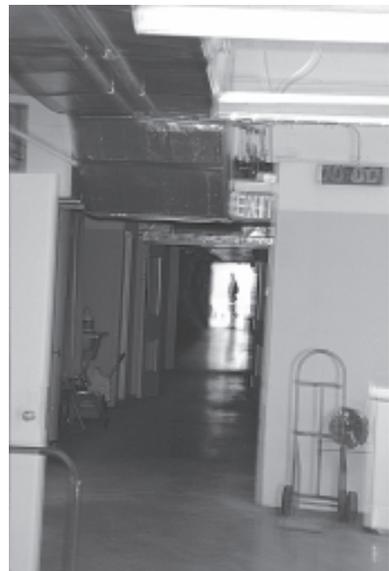
Building 6652L

The building was built in 1955 and served as an underground storage facility for Nike missile. After closure of the base it served as an emergency relocation center for use in the event of a nuclear attack. The only surface manifestations of the facility are two entrances that are set in cement and bounded by earthen mounds. The subsurface portion of the facility has a concrete slab foundation and concrete block exterior walls. The ceilings are suspended acoustical tile and there are no windows. Interior walls are concrete block, lighting is fluorescent, and floors are concrete or wood with tile atop or bare concrete in some areas.

The building is currently being used as a physics laboratory however, only the lighting and electrical systems are functioning. There is no heat or air conditioning in the facility, although these systems were present and should still function if restarted. Pest management and janitorial services are being conducted on an as-needed basis by laboratory personnel. Fire-detection and -suppression devices are currently still operable, but will be shut down in the near future. Security for the building consists of a locked gate located at the entrance to the ALE and controlled access into the building.

However, all environmental controls would have to be reinitiated or replaced completely and pest management and janitorial services would have

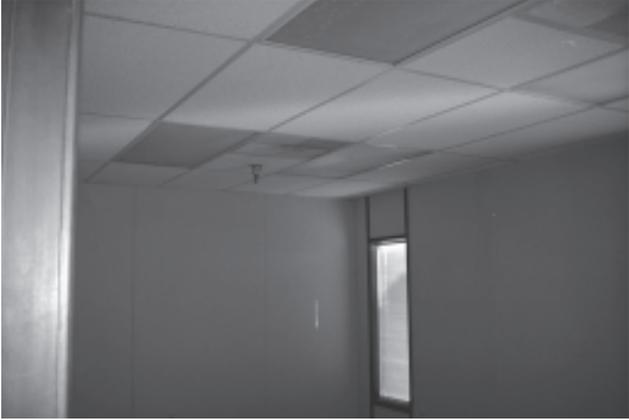
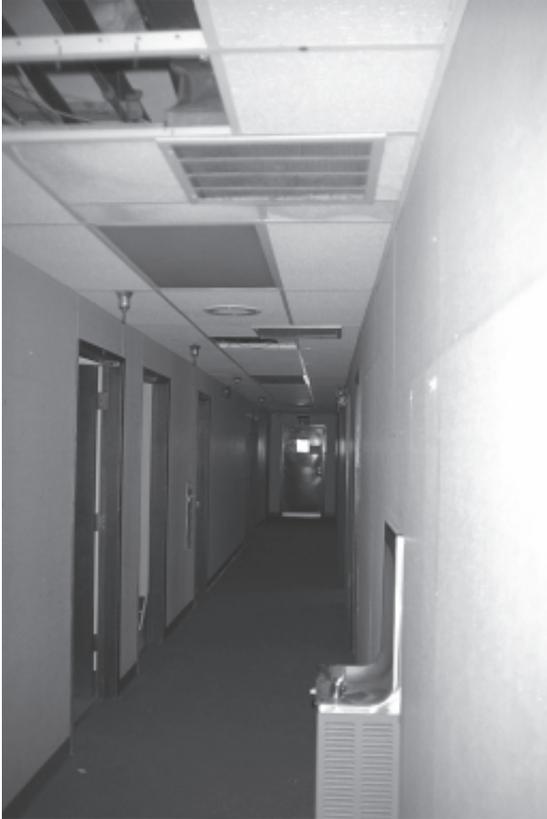
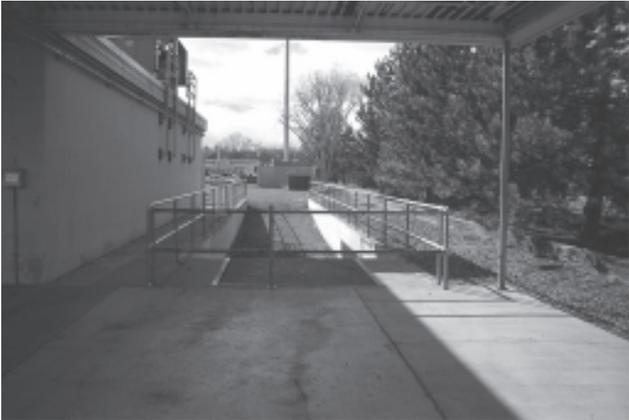
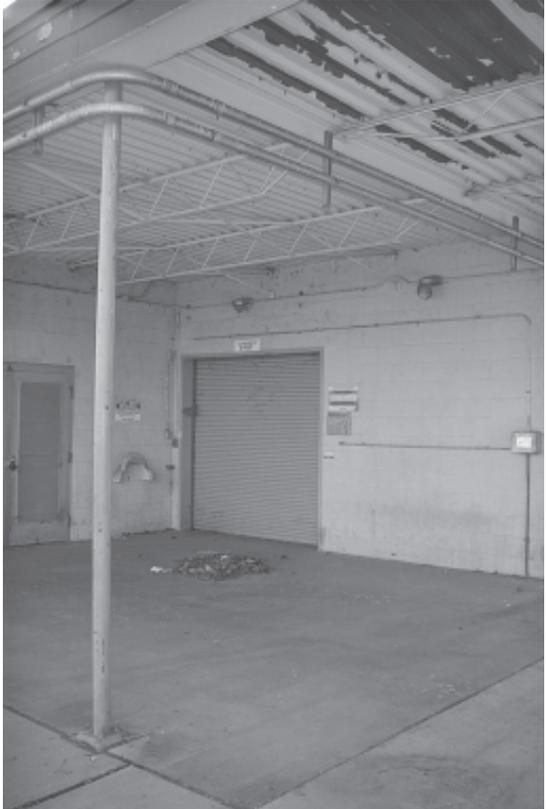
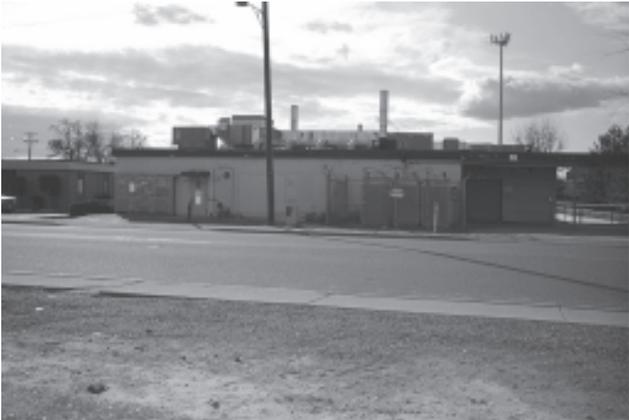
Figure 2. Interior and exterior views of Building 747.

The building has a concrete slab foundation and brick exterior walls. The roof is flat and tar covered (the roof of the addition is metal). The ceilings are suspended acoustical tile and windows are aluminum framed and have some shades. They are secured with simple window locks. There has been some leaking from the roof, but none from the foundation or window frames. Interior walls are wallboard, lighting is fluorescent, and floors are wood with tile atop. Asbestos is present throughout the facility. It is not friable however and has not presented a problem to date.

is no heat or air conditioning in the facility, although these systems were present and should still function if restarted. Pest management and janitorial have likewise been suspended. Fire-detection and -suppression devices are turned off and security for the building consists of controlled access only.

The large size (12,350 ft²) and floor plan of the building are suitable for a collections repository. There is space for offices and laboratories. In addition, there is a large warehouse-like section in the facility that would easily accommodate storage units for collections. Many of the original laboratories have existing cabinetry and fume hoods that could be reused once rehabilitated. The building also possess a roll-up door and loading dock for easy placement of collections. The location would also facilitate easy monitoring of the materials by Hanford personnel.

However, all environmental controls would have to be reinitiated or replaced completely and pest management and janitorial services would have to be reactivated. All asbestos would need to be removed or more fully encapsulated throughout the building. Fire-suppression and -detection systems would have to be completely upgraded to fit current building codes and to comply with 36 CFR Part 79. Security would likewise need to be upgraded to include both intrusion detection and deterrence.

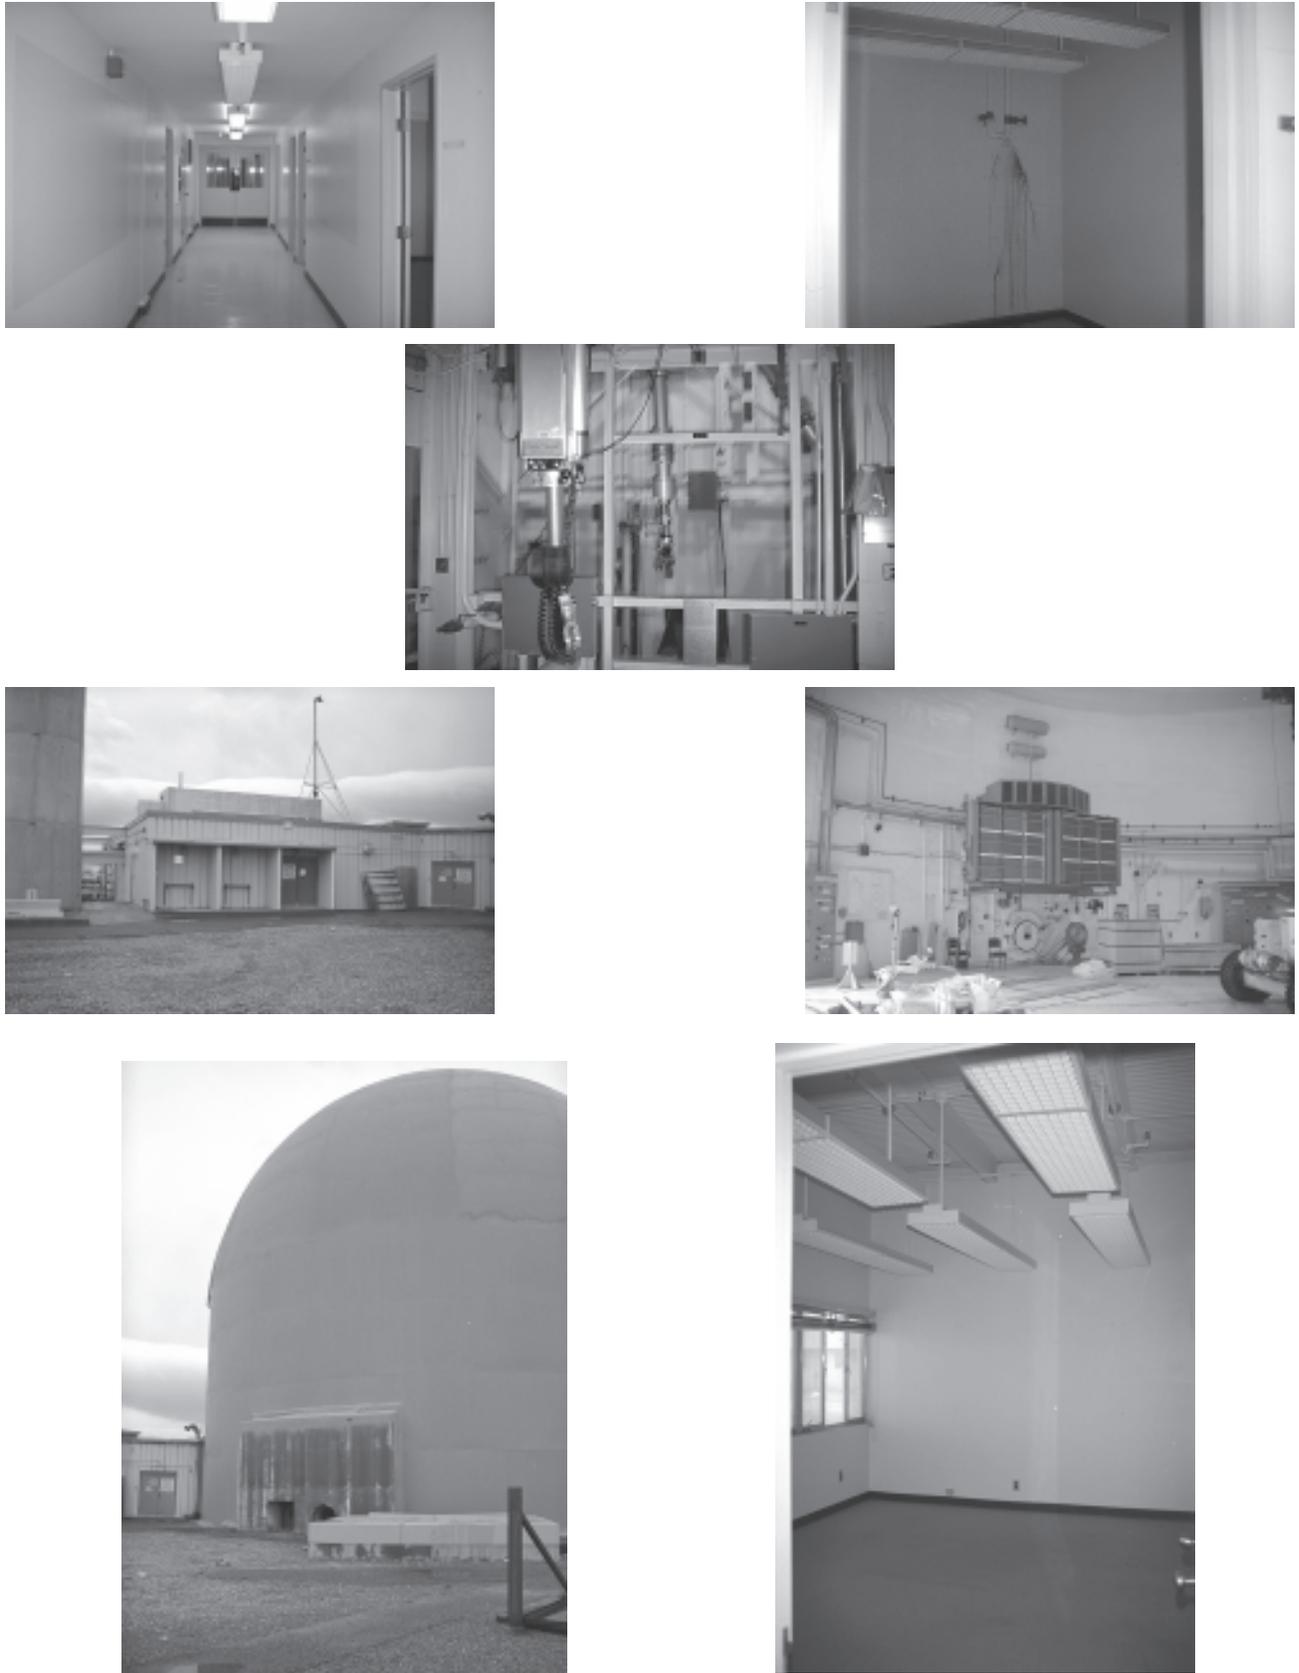
Figure 3. Interior and exterior views of Building 309E

The building has a concrete slab foundation, concrete block exterior walls with aluminum siding (the reactor dome has concrete exterior walls) and a metal roof. Ceilings in 309E are suspended acoustical tile or, in some areas, are exposed to the insulation and piping systems. Windows are aluminum framed, have no shades, and are secured with simple window locks. No leaks from either the roof or foundation has been noted however some air was passing through the window frames. Also, some water has slipped through under doorways resulting in small areas of standing water in various portions of the building. Interior walls are wallboard, lighting is fluorescent, and floors are concrete with tile atop, in some areas, and exposed concrete in others. Asbestos is present throughout the facility. It is not friable, however, and has not presented a problem to date.

The building is currently abandoned and as such all environmental controls have been suspended. Electrical systems are still on and lighting is available to the building. There is no heat or air conditioning in the facility, although these systems were present and should still function if restarted. Pest management is conducted on a biannual basis, but janitorial services have been suspended. Fire-detection and -suppression systems are currently off line and security consists of controlled access only.

All environmental controls would have to be reinitiated or replaced completely and pest management and janitorial services would have to be reactivated. Standing water would need to be removed and safe guarded against. All asbestos would need to be removed or more fully

encapsulated throughout the building. Fire-detection and -suppression systems would have to be completely upgraded to fit current building codes and to comply with 36 CFR Part 79. Security would likewise need to be upgraded to include both intrusion detection and deterrence.

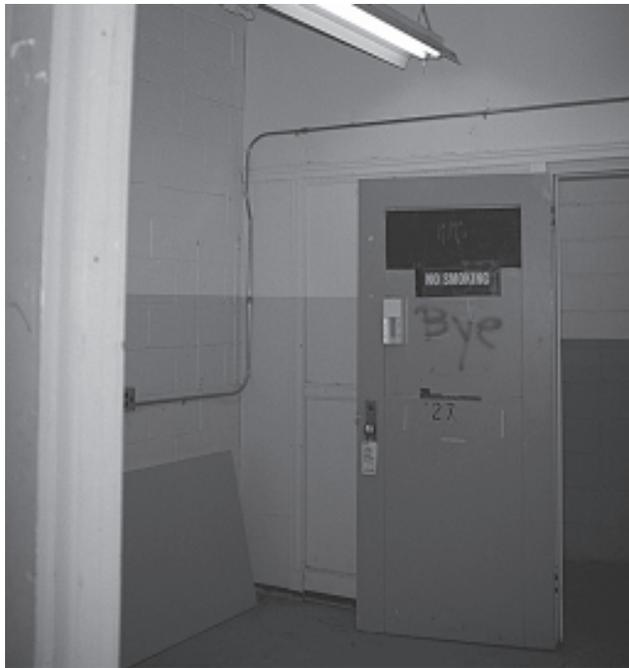
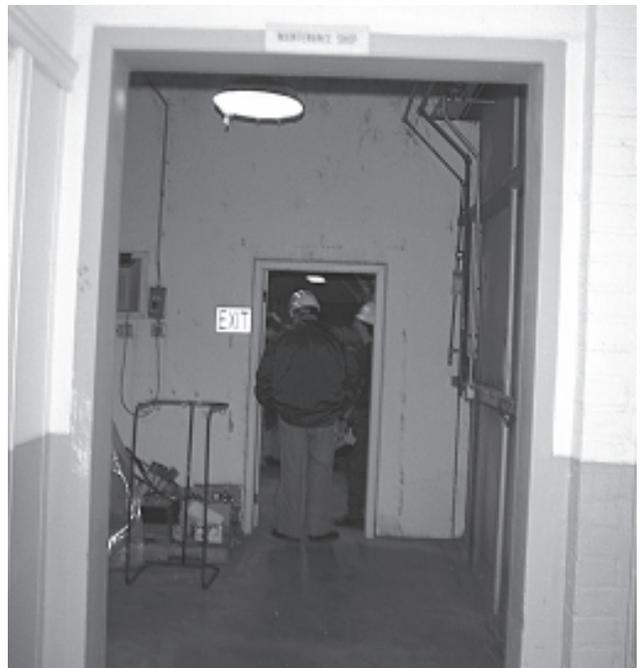
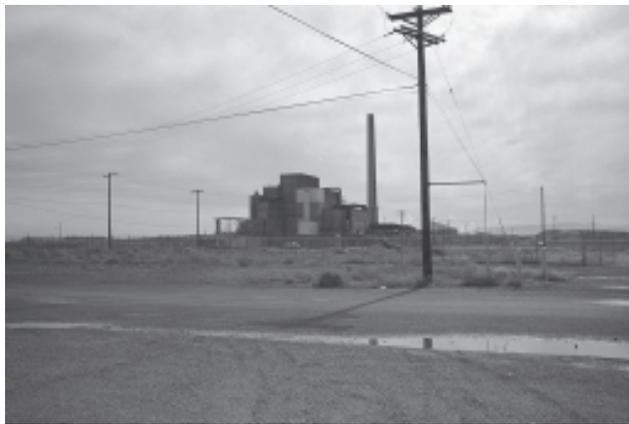
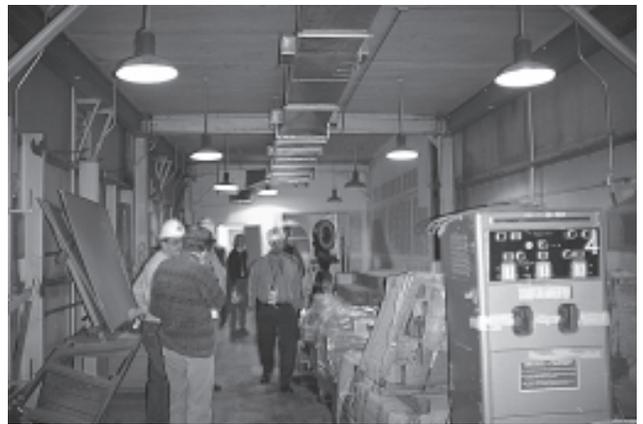
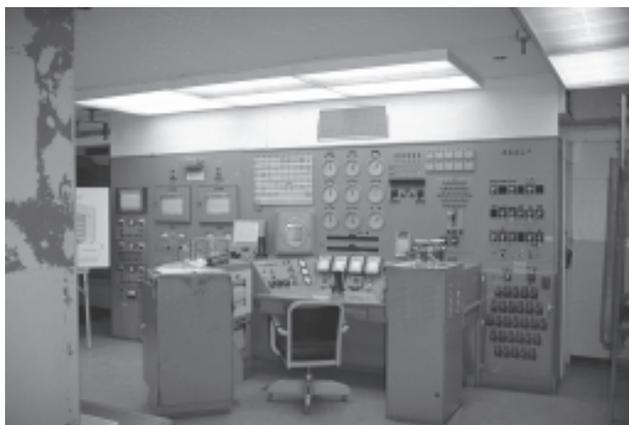
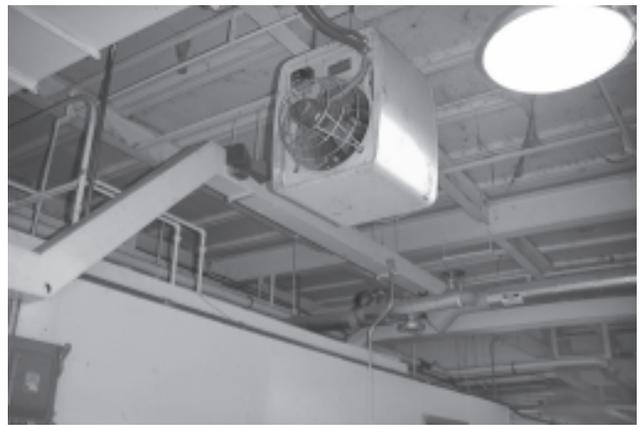
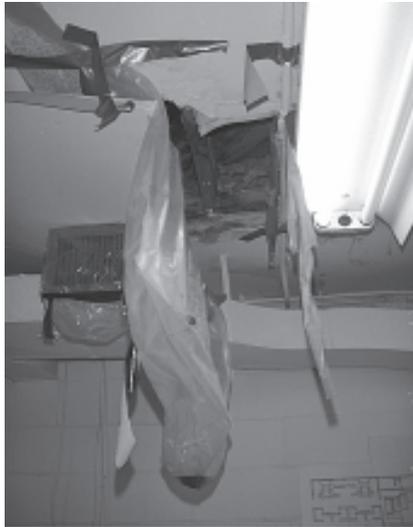
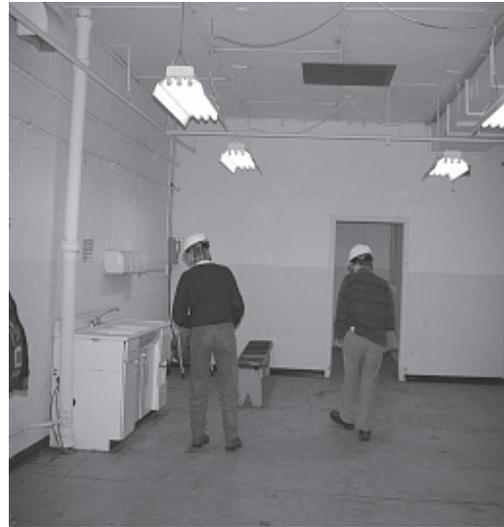
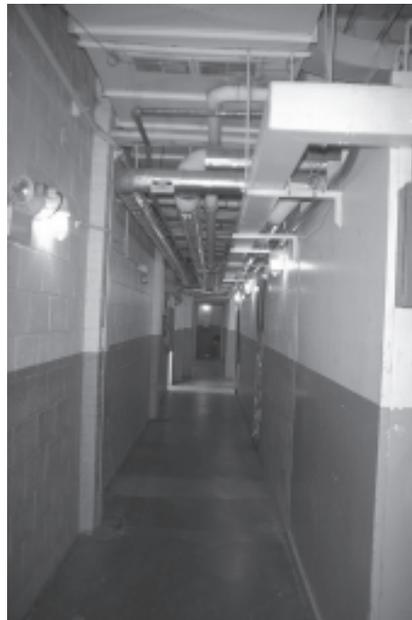
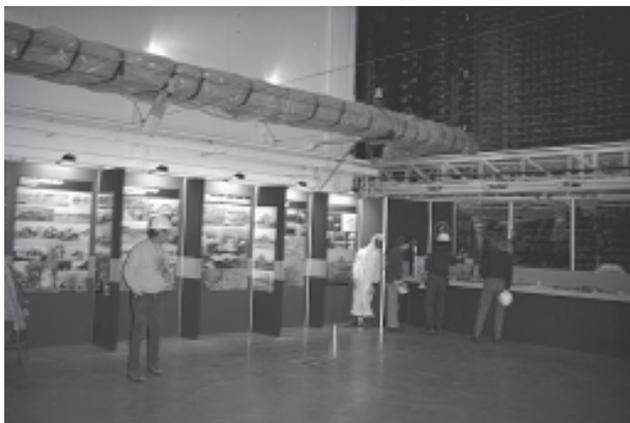
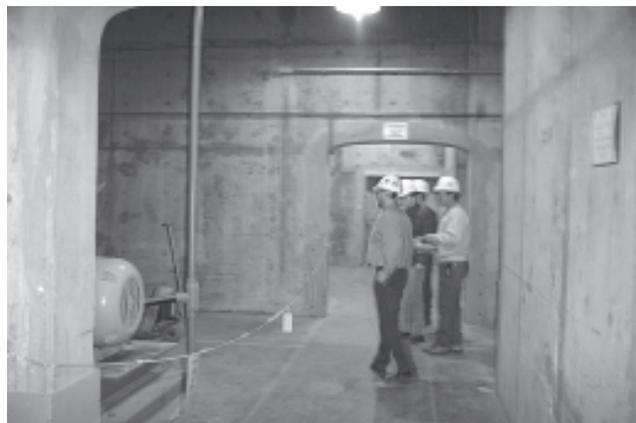
Figure 4. Interior and exterior views of Building 105B.

The building has a concrete slab foundation, concrete and transite exterior walls and a concrete and steel roof. Ceilings in 105B are steel panels throughout the building. Windows are steel framed, have no shades, and have been sealed. No leaks from either the roof or foundation has been noted however some of the old vents from the heating and cooling system have been leaking in the lower levels. Interior walls are plaster, lighting is fluorescent and incandescent, and floors are concrete. Asbestos is present throughout the facility but is not friable and has not been problematic to date.

The building is currently abandoned and as such all environmental controls have been suspended. Electrical systems are still on and lighting is available to the building. There is no heat or air conditioning in the facility, although these systems were present and should still function if restarted. Pest management is conducted on a monthly basis, but janitorial services have been suspended. Fire-detection and -suppression systems are shut off and security consists controlled access only.

All environmental controls would have to be reinitiated or replaced completely and pest management and janitorial services would have to be reactivated. Fire-detection and -suppression systems would have to be completely upgraded to fit current building codes and to comply with 36 CFR Part 79. Security would likewise need to be upgraded to

include both intrusion detection and deterrence. Given the relatively isolated location of reactor adequate planning for protection of the collections in terms of fire safety and theft would be called for to ensure that any collections stored at the repository would be adequately maintained.

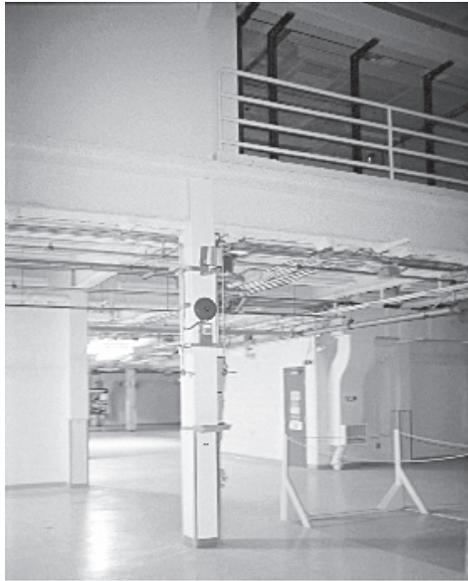
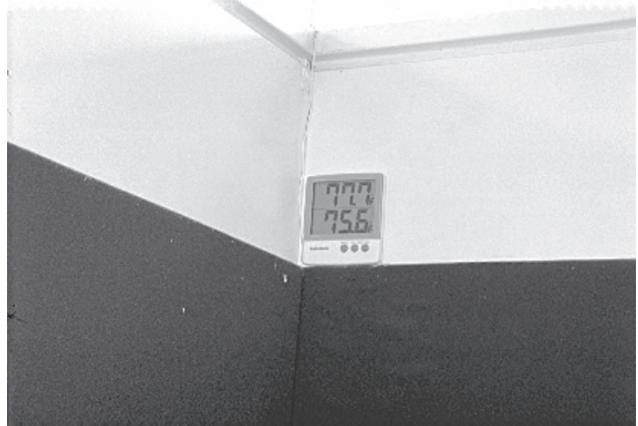
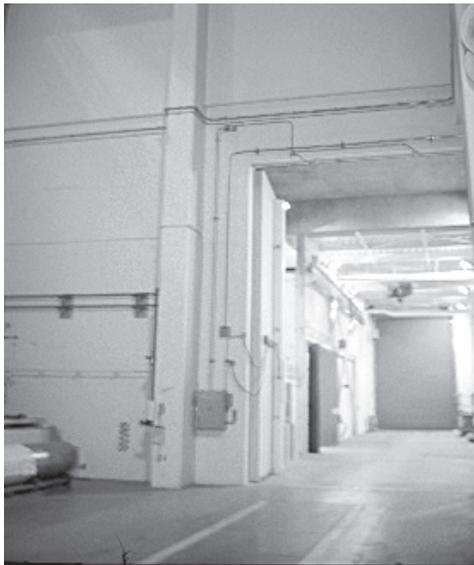
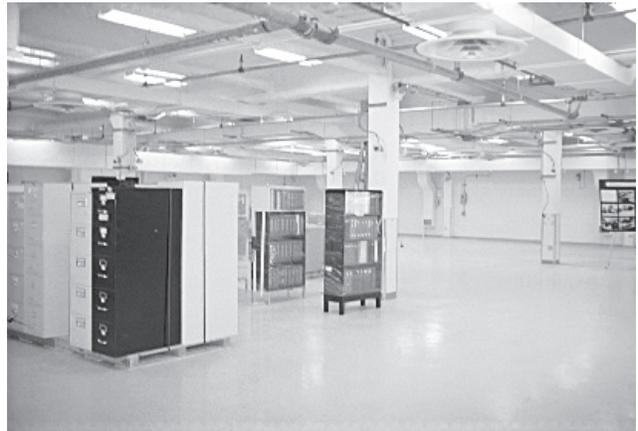
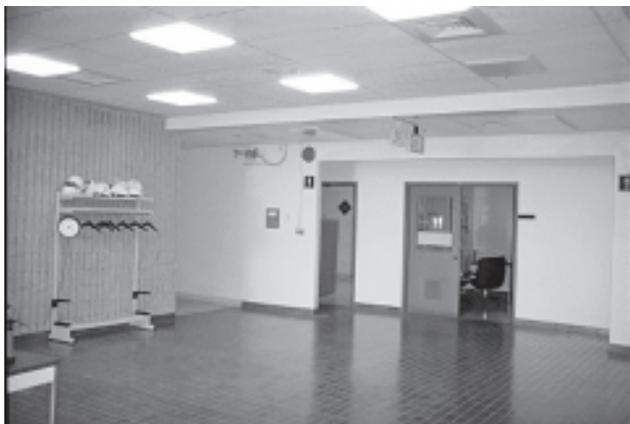
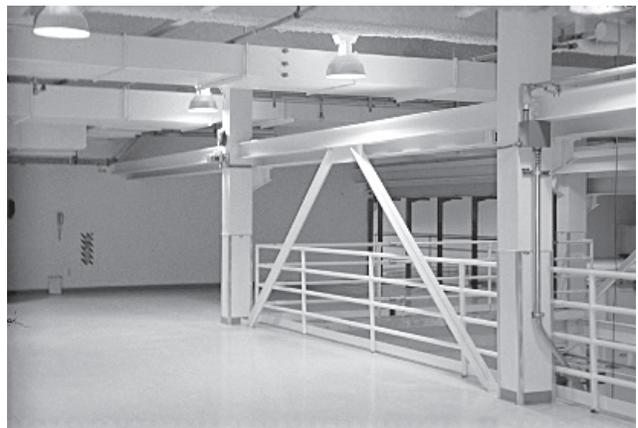
Figure 5. Interior and exterior views of Building 4826.

The building has a concrete slab foundation, concrete exterior walls and a built-up asphalt roof. Ceilings are suspended acoustical tile and windows are steel framed, have shades, and are sealed. No leaks from either the roof or foundation has been noted however some minor leaks have been noted from some vents. Interior walls are wallboard, lighting is fluorescent, and floors are concrete with tile or carpet atop. Asbestos is present throughout the facility but is not friable and has not been problematic to date.

Electrical systems are still on and lighting is available to the building. There heat is turned in the winter, there is no air conditioning during the summer. A cooling system is present and should still function if restarted. Pest management is conducted on an as-needed basis, but janitorial services have been suspended. Fire-detection and -suppression systems are functioning, however, all fire extinguishers have been removed. Security consists of controlled access only.

The building has several rooms and large open spaces on the ground floor and on the mezzanine level that would offer ample space for office, laboratories, and storage. Additionally, there are roll-up doors that could be used for easy placement of collections and a large transfer bay complete with load-lifting equipment that could be converted into a dirty collection/processing laboratory area. All environmental controls would have to be reinitiated and pest management and janitorial services would have to be reactivated. Fire-detection and -suppression systems are currently on line, but the replacement of all fire extinguishers is required. Security measures would require reactivation.

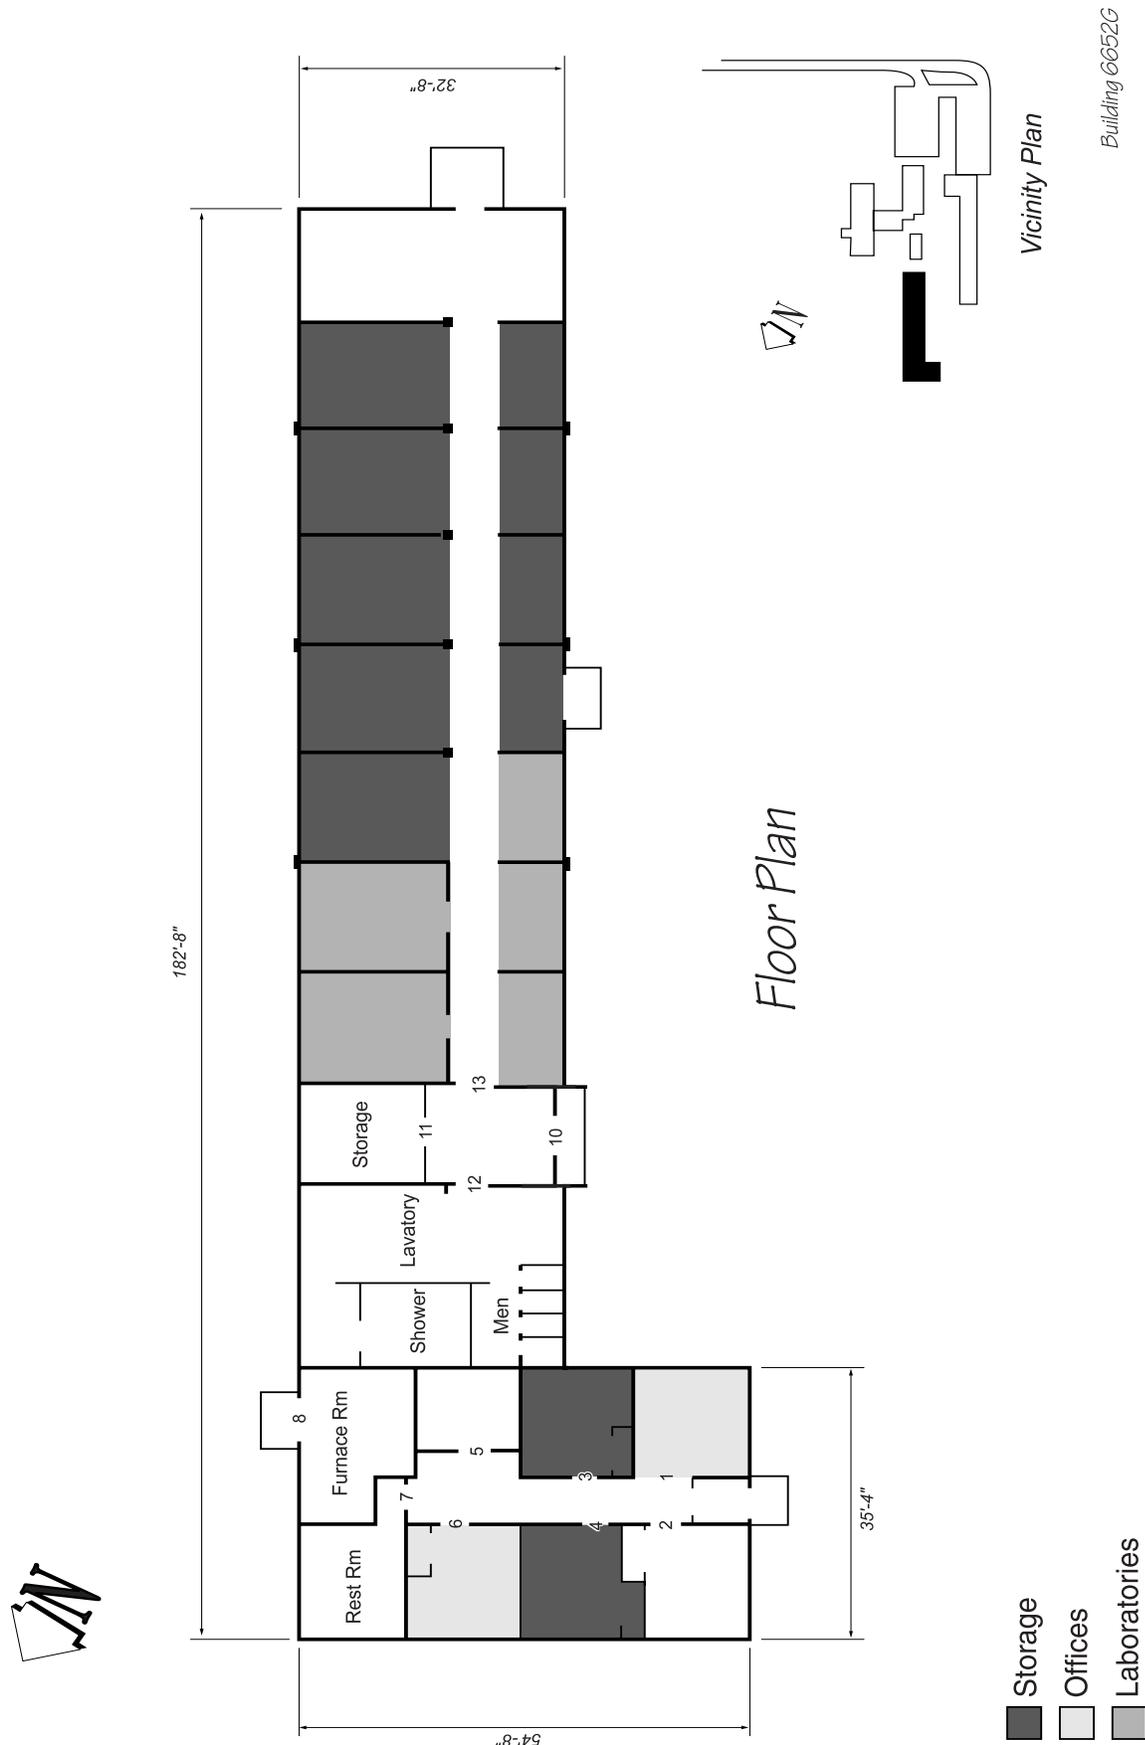
Figure 6. Suggested uses of building 6652G for collections storage based on observations conducted during the assessment.

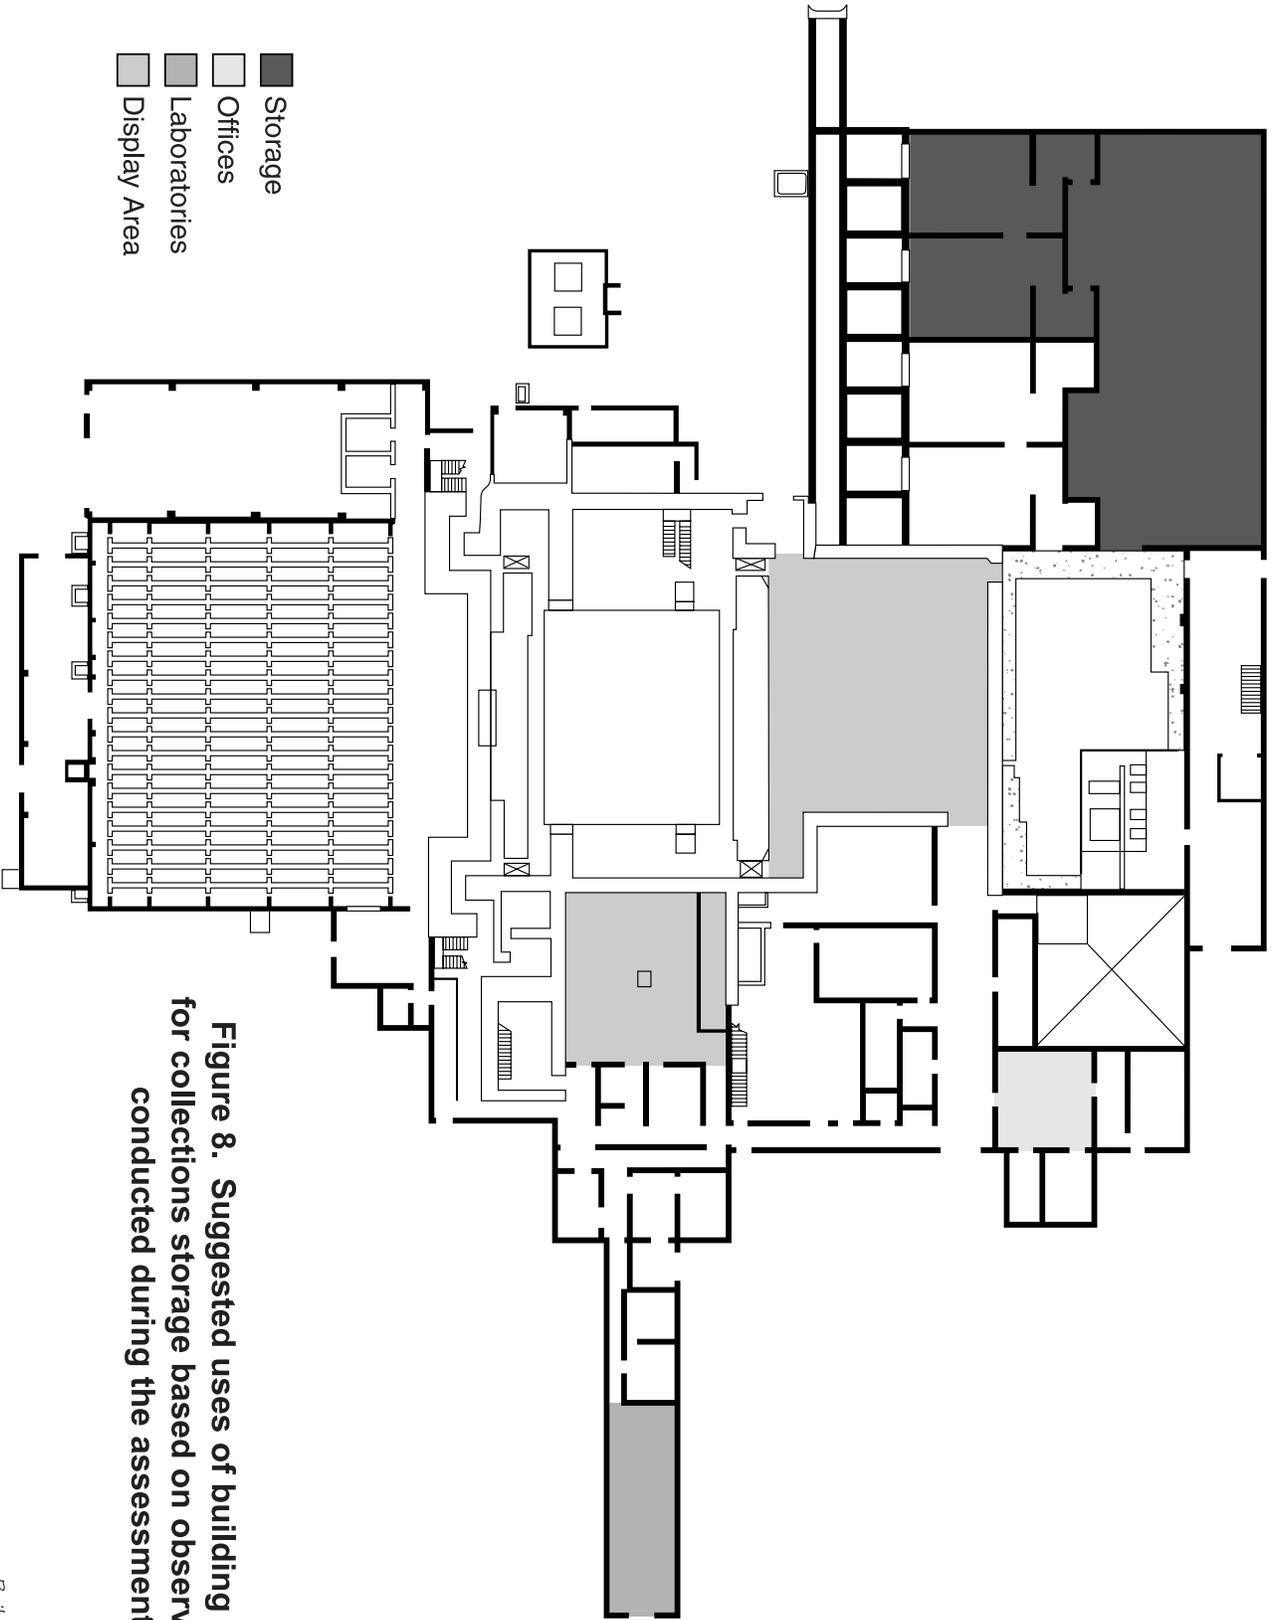
Figure 8. Suggested uses of building 105B for collections storage based on observations conducted during the assessment.

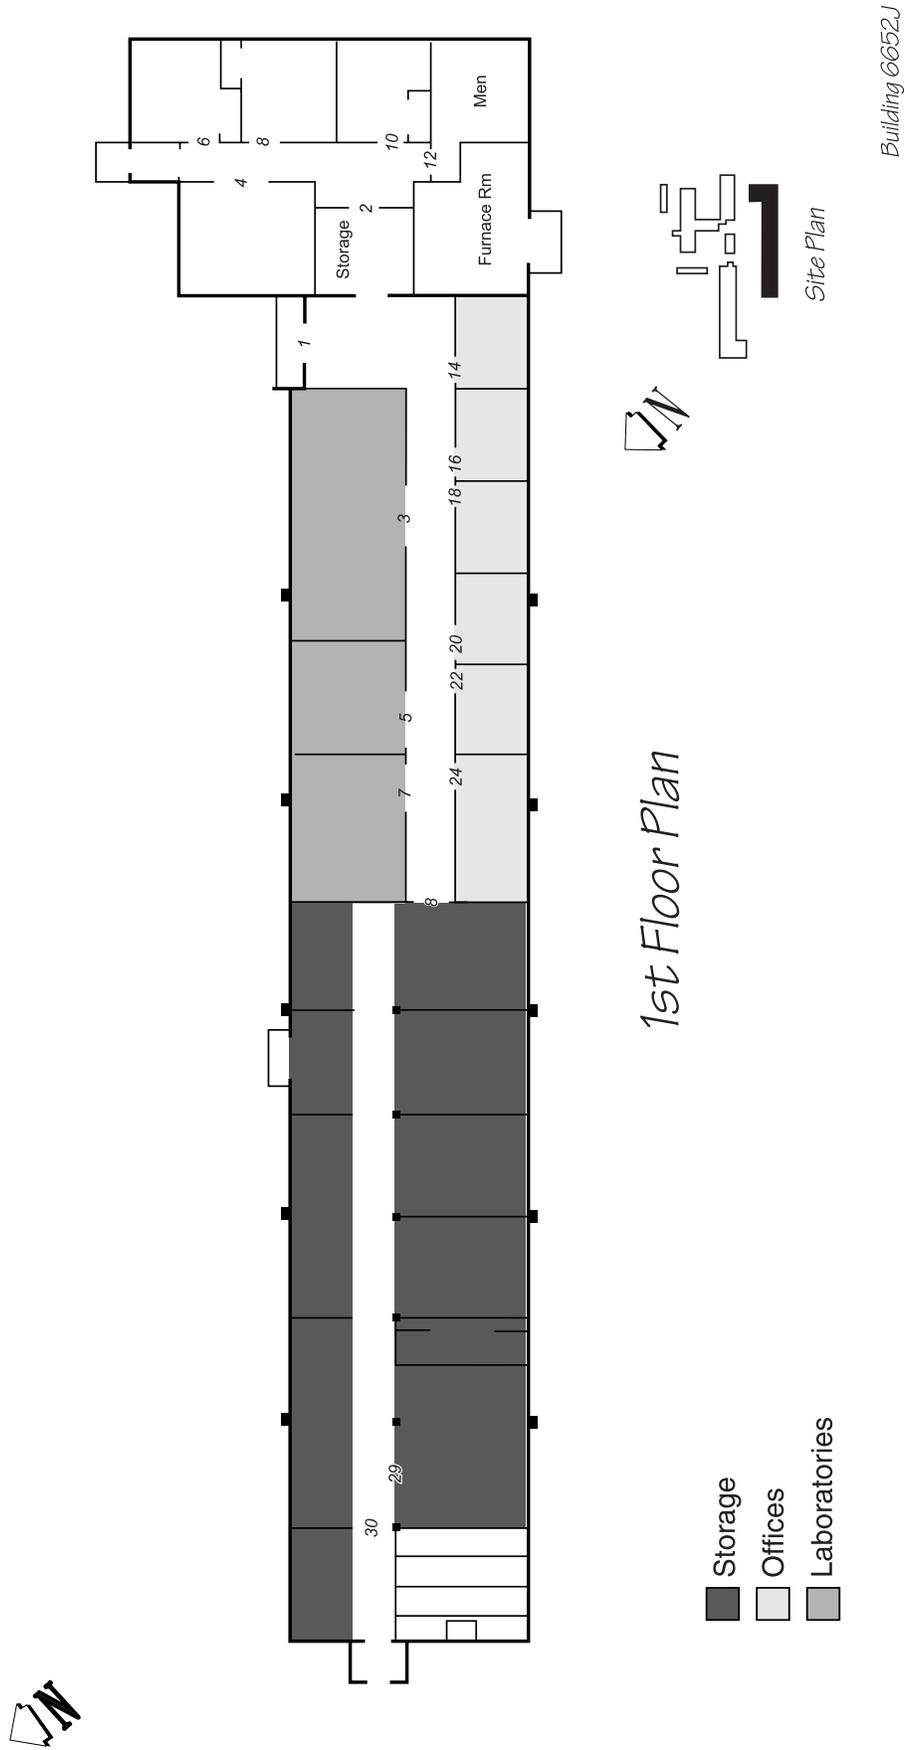
Figure 7. Suggested uses of building 6652J for collections storage based on observations conducted during the assessment.

3. Building 6652J was given an **excellent** rating for repository potential. This rating stems from the fact that (1) there is a large amount of space in the facility that could be *easily* redesigned to accommodate collections storage and office/laboratory space; (2) the building also *possesses* items that could be reused for collections storage purposes (e.g., fume hoods, and cabinetry); and (3) the building possess no water damage and is not contaminated. Figure 8 suggests some uses of the facility for collections storage.
