An Assessment of Potential Curation Facilities at the Hanford Site, Department of Energy

Technical Report No. 26

13. ABSTRACT (Maximum 200 words) In March and June 2000, St. Louis District personnel examined ten facilities that are located on the Hanford Nuclear Test Site in order to determine their potential as curation repositories for Hanford Cultural Resources. The facilities examined ranged from abandoned buildings associated with the NIKE missile complex to nuclear research reactors. All buildings would require substantial rehabilitation to comply with existing regulations for the curation and management of cultural resources (36 CFR Part 79).

Archaeological Curation-Needs Assessments
Technical Report No. 26

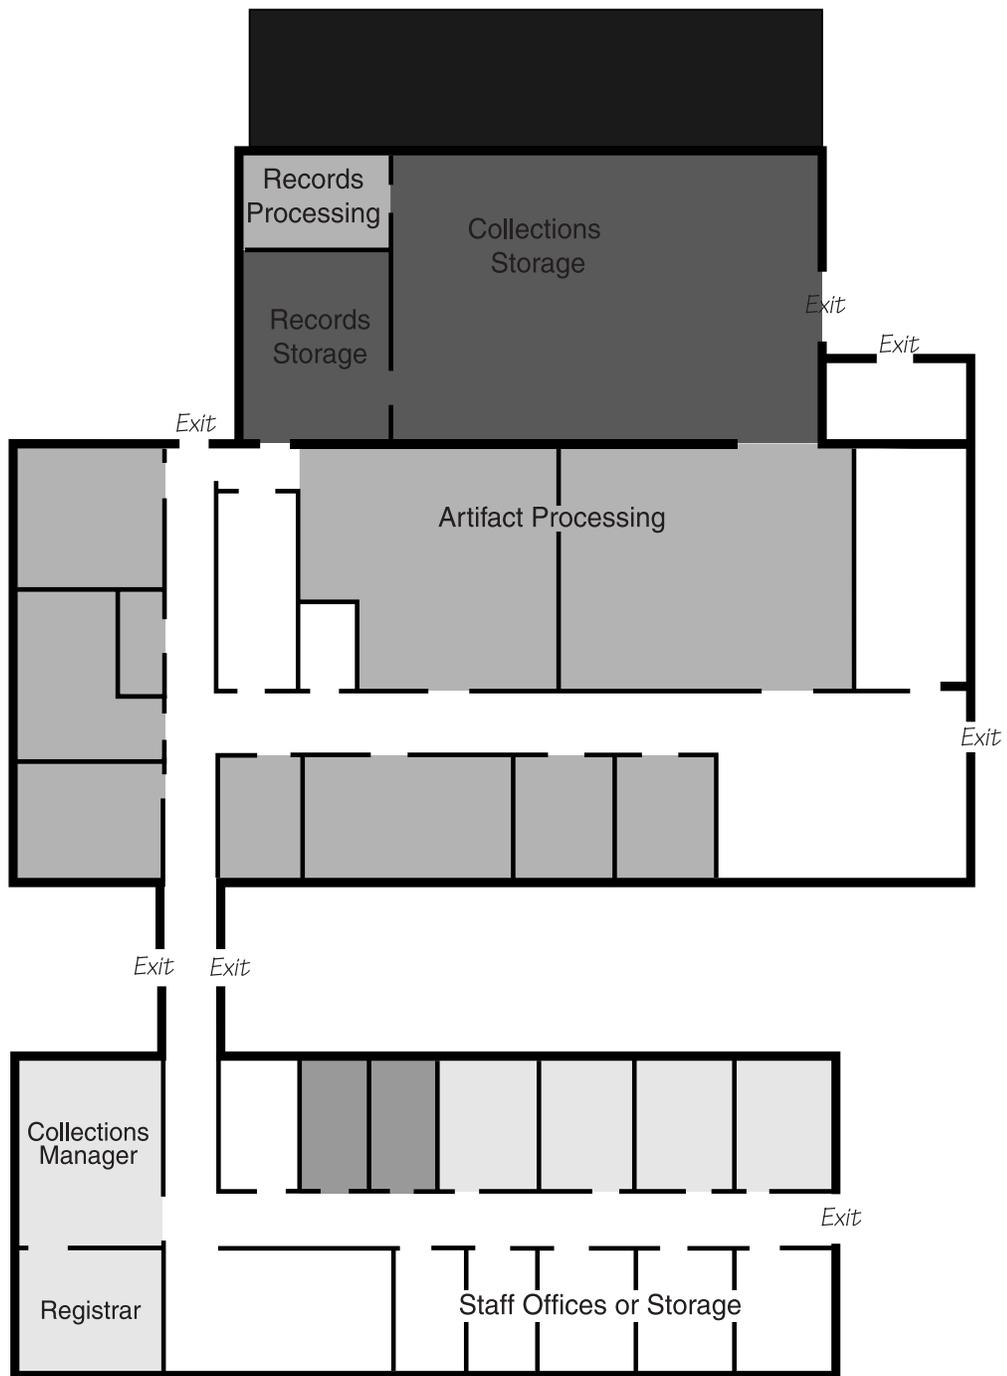
747 AND 747-B Buildings

- Storage
- Restrooms
- Offices
- Laboratories
- Loading Dock

Figure 9. Suggested uses of Building 747 for collections storage based on observations conducted during the assessment.

4. Building 747 was given an **excellent** rating for repository potential. This rating stems from the fact that (1) there is a large amount of space in the facility that could be *easily* redesigned to accommodate collections storage and office/laboratory space; (2) the building also *possesses* items that could be reused for collections storage purposes (e.g., fume hoods, and cabinetry); and (3) the building possess no water damage and is not contaminated. Figure 9 suggests some uses of the facility for collections storage.
