**NORTH ST. LOUIS COUNTY HAUL
ROAD ANALYSIS AND JUSTIFICATION
FOR ADDITIONAL INVESTIGATION-
EVALUATION OF INACCESSIBLE
MATERIALS BENEATH PAVEMENTS
ST. LOUIS, MISSOURI**

**U.S. Army Corps of Engineers
St. Louis District Office
Formerly Utilized Sites Remedial Action Program**

**Science Applications International Corporation (SAIC)
Under Contract No. DACW43-00-D-0515**

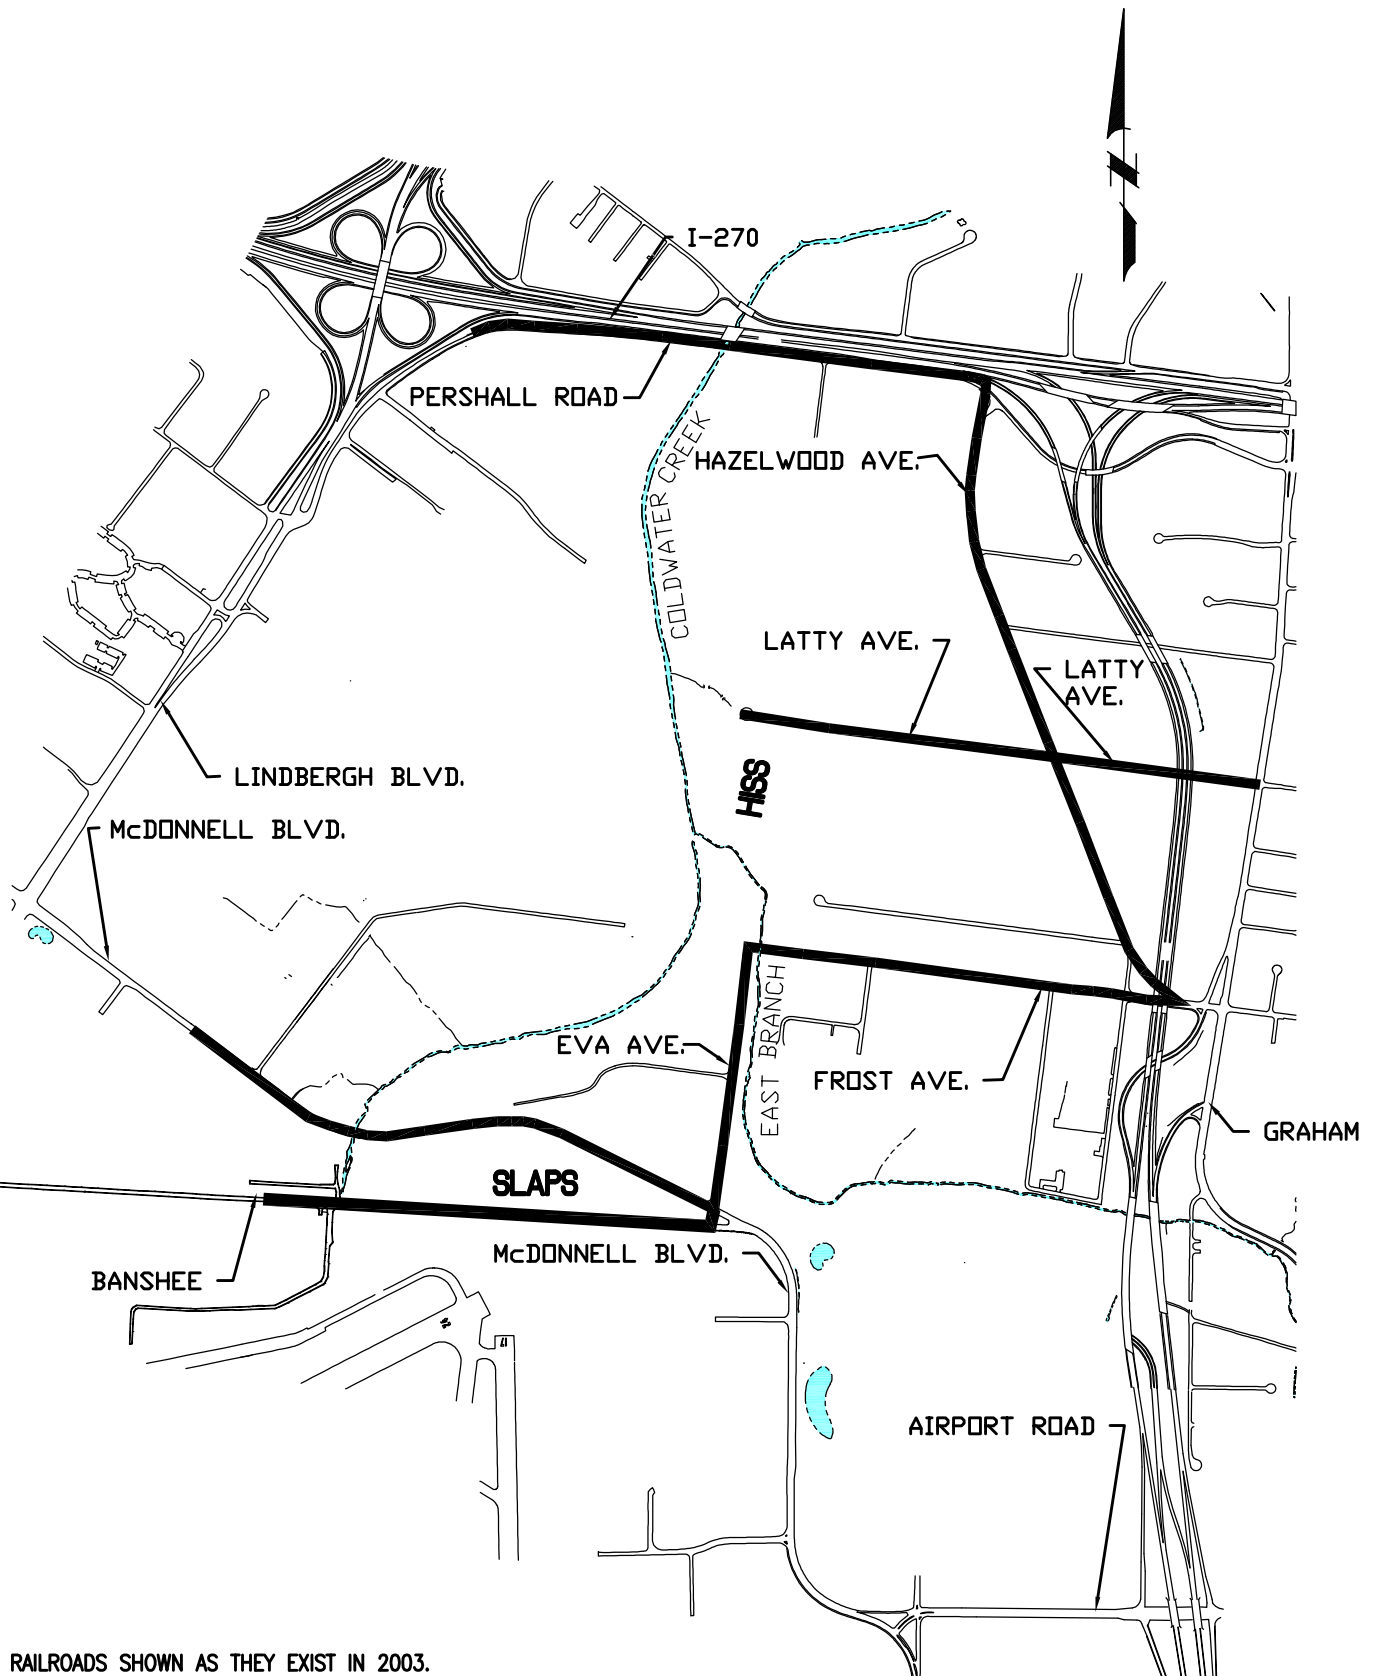
U:\CAD\NorthCo\Draws\HaulRouteP\InvestigativePlan\ROAD STUDY\Road Study cm\2003-06-03 2:4F.dwg, FIGURE 2-4, 1/5/2005 9:42:26 AM

LOCATIONS OF IMPACTS FOUND
BY TESTING

Figure 2-4 shows the roadways in or around which residue has been detected that may exceed remediation goals in the proposed Record of Decision.

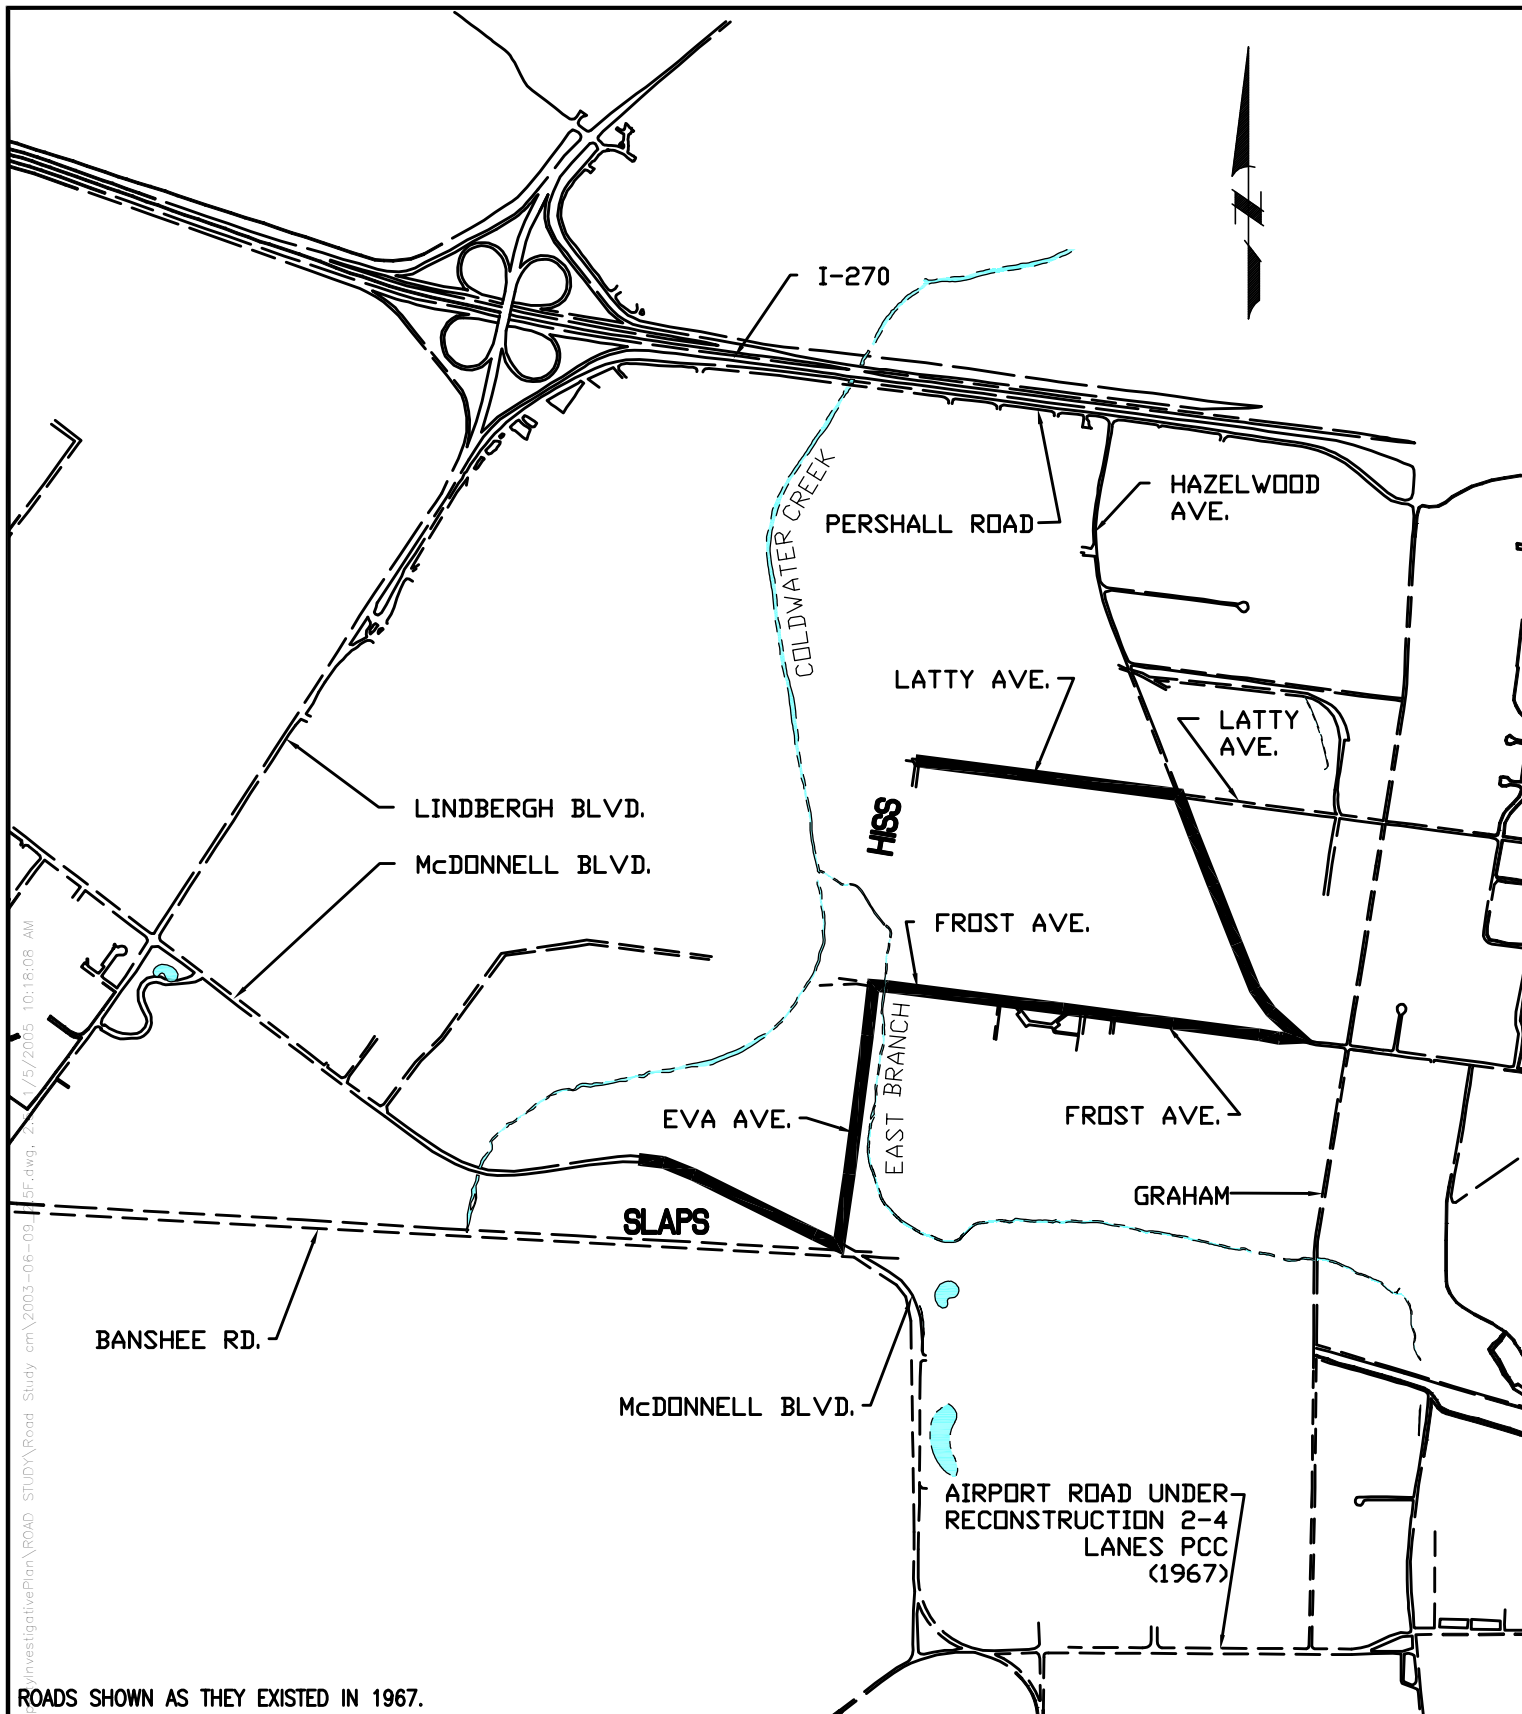
ROADS SHOWN AS THEY EXISTED IN 1967.

ROUTE LENGTH = 2.15 Mi.

While there are many potential routes to get from one site to the other, the most direct route involves a portion of McDonnell Boulevard from the SLAPS to Eva Avenue, Eva Avenue to Frost Avenue, Frost Avenue to Hazelwood Avenue, Hazelwood Avenue to Latty Avenue, and Latty Avenue to the HISS (Route A). Route A is illustrated in Figure 2-5.

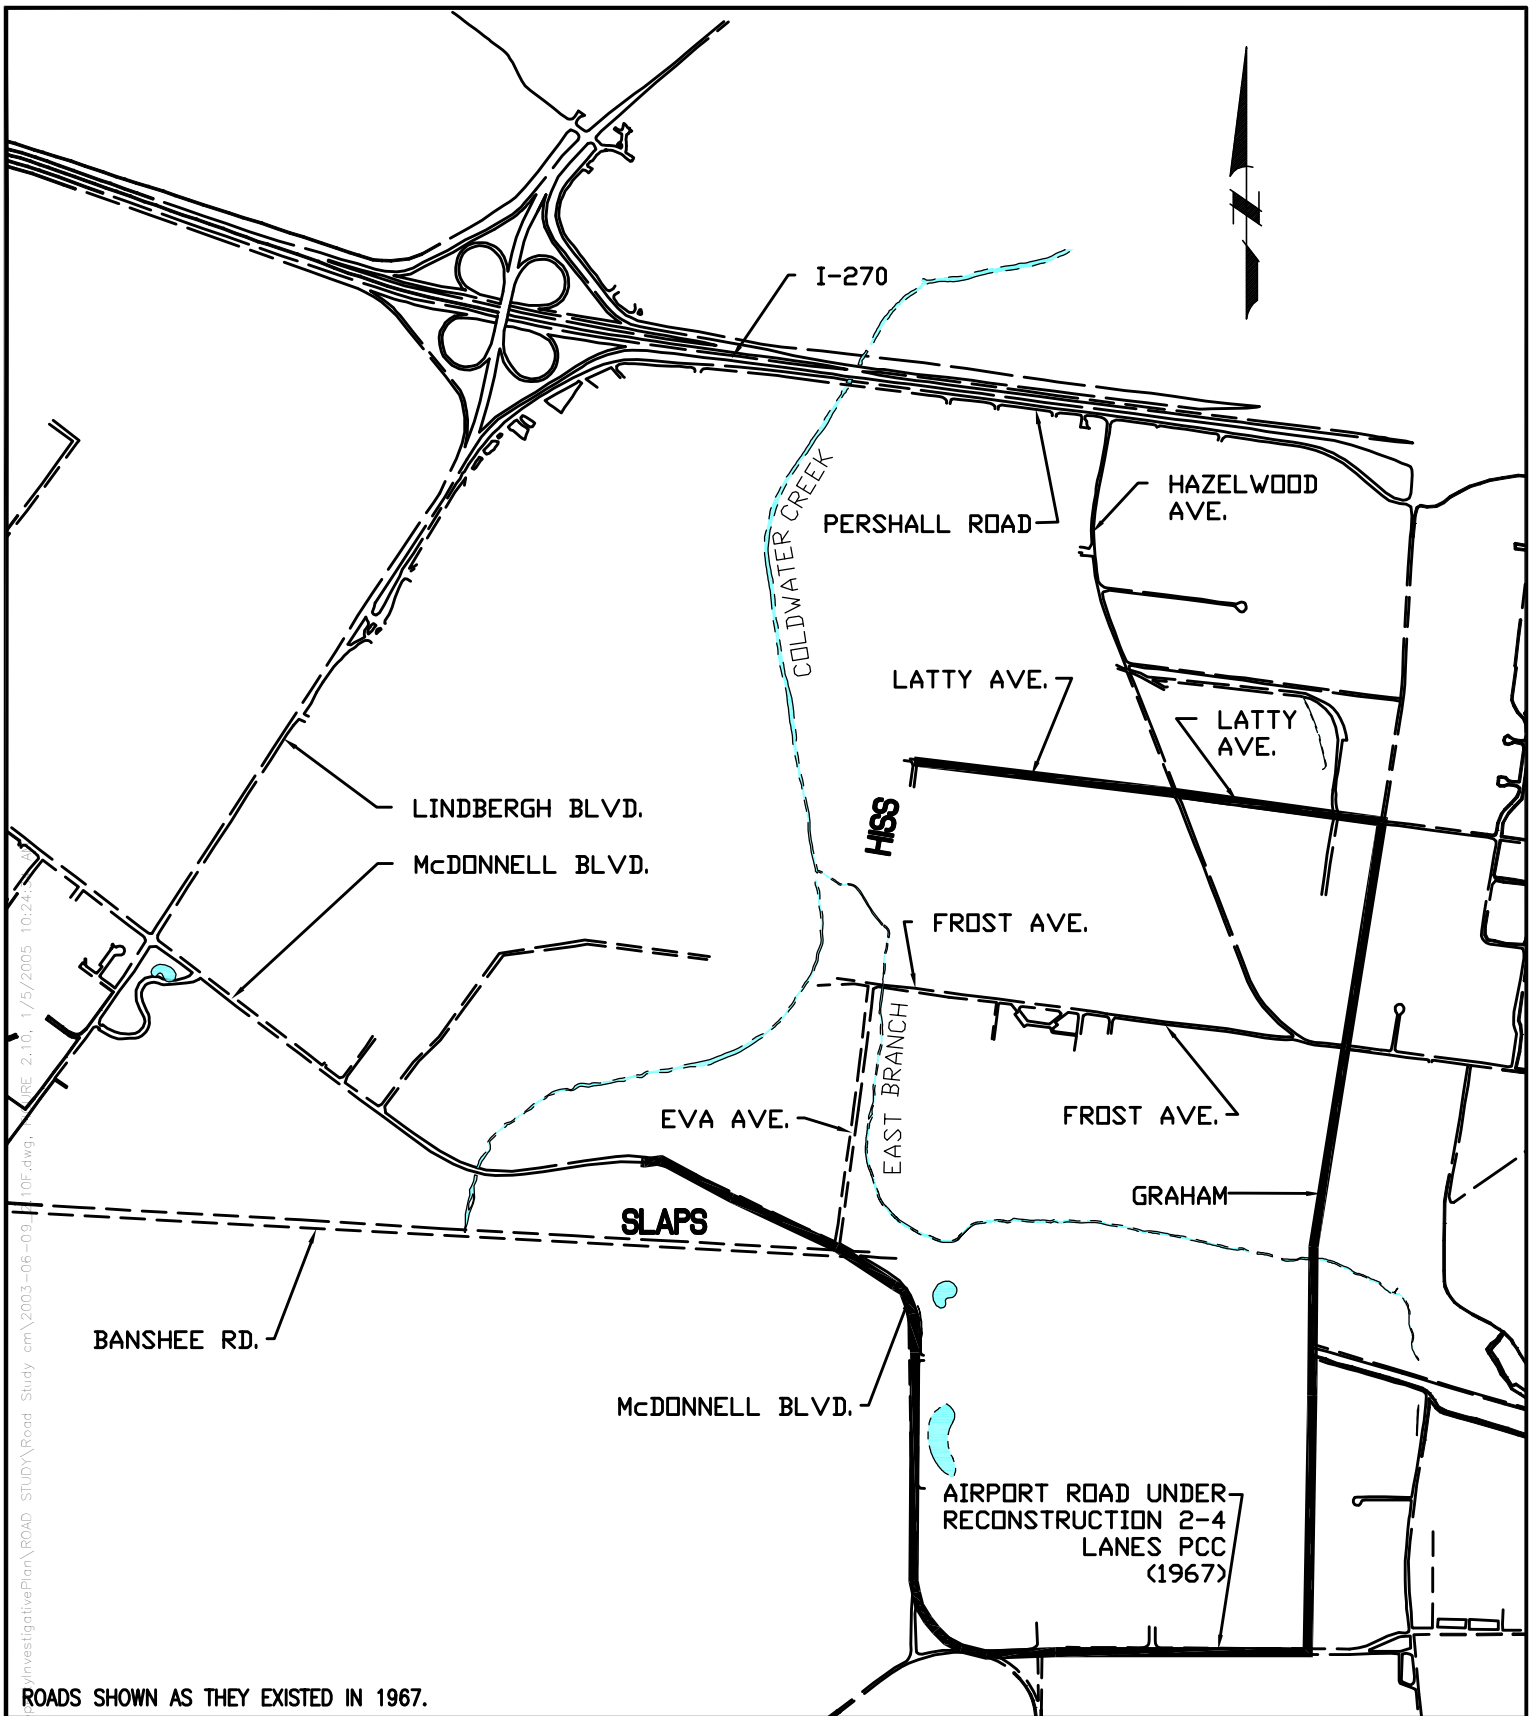
ROUTE BETWEEN SLAPS AND HISS
ROUTE F

LENGTH=3.4 MILES

- Route F - McDonnell Boulevard to Airport Road, Airport Road to Graham Road, Graham Road to Latty Avenue. This route is illustrated in Figure 2-10.

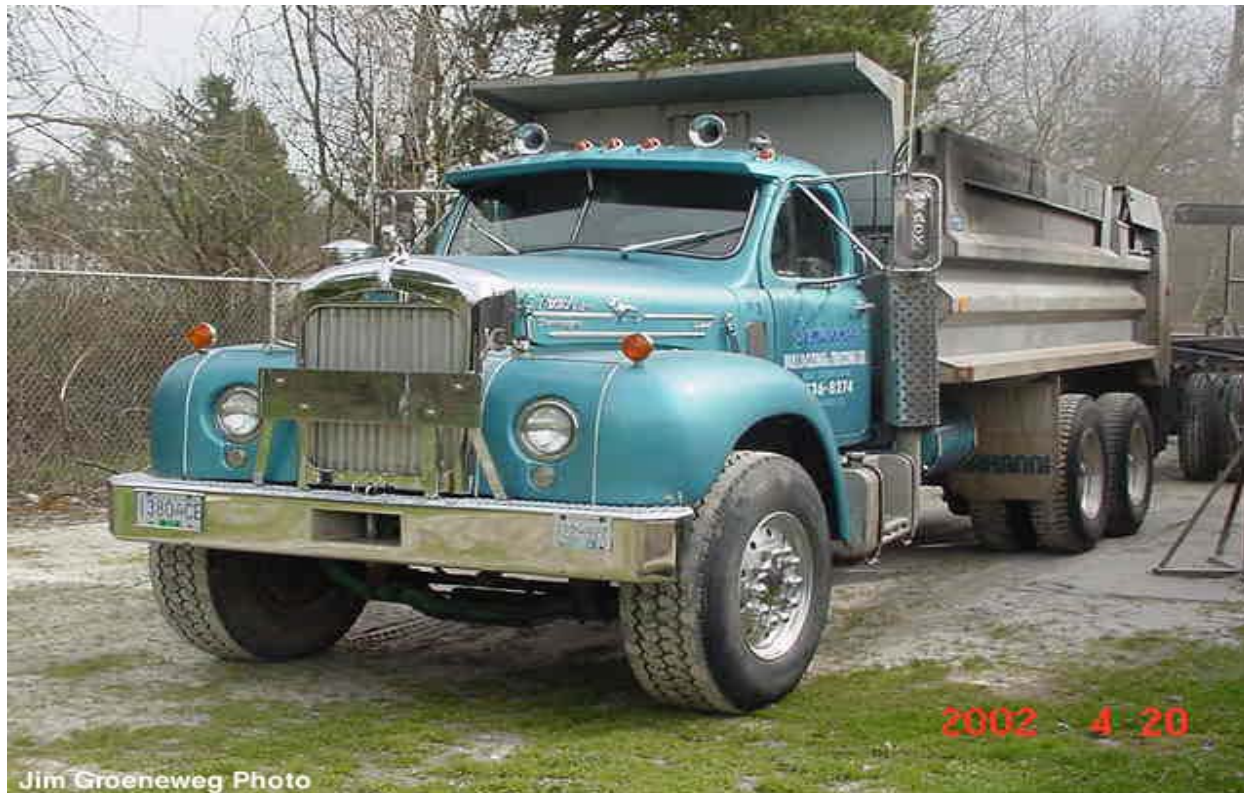
Typical 1960 20-Ton Over-the-Road Dump Truck

The information available indicates that the hauling of materials from the SLAPS to the HISS required 10 dump trucks for a period of five months. A typical 1960 era 20-ton dump truck is shown in Illustration 2.1 above. This type of truck has a bed capacity of 12 cubic yards. Dry loose earth has a typical weight of 2,000 pounds per cubic yard. Heavy wet mud has a typical weight of 3,000 pounds per cubic yard. Assuming a weight for the residue of 2,500 pounds and that each truck was loaded with 12 yards of material would mean that each truck load would carry about 15 tons of material. The trucks would need to be heaped to carry the 20 tons capacity. It is common practice for each truck to carry the maximum possible load. If the material were heaped it would increase the chance of dusting and spillage from the truck bed. To move the 120,000 tons of residue would have required between 6,000 and 8,000 trips.

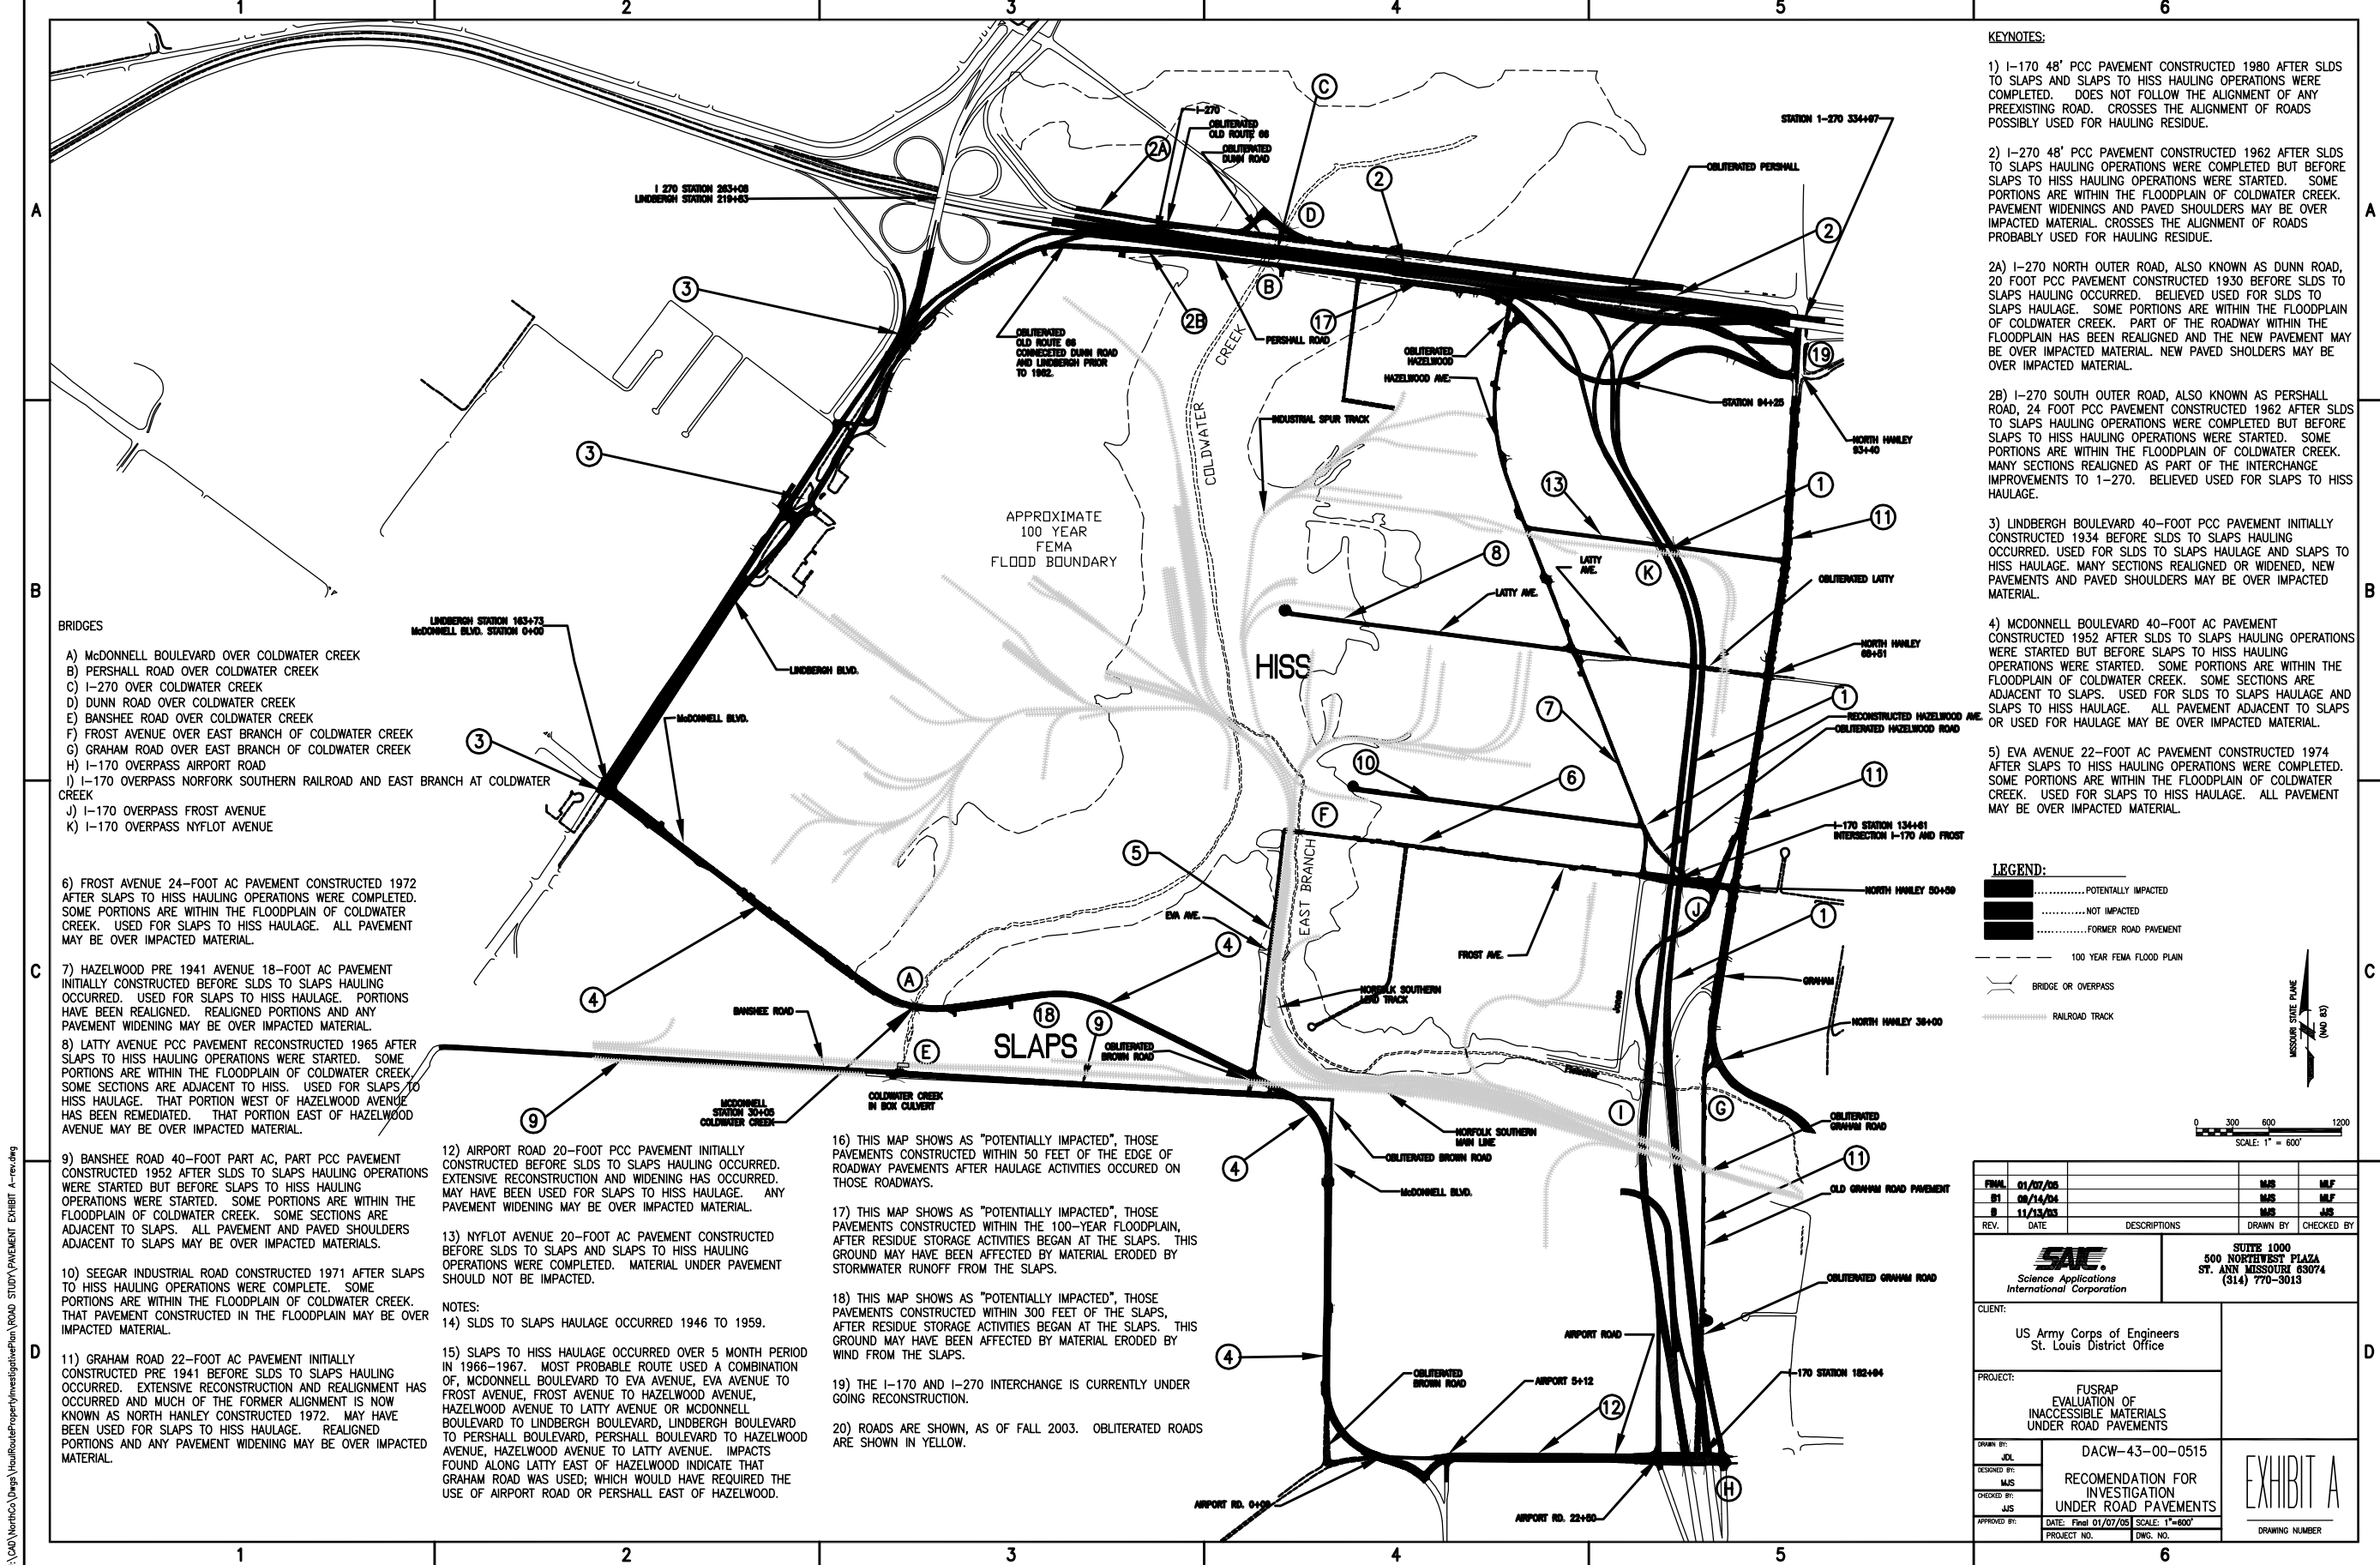
Investigation Under Road Pavements

- 1) I-170 48' PCC PAVEMENT CONSTRUCTED 1980 AFTER SLDS TO SLAPS AND SLAPS TO HISS HAULING OPERATIONS WERE COMPLETED. DOES NOT FOLLOW THE ALIGNMENT OF ANY PREEXISTING ROAD. CROSSES THE ALIGNMENT OF ROADS POSSIBLY USED FOR HAULING RESIDUE.
