ORNL/RASA-90/7

#### RESULTS OF MOBILE GAMMA SCANNING ACTIVITIES IN ST. LOUIS, MISSOURI

### RESULTS OF MOBILE GAMMA SCANNING ACTIVITIES IN ST. LOUIS, MISSOURI

Date published — June 1991

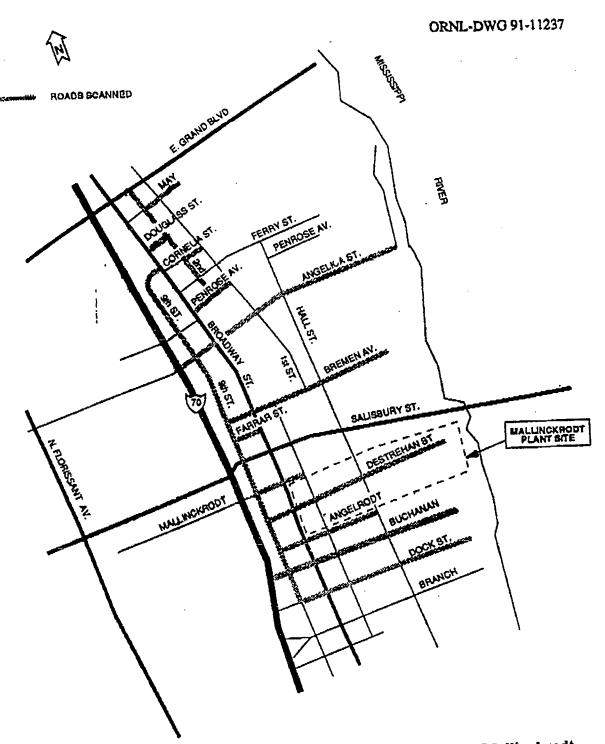
ORNL-DWG 91-11238

Fig. 2. Diagram of route scanned in the vicinity of the Mallinckrodt Chemical Plant site, St. Louis, Missouri.

The Mallinckrodt plants, vicinity properties, and some haul roads in St. Louis have been previously investigated under FUSRAP to determine the extent of on-site radiological contamination. Louis have been previously investigated under FUSRAP to determine the extent of on-site radiological contamination. Louis As a follow-up to earlier investigations and as a precaution to insure that no residual radioactive materials were conveyed to other off-site areas, DOE requested that ORNL conduct an additional survey in the vicinity of the SLAPS and the Mallinckrodt plant (Fig. 1). The survey was restricted to public roadways and to suspected haul routes used when wastes were transferred from the Hazelwood Interim Storage Site (HISS) at 9200 Latty Avenue to West Lake Landfill, and from the Mallinckrodt Plant to the SLAPS. Public roadways and accessible commercial parking areas surrounding the Mallinckrodt site within approximately one-half mile and railroad crossings on the appropriate roads were also scanned (Fig. 2). The purpose of the survey was to assess whether

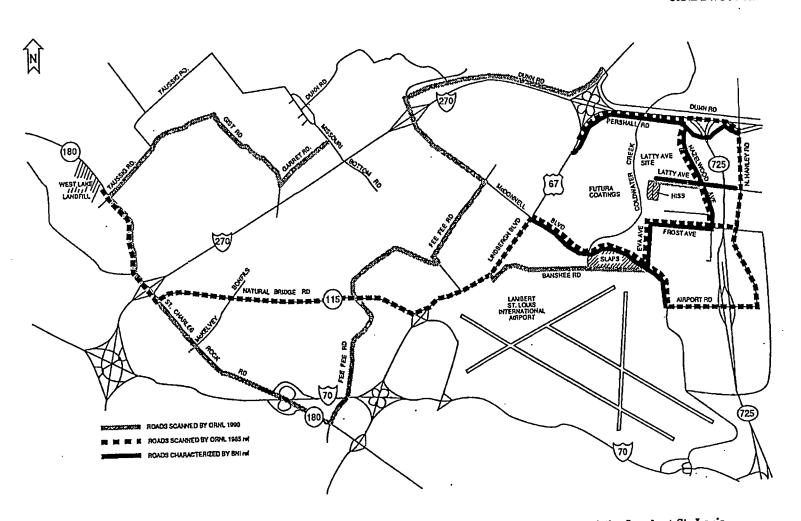
Fig. 3. Diagram of routes scanned by ORNL and routes characterized by BNI in the vicinity of the Lambert-St. Louis International Airport, St. Louis, Missouri.

any residual radioactive material could be detected along any of the routes. Although several haul routes near the airport storage sites were previously surveyed with the mobile gamma scanning van, selected intersections and/or roads near the airport radioactive storage site were also investigated during this survey. The survey was conducted May 15–17, 1990. Figure 3 shows the haul routes investigated by ORNL in 1990 and 1985, and diagrams the roads characterized by Bechtel National, Inc. (BNI) in 1990.
