RE:    Roof Replacement at 9150 Latty Ave in Hazelwood, Missouri

9150 Latty Avenue  
Roof Replacement Photographs

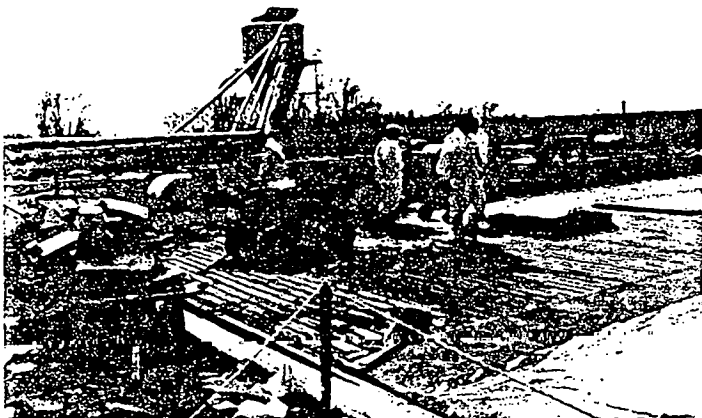
Photo 4:

Taken on April 15, 2002. The carts used to haul the contaminated roofing materials to the roof edge are prone to spillage. This is not a big concern as long as the debris and dust does not become windborne and is only spilled on areas to be removed or cleaned up.

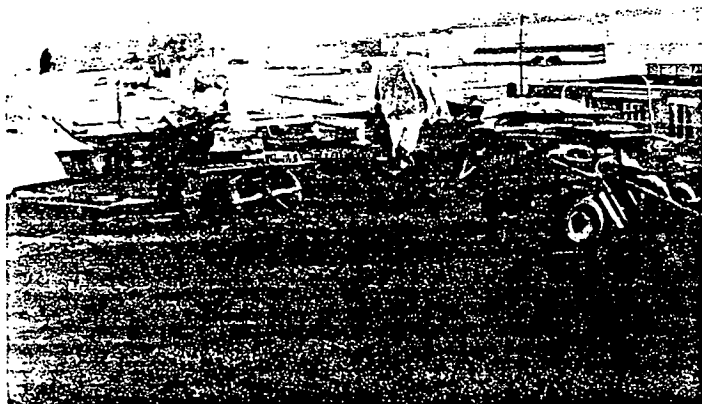
Photo 5:

Taken on Oct. 22, 2002. The areas of the roof that are used to cart the contaminated debris is not roped off and distinguished as being radioactively contaminated. The workers wear protective shoe covers while tearing off the old roofing material. However, workers and visitors must walk across the cart transportation area (that is contaminated) in order to exit the roof. This practice causes a potential
