ST. LOUIS FUSRAP OVERSIGHT COMMITTEE
c/o 111 So. Meramec
Clayton, MO 63105
314-615-1635

***Summary of Meeting
September 10, 1999***

FUSRAP St. Louis Sites Photo Album

Federal Facilities Section FUSRAP/SLAPS Field Report

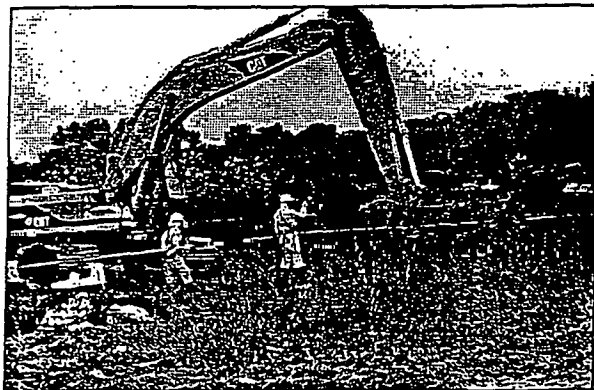
Radium Pit sampling was performed Sept. 8, 1999 using a teletector, the instrument shown below. Sampling data will be available next month.

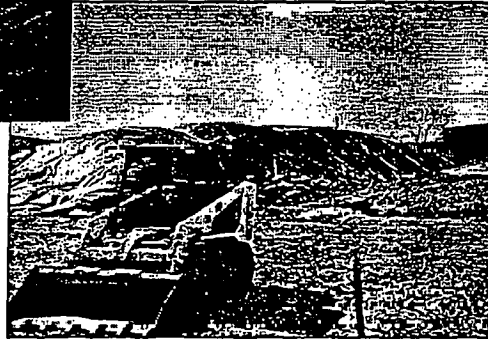
The spoil piles from the construction of the HISS railspur were covered with tarps until they could be removed later this year. However, spring storms made the slopes geologically unstable and created a potential health and safety risk. The back spoil pile is shown above (facing south toward the existing railline.) Shown at right is the front spoil pile, located between supplementary and main storage piles, is shown (facing southwest).

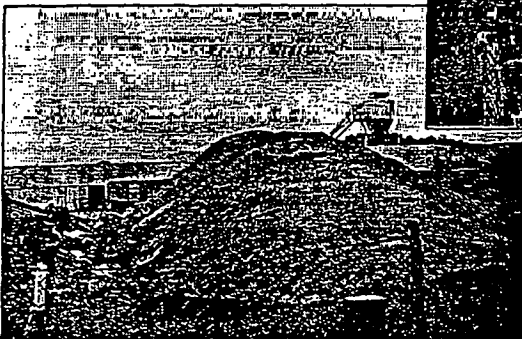
To eliminate potential health and safety concerns, the spoils piles were covered with ContCover®. The gray coating is expected to last until the piles can be removed this fall by the small business contractor. Below is a photo of the front spoil pile (facing west). To the right is a photo of the back spoil pile (facing north).

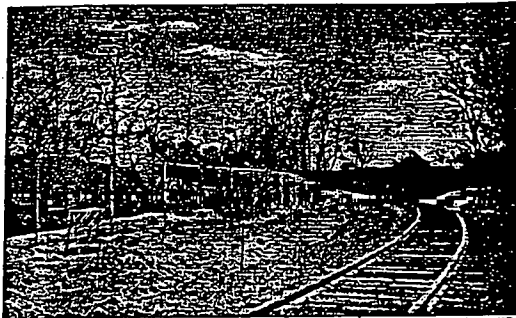
Photos of the completed railspur facing southward. Once the 8(a) contractor is mobilized, the spoils piles will be removed first then the East Pile. The back spoil pile can be seen in the distance in the photo below while the East Pile can be seen in the photo to the left.

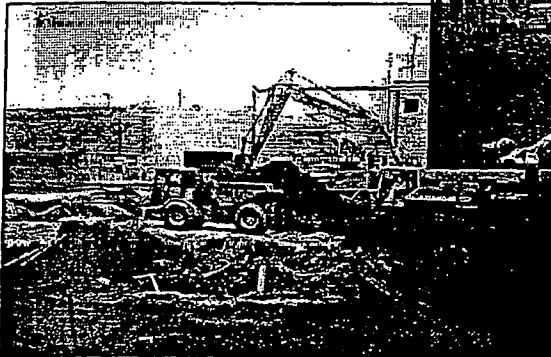
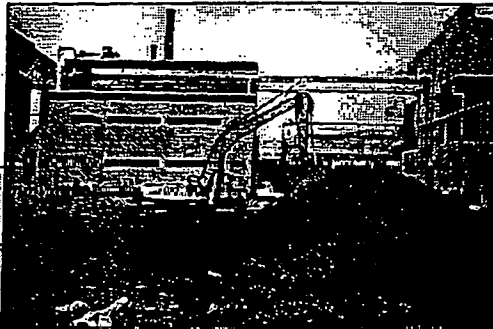
IT Corp. has removed 6,640 cubic yards so far. Work was placed on hold when an ordinance was discovered in a stockpile of excavated soil. Excavation will resume once Ordinance Construction Support Plans are in place.

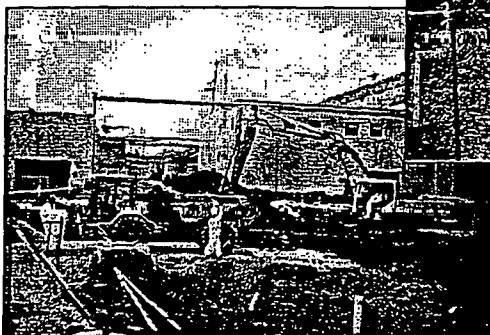
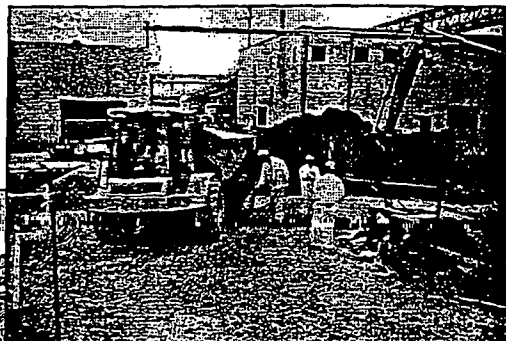
Before leaving the Plant 2 area with a load of material, the tires and the sides of the Hydrema Haulers are cleaned and surveyed to maintain health and safety and to prevent the spread of radiological contamination to other areas.

The Ordinance Construction Support Plans will establish safeguards for worker protection. Magnetometer surveys, explosive experts and trained observers will guide future excavation in Plant 2.
