**REMEDIAL INVESTIGATION AND
BASELINE RISK ASSESSMENT REPORT
FOR THE INACCESSIBLE SOIL
OPERABLE UNIT AT THE
ST. LOUIS DOWNTOWN SITE**

NOVEMBER 10, 2011

**U.S. Army Corps of Engineers
St. Louis District Office
Formerly Utilized Sites Remedial Action Program**

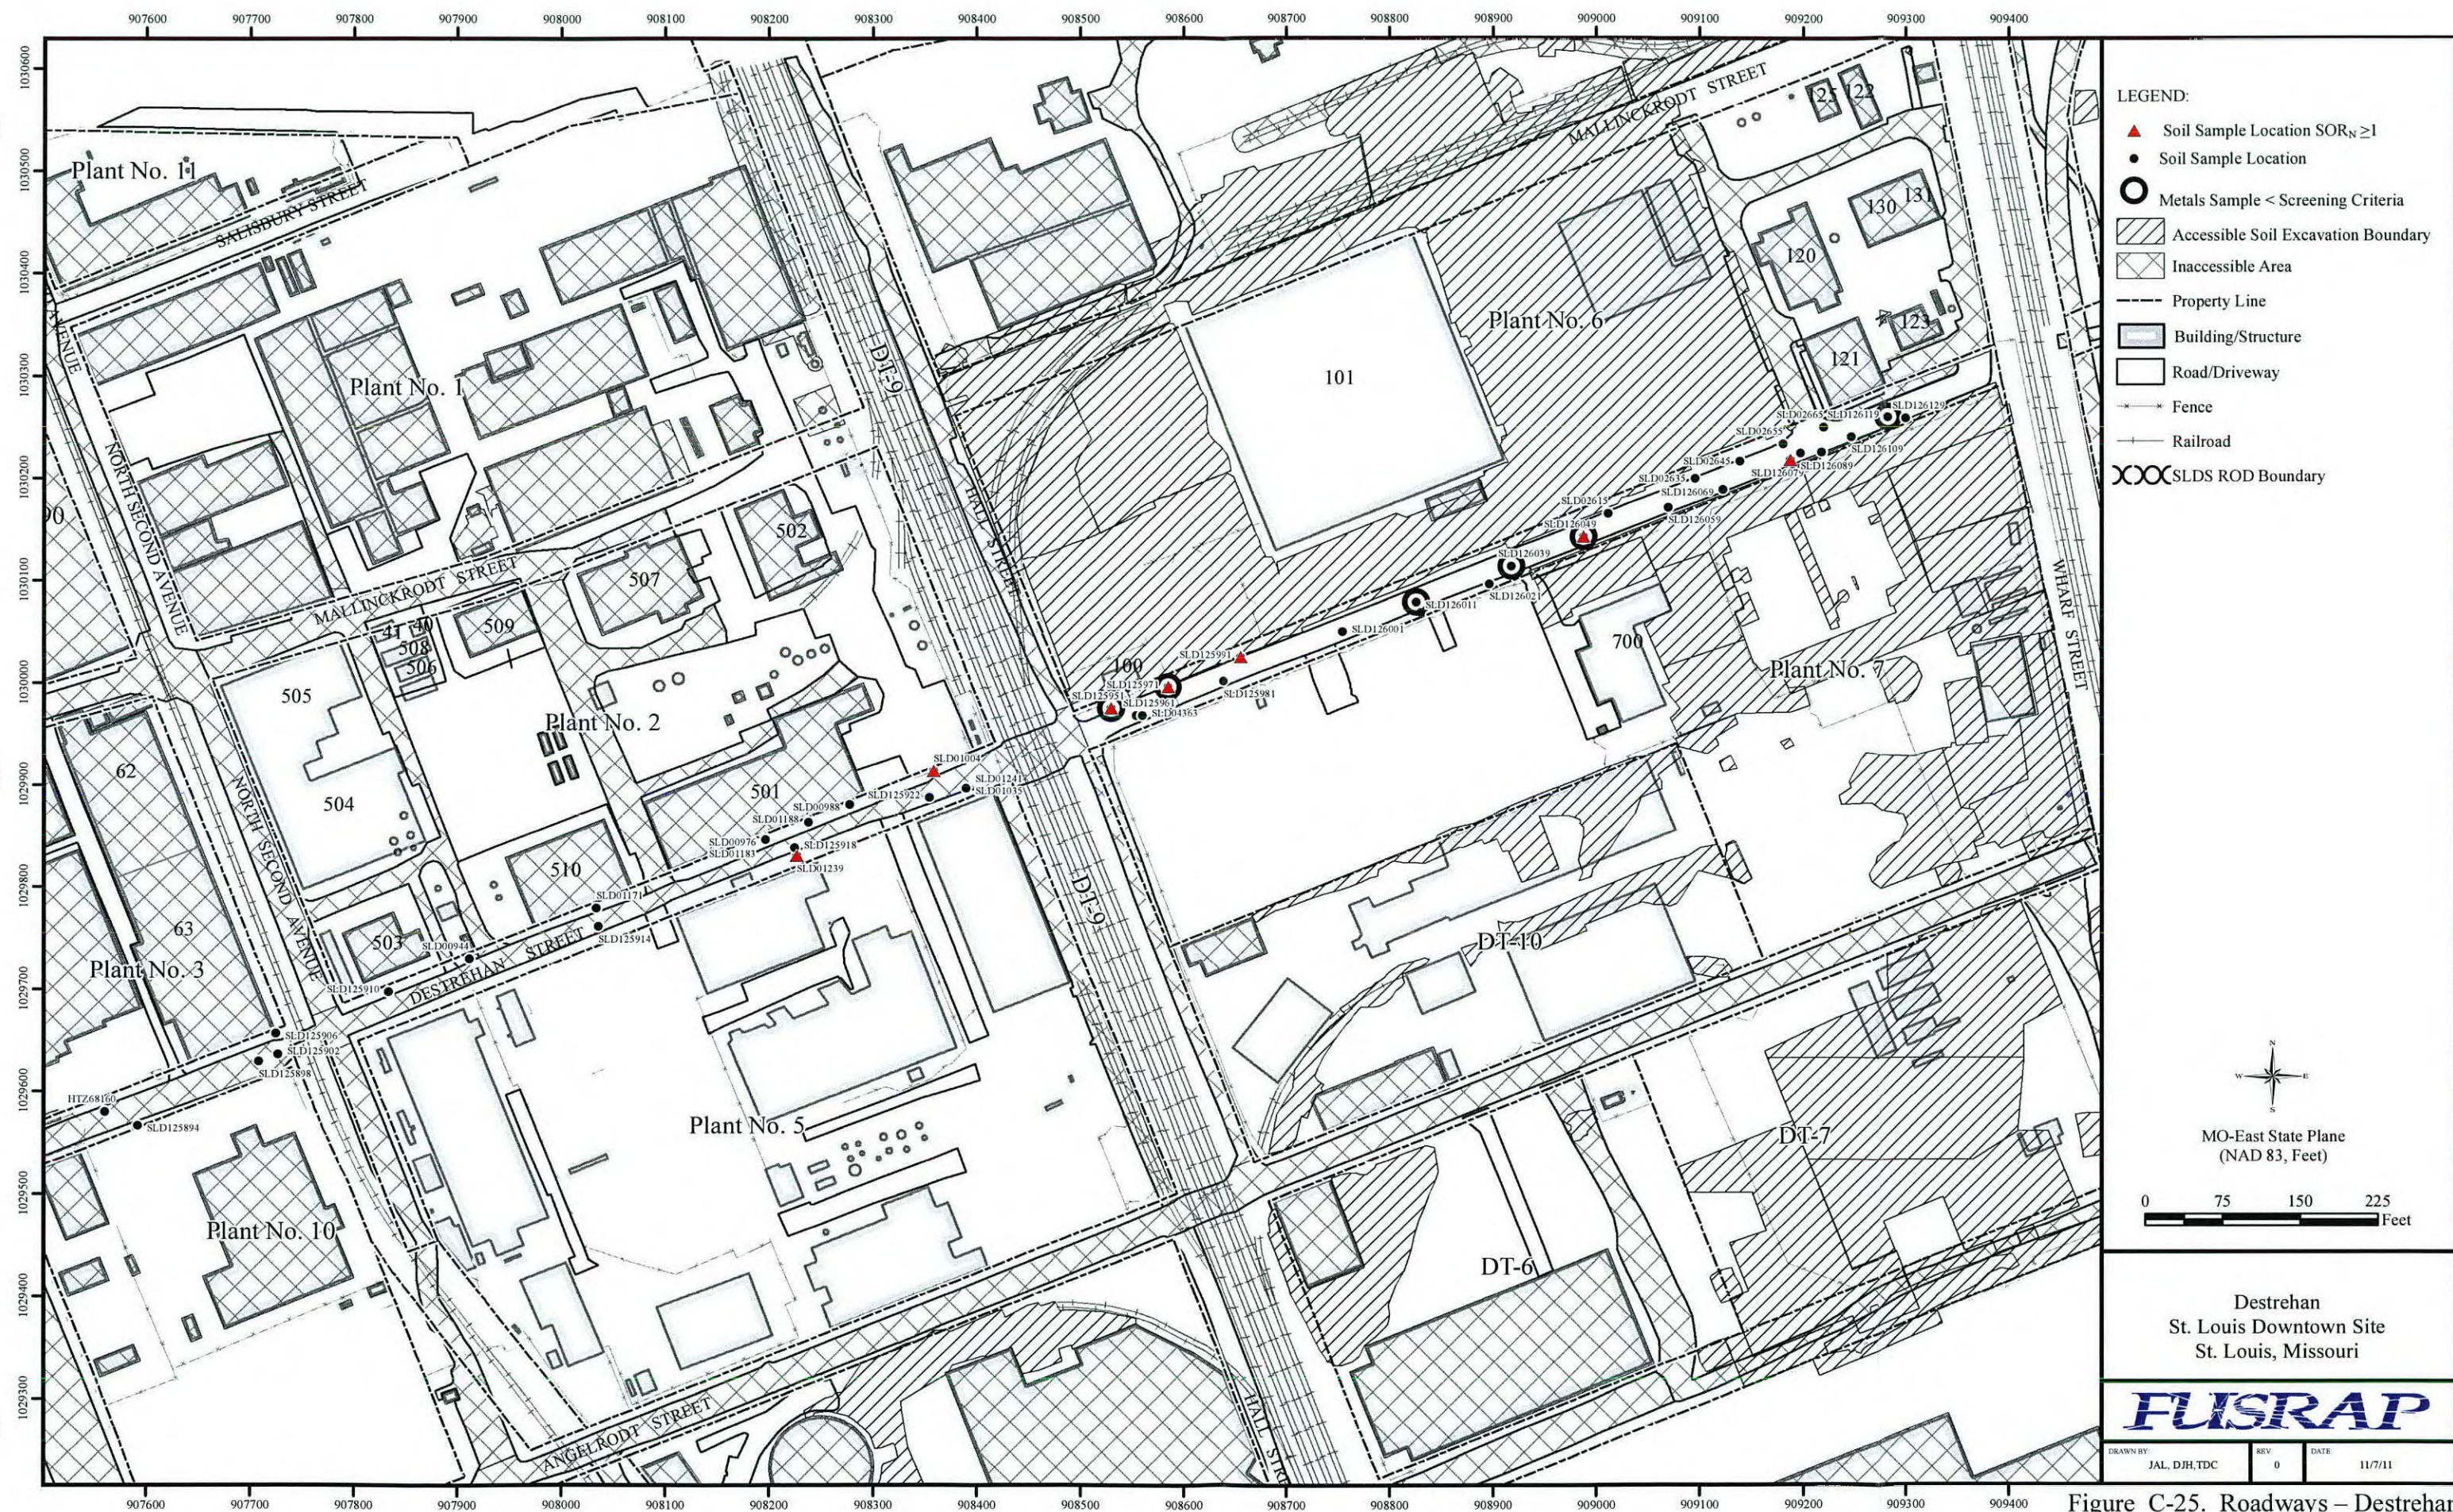
Figure C-24. Roadways – Mallickrodt Street
Soil Sampling Locations

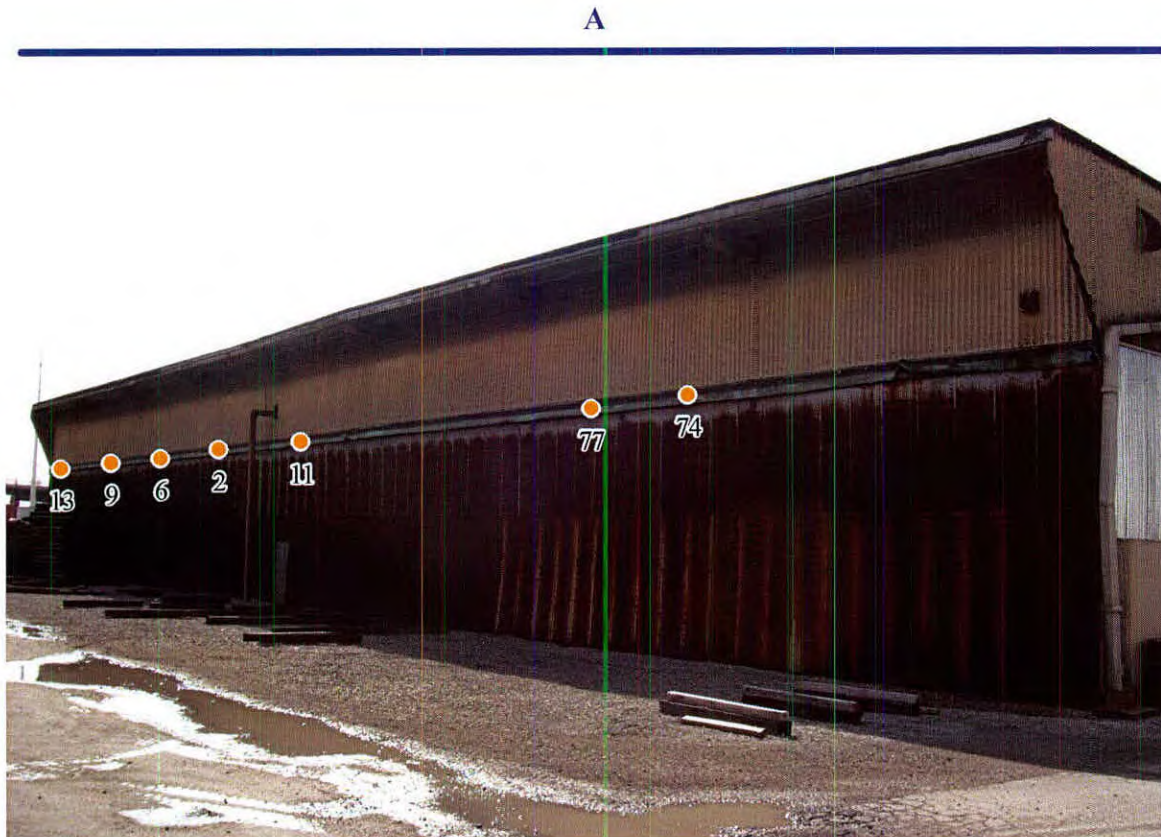
● Elevated measurement above alpha limit of 3900 dpm/100cm².

Surface Measurement Results
(dpm/100cm²)

#02: 17,752	#13: 16,792
#06: 18,728	#74: 22,476
#09: 16,259	#77: 19,196
#11: 15,863

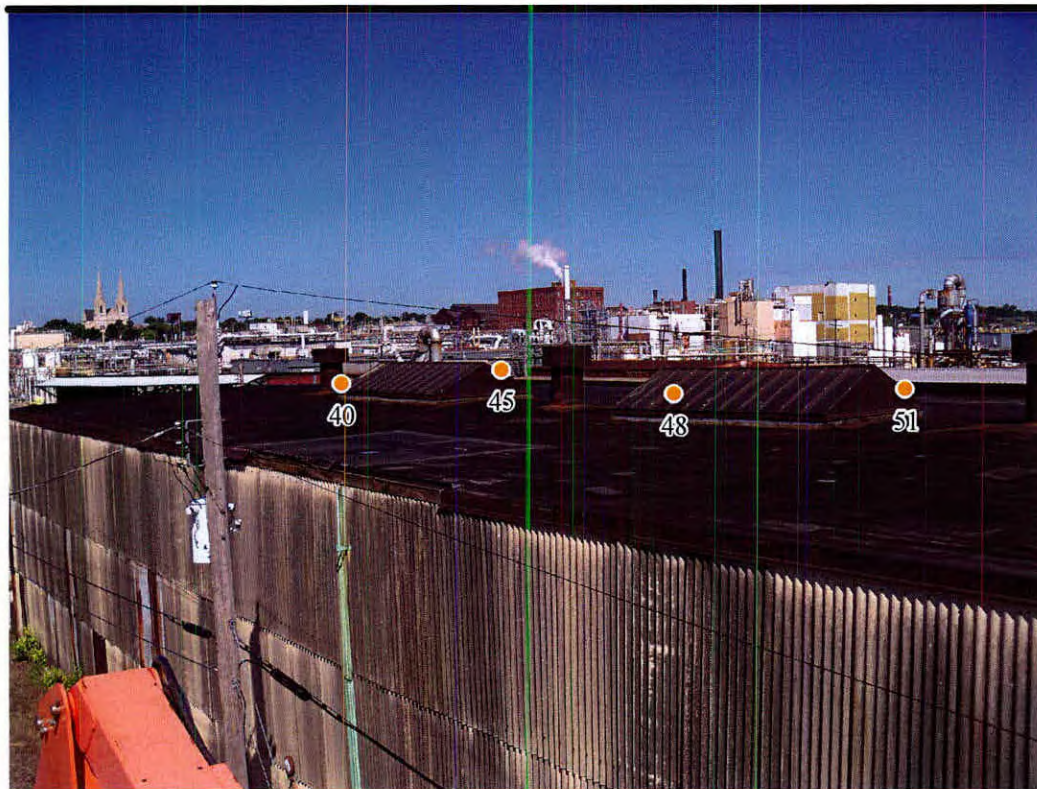
- Elevated measurement above alpha limit of 3900 dpm/100cm².

Surface Measurement Results (dpm/100cm ²)	
#40: 5,831	#48: 6,121
#45: 5,557	#51: 5,709
