APPENDIX R

Ecological Checklist for the SLDS ISOU

Checklist for Ecological Assessment/Sampling

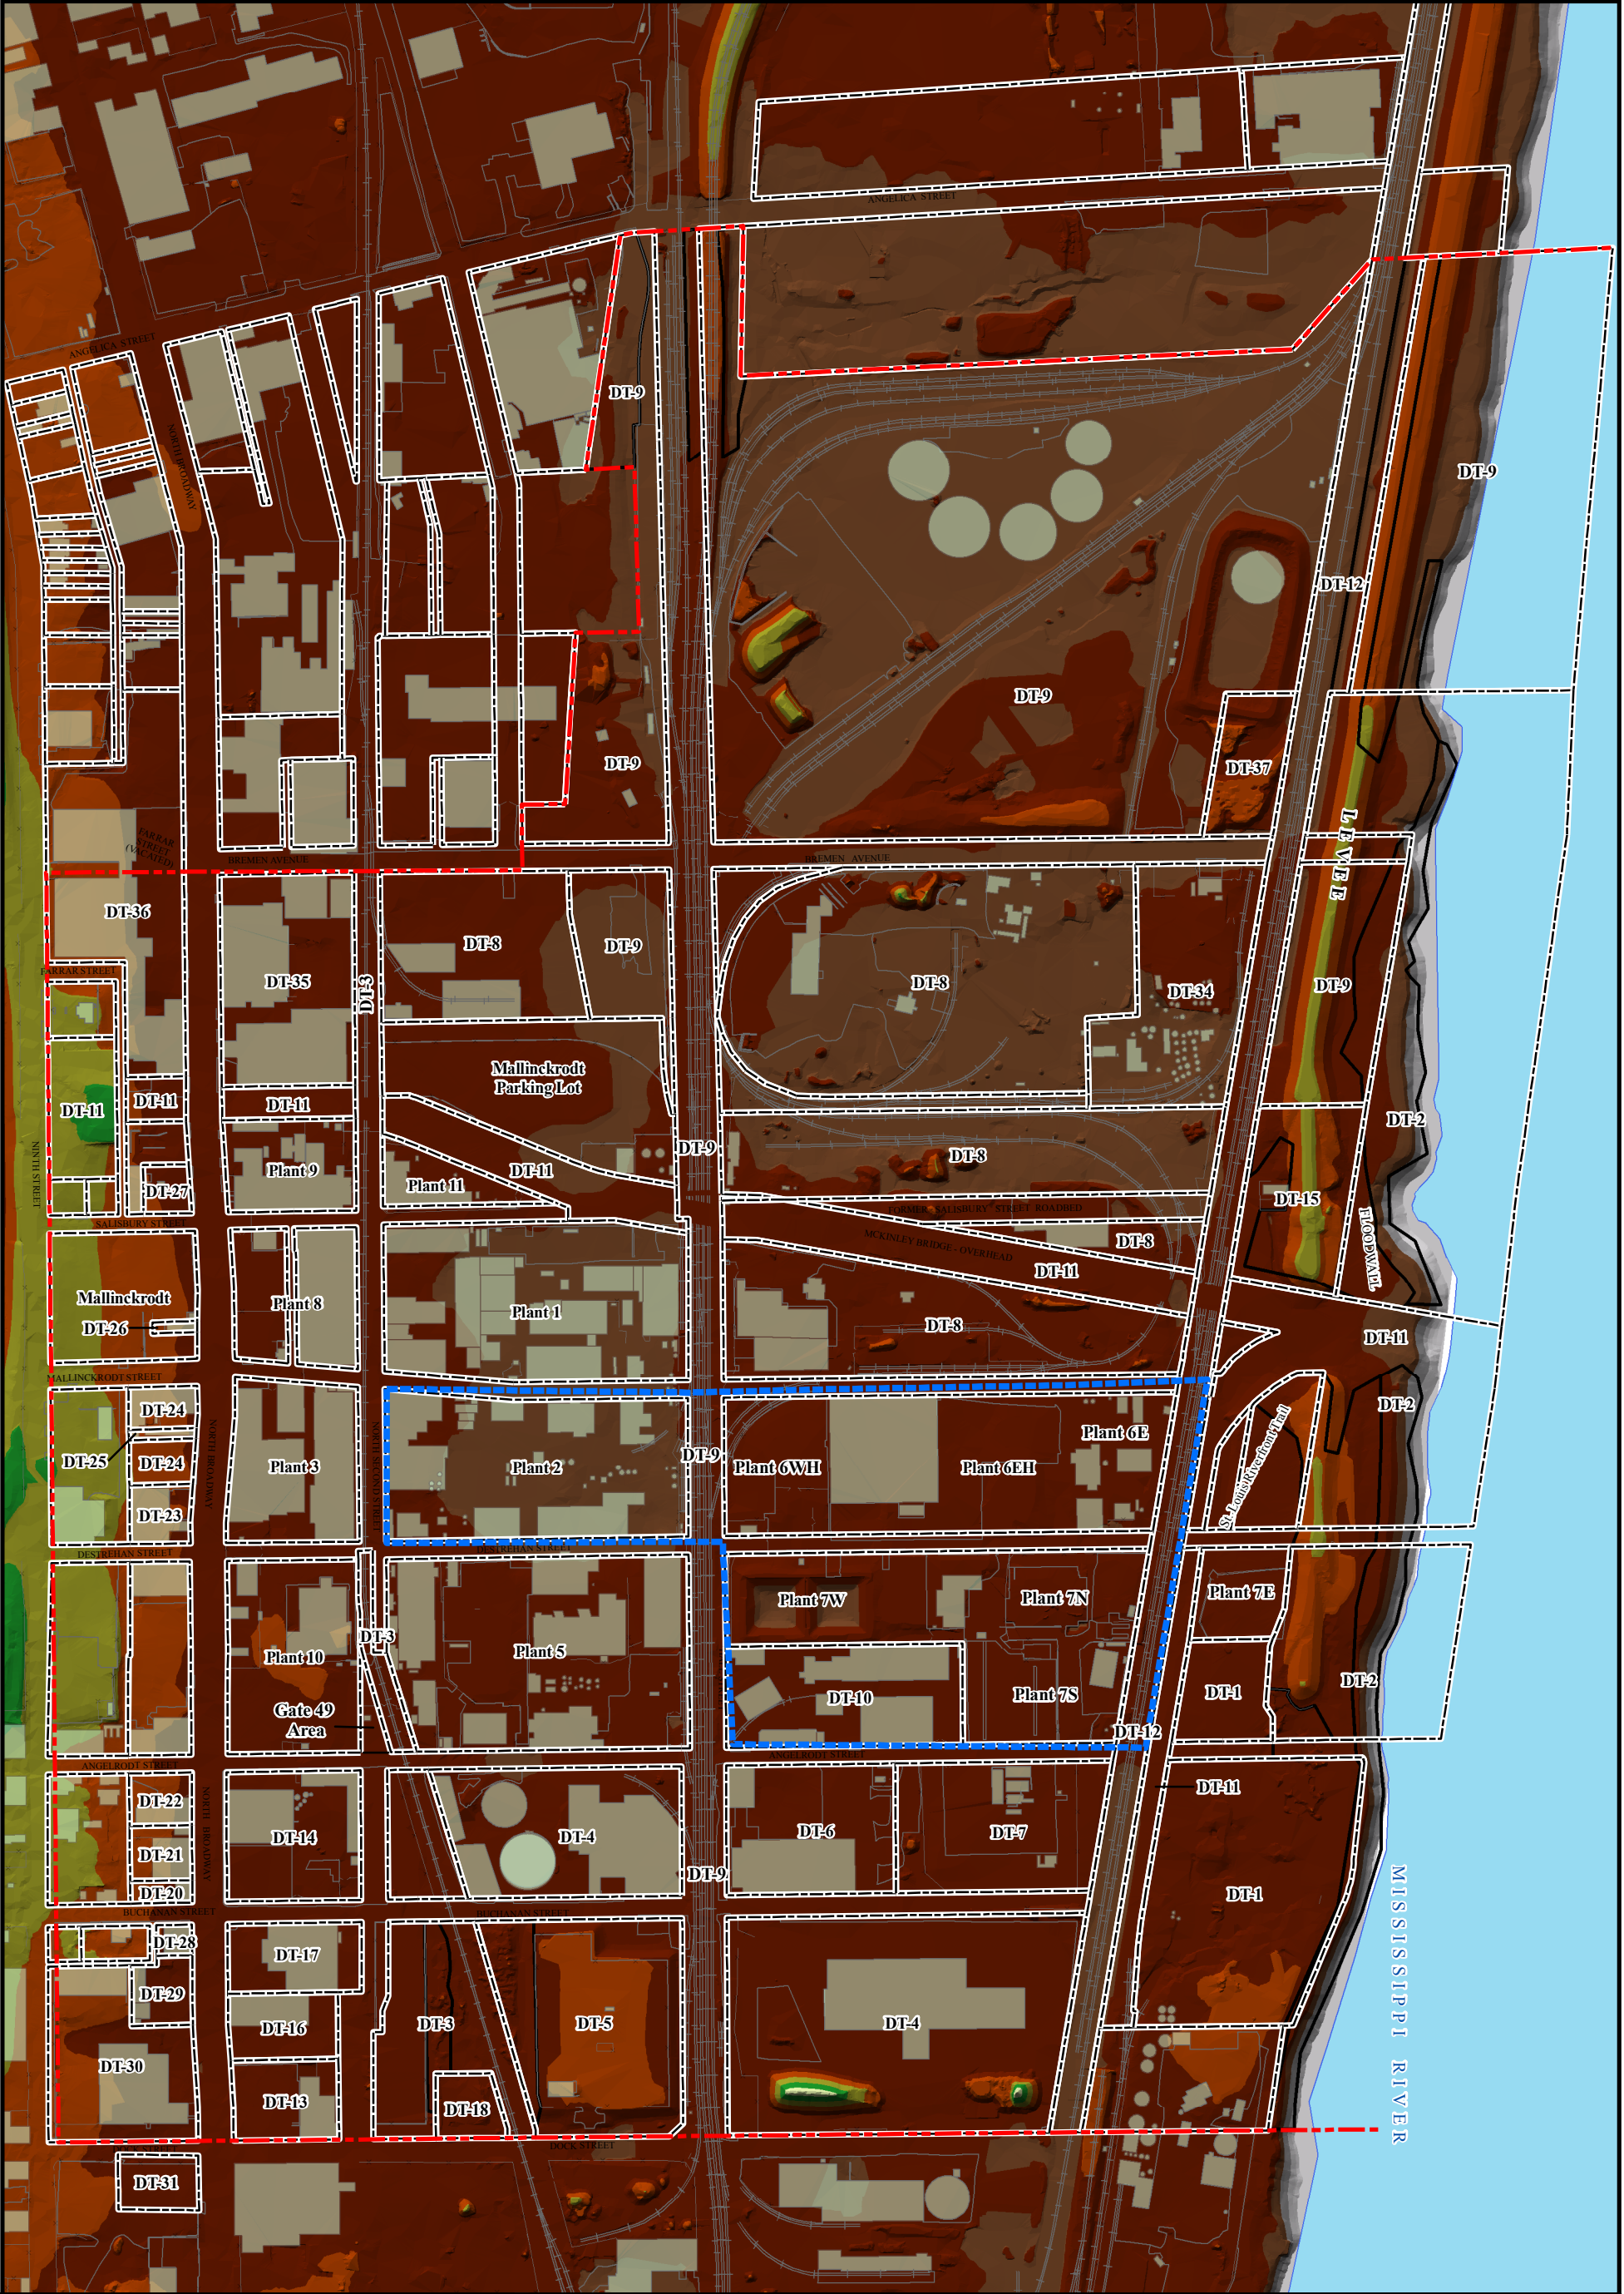
R-1. Topographic Map

- Site Name:** Inaccessible Soil Operable Unit (ISOU) at the St. Louis Downtown Site (SLDS)
U.S. EPA ID Number: MOD980633176
Location: Site is roughly bounded by Dock Street, Ninth Street, Angelica Street, and the Mississippi River.
County: NA **City:** St. Louis **State:** Missouri
- Latitude:** 38-39-44 N **Longitude:** 90-11-21 W
- Attach site maps, including a topographical map, a diagram which illustrates the layout of the facility (e.g. site boundaries, structures, etc.), and maps showing all habitat areas identified in Section III of the checklist. Also, include maps which illustrate known and suspected release area, sampling location and any other important features, if available.** See Figures R-1,R-2, and R-3.

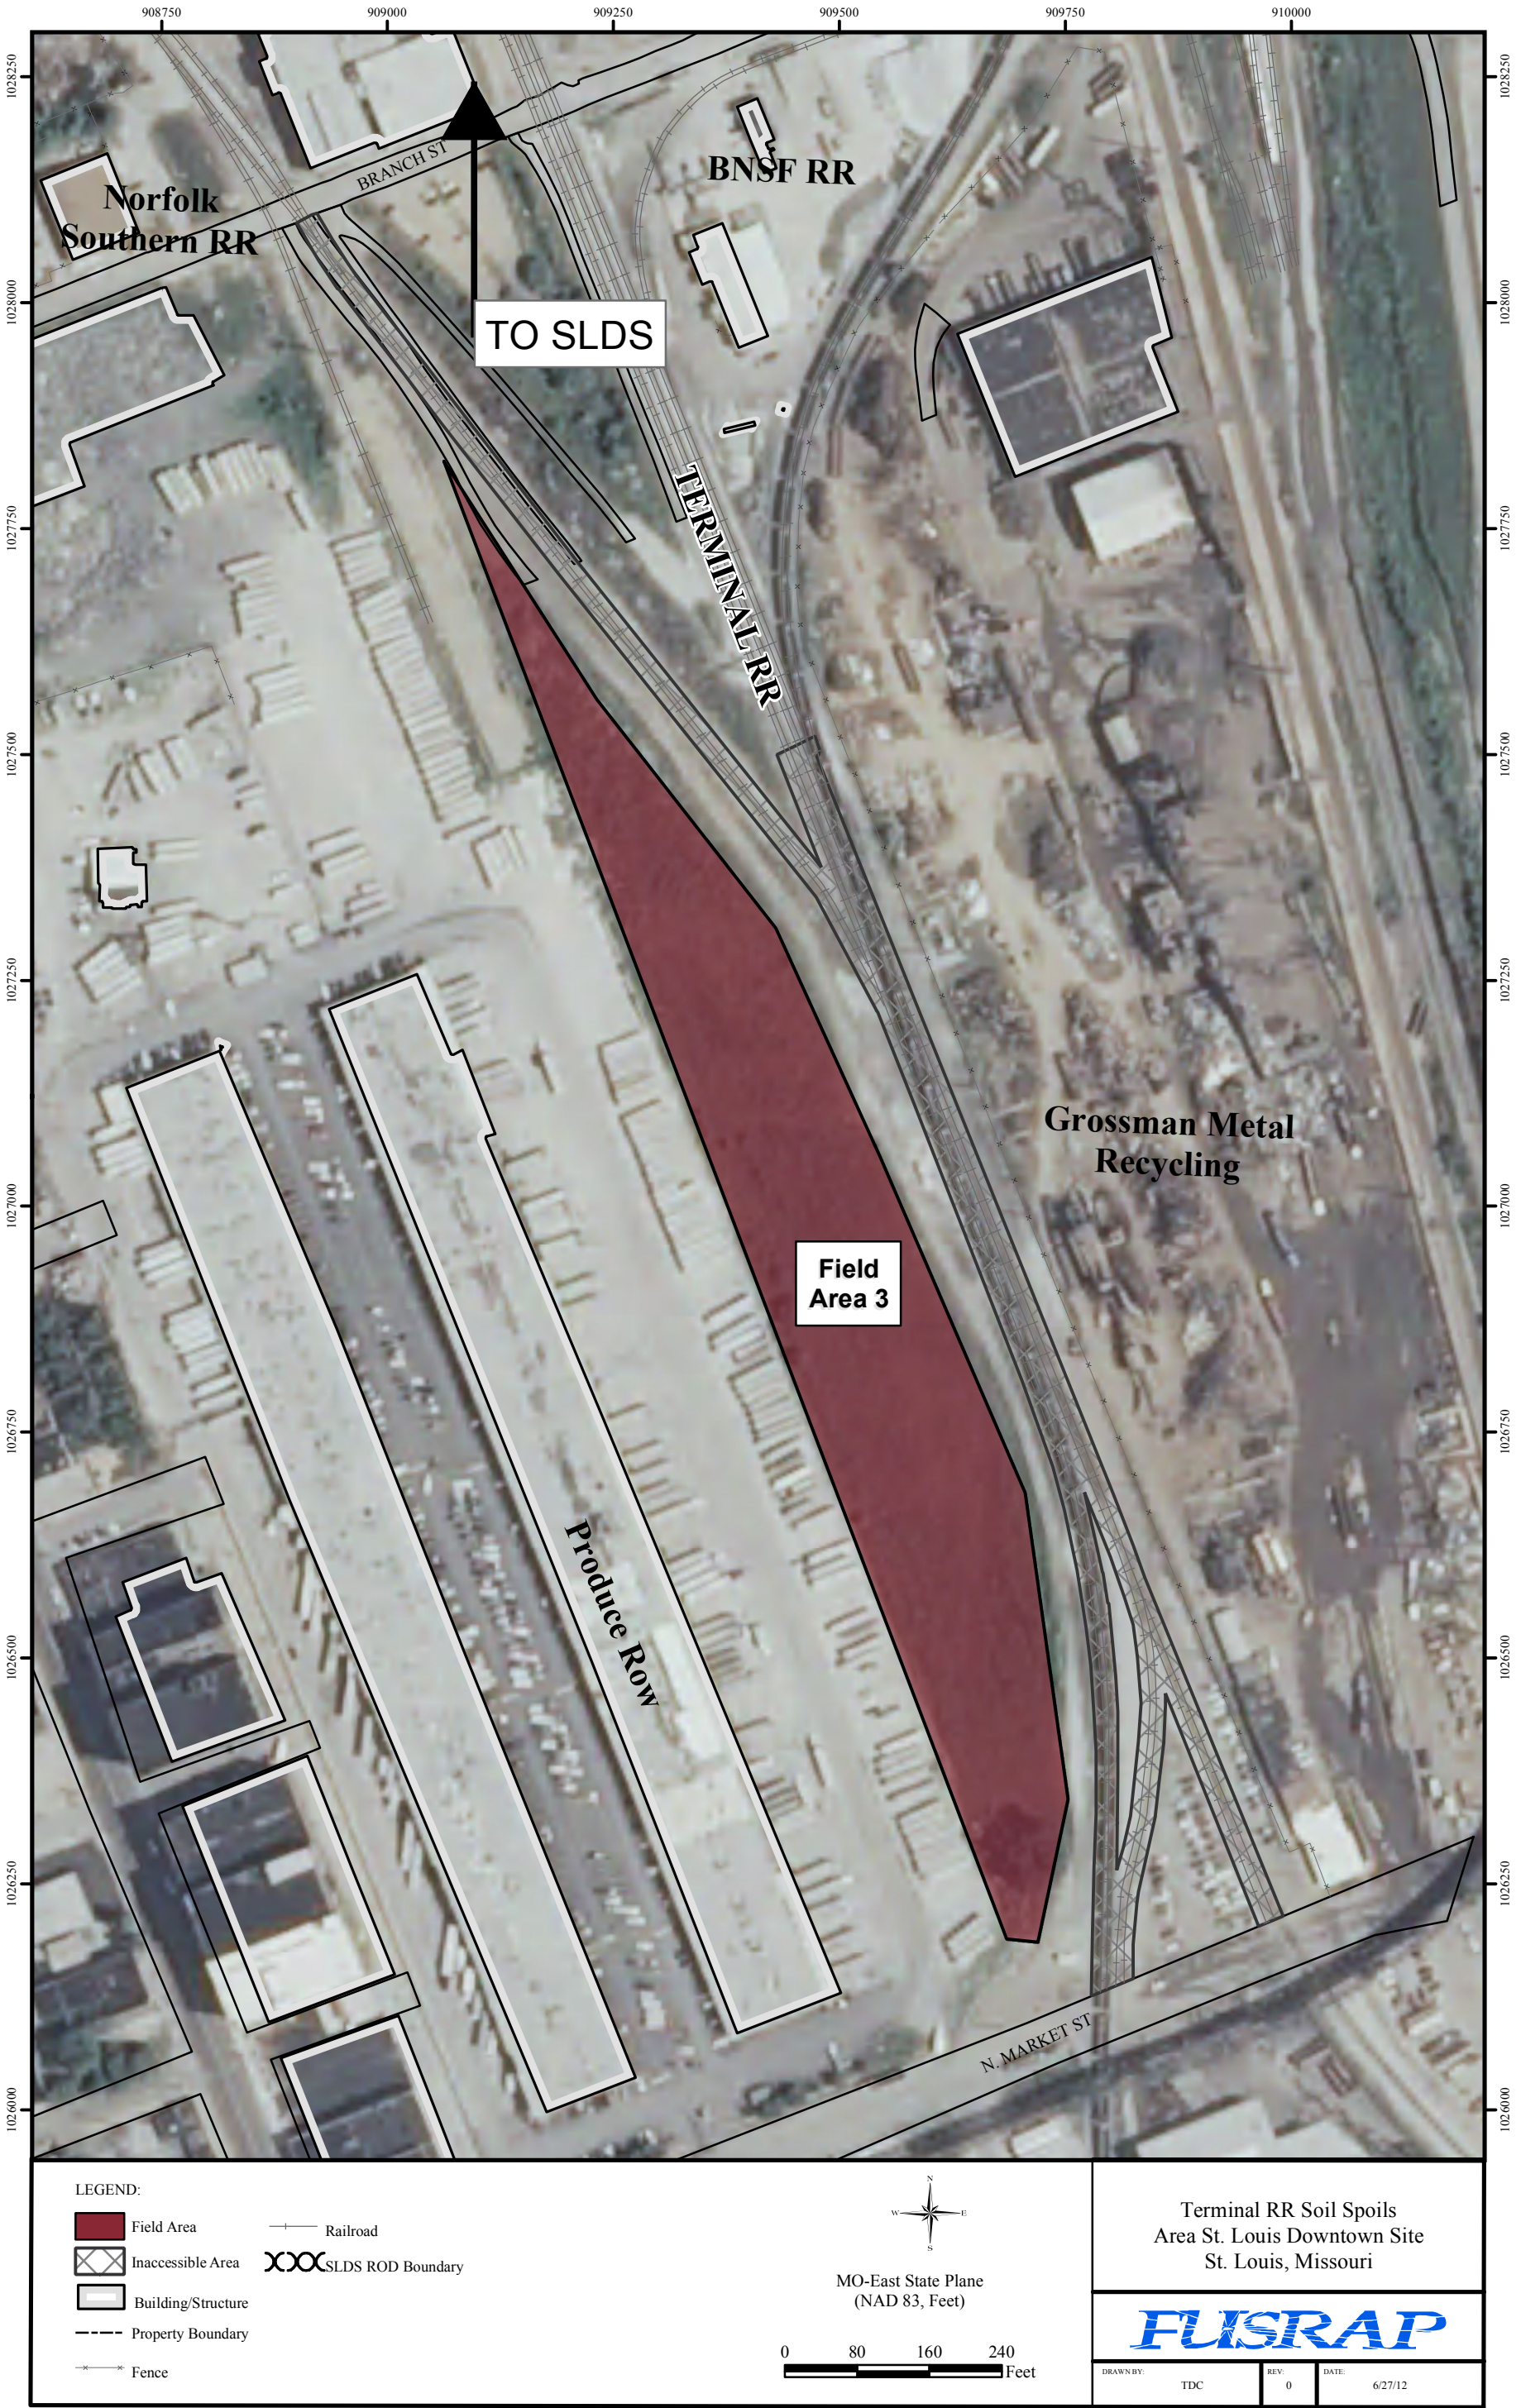
Figure R-3. Terminal RR Soil Spoils Area

Name or Designation: Wooded Area 3 (DT-9); Figure R-3, Photographs 9-12

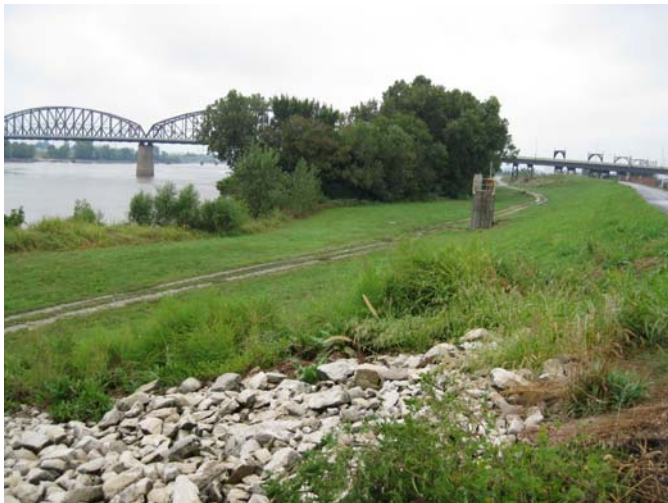
Photo 1. View looking south at the northern edge of the wooded area. McKinley Bridge is visible in the background.

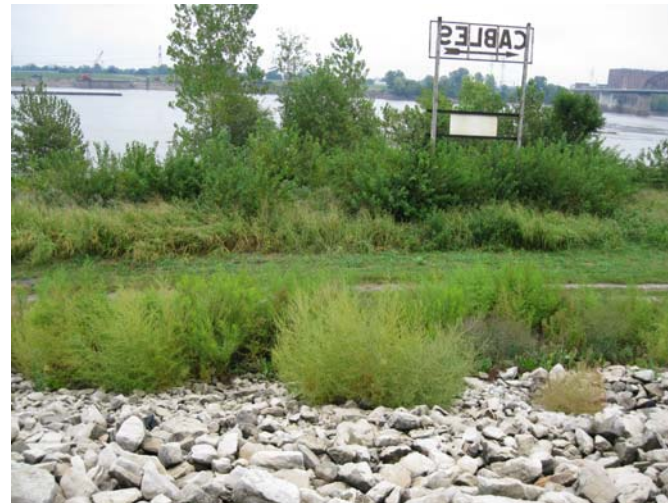
Photo 2. View facing east from the top of the levee at wooded area 1 and field area 1.

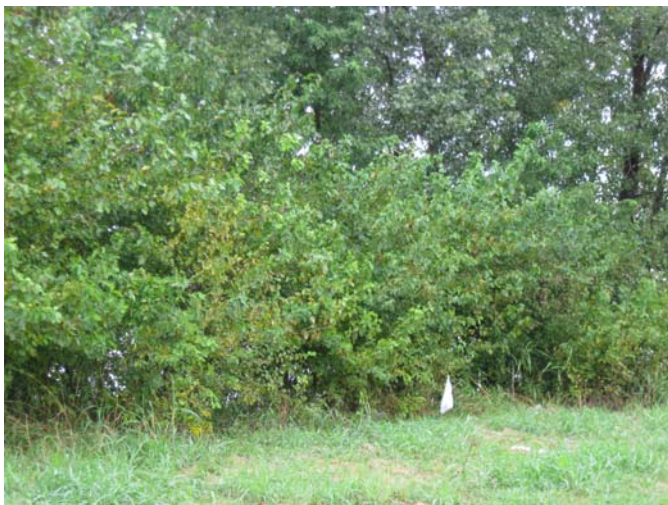
Photo 3. View of wooded area facing southeast.

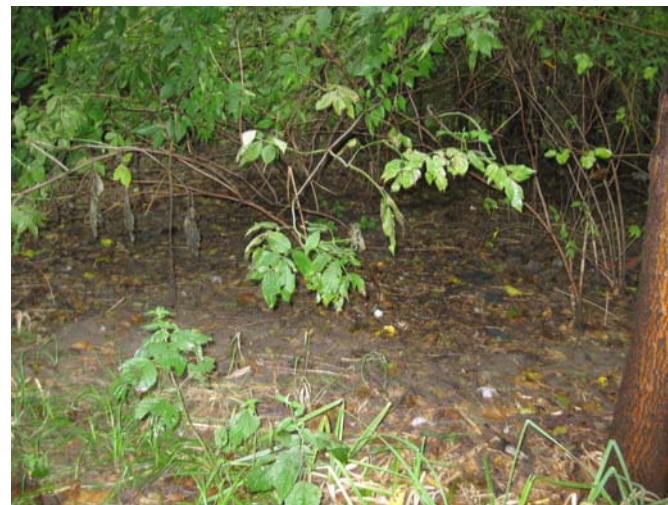
Honeysuckle was the only understory species present. The following species were present in the unmowed areas adjacent to the woods: Johnson grass, foxtail (*Setaria glauca*), goldenrod (*Solidago* sp.), late-flowering thoroughwort (*Eupatorium serotinum*), elderberry (*Sambucus canadensis*).

Photo 4. View of understory within the wooded area.

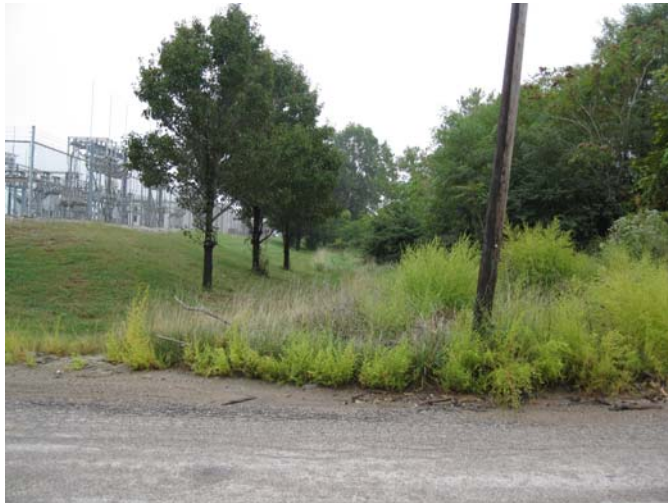
Photo 5. View facing southeast at the edge of the Ameren UE substation. Bradford pears are located to the left with the wooded area to the right. Ragweed and late-flowering thoroughwort are visible in the foreground.

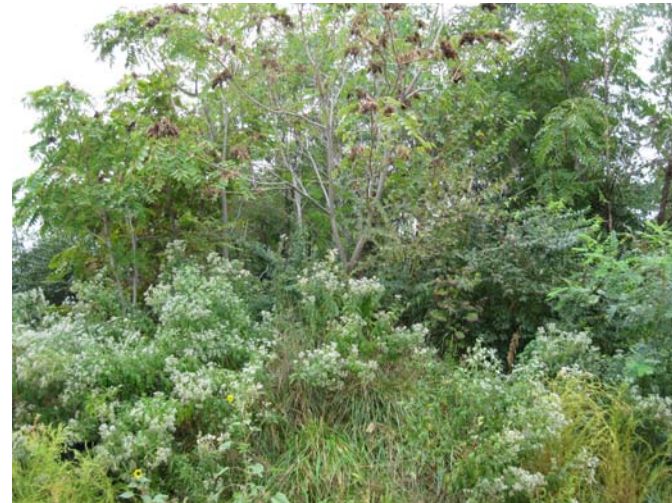
Photo 6. View of wooded area from the railroad tracks. Tree of heaven and late-flowering thoroughwort are the most visible species. Goldenrod and honeysuckle are also present at this location.

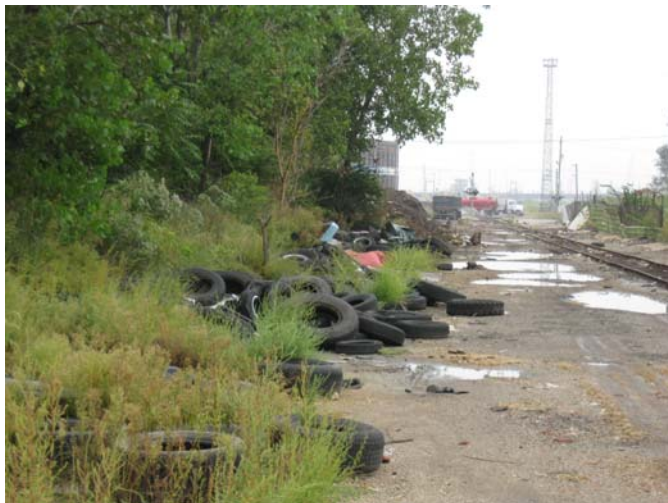
Photo 7. View southeast along the southwest edge of Wooded Area 2.

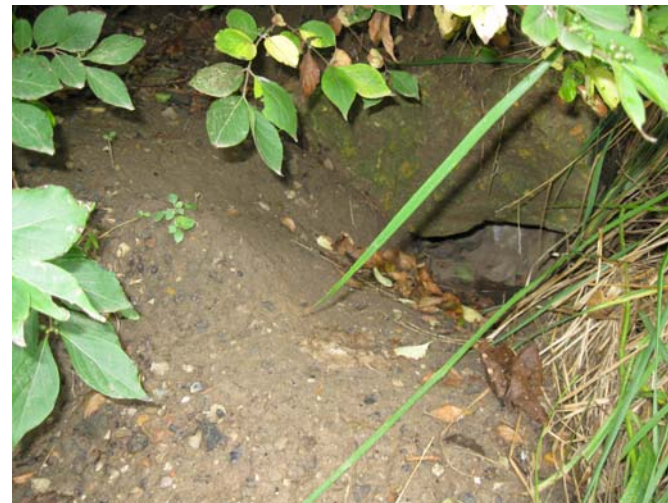
Photo 8. Groundhog den within Wooded Area 2.

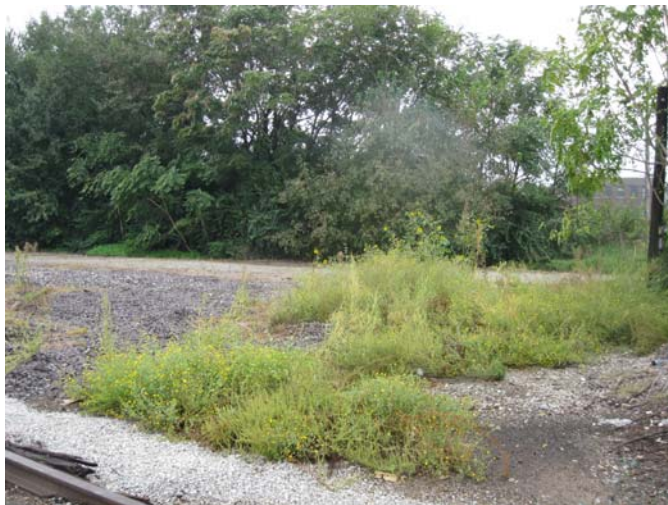
Photo 9. View from the intersection of Angelica railroad crossing. View is facing southwest at woodland on the southwest edge of the railroad tracks.

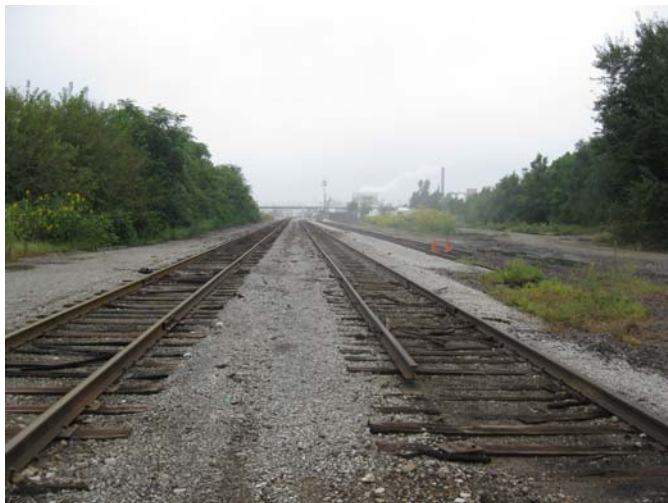
Photo 11. View facing southeast with both strips of woods visible at the edge of the photographs.

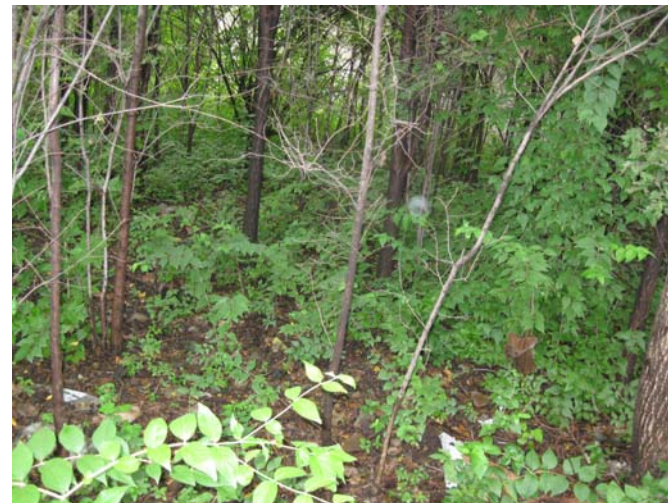
The understory was limited to Amur honeysuckle. Some scattered camphorweed (*Heterotheca subaxillaris*) and annual sunflower (*Helianthus annuus*), as well as a few large clusters of Johnson grass, were present in the gravel area adjacent to the woods.

Photo 12. View of honeysuckle understory.

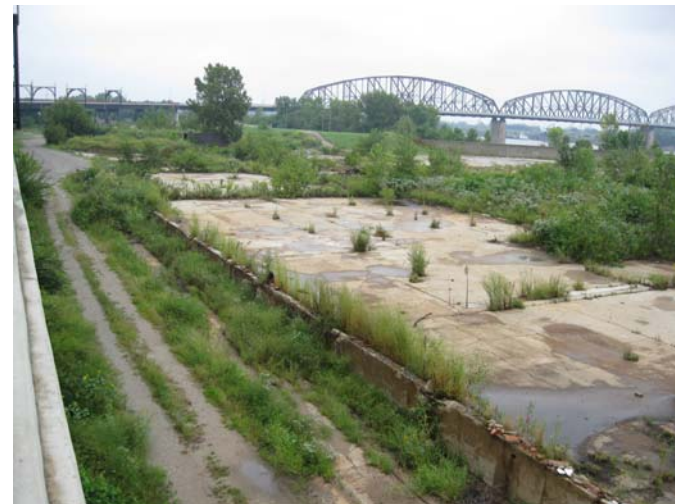
Photo 20. View facing north northeast.

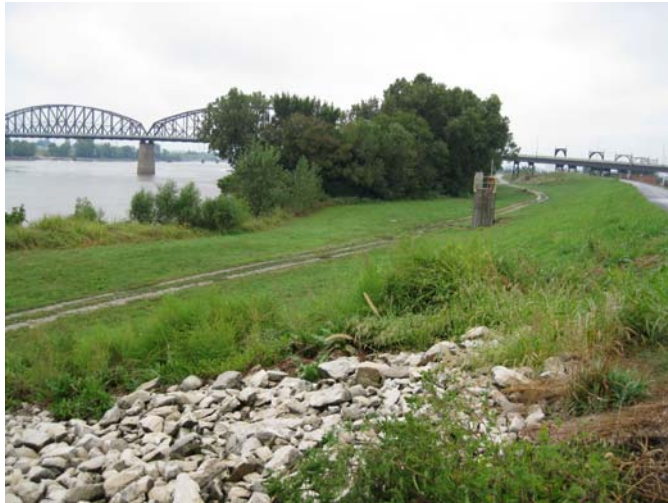
Photo 21. View looking south along the levee. Photograph was taken near the northern boundary of the site. McKinley Bridge is visible in the background.

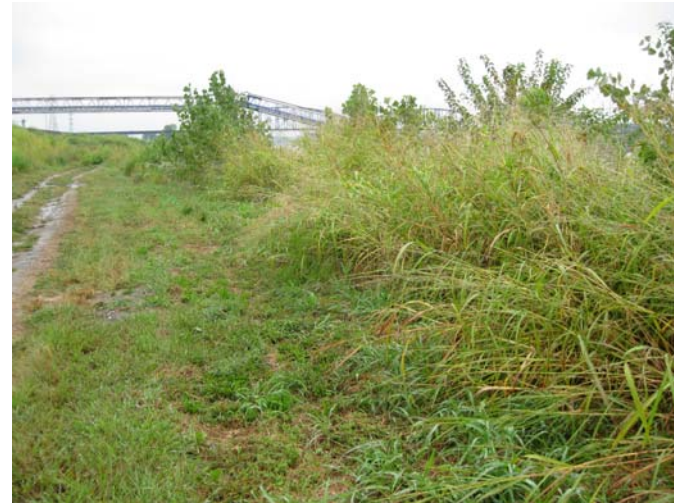
Photo 22. View facing north at the toe of the levee. Photograph shows Johnson grass to the right with several cottonwoods visible in the background.

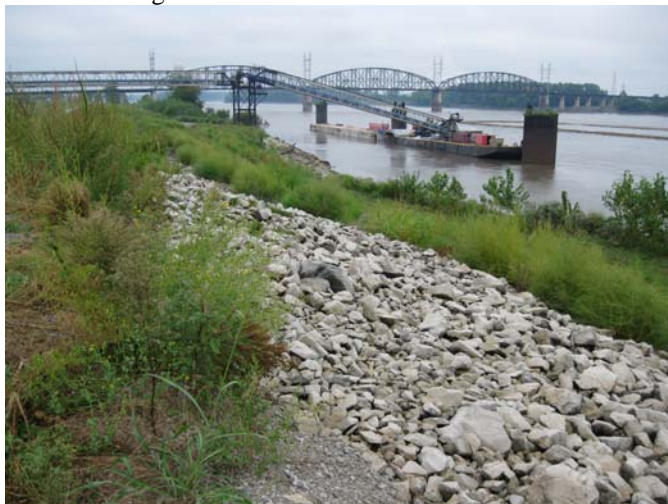
Photo 23. View facing north from the top of the levee. Johnson grass, ragweed, wormwood species are visible along the top and toe of the levee.

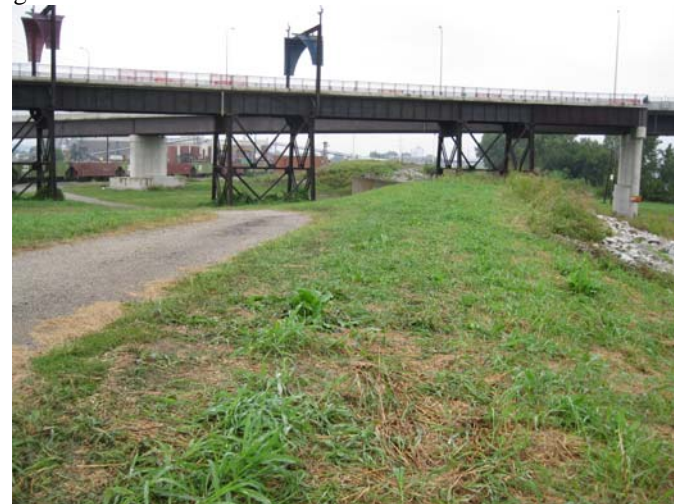
Photo 24. Mowed portion of the levee near McKinley Bridge.

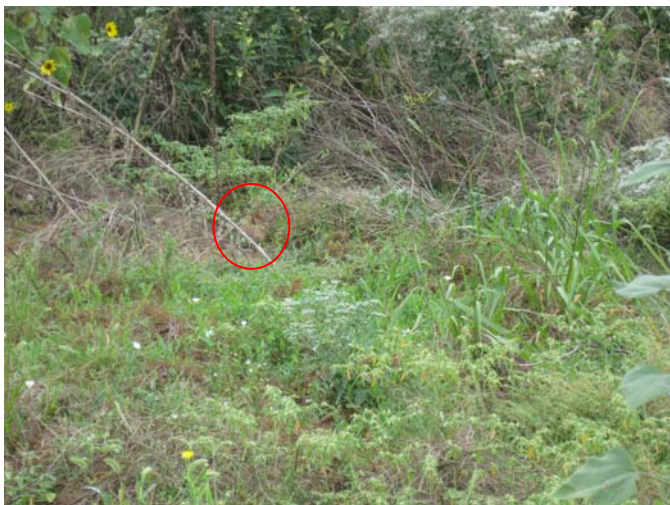
Several species of birds were observed at the site, including swallow, mourning dove, mockingbird, robin, cardinal, American goldfinch, and sparrows. Raccoon tracks were observed along the Mississippi River, and a ground hog den was observed in Wooded Area 2. Evidence of beaver cuts on trees was also observed in the wooded area adjacent to the river. An eastern cottontail rabbit was observed in Field 3.

Photo 27. View facing southwest into vegetation portion of site. Eastern cottontail rabbit is highlighted within the red circle.

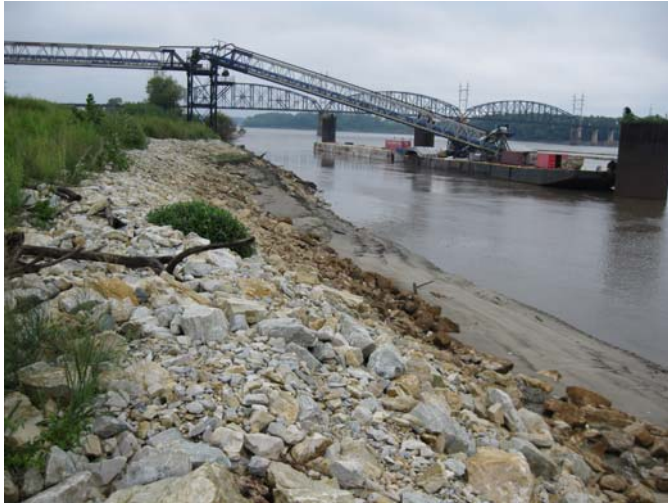
Photo 28. View north along the bank of the river near the northern boundary of SLDS.

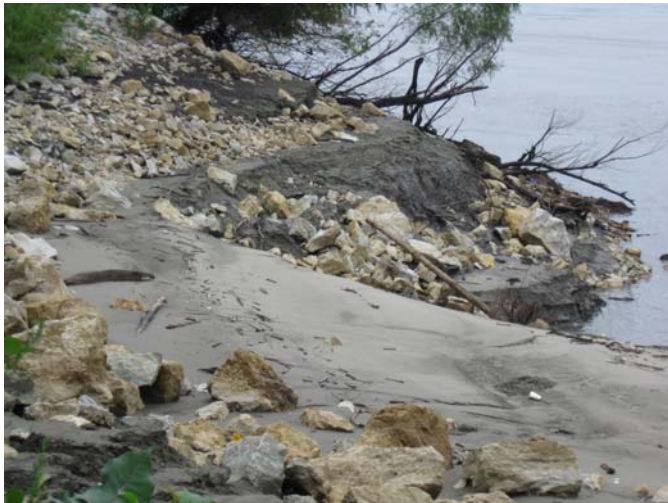
Photo 30. View of the riverbank in the vicinity of McKinley Bridge.

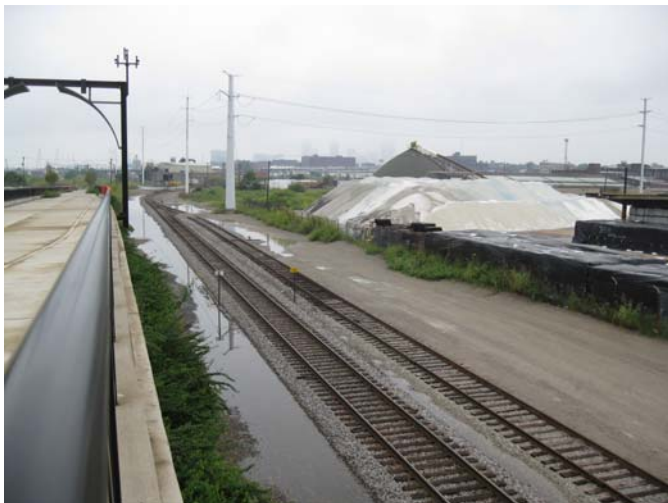
Areas of vegetation less than 0.1 acre in size are scattered throughout the SLDS along fence lines and in the corners of unused lots. In total, it is estimated that these sites total less than 1.5 acres of additional habitat. Vegetation in these areas is characterized by noxious and invasive species, such as Johnson grass, ragweed, mulberry, Amur honeysuckle, and tree of heaven. A few sites contained cottonwoods and sumac. See photographs 32-33.

Photo 32. View facing southwest along rail line. Gunther Salt (DT-4) is visible to the right. Note the vegetation along the fence line and underneath the elevated walkway.

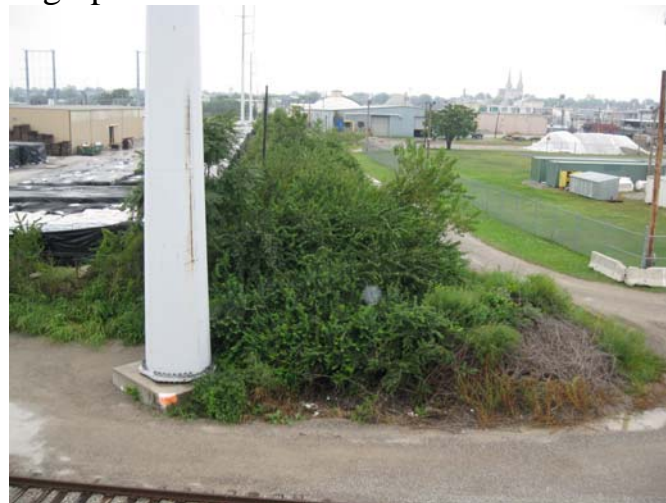
Photo 33. View facing southwest along Buchanan Street at the fenceline next to DT-4 and at the mowed turfgrass adjacent to the USACE trailers.

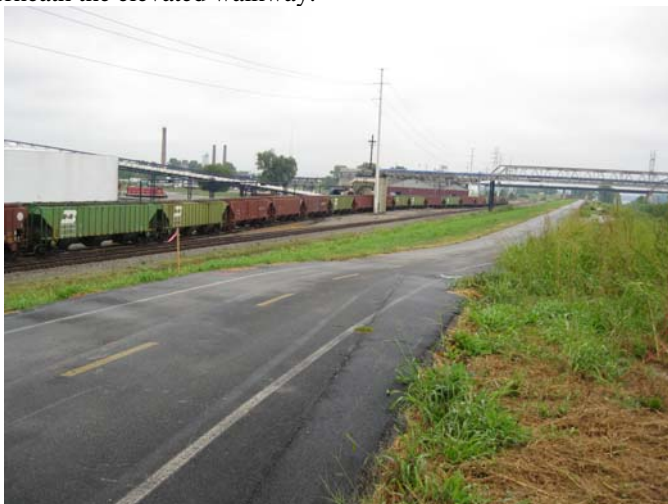
^aFor recreational areas, please describe the use of the area (e.g., park, playing field, etc.).
The Riverfront Bike trail extends along the east side of the property. The bike trail is a paved trail that is located on a levee in the northern portion of the site and then drops into the floodplain area located between the levee and the Mississippi River in the southern portion of the site (See Photos 34 and 35).

Photo 34. View facing north at the Riverfront Trail. This photograph was taken near the north end of SLDS across from DT-9.

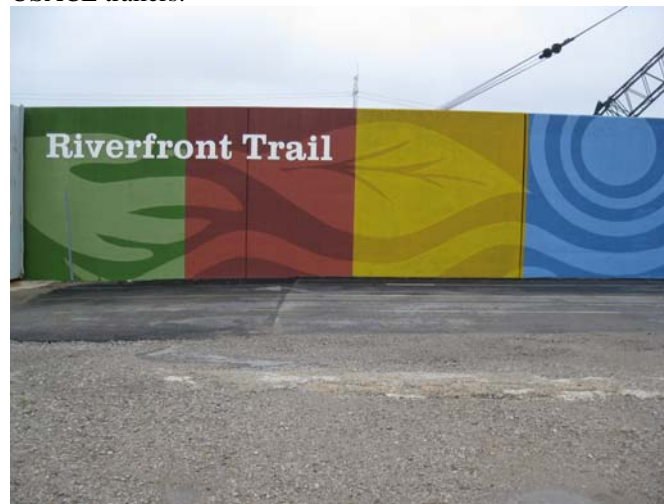
Photo 35. Entrance to the Riverfront Trail at the end of Branch Street just south of the SLDS boundary.
