DRAFT ENVIRONMENTAL ASSESSMENT WITH FINDING OF NO SIGNIFICANT IMPACT

LEVEE REPAIR (PL 84-99)

**STE. GENEVIEVE COUNTY LEVEE DISTRICT NO. 2
STE. GENEVIEVE COUNTY, MISSOURI
RANDOLPH COUNTY, ILLINOIS
MISSISSIPPI RIVER, MILES 122 to 113**

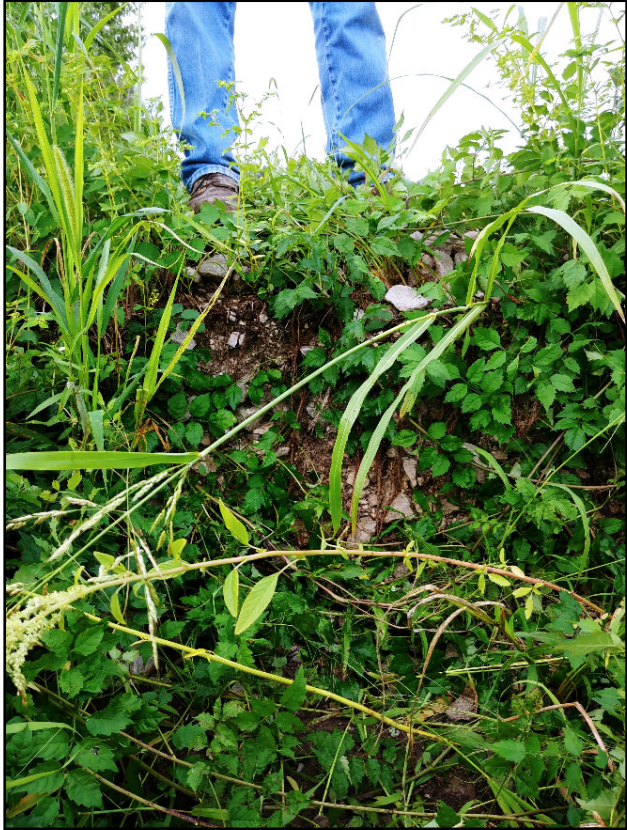
Figure 8. Example of Erosion Type II at the Sainte Genevieve Levee System No. 2.

- Erosion Type II damages would be repaired by filling in the eroded areas using embankment material from designated borrow area(s). Material would be excavated from approved borrow sites, hauled to the damaged locations, placed in the eroded areas, and then compacted. After compaction, the repaired areas would be seeded by spreading seed, fertilizer, and mulch on the disturbed areas. The areas would be watered as needed. This is the recommended repair method for Area 9 (Figures 8-9).

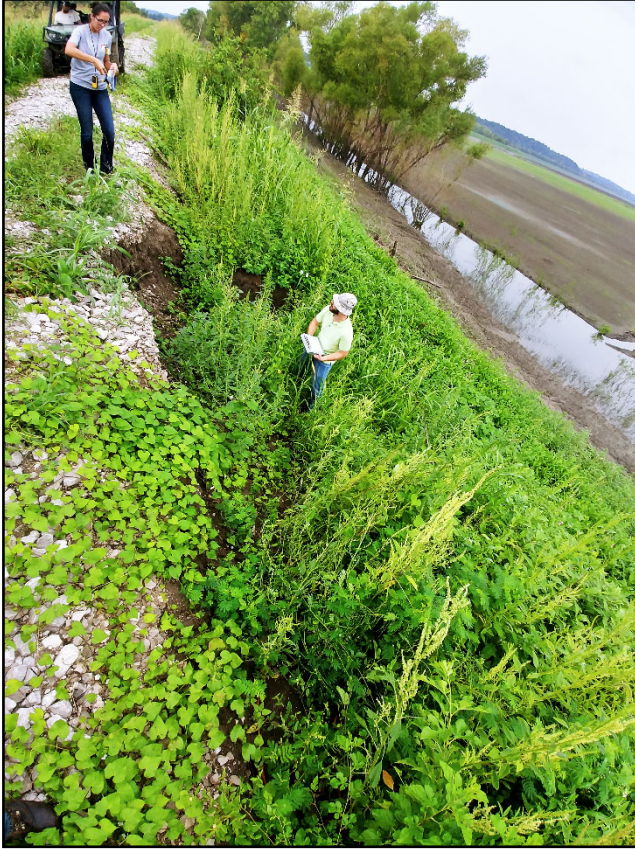
Figure 10. Example of Erosion Type III at the Sainte Genevieve Levee System No. 2.

- Erosion Type III damages would be repaired by filling in the eroded areas using embankment material from designated borrow area(s). Material would be excavated from approved borrow sites, hauled to the damaged locations, placed in the eroded areas, and then compacted. After compaction, the repaired areas would be seeded by spreading seed, fertilizer, and mulch on the disturbed areas. The areas would be watered as needed. This is the recommended repair method for Areas 4, 5, 6, 7, and 8. Figure 10 shows an example of Erosion Type III. Figure 11 illustrates a typical repair for Erosion Type III.

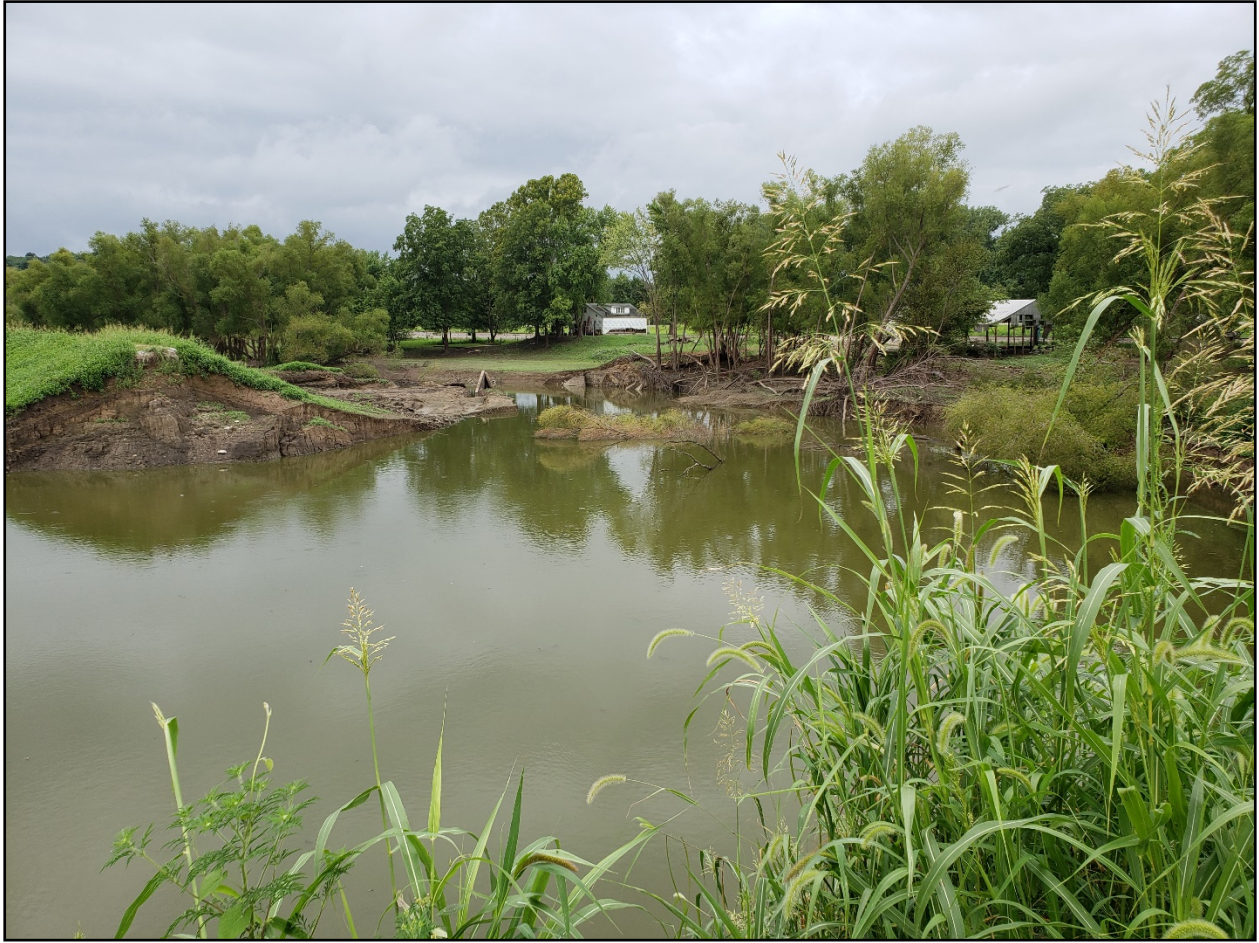
Figure 12. Photo of Breach 1 (Damage Area 10) with scour hole extending through the nearby creek. The damages occurred as a result of the 2019 spring flood at Sainte Genevieve Levee System No. 2.

Figures 12-13 show Breach 1; Figure 14 shows the creek realignment required as a result of Breach 1; Figure 15 shows typical sections for stream restoration and grade control repairs at Breach 1; Figure 16 shows Breach 2. Figure 17 shows the limits of the breaches. Figures 18-19 show the repair profiles for each breach.

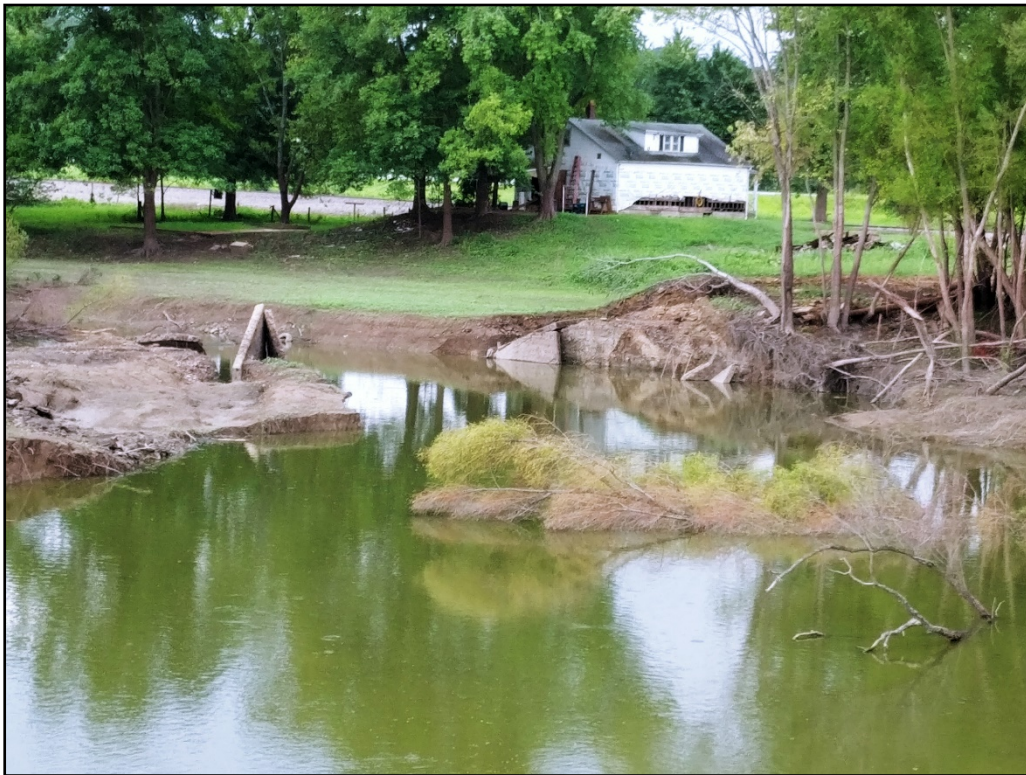
Figure 13. Ramp from the levee, damaged at Breach 1 during the 2019 spring flood.

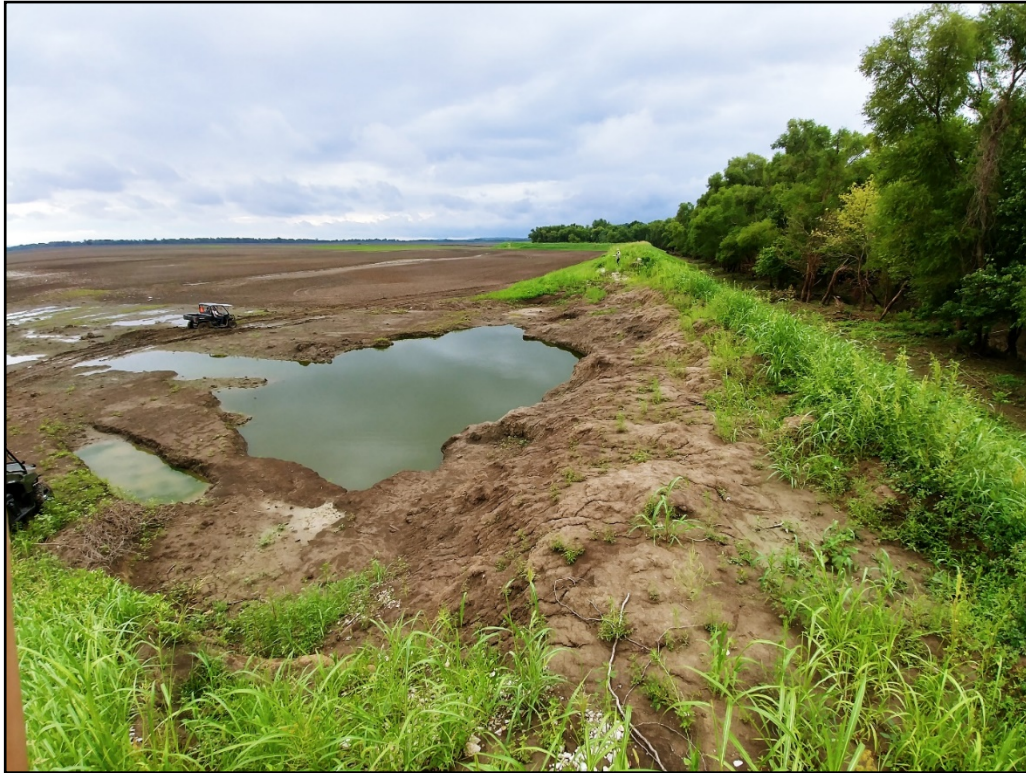
Figure 16. Photo of Breach 2 (Damage Area 11). The damages occurred as a result of the 2019 spring flood at Sainte Genevieve Levee System No. 2.
