**DRAFT ENVIRONMENTAL ASSESSMENT
WITH
FINDING OF NO SIGNIFICANT IMPACT**

**LEVEE REPAIR (P.L. 84-99)
ELM POINT LEVEE DISTRICT
MISSISSIPPI RIVER, RIVER MILE 226 to 228
ST CHARLES COUNTY, MISSOURI**

Prepared by:
Environmental Compliance Section
U.S. Army Corps of Engineers
St. Louis District
1222 Spruce Street
St. Louis Missouri 63103-2833

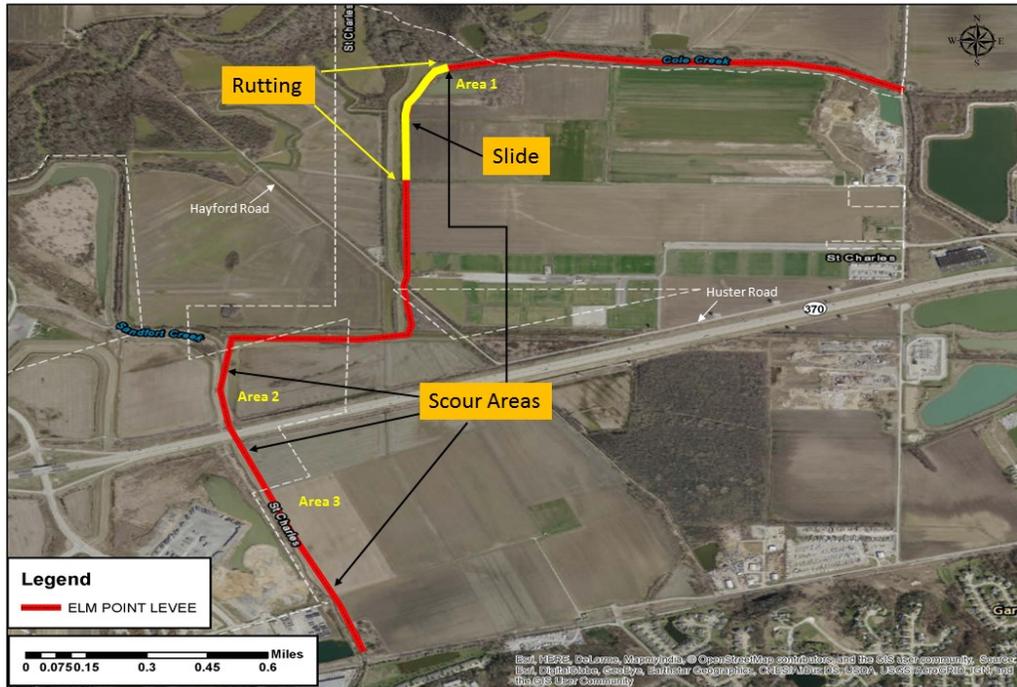
Figure 2. Location of Elm Point levee damage as result of the December 2015 high water event.

Damages sustained by the Elm Point levee as a result of the December 2015 high water event on the Mississippi Rivers consisted of slides, scouring and rutting. Damage locations are shown in Figure 2 below.

- Rutting – Rutting damage caused by vehicular traffic during the flood fighting efforts occurred starting approximately 0.3 miles north of Missouri Highway 370, extending 2300 feet in length on the levee crown with a depth of 4 inches and total width of 5 inches. Figure 2 shows the extent of the rutted area.

Within Area 3 (Figure 2) scour damage occurred at one location greater than five feet into the crown of the levee, the ideal repair for this specific site is a 30 feet levee setback. Figure 5 shows the typical cross section diagram of the 30 feet proposed setback levee. The new levee centerline would be offset at each location and transition smoothly back into the existing levee section and

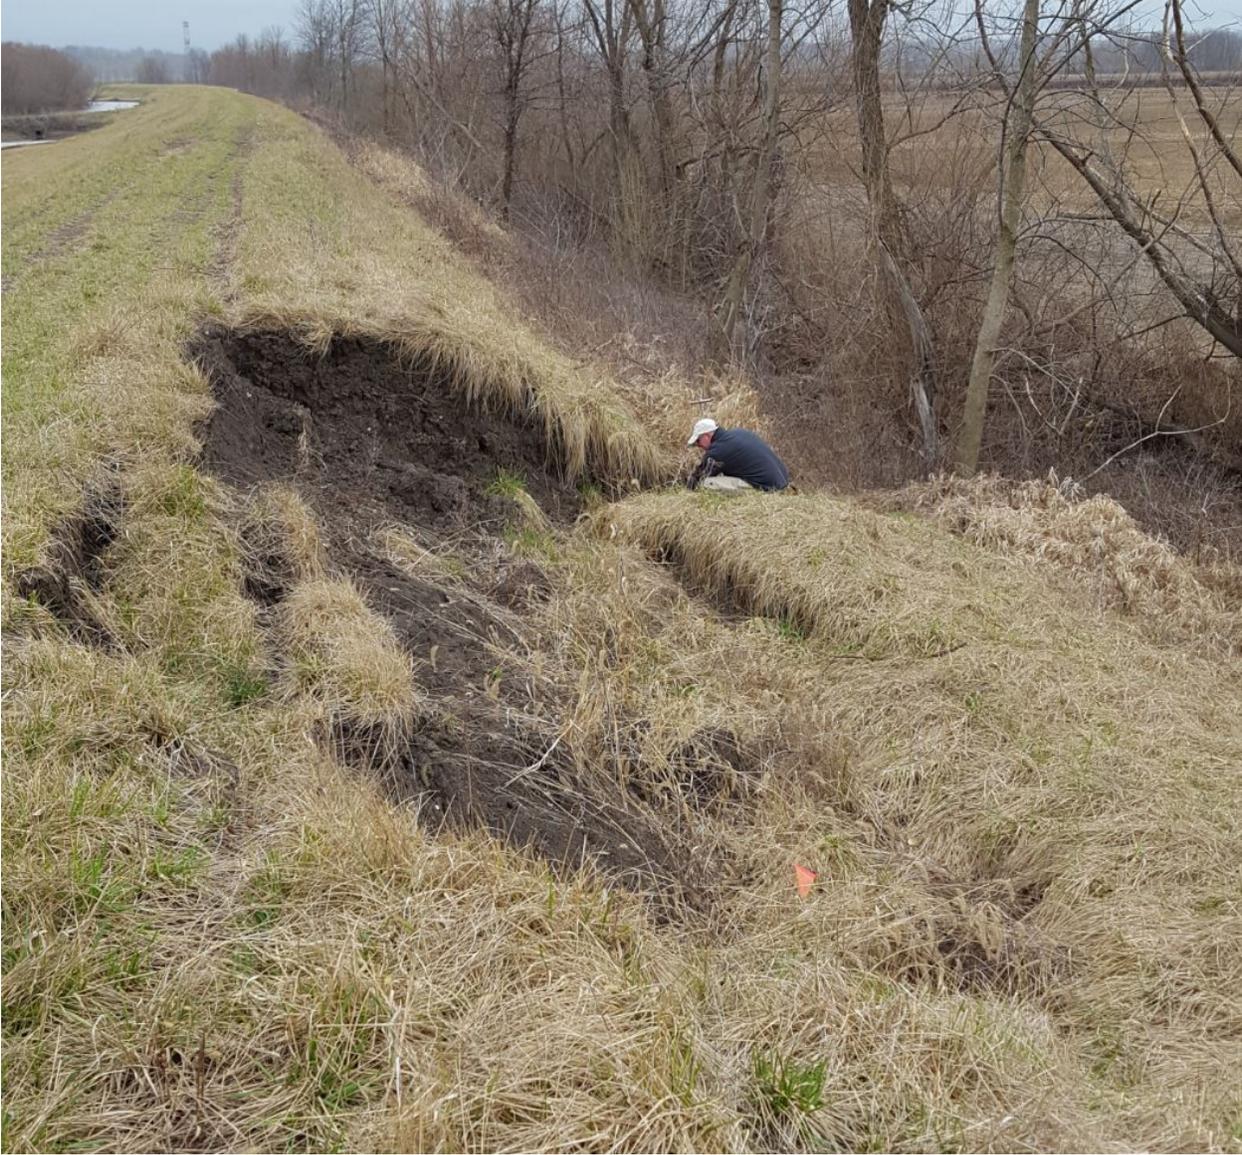
Figure 3. Levee slide along Cole Creek adjacent to Borrow Area 1.

- Slide – One area located on the riverside of Elm Point levee received slide damage resulting from the December 2015 flood event (Figure 3). The area is located approximately 0.5 miles north of Hayford Road. It measures 60 feet in length and the scarp is 3 feet into the riverside crown edge. Vertical distance from the levee crown to bottom of creek bed is approximately 16 feet.

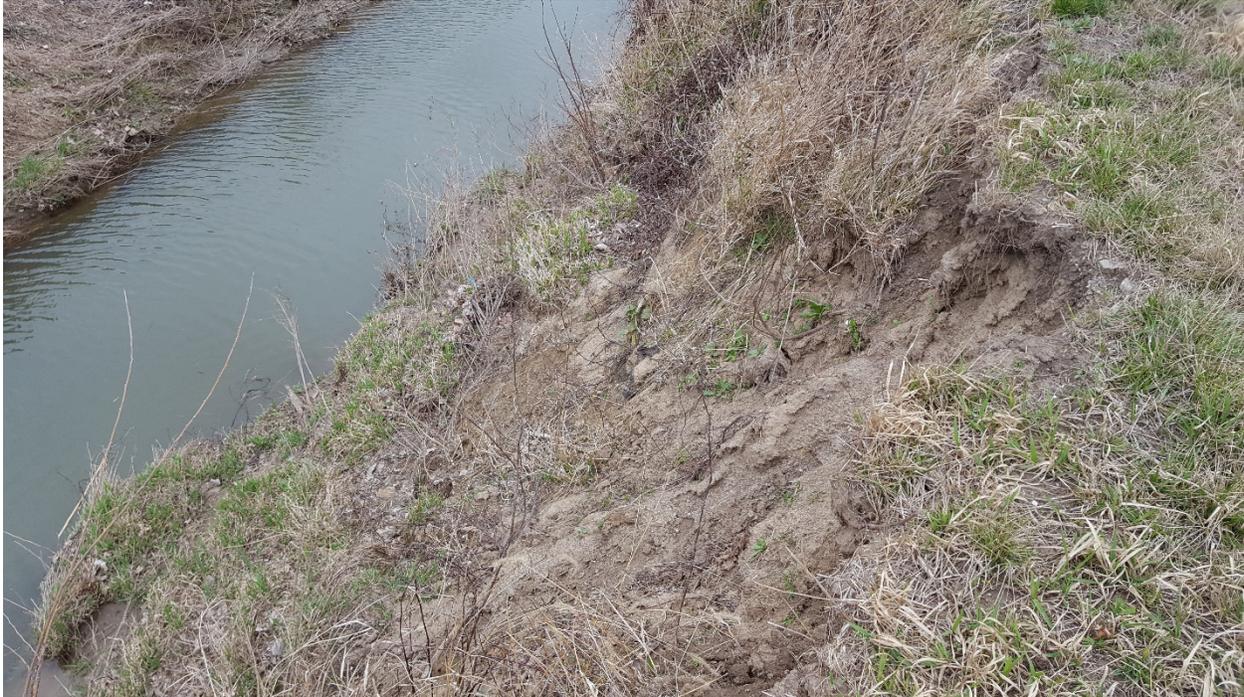
Figure 4. Photo of scour along Cole Creek within Area 2.

- Area 2 - The section of levee immediately adjacent to and north of Highway 370 contains multiple scouring locations along the riverside of Cole Creek. The scour locations along this section of levee add up to 200 feet in length. Figure 4 shows typical scour damage within this area.

All of the scouring damage mentioned above resulted from the December 2015 storm event. Vertical distance from the levee crown to bottom of Cole Creek bed is approximately 16 feet in all scour locations.

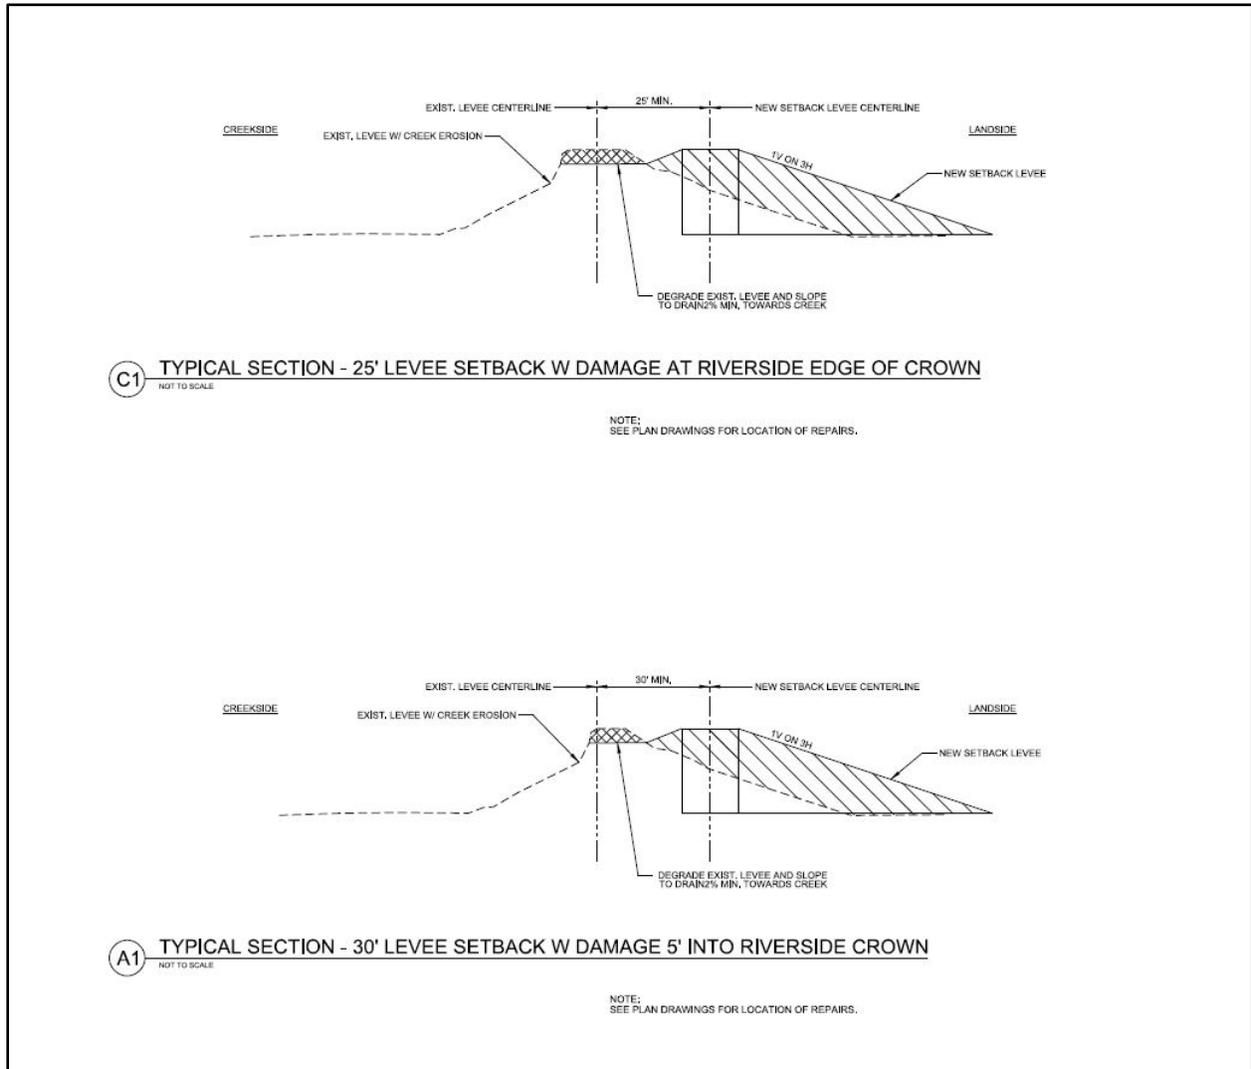
Figure 5. Typical cross section diagram of 25' and 30' levee setback.

- Scour Areas – Excavated material from the existing levee would be utilized for the setback construction in addition to borrow material. A setback of approximately 25 feet is the ideal repair for locations that received less than five feet of erosional damage into the levee crown. Figure 5 shows the typical cross section diagram of the 25 feet levee setback plan.

Due to the widening of the creek meander and continued scour, it is not practical to reestablish the levee within its original footprint. A setback of approximately 25 to 30 feet is the ideal repair method, dependent upon the severity of damage. The damaged areas of the levee would be reconstructed with suitable semi-compacted impervious material until the original slope and grade of the levee is attained. In areas where filling is required, impervious borrow material and pervious sand would be added to the repair sites to restore areas to pre-flood grade. Approximately 8,500 cubic yards of embankment in addition to an estimated 16,000 cubic yards of additional borrow material is needed to restore the levee at damage locations. Repairs would restore the levee to the level of protection that existed prior to the 2015 flood event at slide, scour and rutted locations. All repair areas would then be reseeded when conditions are suitable for grass germination to prevent or minimize erosion.

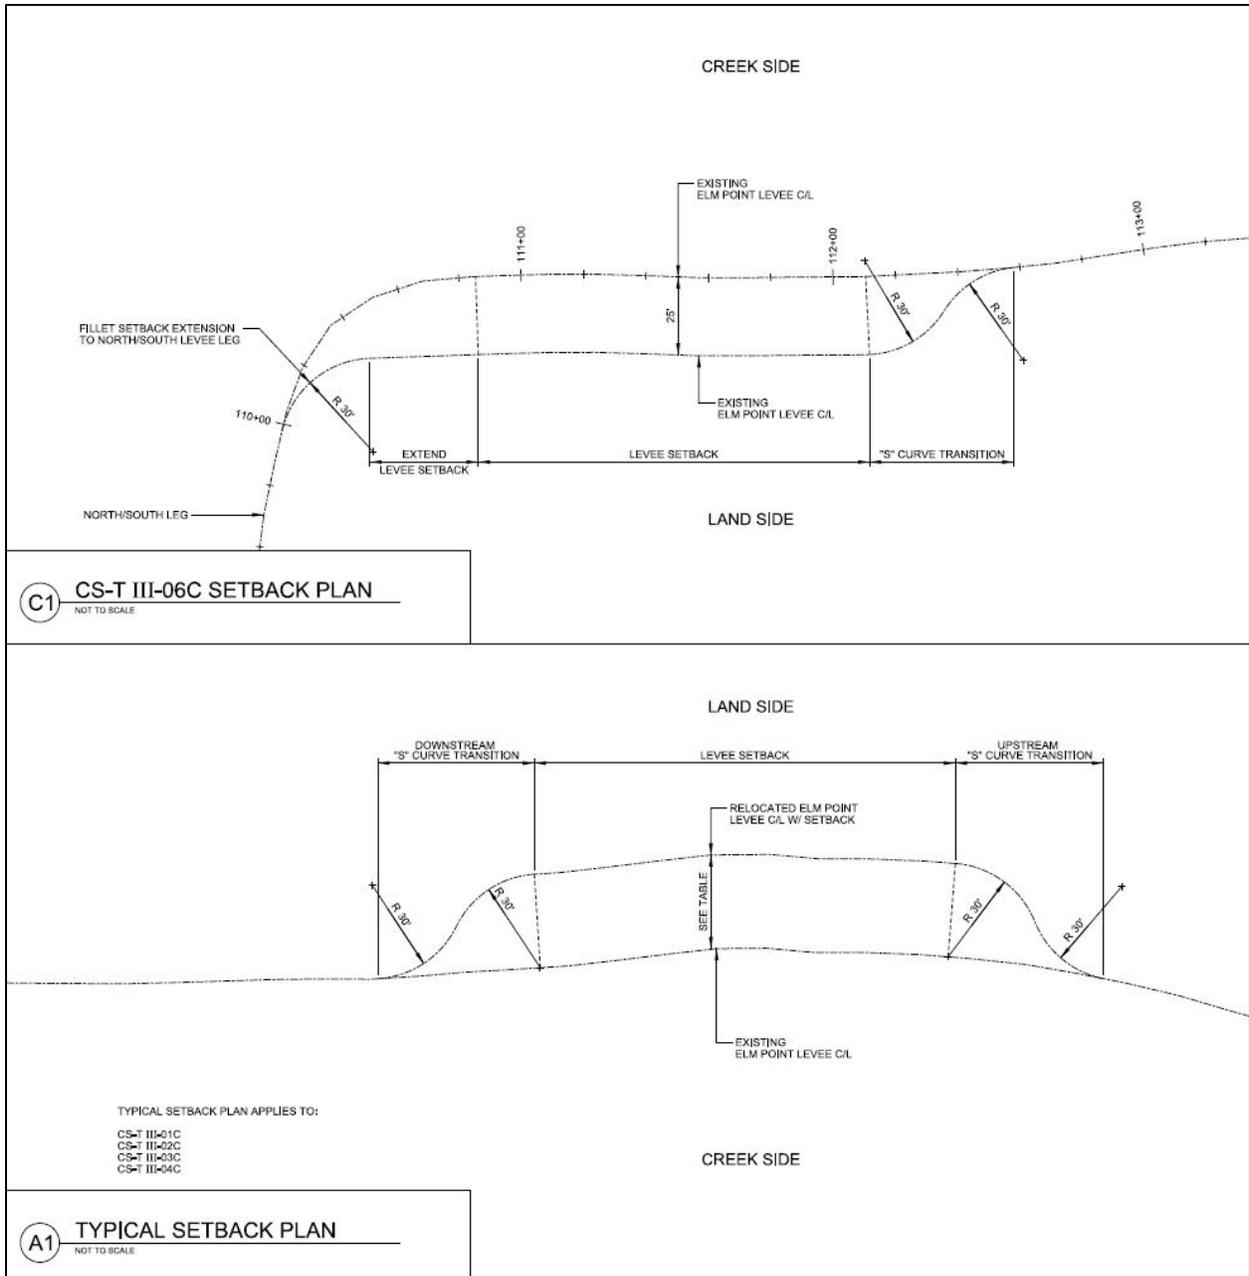
Figure 6. Proposed levee setback alignment.

alignment. Preliminary project plans of the levee setbacks are shown in Figure 6.

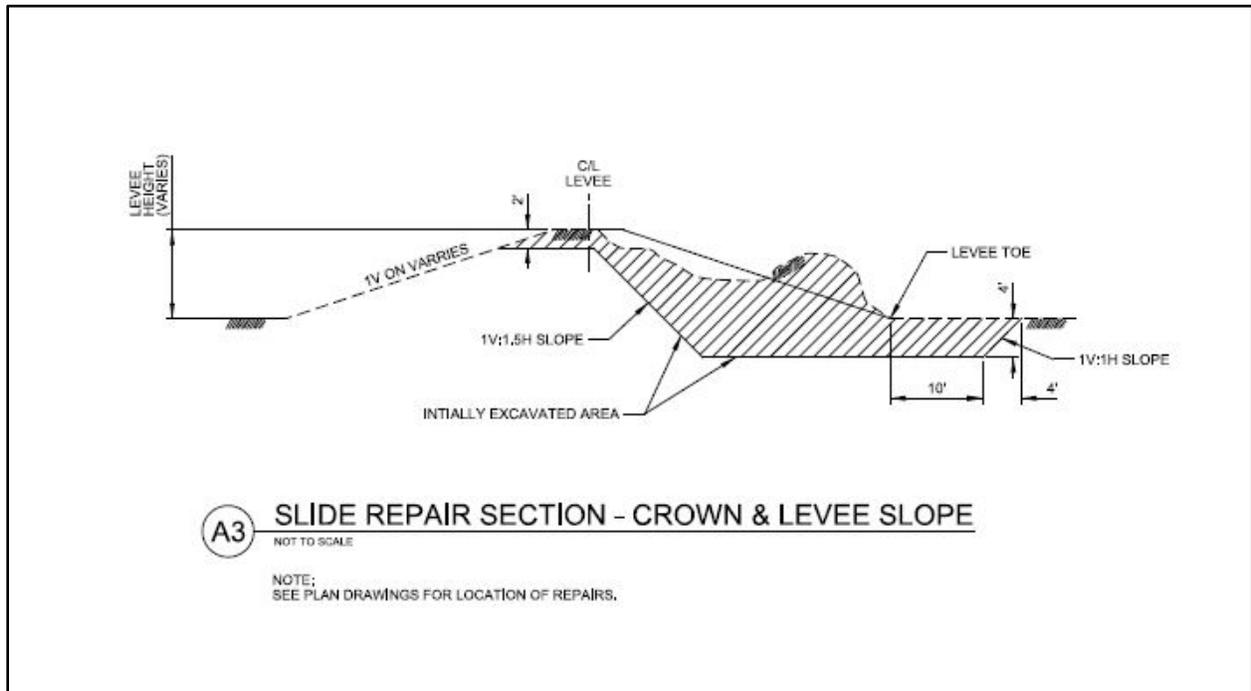
Figure 7. Typical cross section diagram of slide repair.

- Slide Area – Excavated material from the existing levee embankment would be utilized for the repair construction within the slide damage area. A setback design would not be utilized for this repair area. Figure 7 shows a typical cross section of the proposed slide repair.

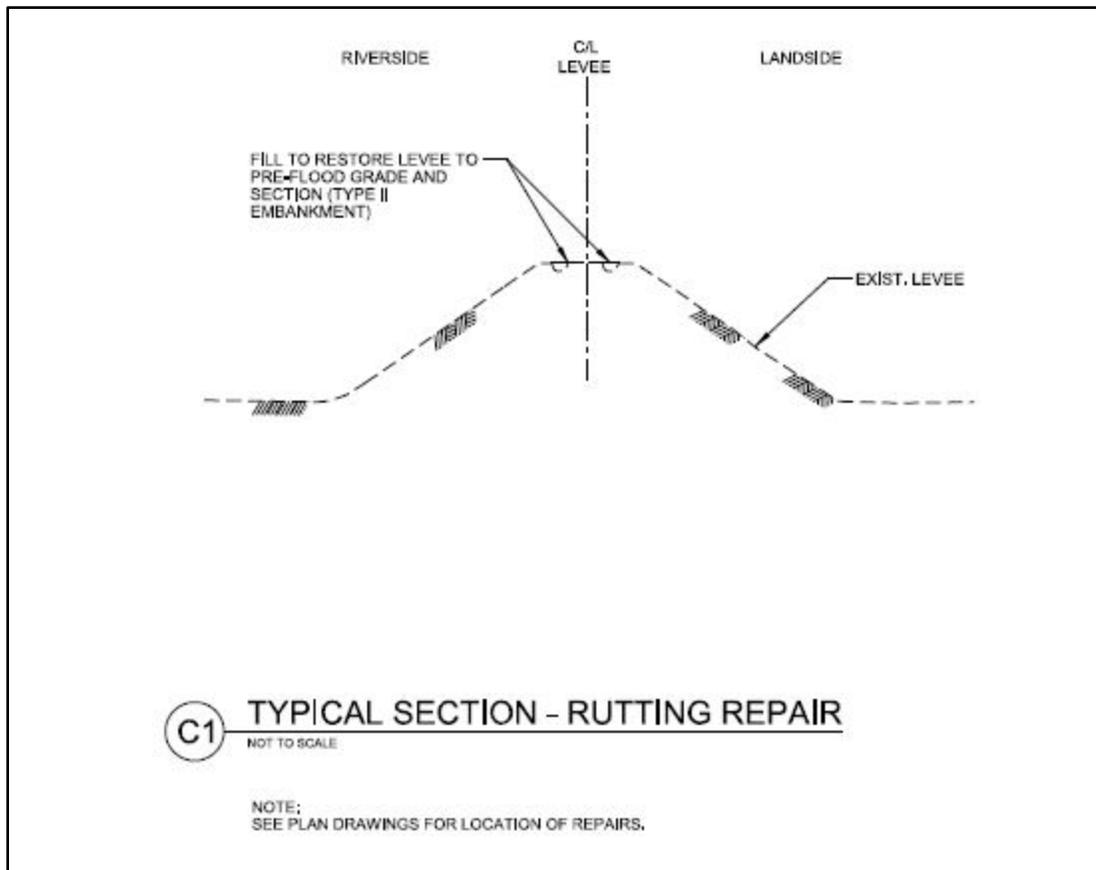
Figure 8. Typical cross section diagram of rutting repair.

- Rutted Area – The repair for this area would require approximately 150 cubic yards of embankment material to bring the levee crown to its original grade. Figure 8 shows an example of a typical levee rutting repair.

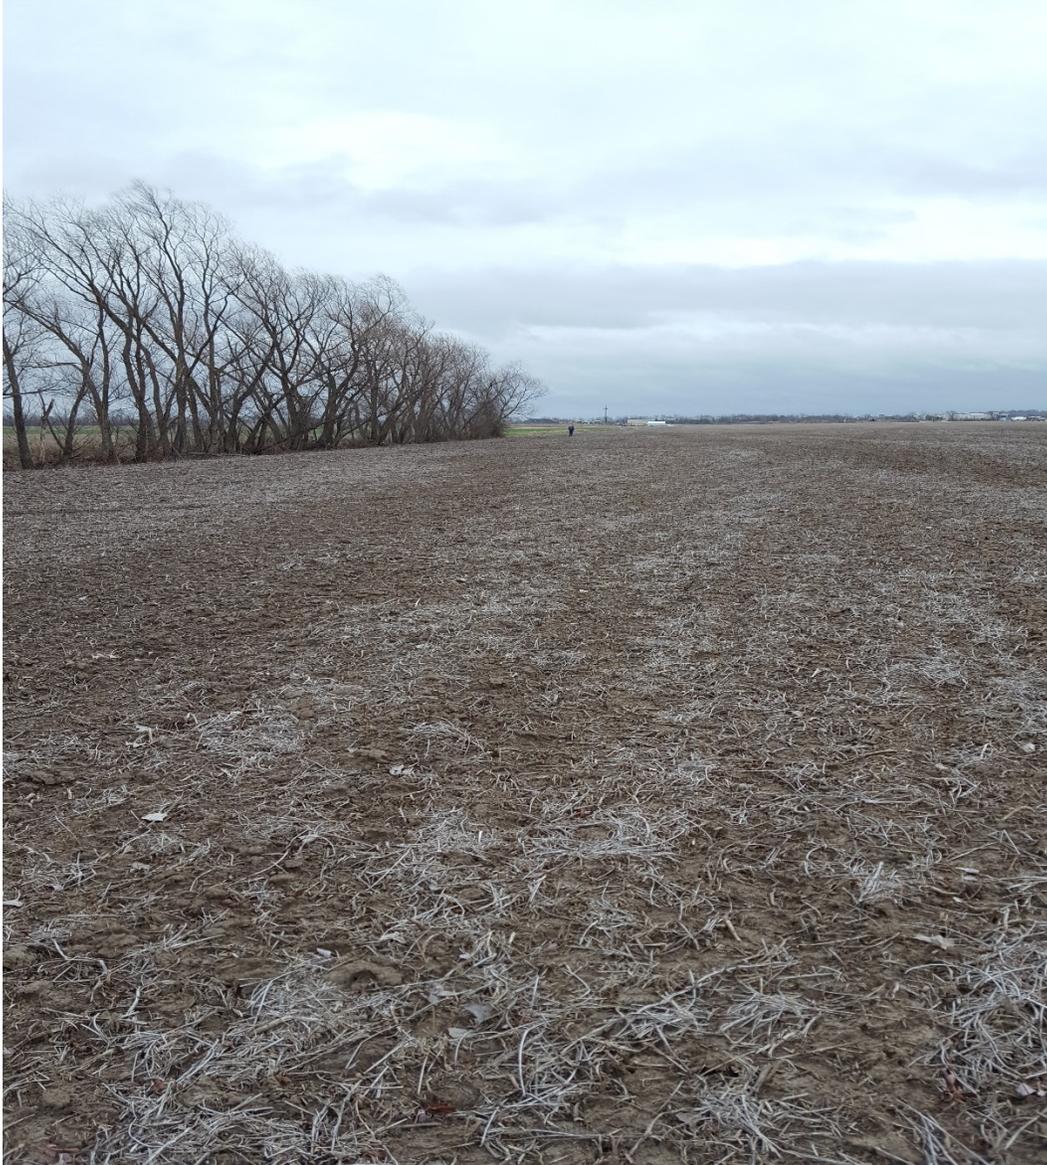
Figure 9. Photo of proposed Borrow Area 2 for the Elm Point Levee District PL 84-99 repairs.

Longitude -90.54771 and Latitude 38.8292, Longitude -90.54596 (See Figures 9 and 10). This site is actively being used for row crop agriculture. Wetland criteria were present on site, but it did not exhibit all required wetland identifiers and would therefore not be regulated. The borrow material is suitable, made up of mostly fat clay. Before obtaining the borrow material, row crop organics would need to be stripped off, stockpiled, and then re-deposited as top dress on the disturbed area. Approximately 3 feet of material would be removed. The borrow area is a reasonable and economically feasible haul distance to the repair. A survey of the borrow area found no evidence of cultural materials. No historic properties would be affected.
