DEPARTMENT OF THE ARMY  
U.S. ARMY CORPS OF ENGINEERS, ST. LOUIS DISTRICT  
1222 SPRUCE STREET  
ST. LOUIS, MISSOURI 63103

MEMORANDUM FOR RECORD

SUBJECT: US Army Corps of Engineers (Corps) Pre-2015 Regulatory Regime Approved Jurisdictional Determination in Light of *Sackett v. EPA*, 143 S. Ct. 1322 (2023),<sup>1</sup> [MVS-2020-406](#)

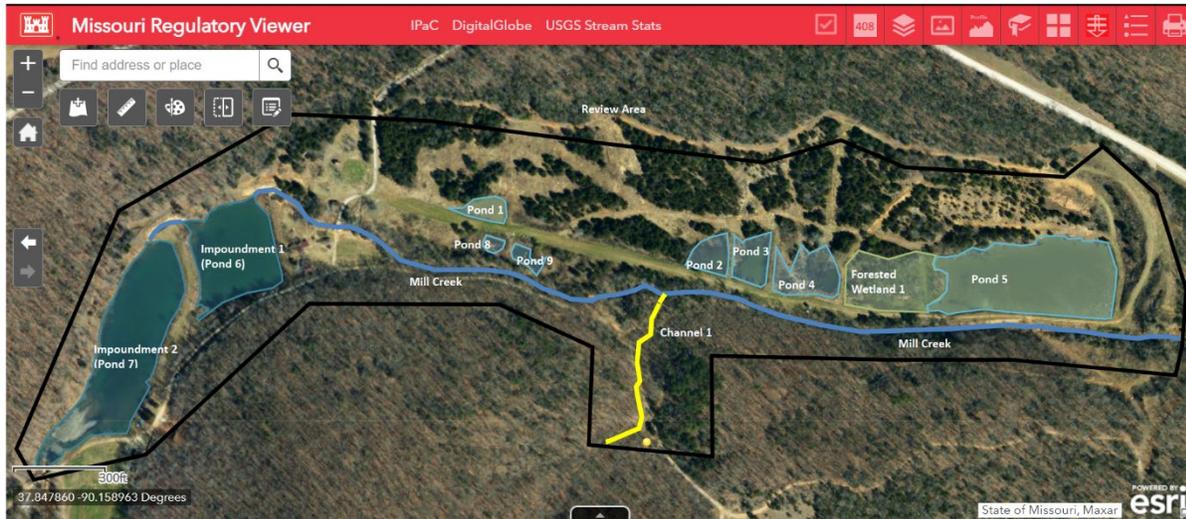
Figure 1. Overall Review Area

Genevieve County, Missouri 63670. Of note review area consists of a site that has a dam structure previously constructed and then intentionally breached which has resulted in unique site conditions and aquatic resources which are detailed in the subsequent sections.

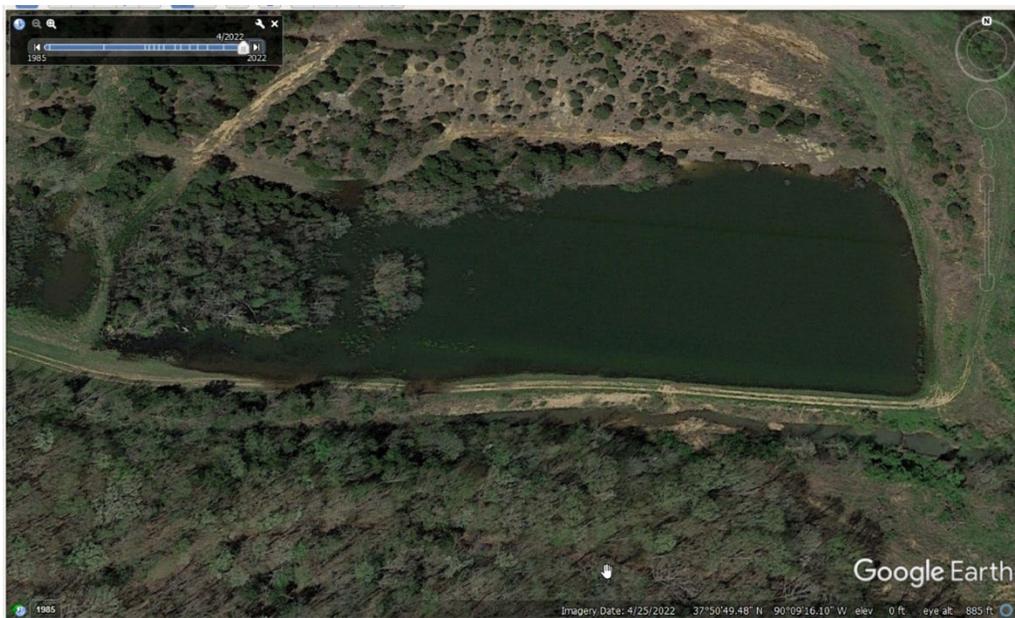
The pond complex appears to primarily lose water through evapotranspiration, but it does appear that during wetter than normal conditions, during the wet season, when excessive rainfall and flow from the Pond Complex contributes to the capacity of the Pond 5 basin being exceeded, that flow overtops the roadway berm via overland sheet flow into Mill Creek at two low lying locations along the embankment (each estimated at approximately 65 feet wide). Of nine aerial imagery captures taken since 2012 only one image shows the basin sheet flowing over the roadway embankment in April 25, 2022. The APT finds that this flow occurred during the wet season in wetter than normal conditions, not representing normal site conditions. Sheet flow across the roadway embankment was observed in low lying areas during the spring March 9, 2023 but not during the USACE's initial site visit September 11, 2020. In reviewing the APT the flow observed on March 9, 2023 was during the wet season in wetter than normal conditions and the lack of flow on September 11, 2020 occurred during the dry season under normal conditions. The review of flow observations from both aerial imagery and site observations show that Pond 5 overtops the basin under wetter than normal conditions, during the wet season, and outside of those conditions flow has not been observed to occur from Pond 5 into Mill Creek.

Figure 4. An April 25, 2022 Google Earth aerial of overtopping area during wet season in wetter than normal conditions.

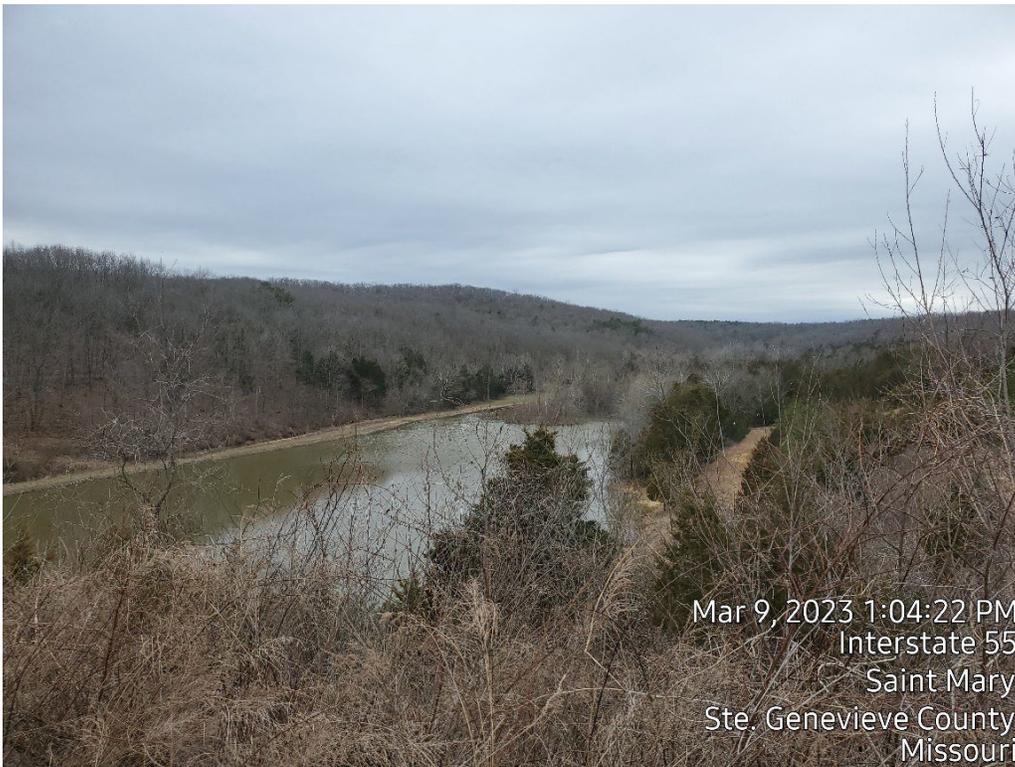
Figure 5. USACE site visit photo (TimePhoto\_20230309\_130422) showing areas where embankment overtops during wet season in wetter than normal conditions.

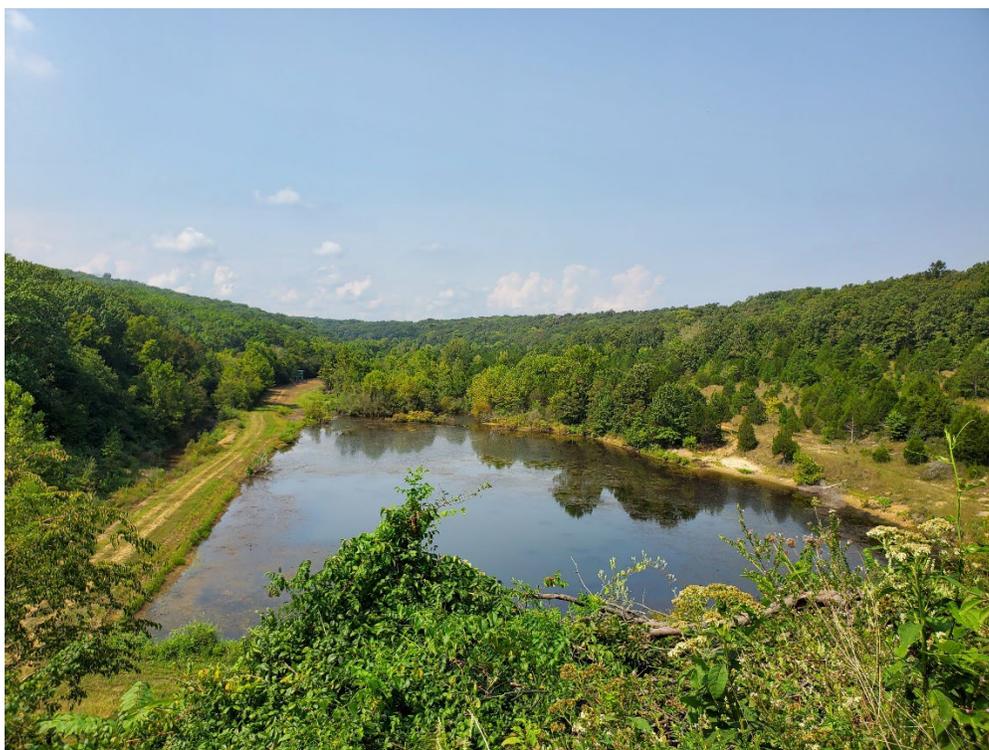
Figure 6. USACE September 11, 2020 site visit photo of road embankment without any overflow during dry season with normal conditions present.
