# **Bartelso Bottoms**

## **Wetland Mitigation Bank**

Addendum No. 3 to the  
*WFI-B Umbrella Mitigation Banking Instrument*  
MKUK-BB-2022-001

March 28, 2022

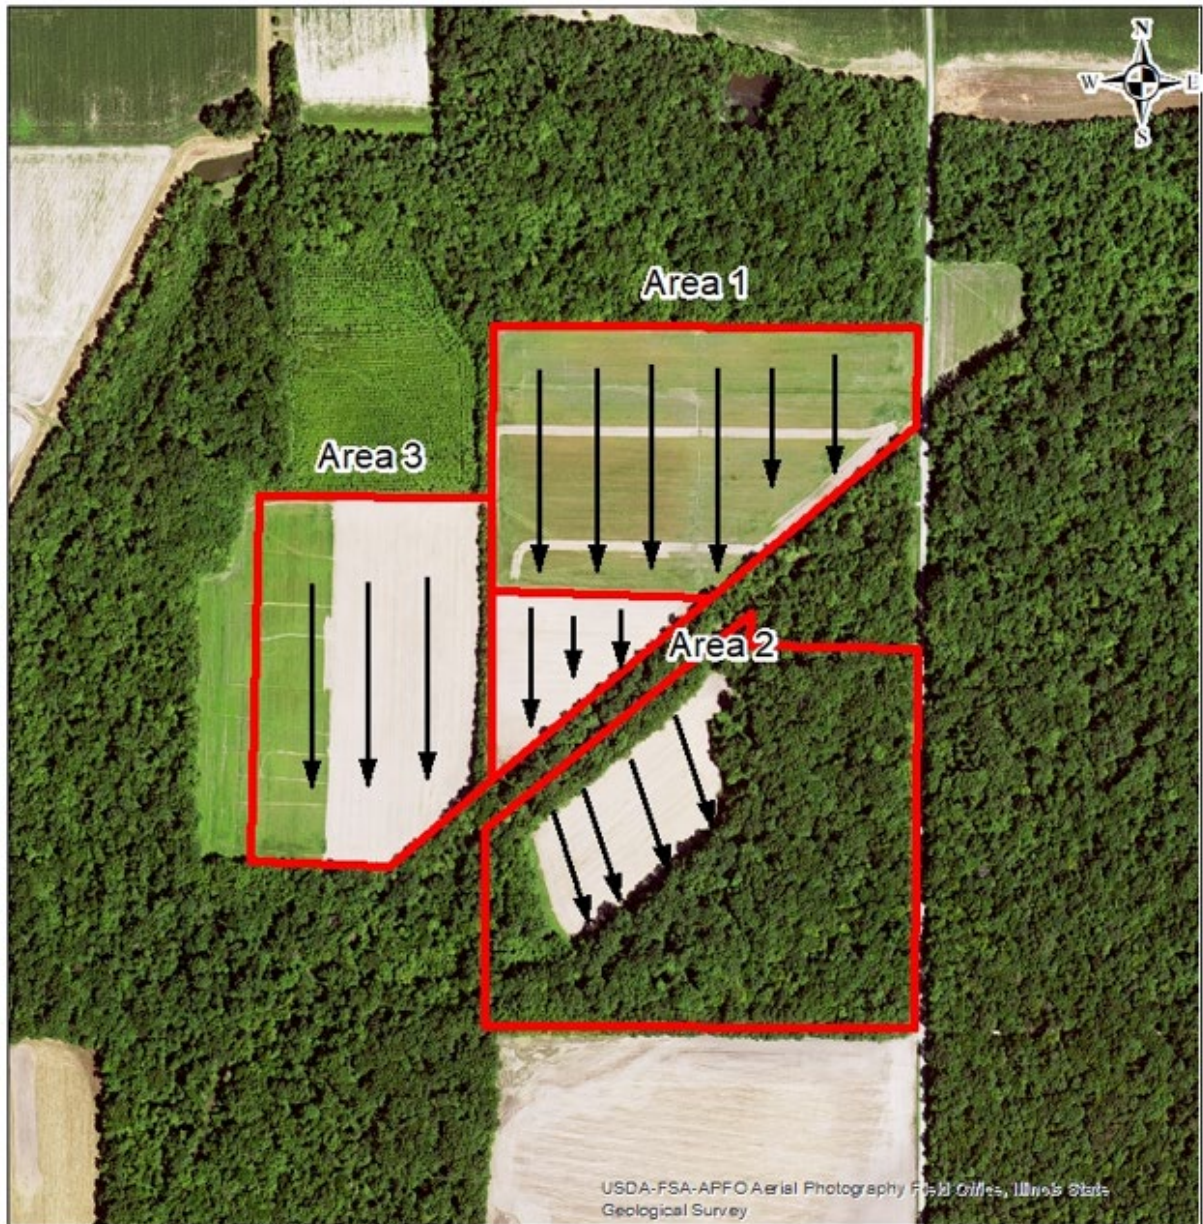
Figure 9A – Berm / Mound Construction

Area 1: 30 rows of berms/mounds @ 40' centers  
Area 2: 11 rows of berms/mounds @ 40' centers  
Area 3: 16 rows of berms/mounds @ 40' centers

Though the Bank Site has hydrologic conditions available, the historical management was designed to increase agricultural production. Existing drain ditches utilized during agricultural production will be modified through small berm construction (< 8 inches in height) to redirect interior water drainage across the site, thus extending duration of interior hydrologic conditions. Further, agricultural ditches will be filled or broken to support the extended duration of interior hydrology. This improvement to hydrology will result in the reestablishment of historical hydrology across the Bank Site and increasing historical depressional drainage locations within the Bank Site. Reference figures below.

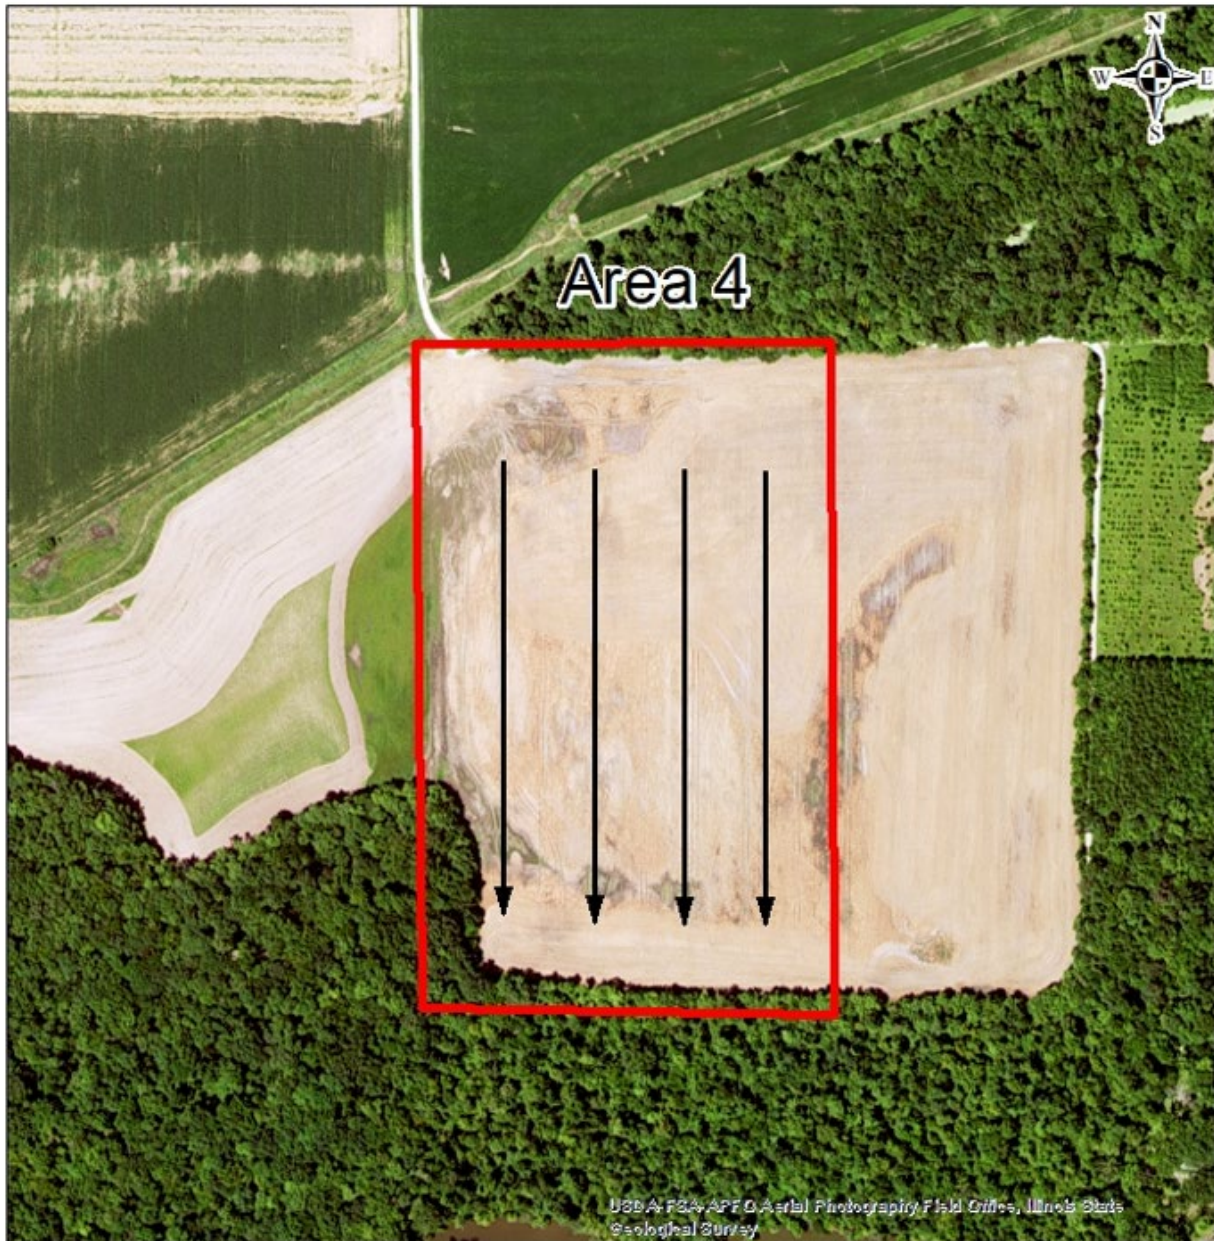
Figure 9B – Berm / Mound Construction (continued)

Area 4: 16 rows of berms/mounds @ 40' center

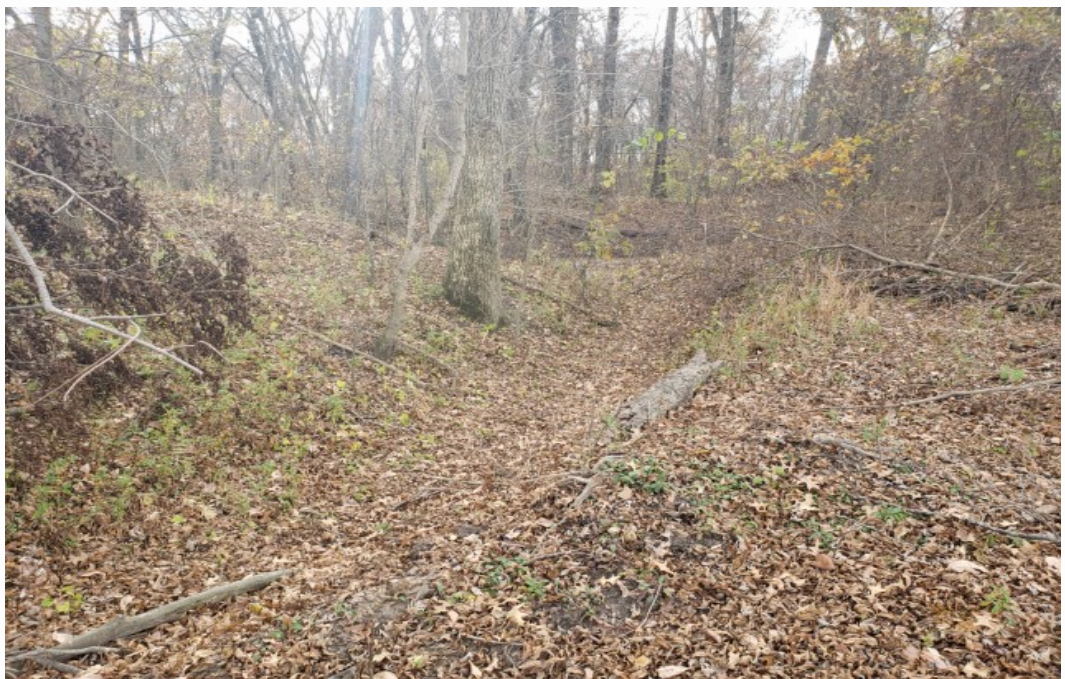
Photo 4. Drainage ditch from forested wetland to a cut in the berm along the Santa Fe Drainage Ditch, facing south

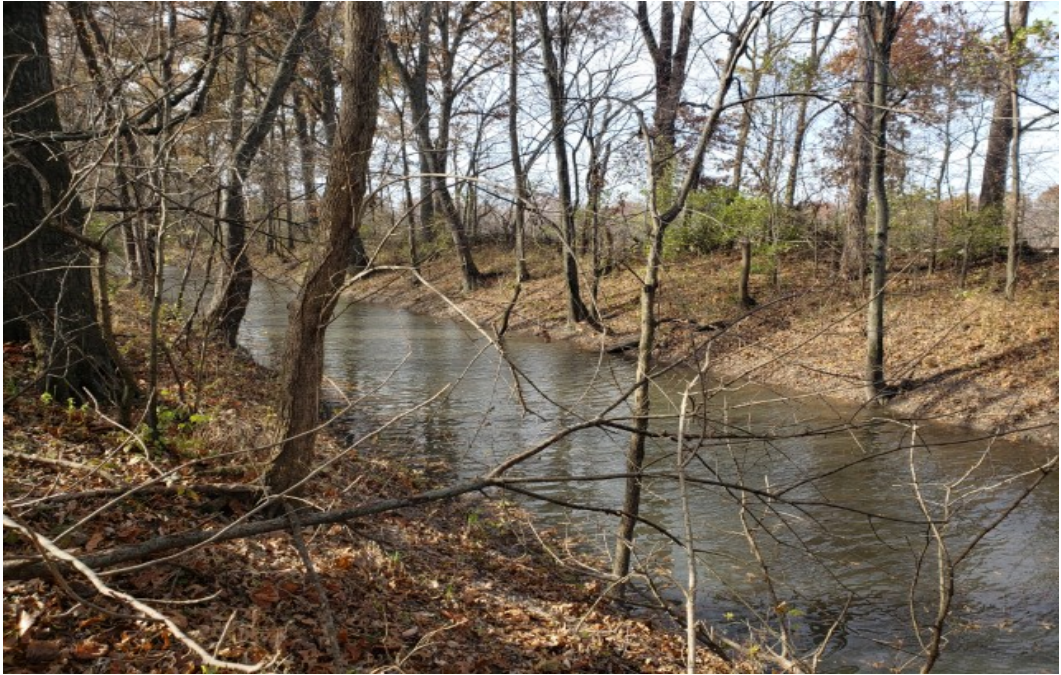
Photo 7. View of the Santa Fe Drainage Ditch from the berm along the south bank, facing southwest
