Mid Rivers Investment Group, L.P.

**BROOKSIDE**
ENVIRONMENTAL SERVICES
6 Brook Lane O'Fallon, Missouri 63368

February 23, 2015

**PROSPECTUS
PERUQUE CREEK MITIGATION BANK
Wilmer Road
St. Charles County, Missouri**

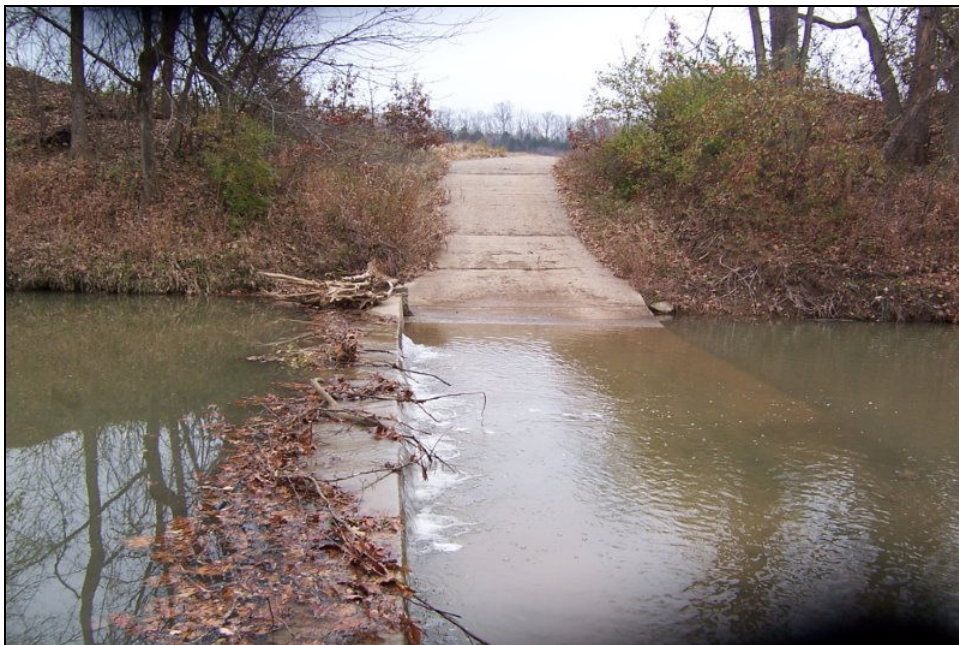
Two low-water crossings located within the Peruque Creek Mitigation Bank, one in each segment, will be removed (see Photo 1, below). The removals will be conducted during low flow conditions and in a manner that minimizes stream impact to the extent practical under site conditions. Steep stream banks, both upstream and downstream of the crossings, will be stabilized by pulling back to an approximately 1v:3h slope, seeding and blanketing exposed soil, and planting native woody species. Heavy boulders will also be placed at the foot of the pulled back stream bank for further stabilization. The access roads leading down to the crossings will be reshaped to natural stream bank condition. The location of the low-water crossings and access roads are shown on Figure 3; Mitigation Activities.

Photo 1. One of two low-water crossing.

[Note: With the Corps' and IRT's acknowledgement, the low-water crossings were removed in 2007 during preparation of the original prospectus. This work was done early to take advantage of good working conditions and mobilized

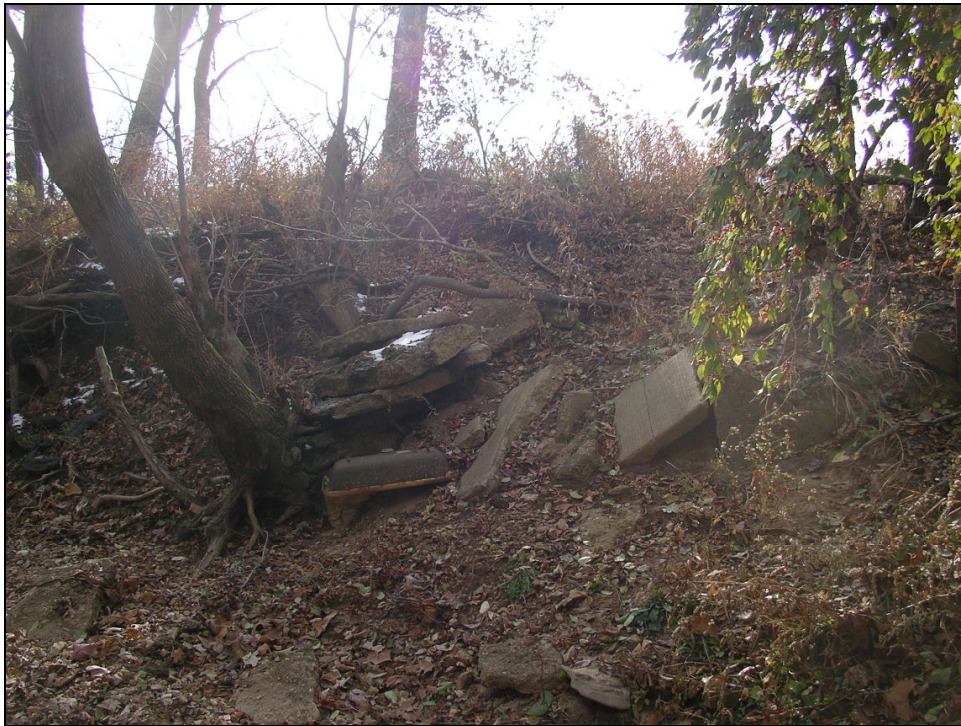
The limited amount of concrete rubble and debris that is located on the banks of Peruque Creek within the boundary of the Peruque Creek Mitigation Bank will be removed (see Photo 3, below). These items are located along a portion of the right descending bank of the West Segment, as approximately shown on Figure 3.

Photo 2. Concrete rubble and household debris along West Segment

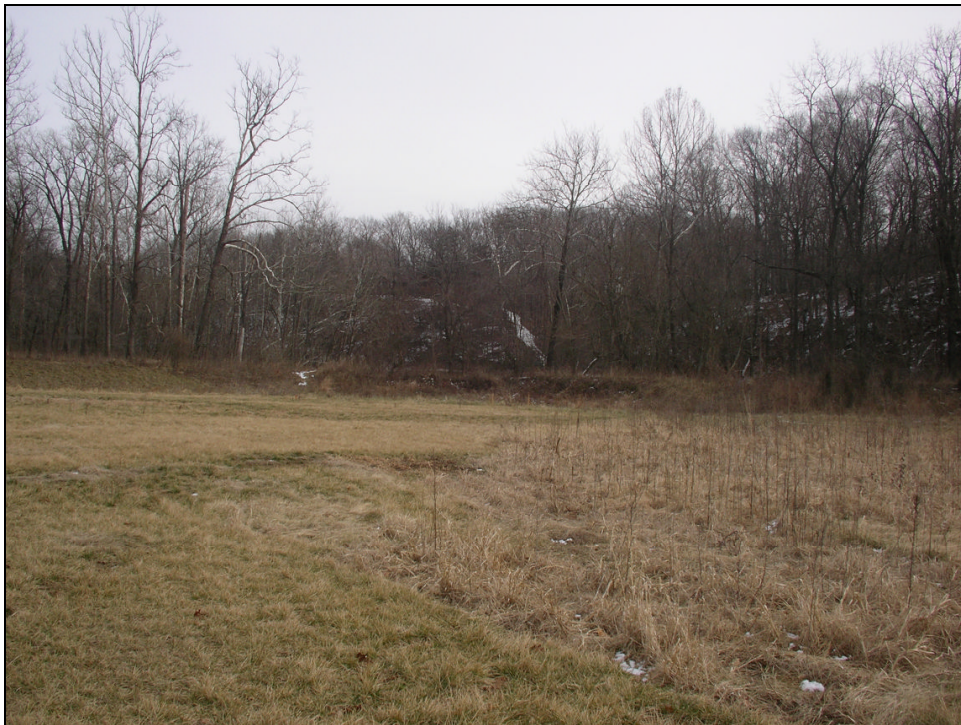
Portions of an of existing agricultural levee, located along approximately 2,600 linear feet of the right descending bank of the West Segment will be removed in order to provide high water connection between Peruque Creek and its floodplain. Sections of the levee that contain mature desirable trees will be avoided to the extent possible. A limited number of areas of steep, unstable stream banks within both the West and East Segments will be pulled back to a 1v:3h slope (see Photos 3 and 4, below). Levee removal and slope pull back will be by earthmoving equipment with special care to avoid desirable mature trees along Peruque Creek. All exposed areas will be seeded and blanketed, and planted with native woody species. Levee removal and slope pull back locations are approximately shown on Figure 3.

Photo 3. Segment of agricultural levee. Peruque Creek behind levee.

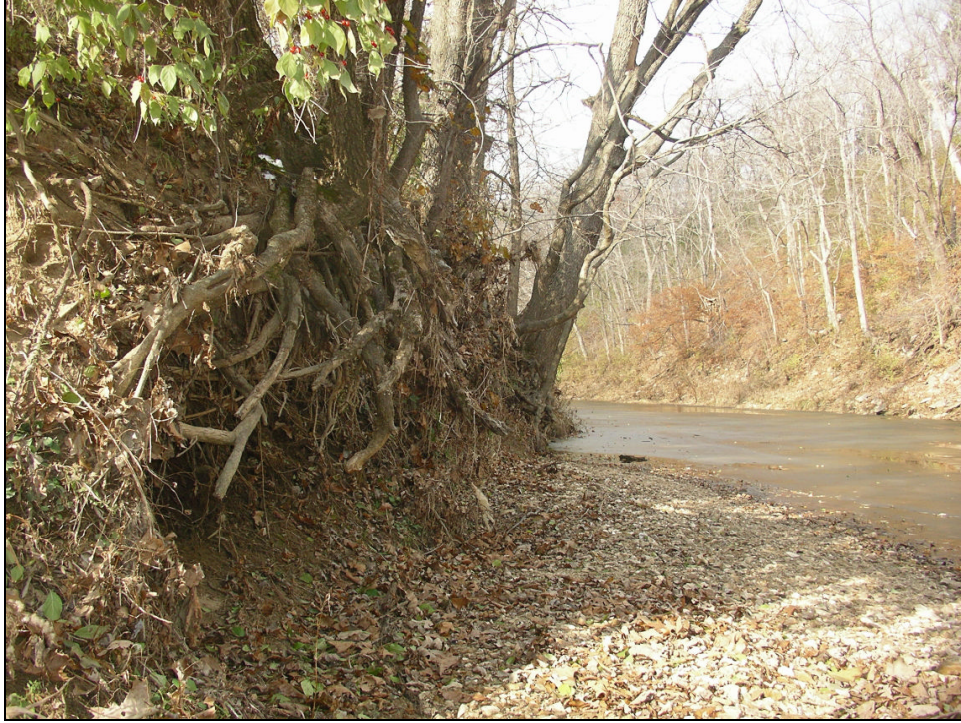
Photo 4. Undercut bank along Peruque Creek.

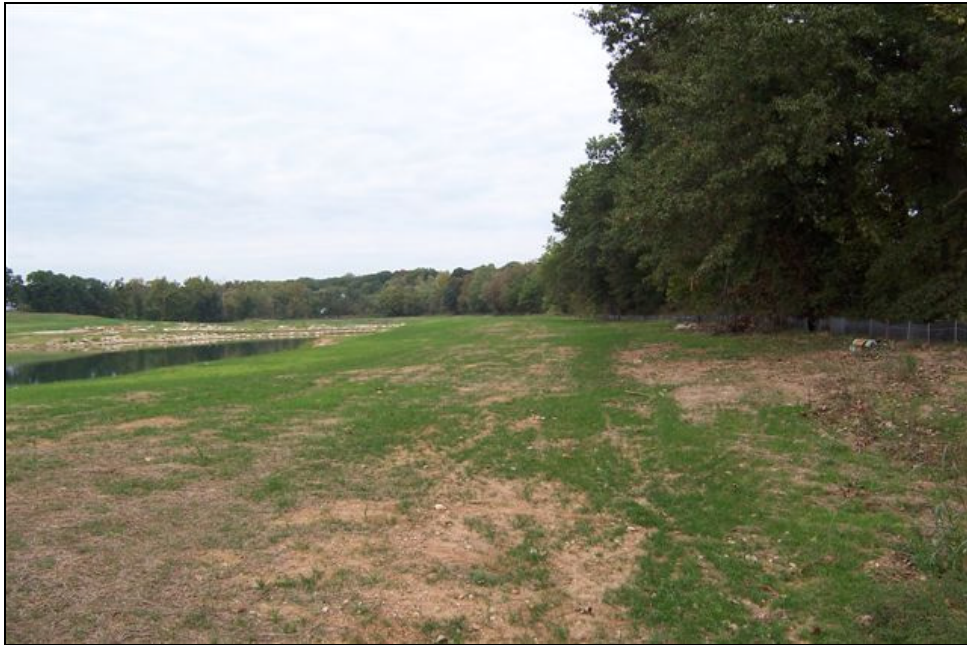
Areas of open floodplain adjacent to Peruque Creek, totaling approximately 14 acres and accounting for 41 percent of the 34 acres of total stream buffer, will be seeding with native herbaceous species and planted with native woody species (see Photo 5, below). The approximate locations of buffer enhancement planting are shown on Figure 3.

Photo 5. Buffer planting area adjacent to Peruque Creek.

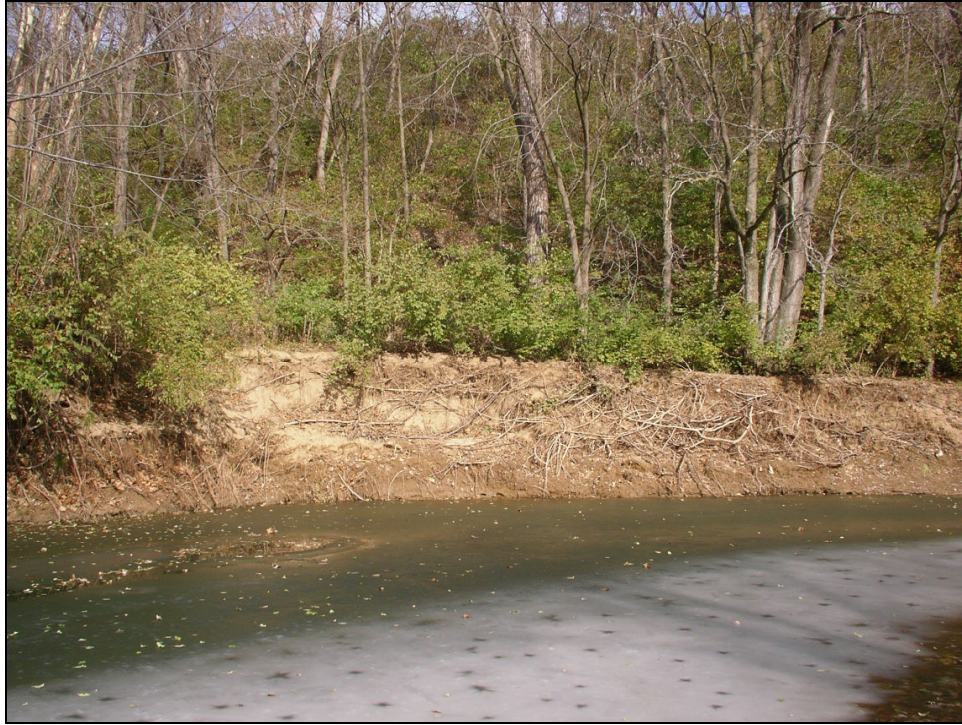
Invasive species appearing on the *Missouri Invasive Plant Species List – Regional Condition 3*, will be controlled, to the extent possible, from the 42-acre Peruque Creek Mitigation Site. These species primarily comprise Bush Honeysuckle and Johnson grass (see Photo 6, below).

Photo 6. Bush Honeysuckle along bank of Peruque Creek.
