SUBJECT: MVS Report on the Grade Control Structure, Carlyle Lake/Kaskaskia Navigation Project

2. MVS Technical Report M27 (enclosed) has been prepared in partial fulfillment of the guidance provided in reference 1b above. This report concludes that the Kaskaskia Navigation Project Grade Control Structure at river mile 35.9 is operating as designed. The report finds that impacts are occurring off project lands to, private property, the associated watershed ecosystem and the riverbed and channel as a result of the Kaskaskia Navigation project initial canalization.

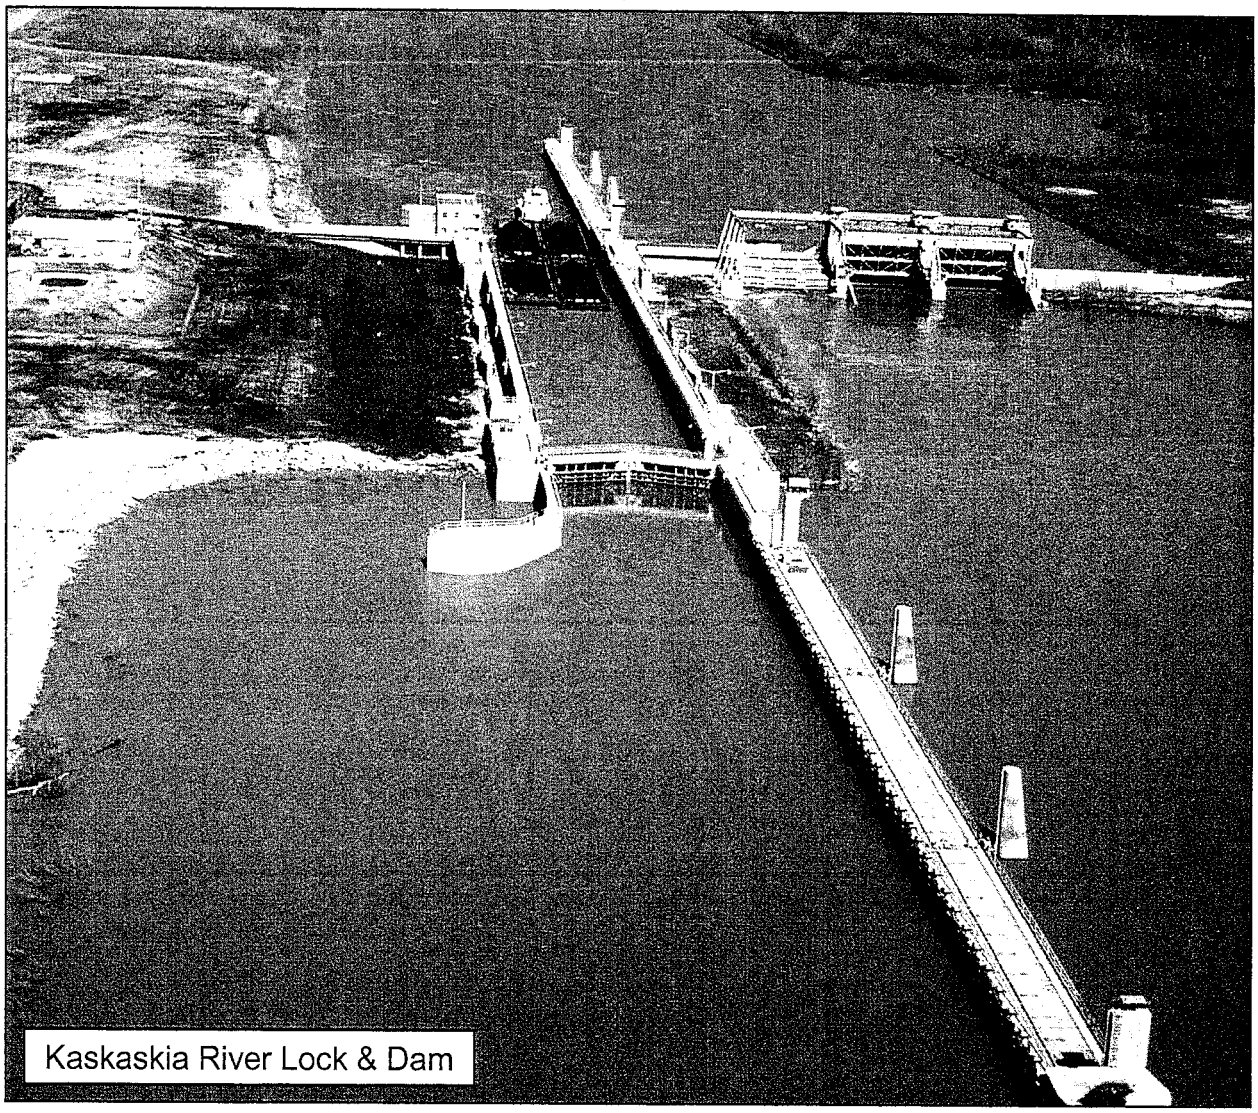
Figure 3

The Lock and Dam (Figure 3), completed in 1974, consists of a single lock, 600 feet long by 84 feet wide. A 130 foot long gated spillway with two 60-foot-wide control gates is utilized to regulate a maximum regulated navigation pool of 368.0 NGVD. (A pool deviation of +0.8 feet has been in use since May of 1988 to address shallow water conditions in the mouths of the numerous remnant channels).
