**US Army Corps  
of Engineers,**  
St. Louis District

# **Archaeological Research Collections Center Evaluations for the U.S. Department of Interior Bureau of Reclamation Great Plains Region**

## **Final**

**March 2004**

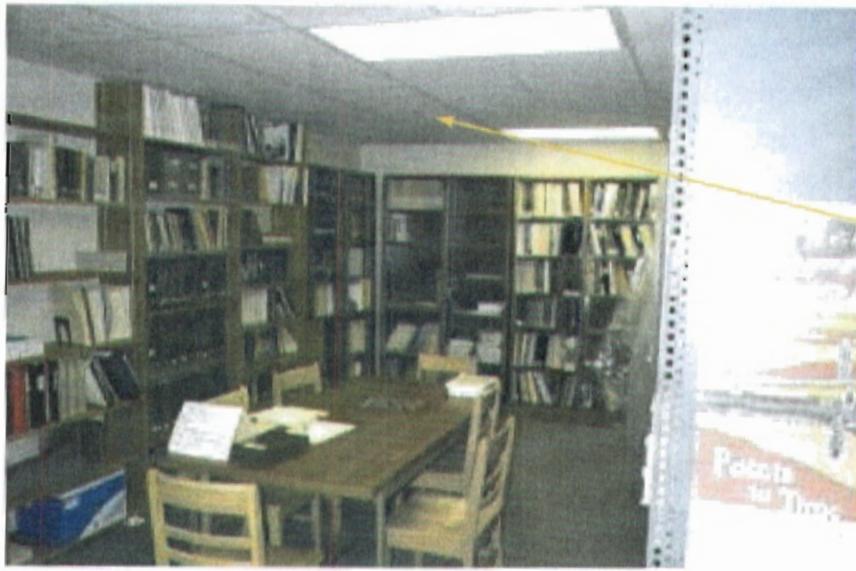
Figure 7. NSHS third floor research area.

Sprinkler system head for the water-based fire-suppression system installed throughout the building

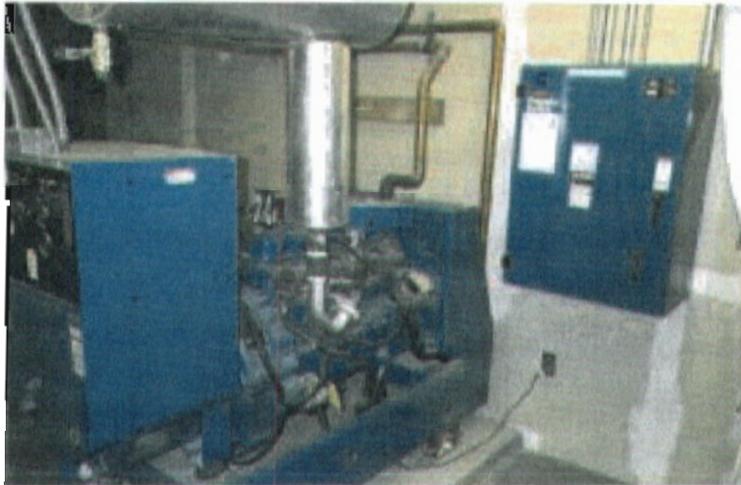
laboratory showed readings of 74° F with a two-degree fluctuation for the week. The RH reading ranged from a low of 48% to a high of 68%. In contrast, the basement climate readings were stable showing a constant temperature of 65 degrees F and a constant RH reading of 45%. The collections manger indicated both instruments are in good working condition. An emergency generator ensures uninterrupted electrical power to the building in the event there is a power outage by the local utility supplier (Figure 17).

**Figure 17. View of the emergency generator.**

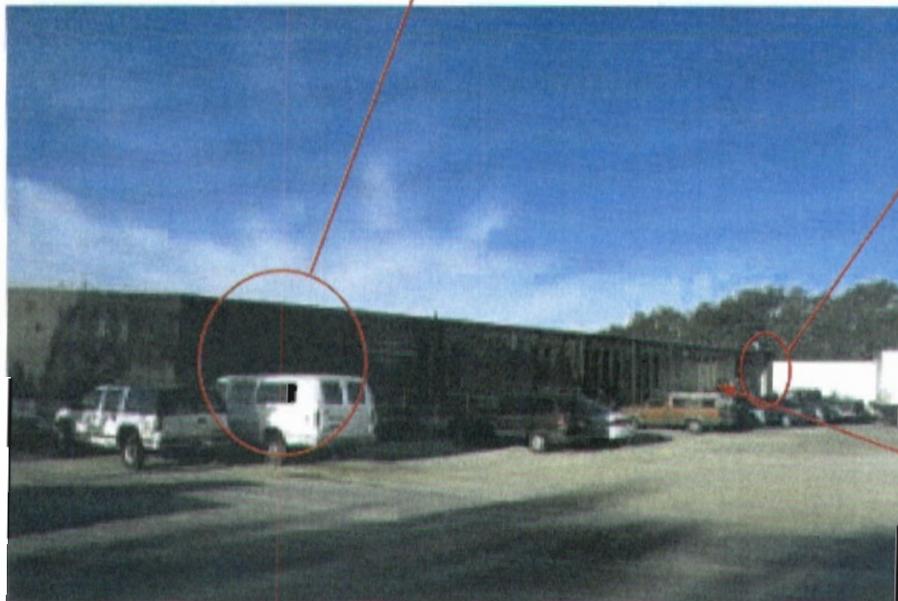
The South loading dock is the only accessible entrance to the CAR

Figure 23. Front or east side of CAR. The main entrance is in the center. Facing the parking lot are 10 large windows.

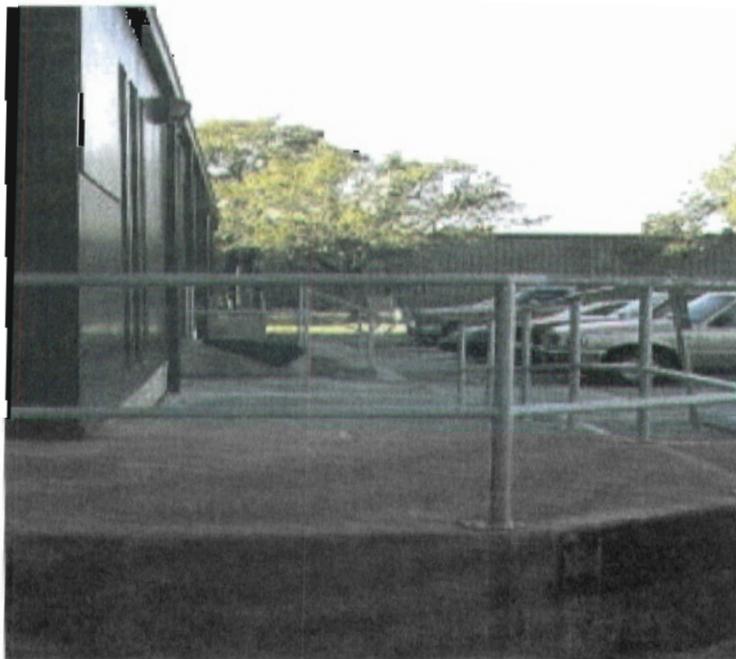
**Figure 26. ADA-accessible ramp at the south loading dock.**

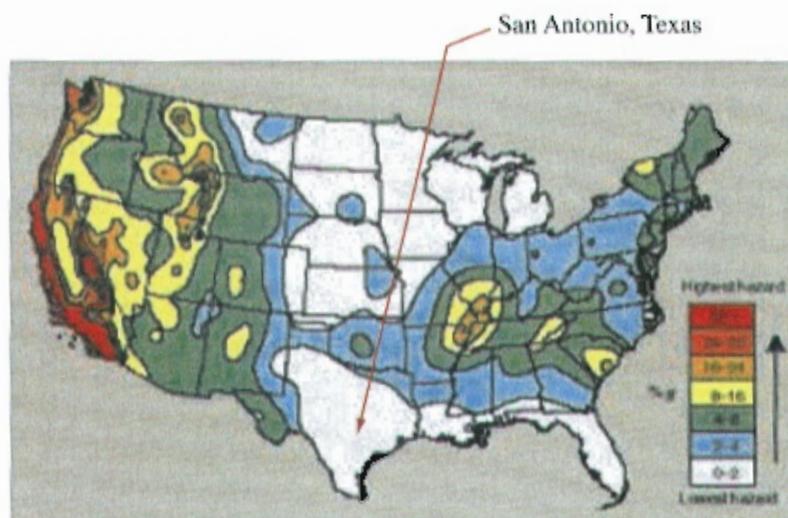
Figure 38. USGS National Seismic Hazard Map. San Antonio, Texas, is located in a low hazard seismic zone.

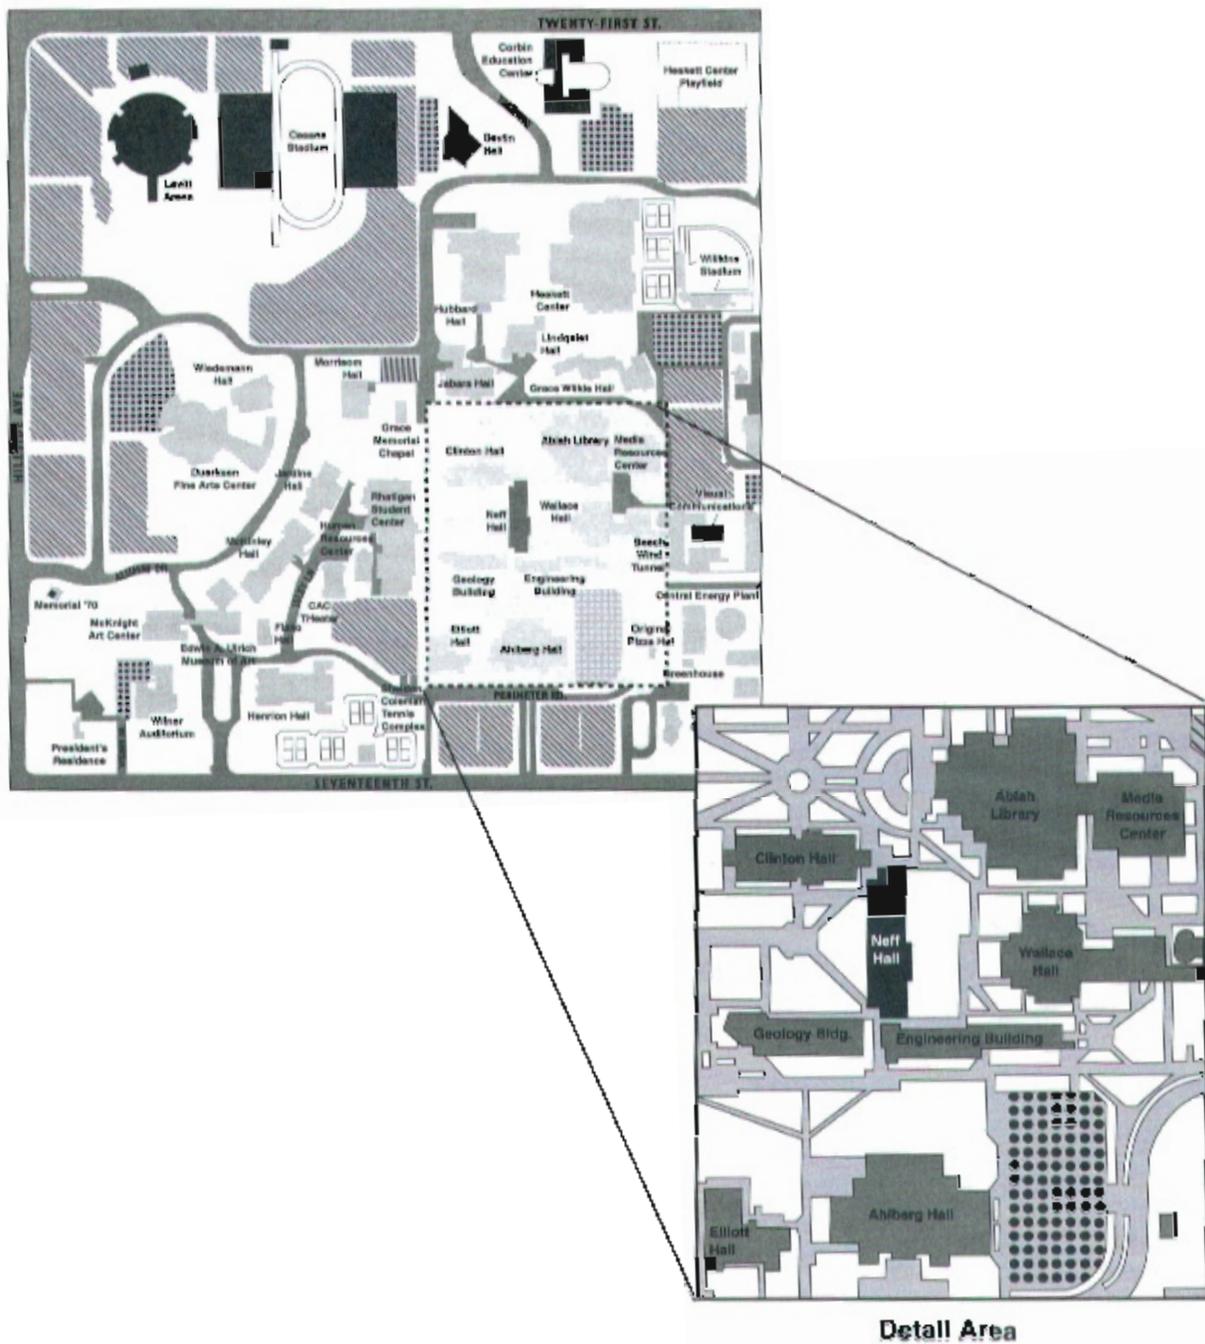
This results in the building being hard to locate for a first-time visitor and challenging for a disabled scholar who might drive to campus. A mixture of overstory trees, small flowering trees, and deciduous and evergreen shrub foundation plantings enhances the image of the building.

Figure 41. Partial campus map of Wichita State University. Note how inaccessible Neff Hall is to the campus parking lots; the closest one is located east of Ahlberg Hall.

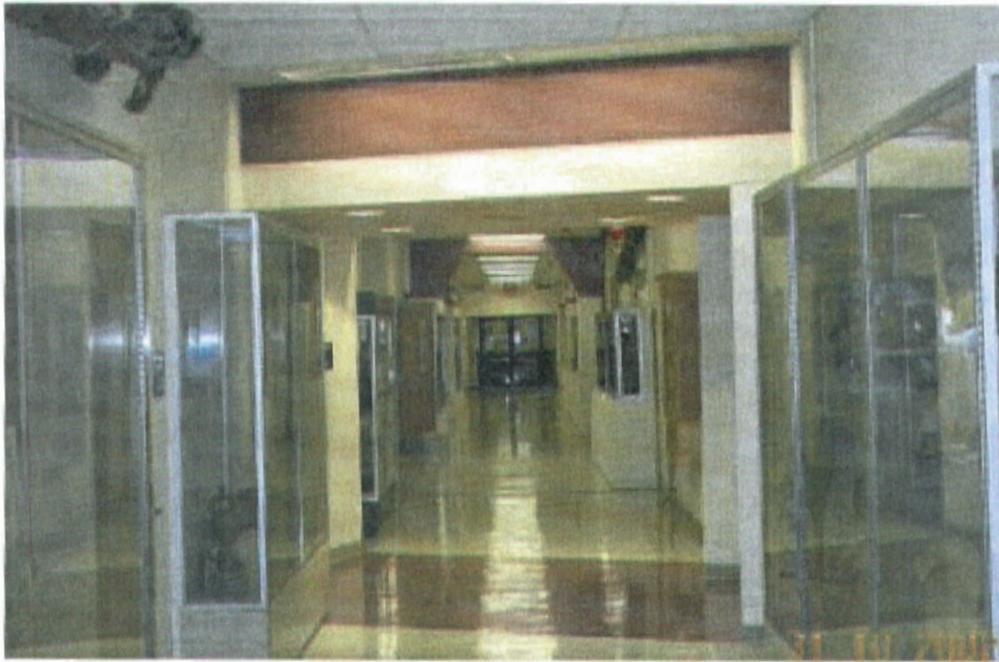
The building is well maintained, clean, and had no visible sign of insect infestation. Extremely wide corridors allow for display cases and exhibits to be installed on both sides without encroaching on the safe width required for exiting (Figure 43). As reported, the campus fire marshal monitors this situation. Wide corridors also exist on the second floor (Figure 44).

**Figure 43. First floor corridor in Neff Hall.**

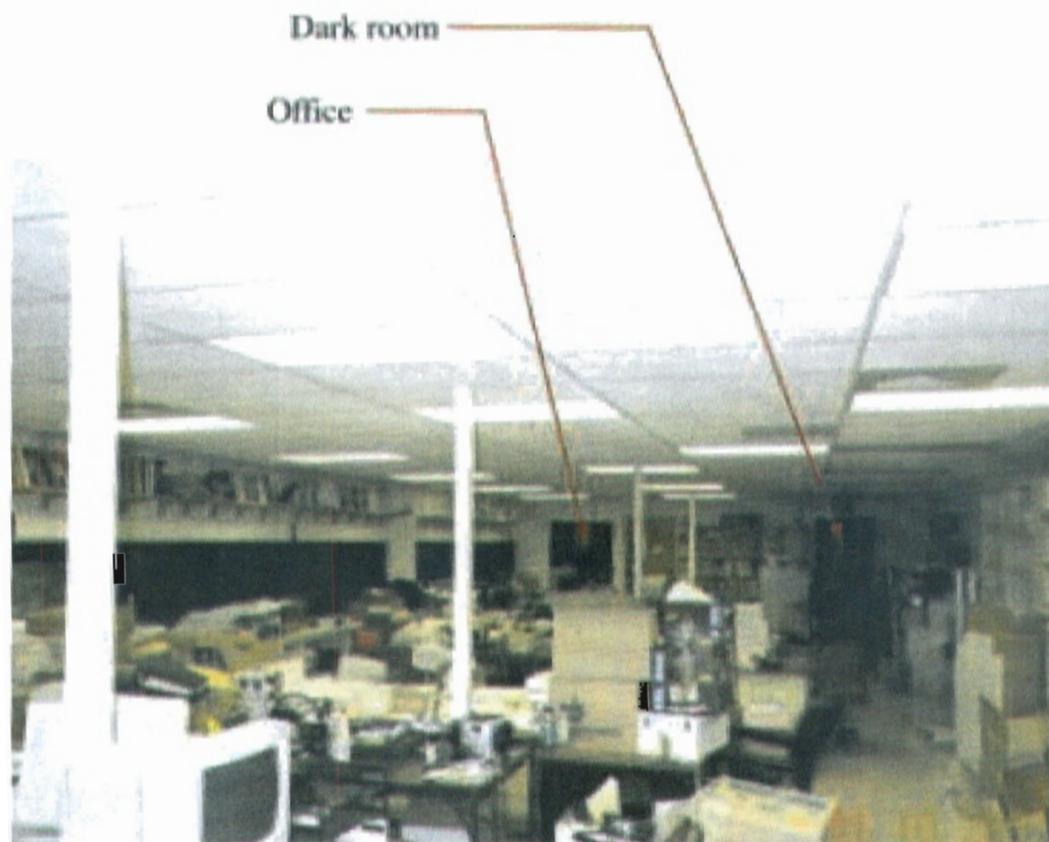
Electrical power to the rooms is supplied inside power poles that extend from the ceiling and are aligned along the center of the room. This is a typical method used to supply electrical power to the center of large rooms such as the Zooarchaeology Research Laboratory (Figure 47). Only one room (Room 218) in Neff Hall has a fume hood, which is vented to the exterior (Figure 48). As reported, acetone is the only chemical used in the building and is used only with the aid of the fume hood.

Figure 47. The Zooarchaeology Research Laboratory (Room 202) at WSU. Note the poles in the middle of the room that are used for electrical wiring.

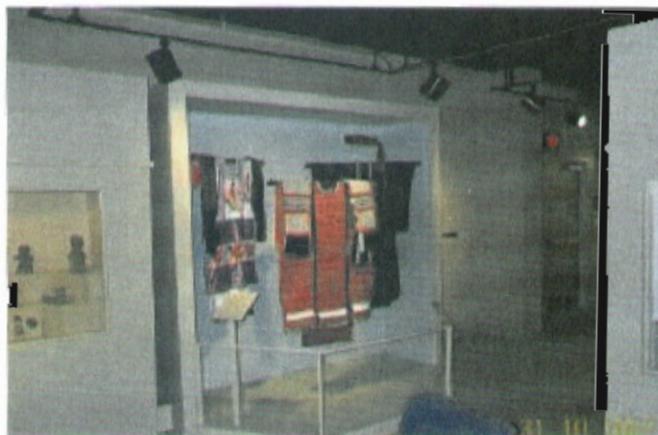
**Figure 50.** A student-built exhibit in the Museum gallery.

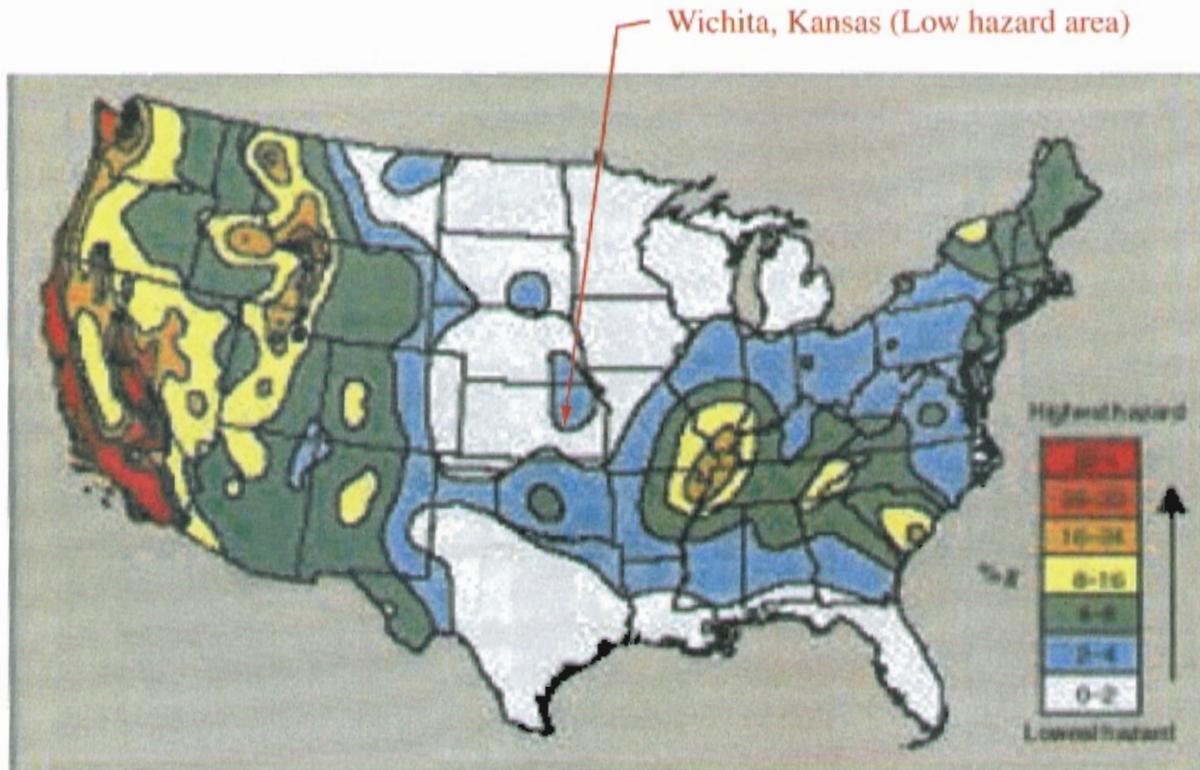
Neff Hall is in a low earthquake hazard area of the United States, and as a result, the probability of an earthquake occurring and subsequent damage and injury are minimal (Figure 52). Below is a seismic hazard map that illustrates seismic zones through the United States.

Figure 52. U.S.G.S. National Seismic Hazard map. A crosscheck with the seismic zone map of the U.S. contained in UBC Chapter 16 indicates Wichita, Kansas, is located in Zone 1.

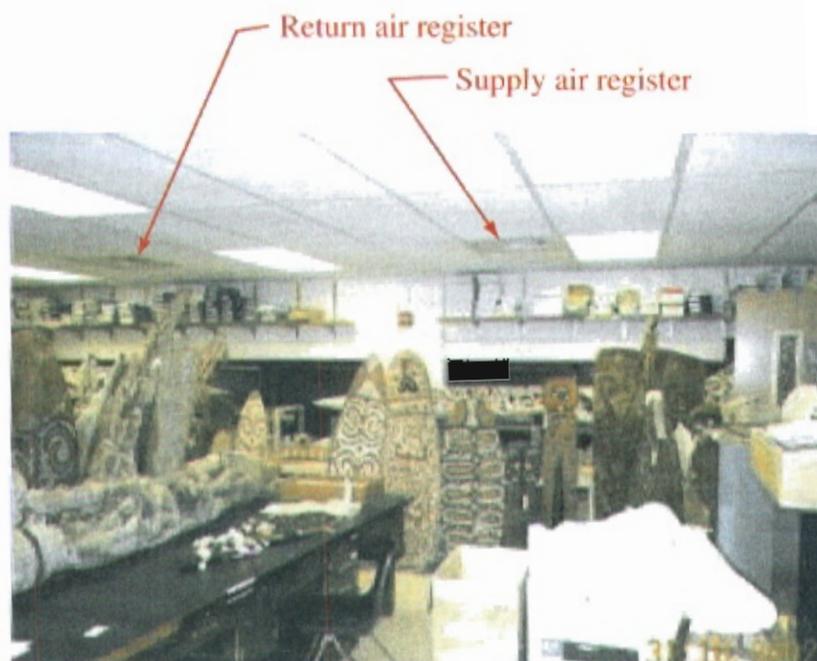
**Figure 53.** Room 103 is referred to as the Southwest Archaeological Research Lab, and it contains the Asmat Western New Guinea collection. Supply and return air registers are mounted in the ceiling.

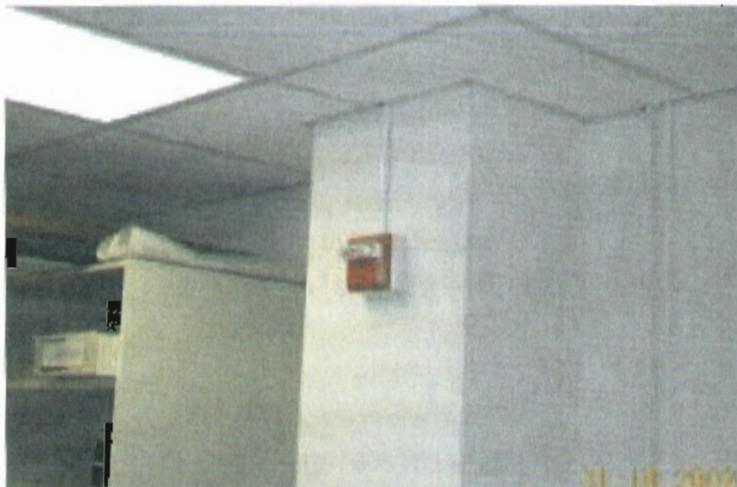
Per the 1994 Uniform Building Code, UBC (local code), and the National Fire Protection Association Code (NFPA 101 followed by the state of Kansas), the concrete construction materials used for Neff Hall allow the building to be classified as "fire-resistive," which means the likelihood of the building structure burning is minimal. Neff Hall serves students above the 12th grade and falls under the UBC occupancy classification as "B" or business. The location of Neff Hall on the WSU campus is such that the space immediately adjacent to three exterior sides is essentially open and not occupied by another building. As a result, the likelihood of a fire (in Neff) spreading to or from an adjacent building is negligible. Because the building is open on three sides, typical area limitations for this type of structure, at 8,000 square feet per floor, can be doubled. In other words, the maximum area per floor is 16,000 square feet or a total for both floors of 32,000 square feet. The actual size of Neff is 29,004 square feet. The UBC and NFPA were referenced to determine whether the building was required to have an automatic sprinkler system installed, and in both situations it was not. Typically, if the local and state building codes do not require an automatic fire suppression system, one will not be installed and the situation at Neff is normal. Code-required detection, alarm, and communication systems have been installed and are visible to users of the building (Figure 55). In the event of a fire, the alarm is energized and an auto-dialer system calls the police department and reads a recorded message.

Figure 55. Fire alarm enunciator in Room 202.
