## GUIDANCE FOR CCTV AND SONAR INSPECTION PIPES PENETRATING LEVEES

FEBRUARY 2013

## Flood Wall / Inspection: Gate 150

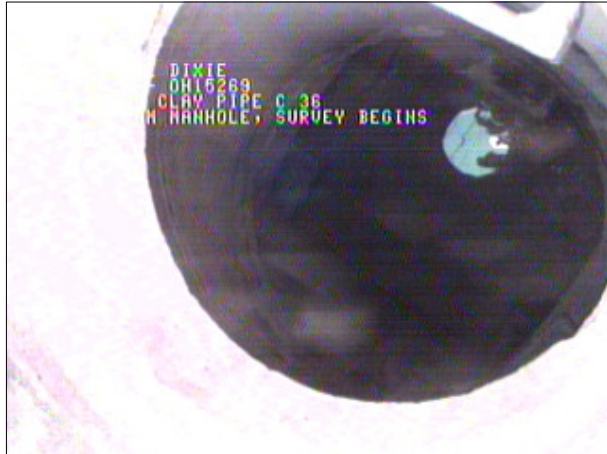
Photo: OH15269\_OH15266123825\_05112009\_A.JPG, VCR No.: FLOOD WALL#2, 01:42:22  
0FT, Downstream Manhole, Survey Begins

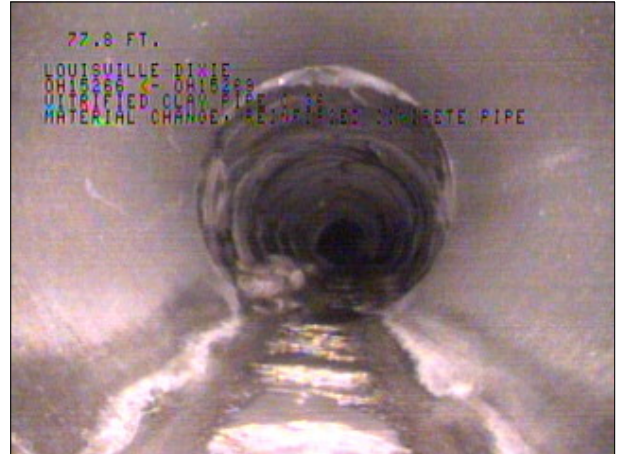
Photo: OH15269\_OH15266124720\_05112009\_A.JPG, VCR  
No.: FLOOD WALL#2, 01:45:49  
77.8FT, Material Change, Reinforced concrete pipe

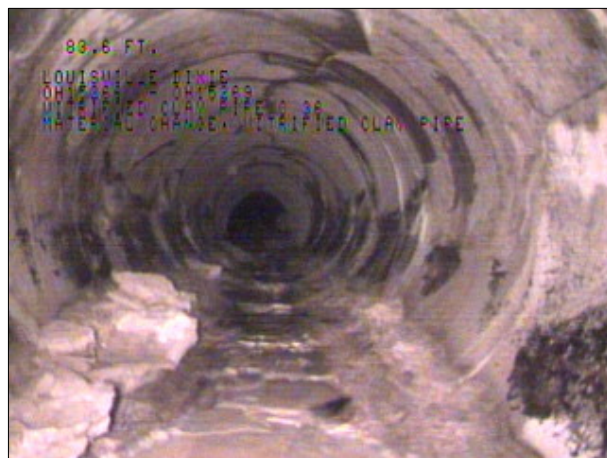
Photo: OH15269\_OH15266124748\_05112009\_A.JPG, VCR  
No.: FLOOD WALL#2, 01:46:07  
83.6FT, Material Change, Vitrified clay pipe

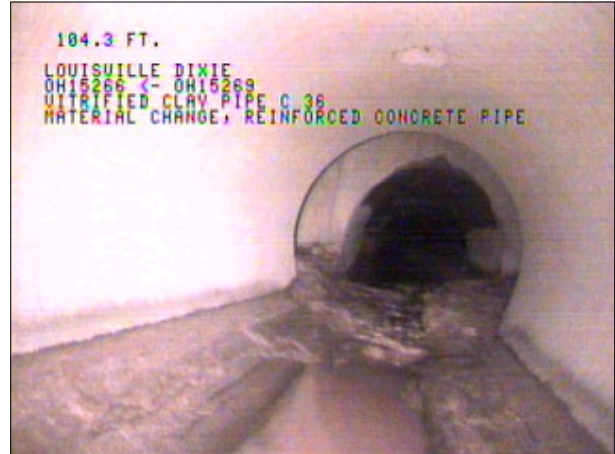
Photo: OH15269\_OH15266124907\_05112009\_A.JPG, VCR  
No.: FLOOD WALL#2, 01:46:54  
104.3FT, Material Change, Reinforced concrete pipe

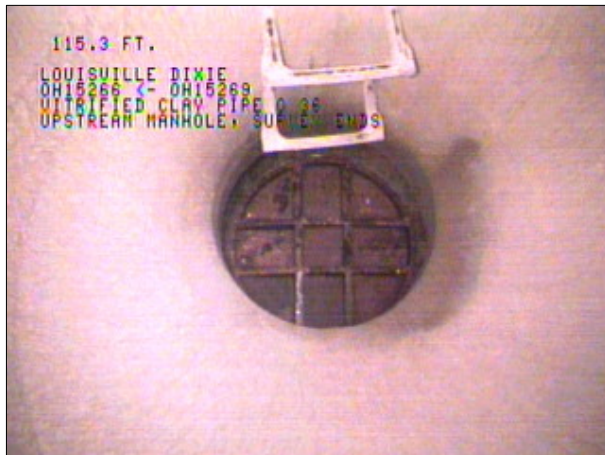
Photo: OH15269\_OH15266124956\_05112009\_A.JPG, VCR  
No.: FLOOD WALL#2, 01:47:25  
115.3FT, Upstream Manhole, Survey Ends
