Swan Lake Habitat Rehabilitation and Enhancement Project, Flood Damage Assessment Letter Report with Environmental Assessment

US Army Corps of Engineers 1222 Spruce St. St. Louis, MO 63103 December 2022

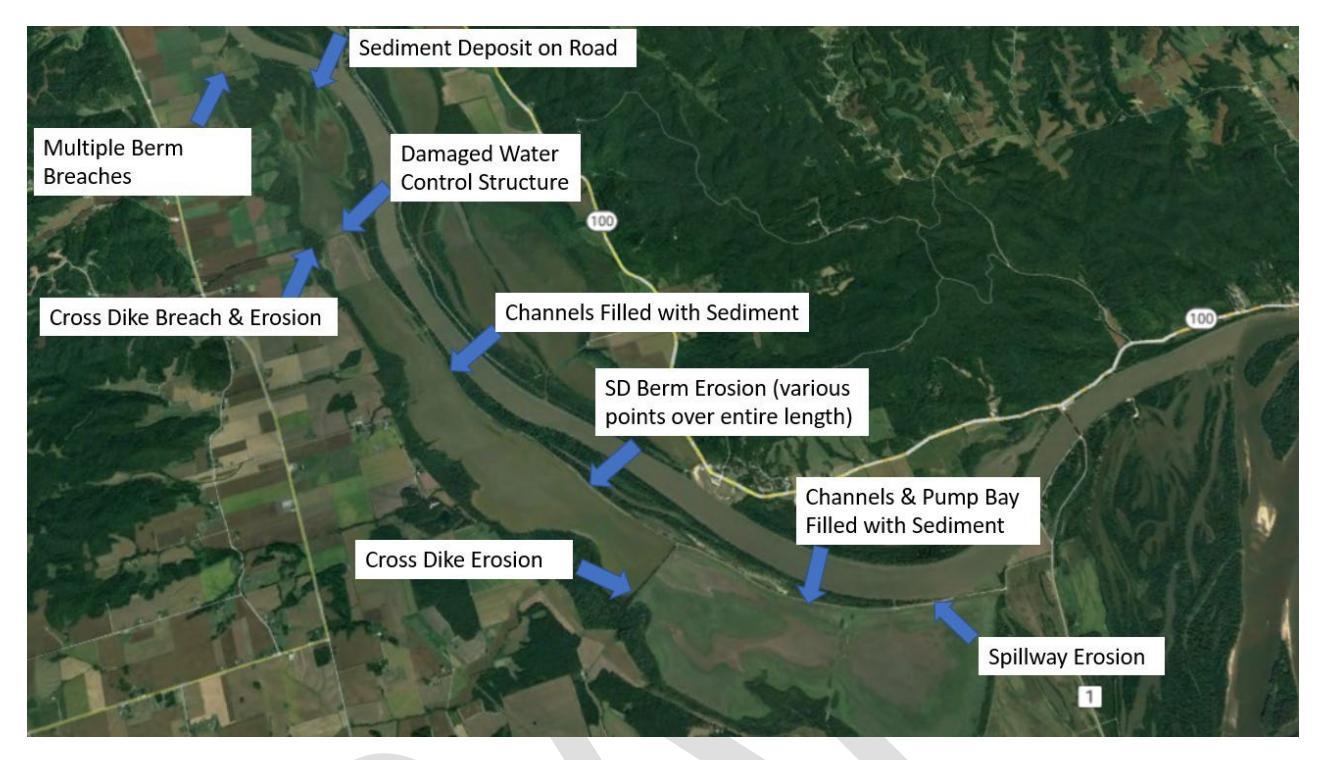
Figure 5. Issues Affecting Swan Lake Functionality

A team of personnel from US Army Corps of Engineers (USACE), USFWS, and IDNR visited the site to evaluate the flood damages and take a holistic approach to repairing the system with resiliency to enable it to function as intended. The first site visit was conducted in October 2021 with a follow up site visit in December 2021. During the October 2021 site visit, the team viewed the damages at Lower and Middle Swan Lake. They accessed the southern end of Fuller Lake by the cross dike and pump station, but road conditions prevented access to the majority of the berm along Fuller Lake. The second site visit predominantly focused on viewing the cross dike between Middle Swan and Fuller Lake, as well as multiple breaches on the berm near the tie into higher elevation at Fuller Lake. Figure 5 below shows approximate locations of the major problems noted at those site visits. These are the problems recommended to be

addressed with the Repair with Resiliency Alternative. A comprehensive list of all the problems observed can be found in Appendix A.

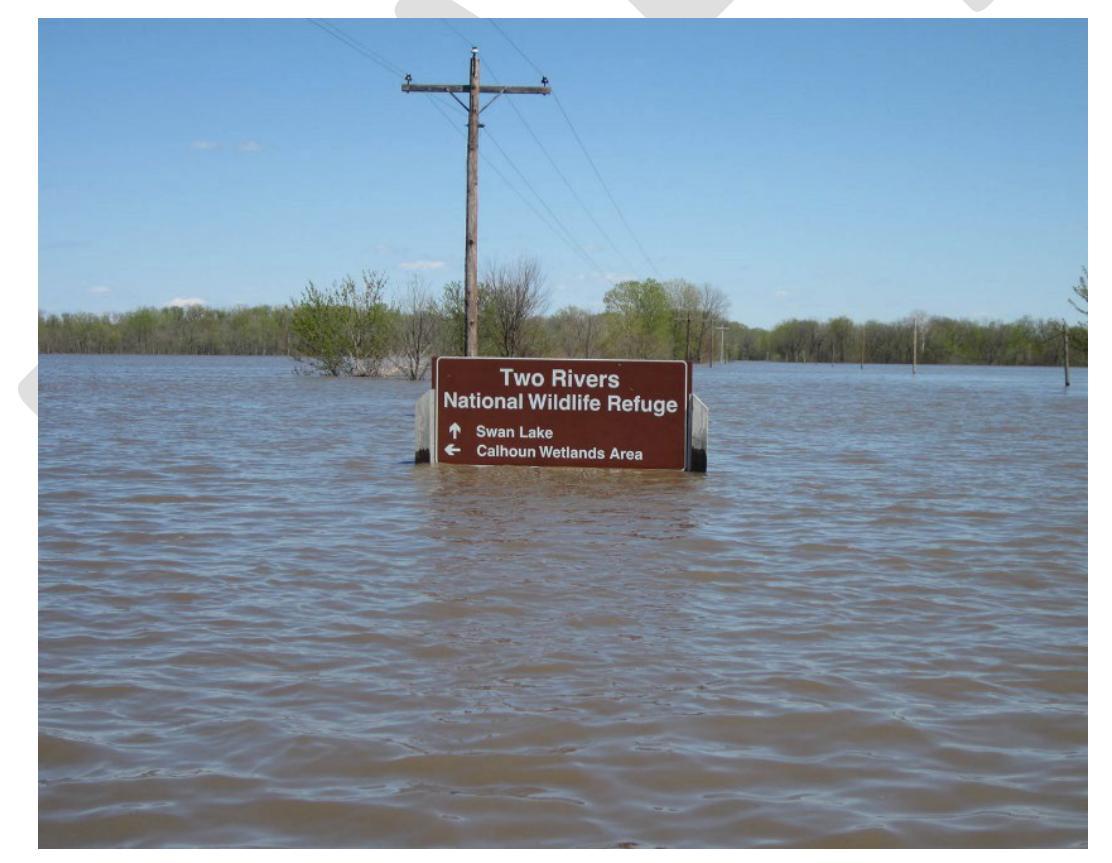
Figure 6: 2019 Flooding at Two Rivers NWR (Photo courtesy of: www.riverbender.com)

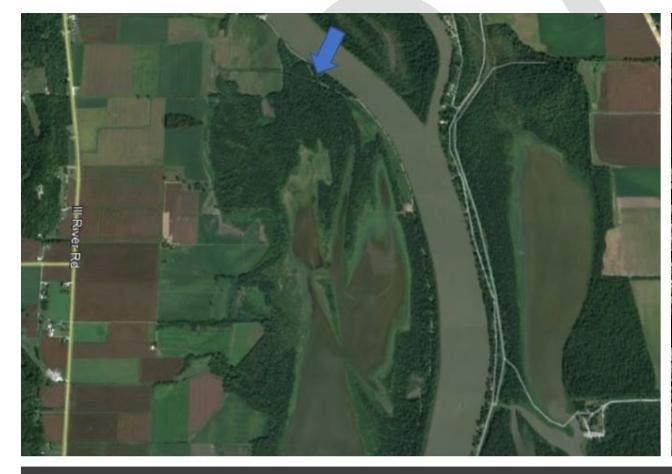
Aerial depicting approximate location of sediment deposition

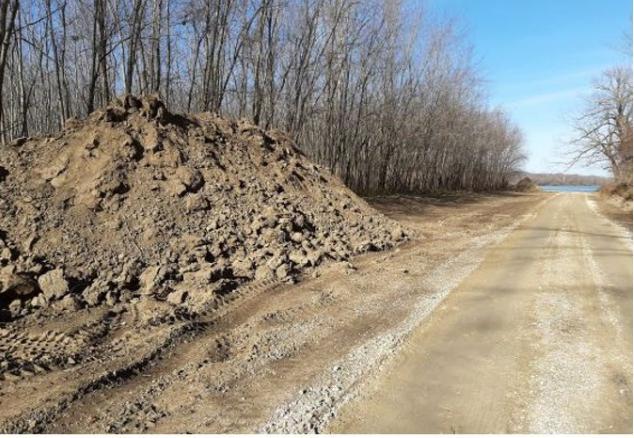
Sedimentation on road- Fuller Lake

Ground level view of sediment deposition/removal on road. Road now sits about 4ft lower than surrounding land due to years of sediment deposition.

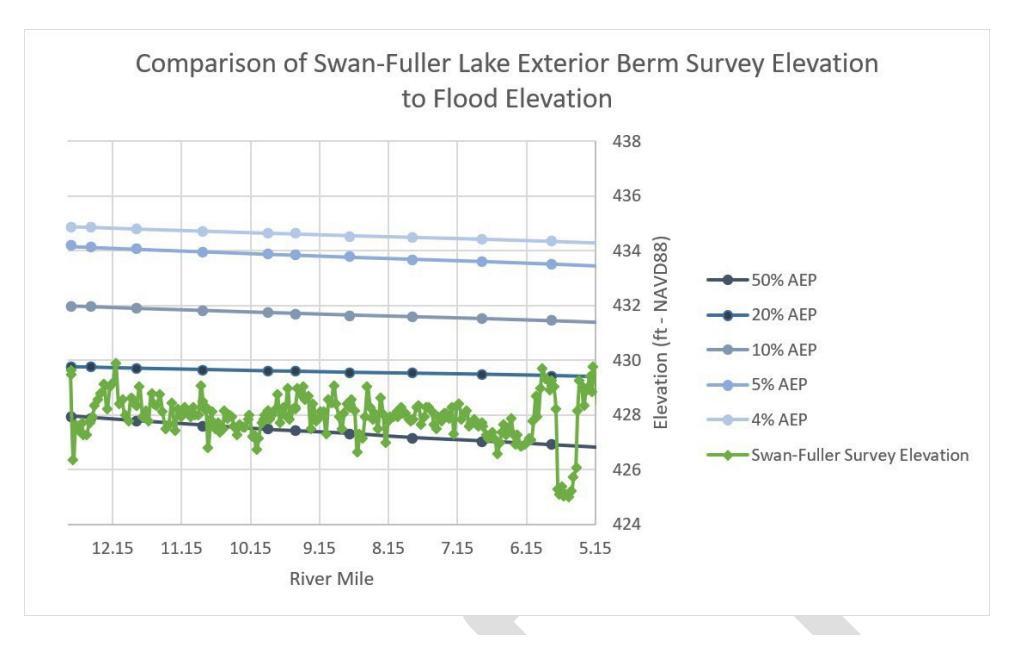
Comparison of Swan-Fuller Lake Proposed Exterior Berm Elevation to Flood Elevation

The frequency of overtopping was determined by plotting the berm elevation against flood elevations. Fuller Lake and Swan Lake both have locations that are currently below the 50% AEP flood event level. Additionally, the vast majority of the sedimentation deflection berm is below the 20% AEP flood event level. The proposed berm realignment and restoration to as-built elevations result in the Fuller Lake portion of the berm being above the 20% AEP flood event level, specifically at a 16% AEP level, and the spillway on Lower Swan being between the 50% AEP and 20% AEP flood event levels, specifically at a 34% AEP level. Figure 14 shows plots of the berm elevation against flood elevations.

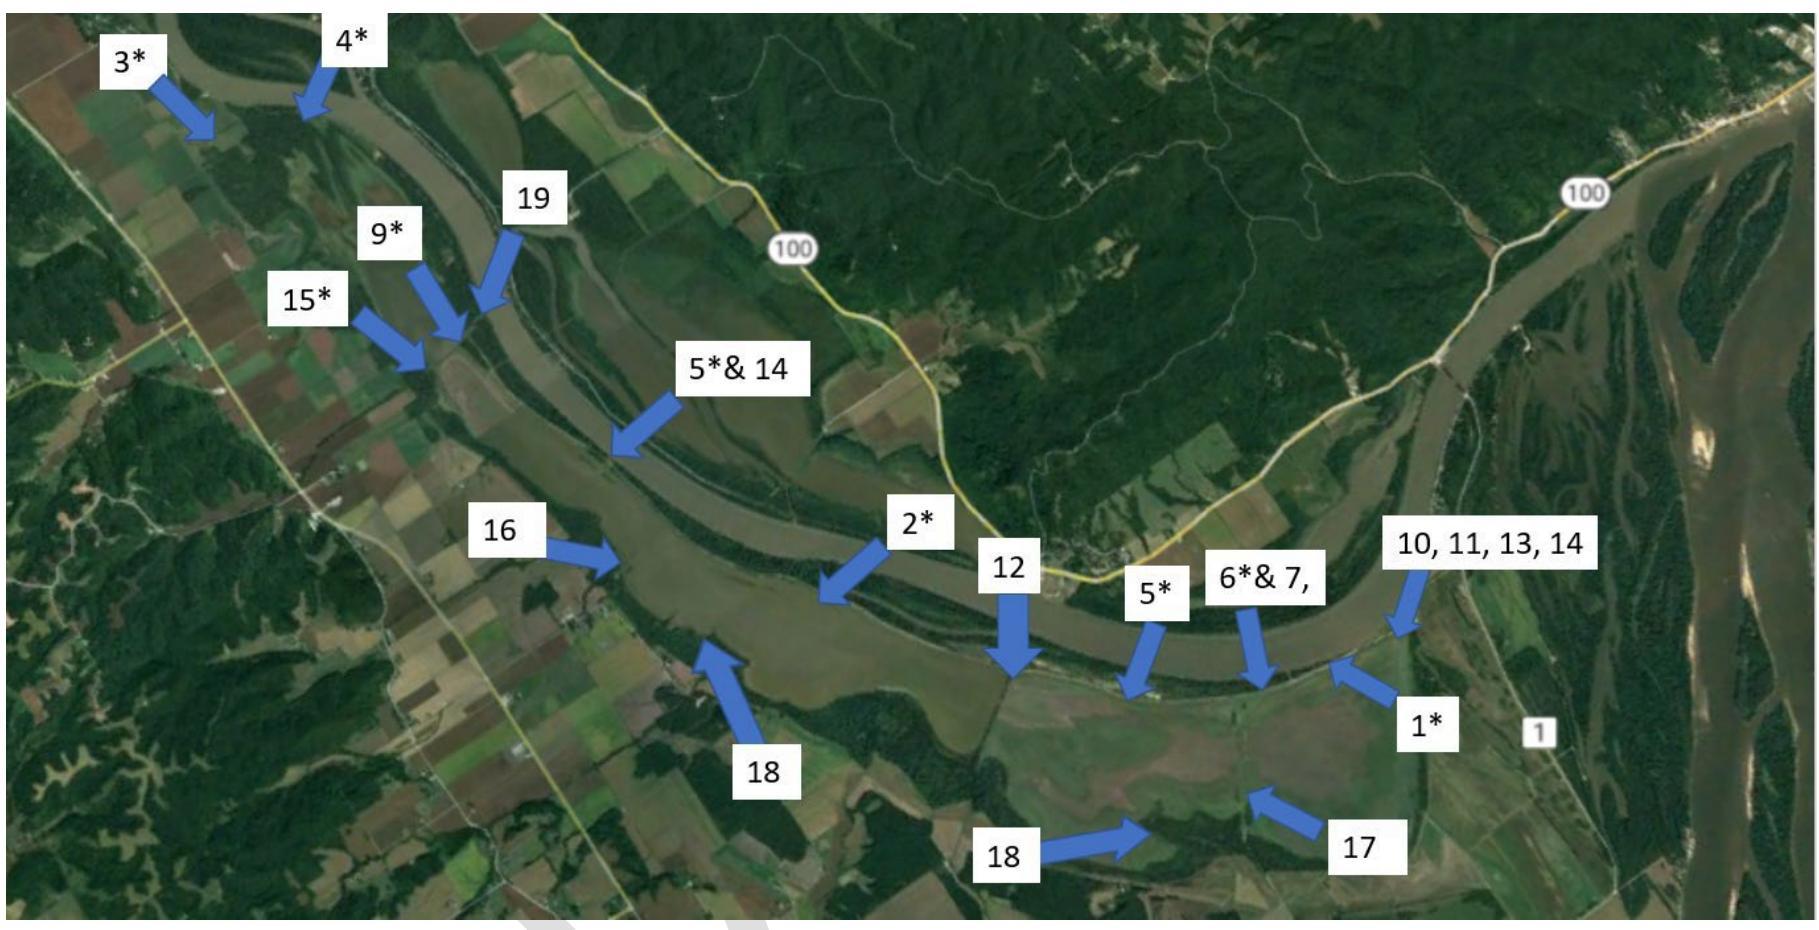
Figure A- 1: Map of Approximate Locations of Problems at Swan Lake (2022)

15 (*)	Breaches in cross dike between Middle and Fuller due to flood events	Repair cross dike between Fuller/Middle Swan to as built conditions and remove spillway to separate management	FDA/Other
16	Middle Swan Islands severely eroded and are non-functional due to flood events	Repair Islands	FDA/Other
17	Lower Swan Islands eroded but had rock protection so still exist. Floods continue to erode.	Repair Islands	 FDA/ Other
18	Significant upload flow contributing to water volume and sedimentation	Reduce upland flow entering lake	Other

19	Fuller Lake Pump- Mechanical components subject to failure / high maintenance needs due to excessive sedimentation in channels and forebay from flood events	Repair OR Replace pump & dredge channels	Other

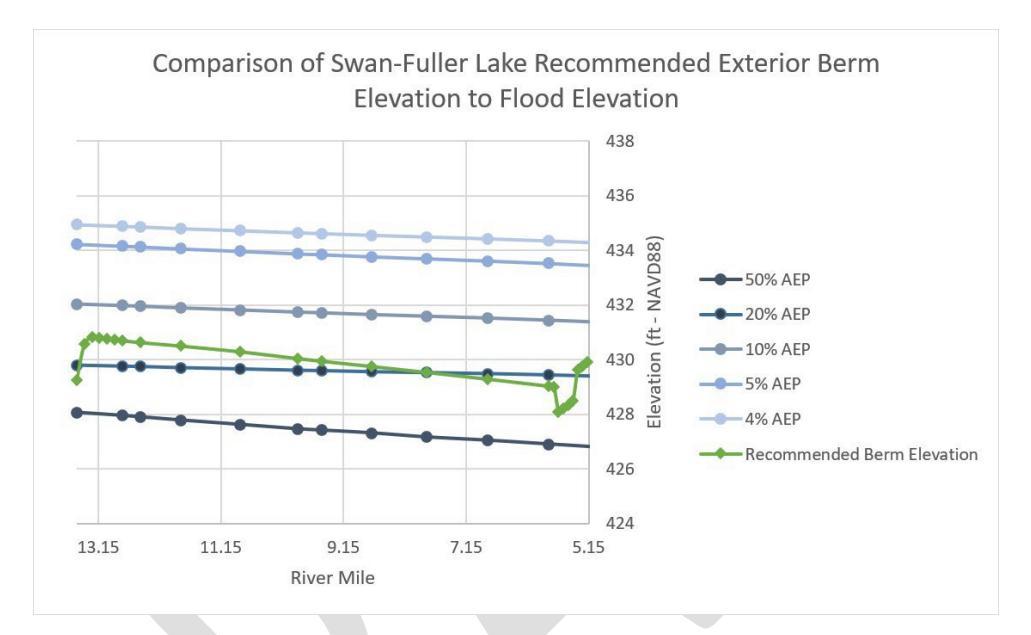
Figure E - 2: Comparison of Recommended Berm Configuration Elevation to Flood Elevation

The frequency of overtopping for the recommended berm configuration was also evaluated. Figure E - 2 shows the elevation of the recommended realignment and recommended

restoration to as-built conditions plotted against flood elevations. The recommended berm configuration would bring the entire system above the 50% AEP flood event. Additionally, the Fuller Lake portion of the system would be above the 20% AEP flood event, while the southern portion of Swan Lake would be between the 50% AEP and 20% AEP flood events. Restoring the level of protection from the current degraded state would reduce the frequency of sediment laden water entering the area, reducing the amount of sedimentation interior to the berm.

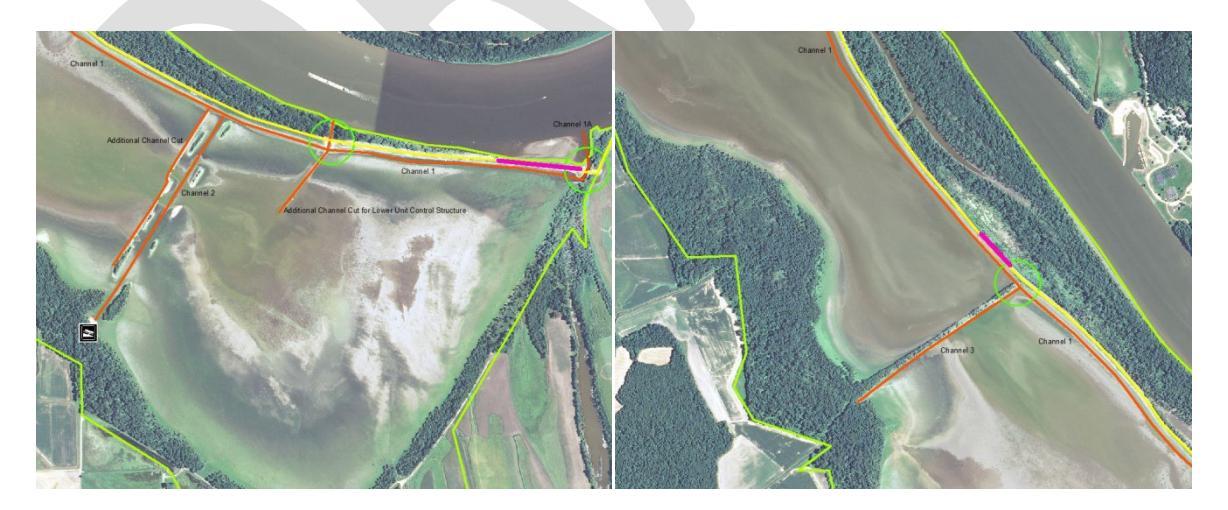
2020 Inspection Results: Wave action/wind fetch and flooding was observed to have caused severe sedimentation in channels. 3-4 inches of sediment were removed from the top of the Middle Swan berm after the 2019 flood; estimates of sedimentation deposition in the lake channels were likely greater.

Fall 2021 Site Visit Results: Sedimentation observed in previous inspections remained unchanged or potentially increased as a result of continued wave action and wind fetch.

Figure G - 2: Channel Cuts 1, 1A, 2 and 3 Completed to Facilitate Watering and Dewatering

Recommendations / Considerations: Siltation will always be an issue with the backwaters on the Illinois River. The life expectancy of these channel cuts could be relatively short, depending on the exposure to sedimentation. Movement of flocculent material in the lake bottom via wave action occurs nearly continuously and flood events can bring in a substantial amount of sediment in a very short period of time. Care should be taken in the design process to consider all sources of sediment and limit the exposure of the excavated channels. Routing of upland sediment to alternate locations for deposition and appropriate berm protection from adjacent river flows are critical design decisions. Additional consideration of the quality of the dredge material should also be considered for use of the dredged material for other project features.

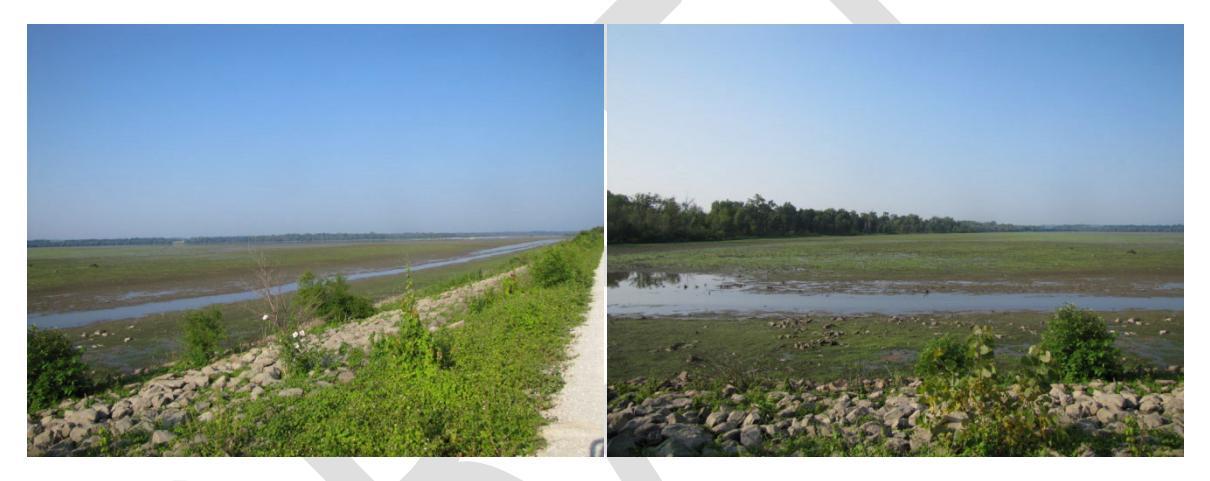
Figure G - 4: Channel Cut 1 Near the Lower Swan Spillway

2013 Inspection Results: Channel 1 is was observed to be failing to act as overwintering habitat for fish. Siltation, loss of depth, and current management were all contributing factors to the failure of channel 1 to act as an overwintering habitat for fish. Originally, Lower Swan was to be managed for fishery habitats and Middle Swan for emergent vegetation and waterfowl habitats, but because of dewatering capability, the management of these two units has been switched. This made river connectivity for winter habitat an issue.

Fall 2021 Site Visit Results: It was noted during the site visit that the performance of this project feature had degraded significantly due to siltation / loss of depth of the dredge cut. Water control structures connecting segments of the dredge cut were observed to have silted in completely and Site Manager workarounds (construction and removal of earthen dam material adjacent to the water control structures) were discussed.

Recommendations / Considerations: The construction of the exterior berm utilizing material from a dredge cut immediately adjacent to the dredge cut was an efficient operation. It also allowed for practical, land-based maintenance. A long-reach excavator operating from the berm could be used to dig sediment out and cast it along the landside slope; however, the rate of sedimentation has outpaced the Site Manager's ability to keep this channel open. This situation has degraded the ability of this dredge cut to function as a connection between the different units of Swan Lake. A risk analysis focusing on long term functionality of the systems / features designed for future HREPs could inform on project designs both during the planning and preconstruction, engineering, and design (PED) phases of HREPs. The analysis should recognize that Site Manager decisions based on degrading performance of individual project features will likely have a significant impact on the functionality of all other system components.

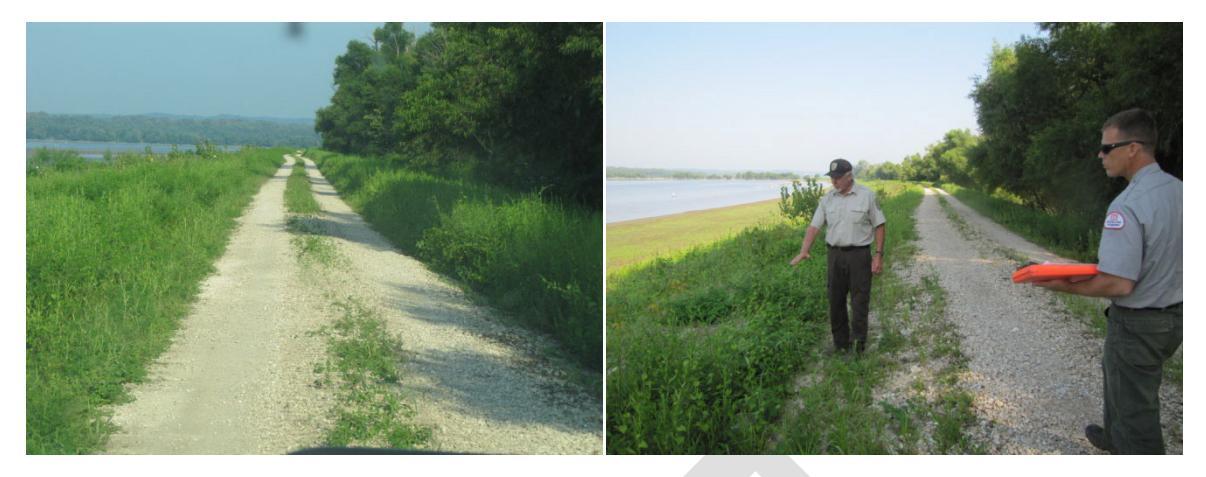
observed to have been working well and had reduced some of the issues with rock being carried away during flood events. The Middle Swan spillway had some of the riprap removed during the 2013 flood event. The steepness of the slope of the exterior berm is contributing to the instability of the riprap (according to Site Manager). Some erosion of the exterior berm from wave action was also observed.

Figure G - 8: Exterior Sediment Deflection Berm at Lower Swan Lake (North of the Pump Station)

Recommendations / Considerations: Observation of the performance of the exterior berm has led to several lessons learned. First, the slopes on the interior (Swan Lake) side of the berm are relatively gentle at 1V to 6H. However, some scour during overtopping events could be alleviated with an even more gentle, more natural slope of up to 1V to 10H, where practical. Lesser slopes of 1V to 8H in areas shown to be more at risk of scour would also likely be more resilient than as-built.

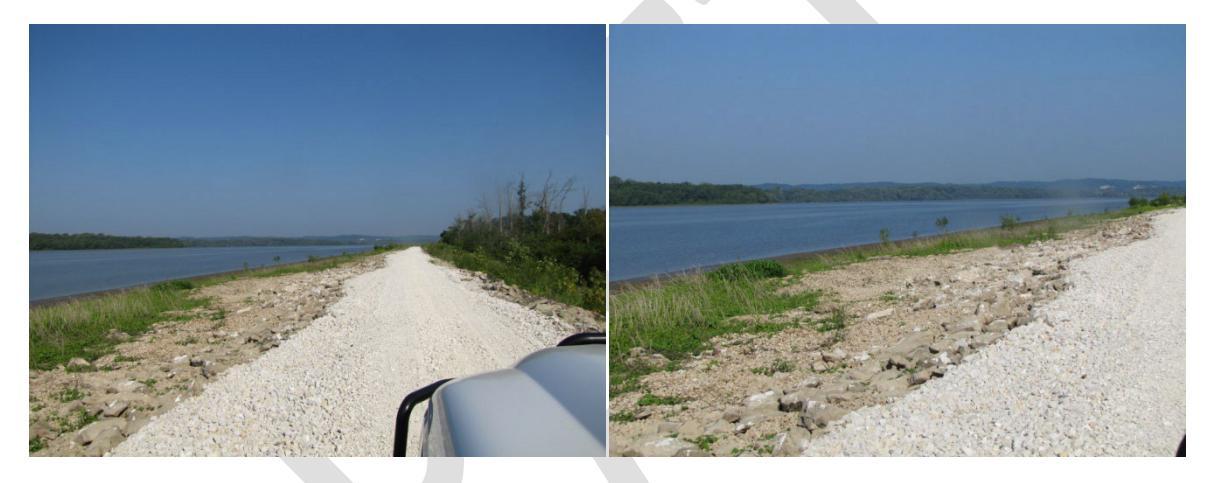
2020 Inspection Results: Site Manager indicated that there is a repetitive problem with the riprap being eroded from the roadway and spillway. Site Manager found that building a mound of large riprap immediately adjacent to and higher than the access road has greatly reduced loss of gravel from the road when the spillway overtops. The Lower Swan berm was observed to be holding up better than Middle Swan; at the time it was believed that the gentler slope and wider base of the Lower Swan berm is largely part of this reason. It has also been noted that the current condition of the berm at the time of the inspection, based on observations of previous flood events, there was very little elevation change between the upper end of Middle Swan to the lower end of Lower Swan. Since the Illinois River falls about two inches every mile, if this observation was correct, the berm would naturally more susceptible to over-topping floods on the upper end of the project.

Figure G - 9: Exterior Sediment Deflection Berm and Spillway at Middle Swan Lake (South of the Pump Station)

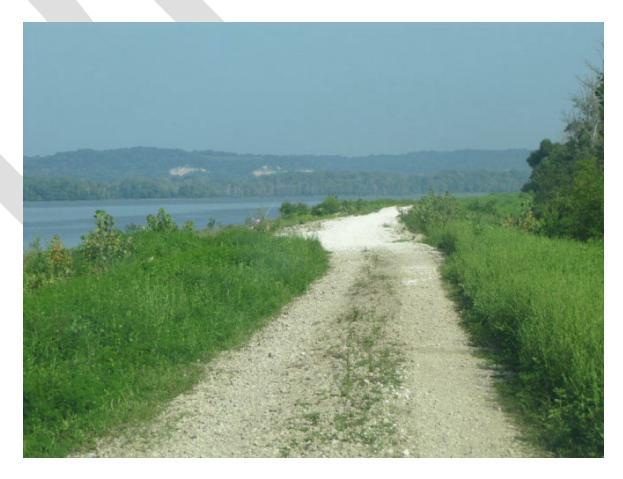
Figure G - 10: Spillway of Middle Swan Lake

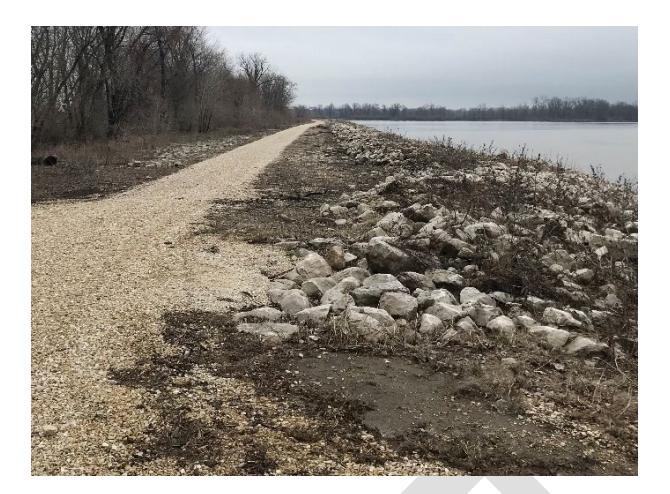
Figure G - 11: Lower Swan Lake Spillway (Notice riprap elevated above road grade to prevent gravels from washing during overtopping events. Photo taken March 2020)

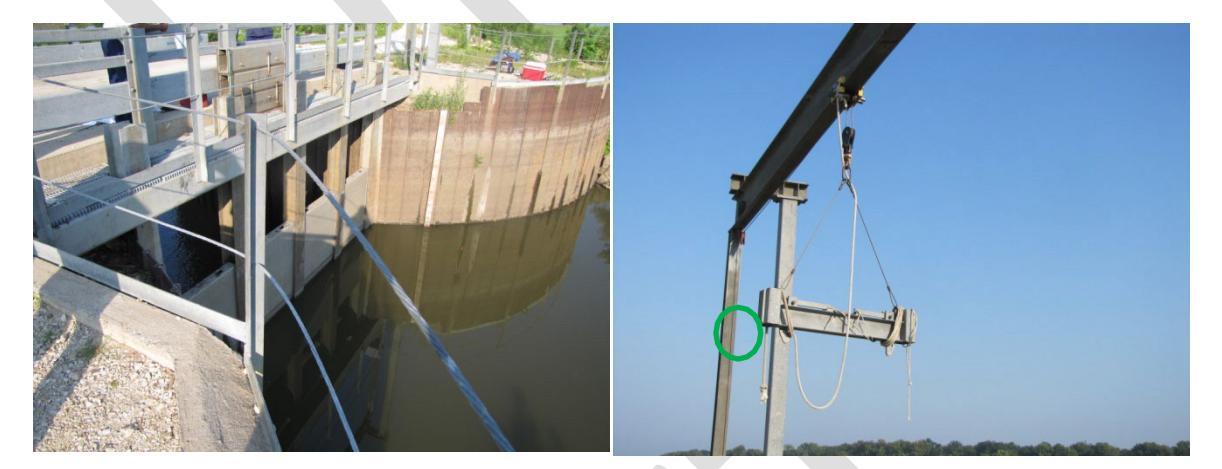
2013 Inspection Results: Site Manager was pleased with the general operation of this stoplog structure. The aluminum stoplogs operated well, but the trolly hoist required a brake along the I-beam to keep it from moving when lowering or raising the gates with the lifting beam. They did have to replace the lifting cable with a thicker cable (the lifting beam is gravity engaged and lanyard released). The lifting beam did not effectively hook into the lifting lugs on the stop logs when there was flow over the gates (Figure G - 13). The USFWS manufactured a device that allows them grab ahold of the stoplogs when there is flow (Figure G - 16), but use of the device was cumbersome because the lifting lugs would get ripped off the stoplog if they were glued on (Figure G - 20). The bolted seals have greater longevity. The widening of the control structure was sufficient to facilitate the passage of USFWS machinery. The slope leading up to the control structure and tops of cofferdams has had issues with gravel being eroded away during flood events.

Figure G - 13: Stoplog Structure and Trolley Hoist for Lower Swan Lake. (The lifting beam and hooks do not work well when there is flow.)

Recommendations / Considerations: Future lifting beam designs should include the development of a hand braking system that holds trolly in place. Additionally, hydraulic controls, the lifting beams, cabling, and aluminum stoplogs (including lifting lugs) should be designed to be sufficiently strong to meet the need of Site Managers during all river flow conditions. Bolted on seals were much more resilient on the stoplogs than the seals that were glued on.

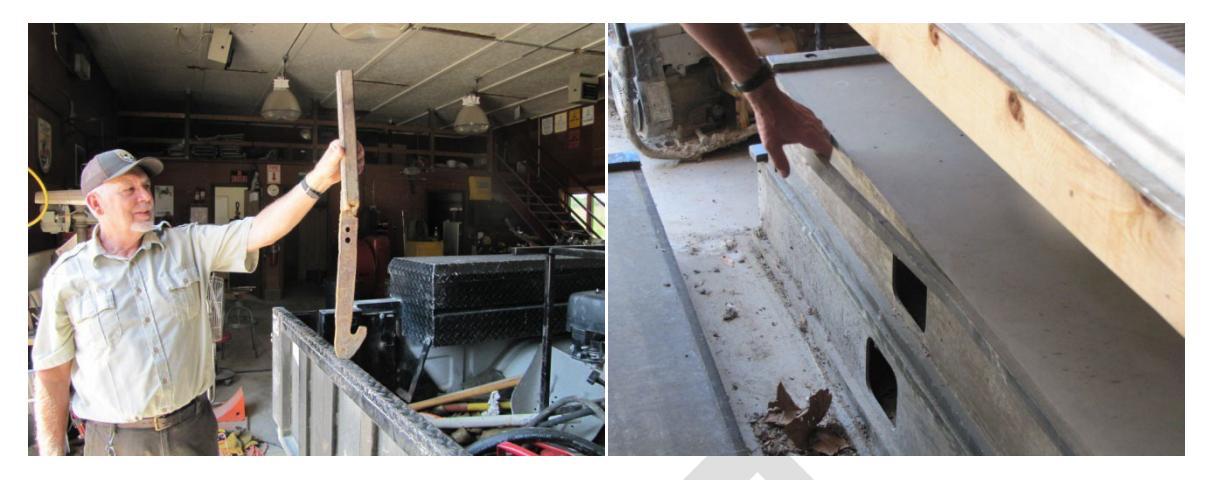
Figure G - 16: USFWS Designed Apparatus to Lift Trolly Beam

(Hooking onto the stoplogs when flow was present proved to be difficult with the trolley beam lift. USFWS designed an apparatus that worked, with some difficulty (left). The rubber seals that were glued to the stoplogs have the tendency to separate from the stoplog (right). Bolted on seals work better.)

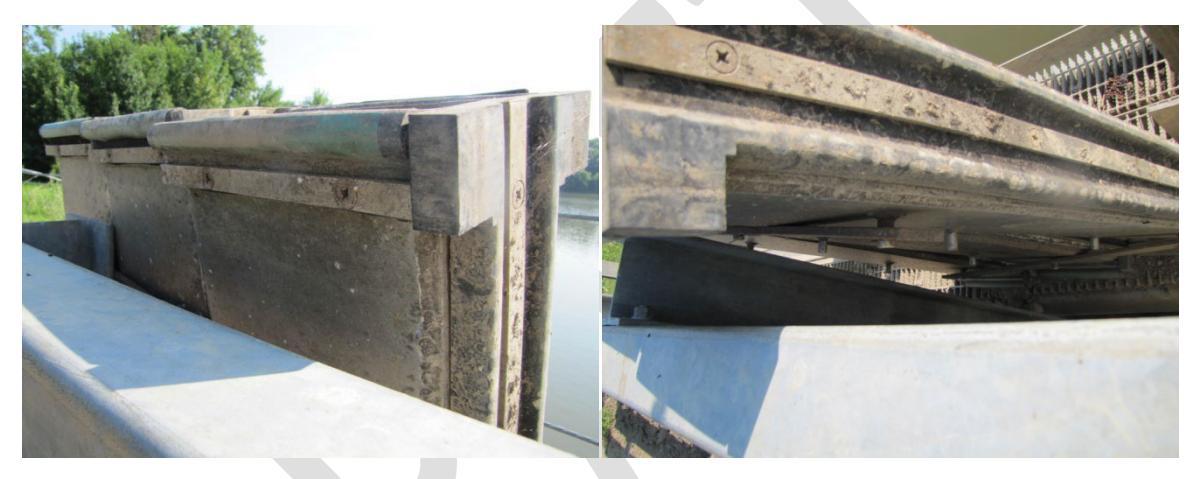
Figure G - 20: The Bolted Seals (left) Work Better than the Glues Seals (right) (The bolted gaskets on the stoplogs worked better than the glued ones.)

Recommendations / Considerations: Future lifting beam designs should include the development of a hand braking system that holds the trolly in place. Additionally, hydraulic controls, the lifting beams, cabling, and aluminum stoplogs (including lifting lugs) should be designed to be sufficiently strong to meet the needs of Site Managers during all river flow conditions. Bolted-on seals were much more resilient on the stoplogs than the seals that were glued on.

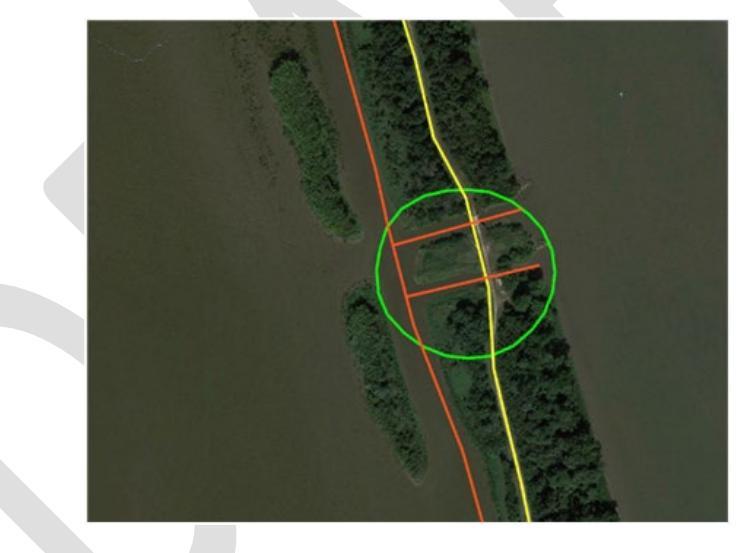
2013 Inspection Results: The intake on the riverside of the pump station was filling in with sediment. The depth gauges became covered with sediment and difficult to read, but the remaining portions of the structure work as designed. Recommendations: Clean the intake channel with excavator periodically.

The siltation issue that impacts nearly every feature of the Swan Lake system is also a significant concern at this location as it prevents efficient water flow to the pump station from either side. No direct means for addressing siltation issues was designed and constructed as part of the project, but this could be a consideration for future designs where the risk of siltation is high. Another consideration, perhaps even more importantly, is to prioritize locating pump station inlets in locations that are at a low risk of siltation whenever possible.

Figure G - 25: Middle Swan Lake Pump Station

Recommendations / Considerations: The geometry of the mechanical components of this pump station is suitable for safe, low maintenance operation. The pump is reasonably sized for the application at 30,000 GPM and thus does not overstress associated mechanical components. It is recommended that future pump stations rely on a larger concrete pad around equipment to reduce safety and maintenance concerns for the site manager. No issues associated with the use of CMP were reported by the site manager. This building material is readily available to contractors and likely at a lower cost than other concrete components.

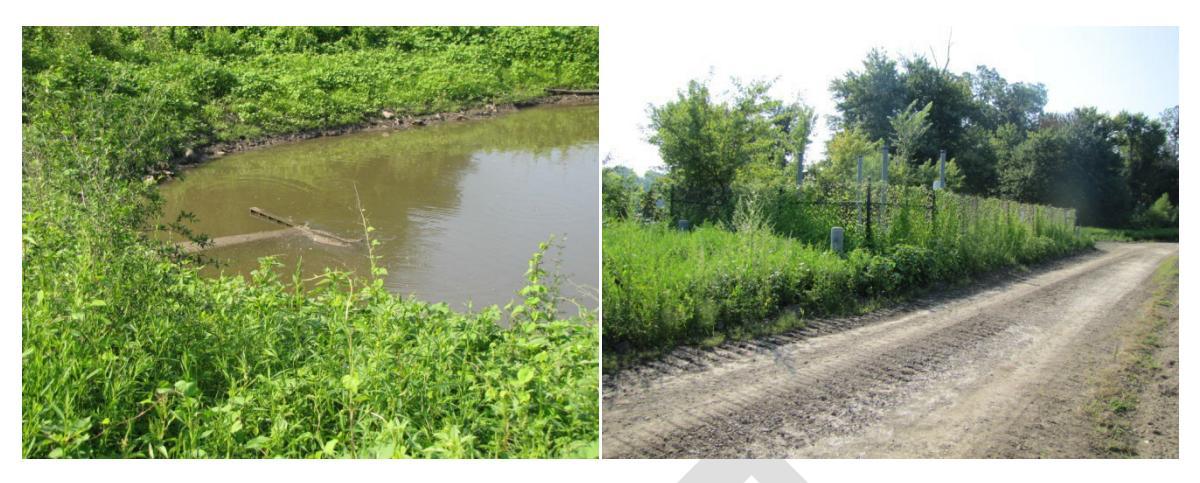
Figure G - 26: Intake Pipe for Middle Swan Pump Station (left) and Fence Around Pump

Fall 2021 Site Visit Results: Overall structure is holding up well and functions as designed. The pump station was noted to be a manually operated and powered by a diesel engine. Siltation was observed on both sides of the pump station, and significant vegetation had grown in the

immediate area around the pump station equipment, which presents an O&M and safety risk. A large snake was observed (moments before being tread on) that had been obscured by the vegetation.

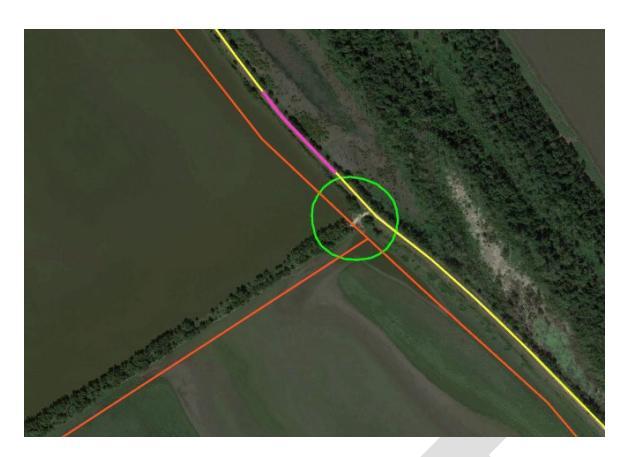
Figure G - 27: A 42-inch gated CMP exists between Middle and Lower Swan Lake

c. Middle Swan Lake to Lower Swan Lake. Through the interior lake closure between Lower Swan and Middle Swan Lake is a 42-inch gated CMP to exchange water between Middle Swan and Lower Swan (Figure G - 27,G - 28, G - 29). The drainage structure consists of a 42-inch diameter Waterman Industries, Inc. C-20-SB- Y canal gate mounted on the 42-inch CMP inside a 72-inch diameter CMP riser pipe.

Fall 2021 Site Visit Results: This structure was observed during the Fall 2021 Site Visit. The structure had clearly been silted in and was no longer functional. The CMP riser pipe was visible and in good shape. A black coating was observed on the riser pipe, likely to reduce rust and corrosion. The 20-foot notch described in the 2020 inspection results above was also observed.

Recommendations / Considerations: The functionality of this structure was a key component of the Swan Lake HREP design. As a result of the silting in of this structure, the USFWS estimates that they spend up to \$50K per year in fuel and labor expenses that could be otherwise be allocated elsewhere on the project. Given the conditions that exist today, this structure is likely significantly undersized and poorly located for optimal project functionality. Future designs should consider a higher factor of safety for flowrates and sediment passage for key infrastructure such as this one.

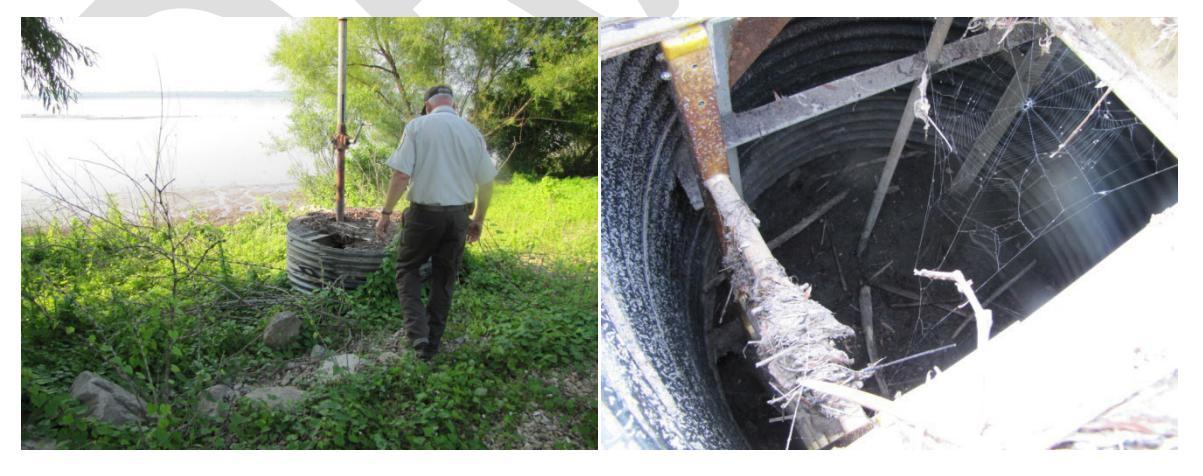
Figure G - 29: Control Structure within the Cross Dike Show to be Filled with Sediment

2013 Inspection Results: The cross dike between the two units was observed to function satisfactorily. It was observed to be, however, overgrown with woody vegetation (Figure G - 28). The control structure was not functional at the time of inspection. It had been completely sedimented in in both units (Figure G - 29).

2020 Inspection Results: The cross dike between the two units was observed to function satisfactorily. It was, however, overgrown with woody vegetation (Figure G - 28). The control structure was not functional at the time of inspection. It had been completely sedimented in in both units (Figure G - 29) and the gearbox had been compromised. To mitigate the impacts resulting from the failed structure, a 20 foot wide notch was excavated from the cross dike to facilitate flow between units.

(The water control structure no longer functions. The pipe on both sides is completely sedimented in. Note: The control structure itself is also sedimented in (right)

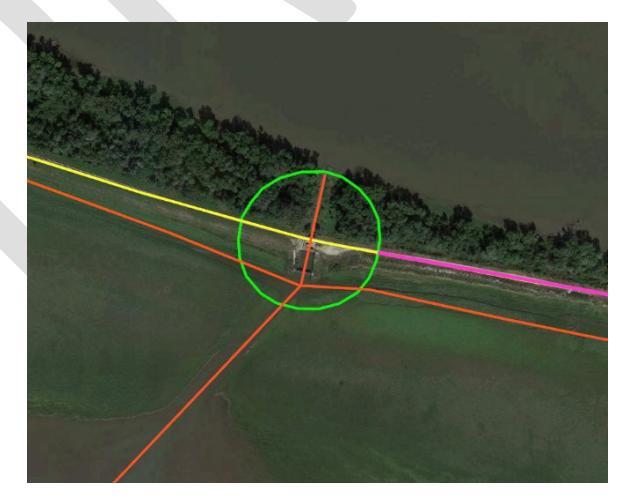
Figure G - 30: Lower Swan Lake Pump Station Controls Watering and Dewatering of Lower Swan Lake

2020 Inspection Results: At the time of inspection, the lower pump station was operational; however, there was a noise emanating from the bottom end of the pump. Due to the costs associated with pulling the pump, it had not been adequately diagnosed. The pump unit's right angle gear box was submerged in 2019, causing mineral deposits on metal parts, loss of lubrication, debris deposits, sediment deposits, third failure of input bearing, broken teeth on ring gear, pinion failure, and eight belts catching fire. Other factors such as stress resulting from bearing thrust from belts and sheaves, vibration of metal parts, weld breakages, corrosion of metal from chemical reactions resulted from being submerged in floodwater. Consequently, flooding has caused increased amount and cost of maintenance.

The water conveyance channels to pump were observed to have all filled with sediment making dewatering of Lower Swan not feasible. The pump sump area was also full of sediment and required maintenance. The trash pump was not functional as a result of sediment deposition in sump not allowing the vacuum pump system to prime and thus could not dewater sump.

Recommendation / Considerations: Future pump station designs should avoid the indirect drive from the power units. This has proven to be a significant problem for reliability and safety at this pump station.

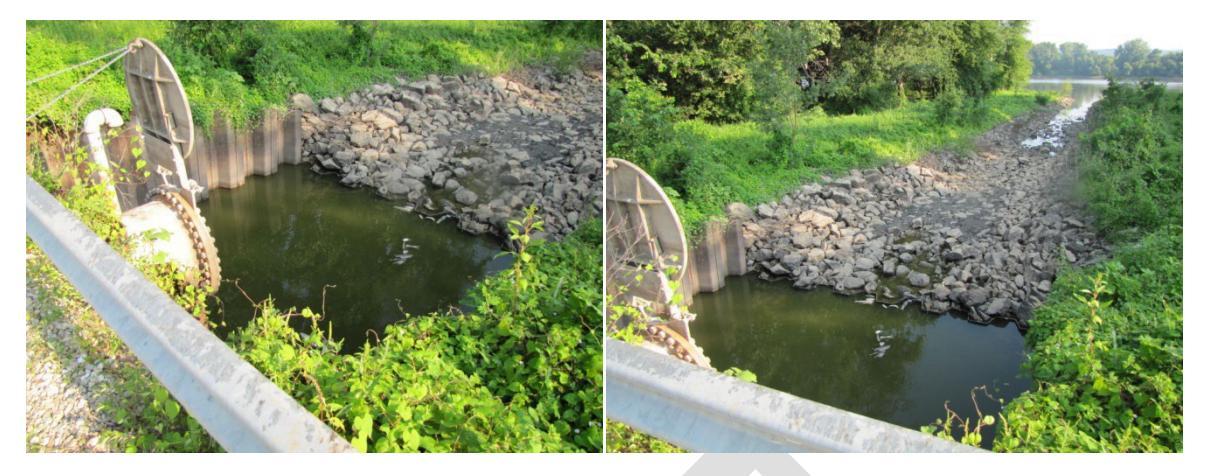
Figure G - 31: Outlet Structure (riverside) for Lower Swan Lake Pump Station

The use of a flap gate on the discharge side of the pump station has restricted the flow of the pump station and is commonly propped open by the Site Manager to maximize pump efficiency. The flap gate has proven useful in the past for preventing overtopping flows from entering the pipe and causing damage and/or maintenance issues to the pump as a result.

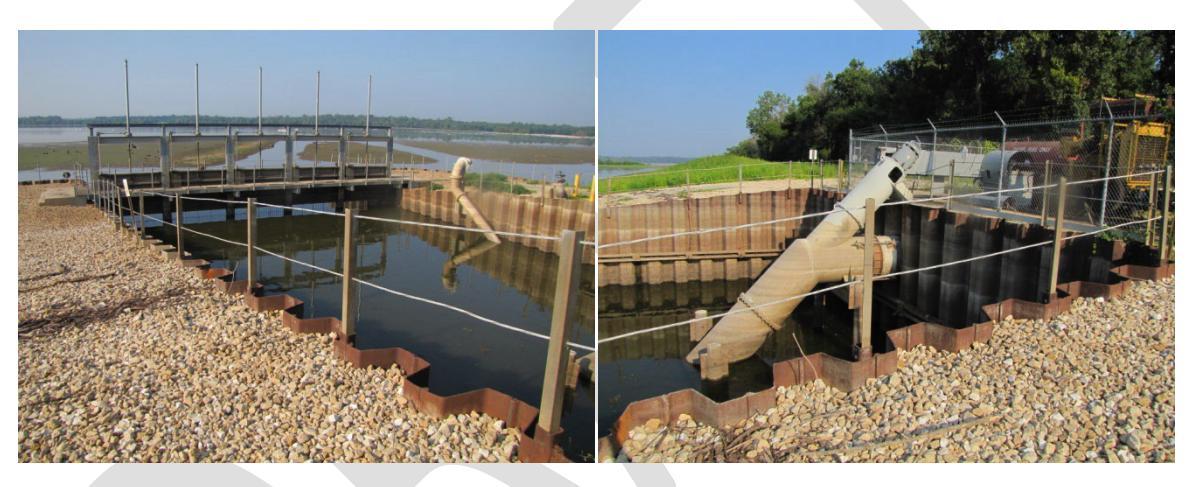
Figure G - 322: Pump Intake Station (Swan Lake Side) for Lower Swan Lake Pump Station

The siltation issue that impacts nearly every feature of the Swan Lake system is also a significant concern at this location as it prevents efficient water flow to the pump station from either side. Direct removal of silt via mechanical methods (excavator) is a necessary maintenance measure for current conditions at Swan Lake, and this should be a consideration for future designs where the risk of siltation is high. Another consideration, perhaps even more importantly, is to prioritize locating pump station inlets in locations that are at a low risk of siltation whenever possible.

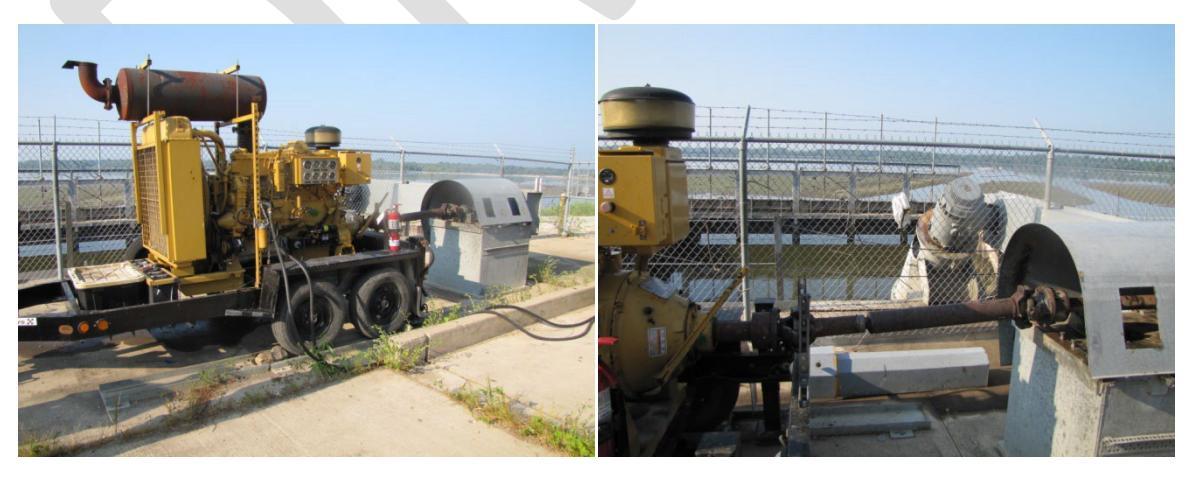
Figure G - 33: Diesel motor that operates pump at Lower Swan

particularly the right-angle gear boxes, were discussed. The geometry of the mechanical components results in the need for two right-angle gear boxes and a large belt drive assembly that are prone to wear and high O&M costs, particularly in this relatively high-powered pump setup.

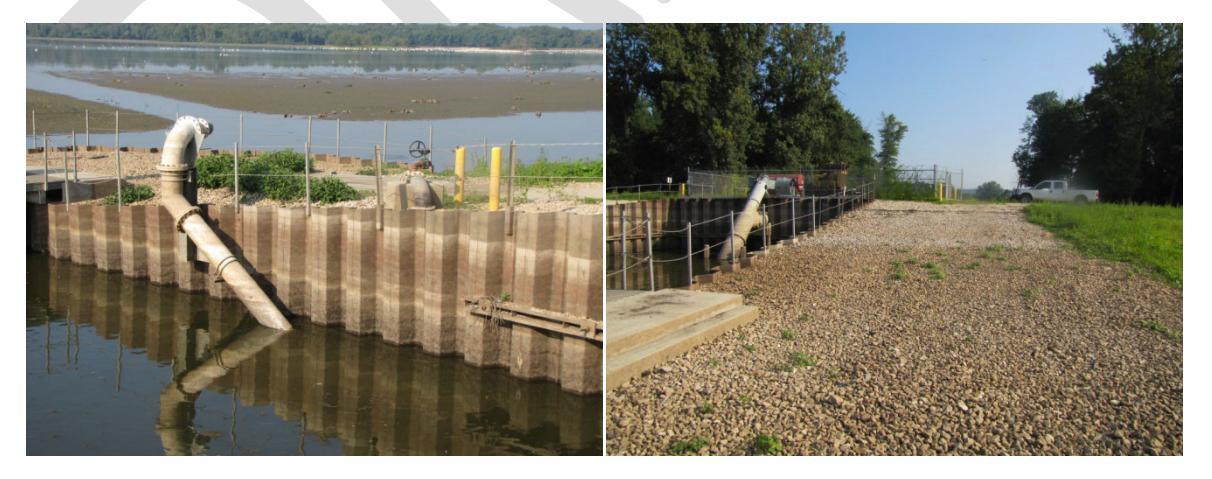
Figure G - 36: Auxiliary Pump Site (left)

(Larger gravel placed around the pump station (right) worked better than the previous smaller diameter gravel.)

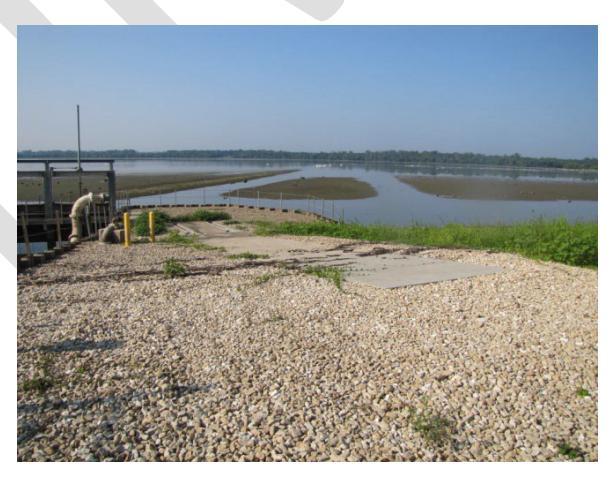
Figure G - 39: Channels Leading to Control Structure Sediments in Rapidly
