SUBJECT: Supplement No. 1, Design Memorandum No. 504, The Master Plan, Carlyle Lake, Kaskaskia River, Illinois

SUBJECT: Supplement No. 1, Design Memorandum No. 10, The Master Plan, Carlyle Lake, Kaskaskia River, Illinois

CARLYLE LAKE MAINTENANCE COMPLEX

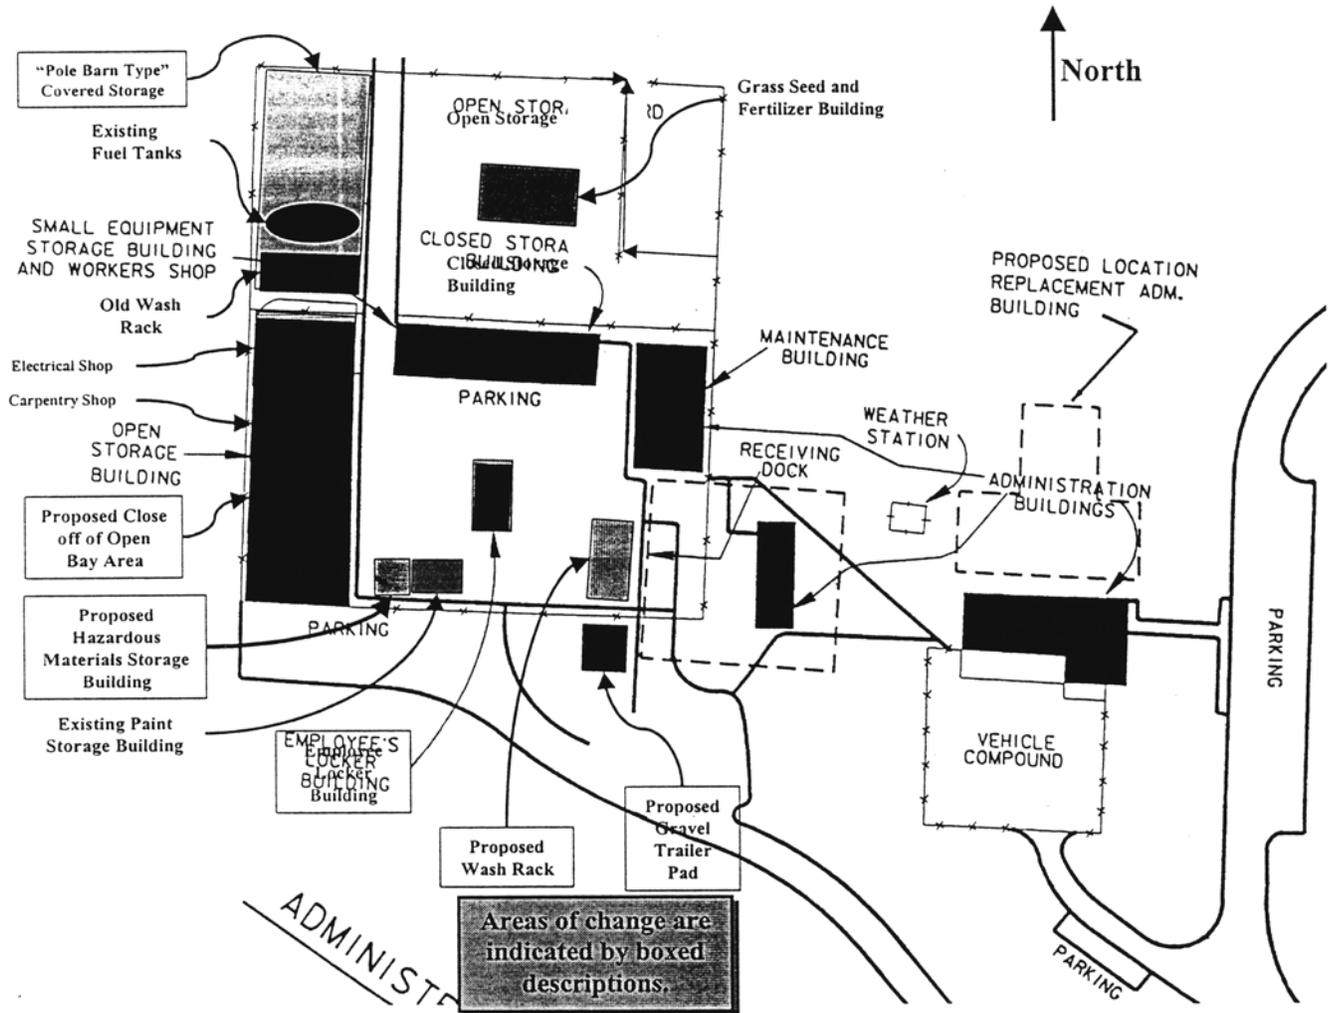
Work effort can be broken down into five (5) distinct areas. Each area will be listed and discussed separately. Diagram of administration/maintenance work compound is included.

a. Existing wash rack is located to the north side of the "Electrical Shop". Use of existing rack is limited due to soap and water run off being discharged into grass and wooded area. The installation of an "Oil Water Separator" has been recommended. Current wash rack is not close enough to the local lift station thus the installation of new wash rack is recommended.
