GUIDANCE FOR CCTV AND SONAR INSPECTION PIPES PENETRATING LEVEES

FEBRUARY 2013

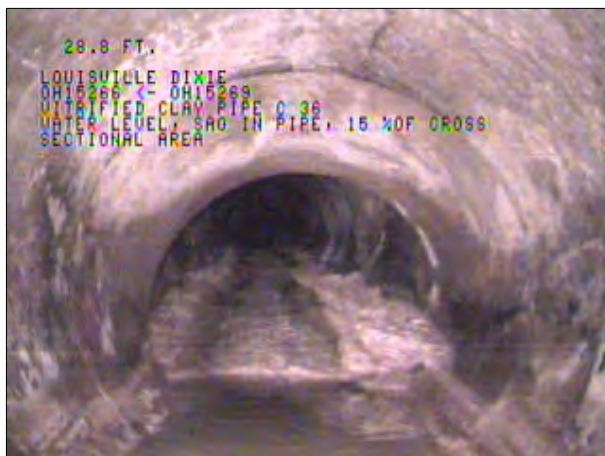
Photo: OH15269_OH15266124455_05112009_A.JPG, VCR No.: FLOOD WALL#2, 01:43:58
28.8FT, Water Level, Sag in pipe, 15 %of cross sectional area

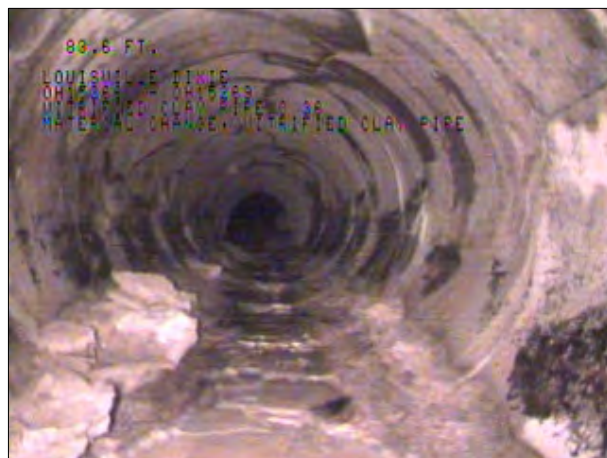
Photo: OH15269_OH15266124748_05112009_A.JPG, VCR
No.: FLOOD WALL#2, 01:46:07
83.6FT, Material Change, Vitrified clay pipe

77.80	MMC	Material Change, Reinforced concrete pipe	00:04:24	65_7A	
	83.60	MMC	Material Change, Vitrified clay pipe	00:04:43	65_8A	
	83.60	S1 CM	Crack Multiple, from 09 to 03 o'clock, within 8 inches of joint: YES, Start	00:04:50	65_9A	S 3

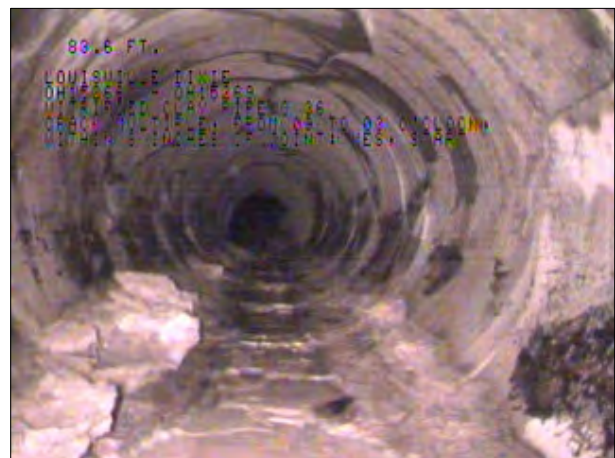
Photo: OH15269_OH15266124807_05112009_A.JPG, VCR
No.: FLOOD WALL#2, 01:46:12
83.6FT, Crack Multiple, from 09 to 03 o'clock, within 8 inches
of joint: YES, Start

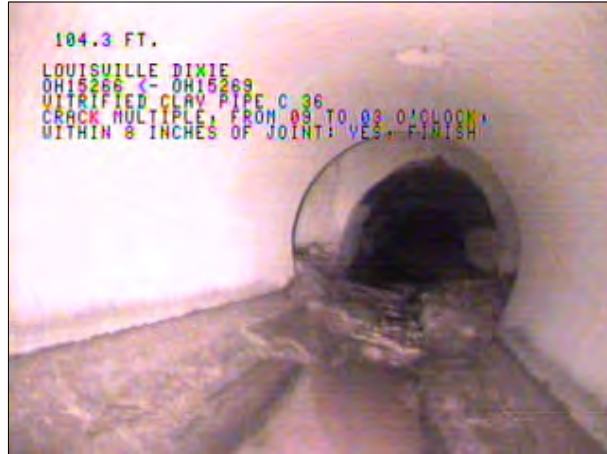
Photo: OH15269_OH15266124848_05112009_A.JPG, VCR
No.: FLOOD WALL#2, 01:46:48
104.3FT, Crack Multiple, from 09 to 03 o'clock, within 8 inches of joint: YES, Finish

104.30	F1 CM	Crack Multiple, from 09 to 03 o'clock, within 8 inches of joint: YES, Finish	00:05:27	65_10A	S 3
	104.30	MMC	Material Change, Reinforced concrete pipe	00:05:34	65_11A

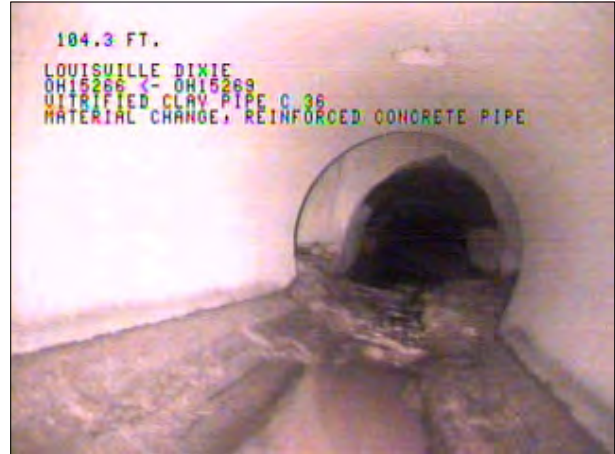
Photo: OH15269_OH15266124907_05112009_A.JPG, VCR
No.: FLOOD WALL#2, 01:46:54
104.3FT, Material Change, Reinforced concrete pipe

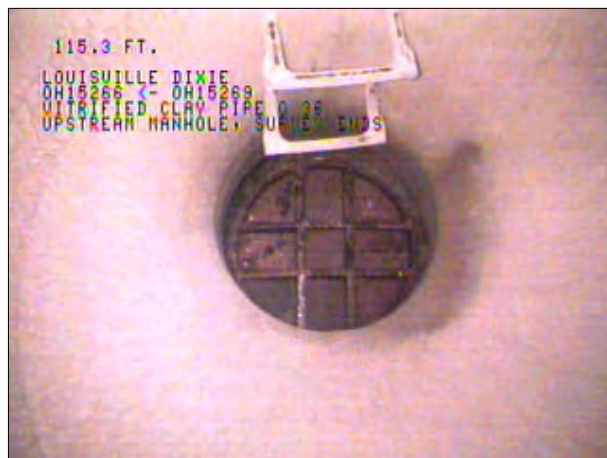
Photo: OH15269_OH15266124956_05112009_A.JPG, VCR
No.: FLOOD WALL#2, 01:47:25
115.3FT, Upstream Manhole, Survey Ends
