**PRE-DESIGN INVESTIGATION
SUMMARY REPORT FOR ST. CIN PARK,
THE ARCHDIOCESE OF ST. LOUIS
PROPERTY, AND DUCHESNE PARK**

ST. LOUIS, MISSOURI

JUNE 24, 2015

**U.S. Army Corps of Engineers
St. Louis District Office
Formerly Utilized Sites Remedial Action Program**

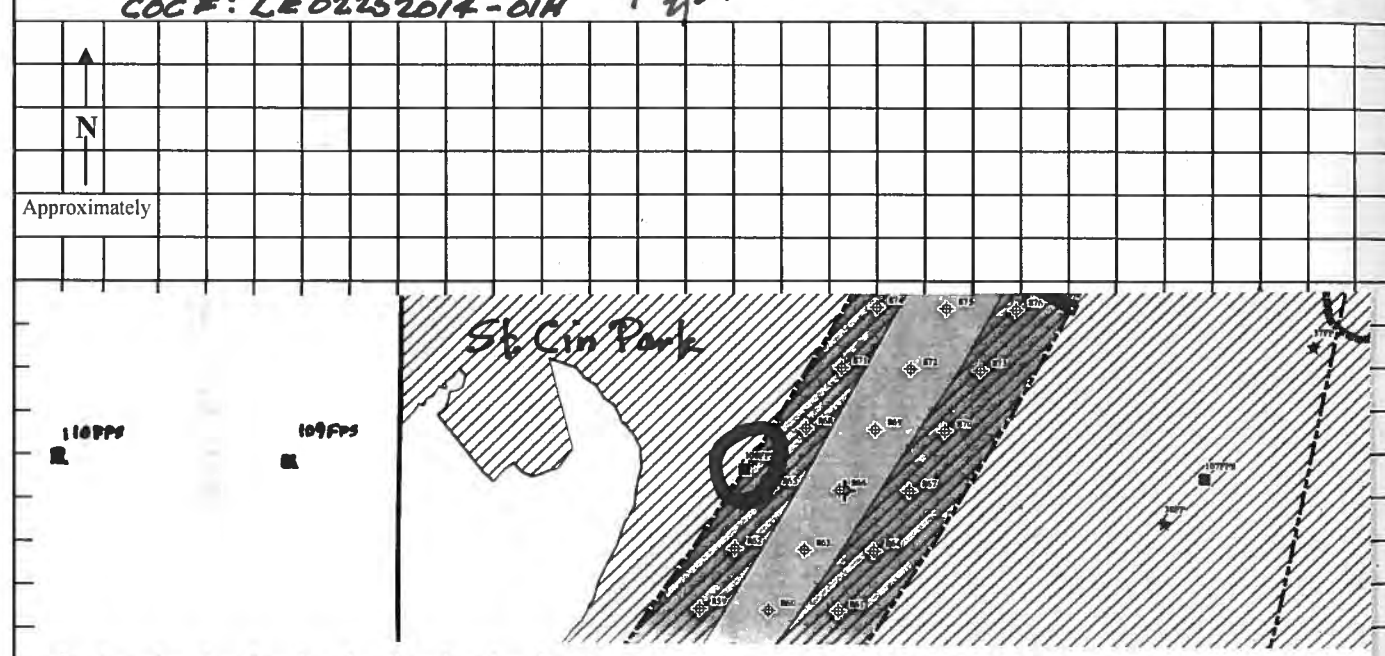
22. DISPOSITION OF HOLE Backfill using bentonite		BACKFILLED w/bentonite		MONITORING N/A OTHER (SPECIFY) N/A	
23. SIGNATURE OF INSPECTOR Gary Neutzling					
LOCATION SKETCH/COMMENTS w/ grass play on top 2/24/14 COC #: LE02252014-DIN SCALE: None

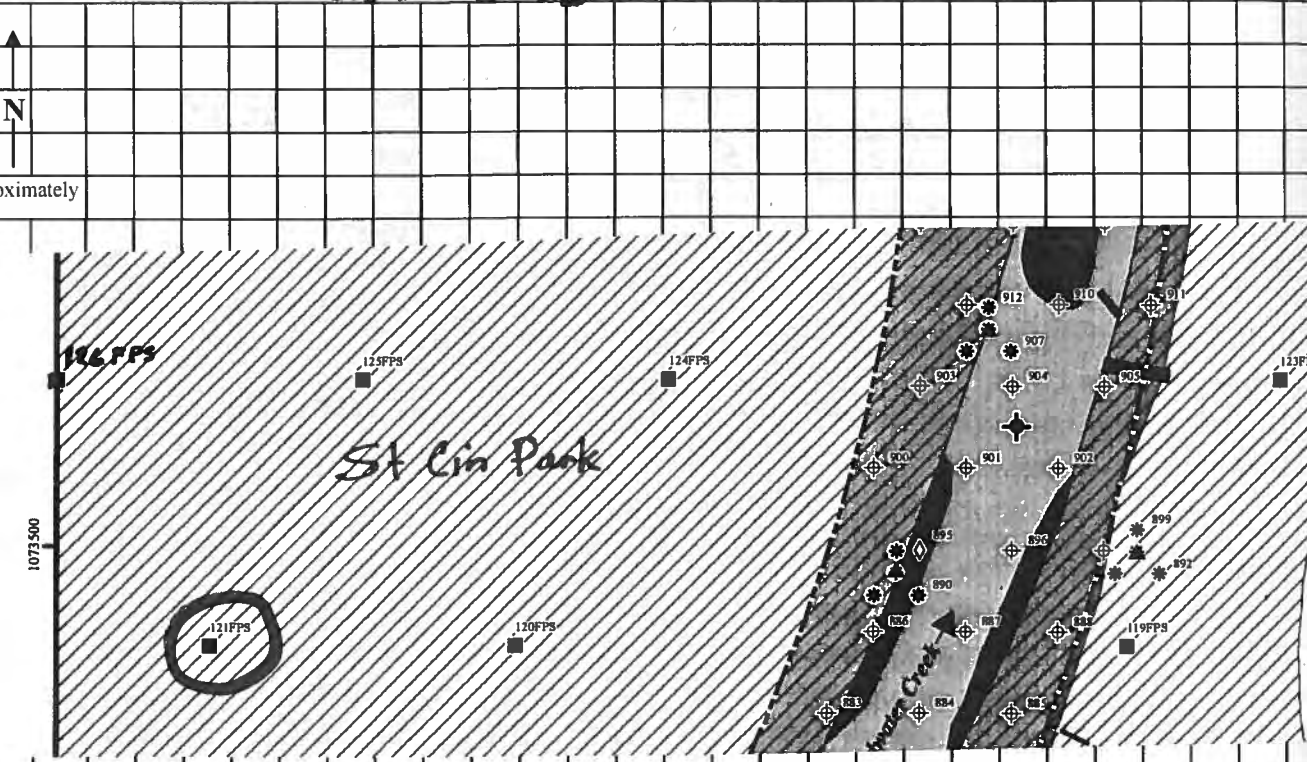
19 TOTAL NUMBER OF CORE BOXES: N/A		20. SAMPLES FOR CHEMICAL ANALYSIS VOC: N/A METALS: N/A RAD SAMPLES: 4 QA/QC SAMPLES: 1 set of 2 ARCHIVE SAMPLE: 0		21 TOTAL CORE RECOVERY: N/A	
22 DISPOSITION OF HOLE Backfill using bentonite		BACKFILLED: w/bentonite MONITORING: N/A OTHER (SPECIFY): N/A		23 SIGNATURE OF INSPECTOR: Gary Neutzling	
LOCATION SKETCH/COMMENTS: and grass plug 2/25/14 Coc #: LE02252014-02H					
SCALE: None
