**APPROVED JURISDICTIONAL DETERMINATION FORM**  
**U.S. Army Corps of Engineers**

**B. DISTRICT OFFICE, FILE NAME, AND NUMBER:** St. Louis District, Specialty Granules Inc., MVS-2008-826-002-SNR\_Stream 1 and MVS-2008-826-002-SNP\_Stream 2

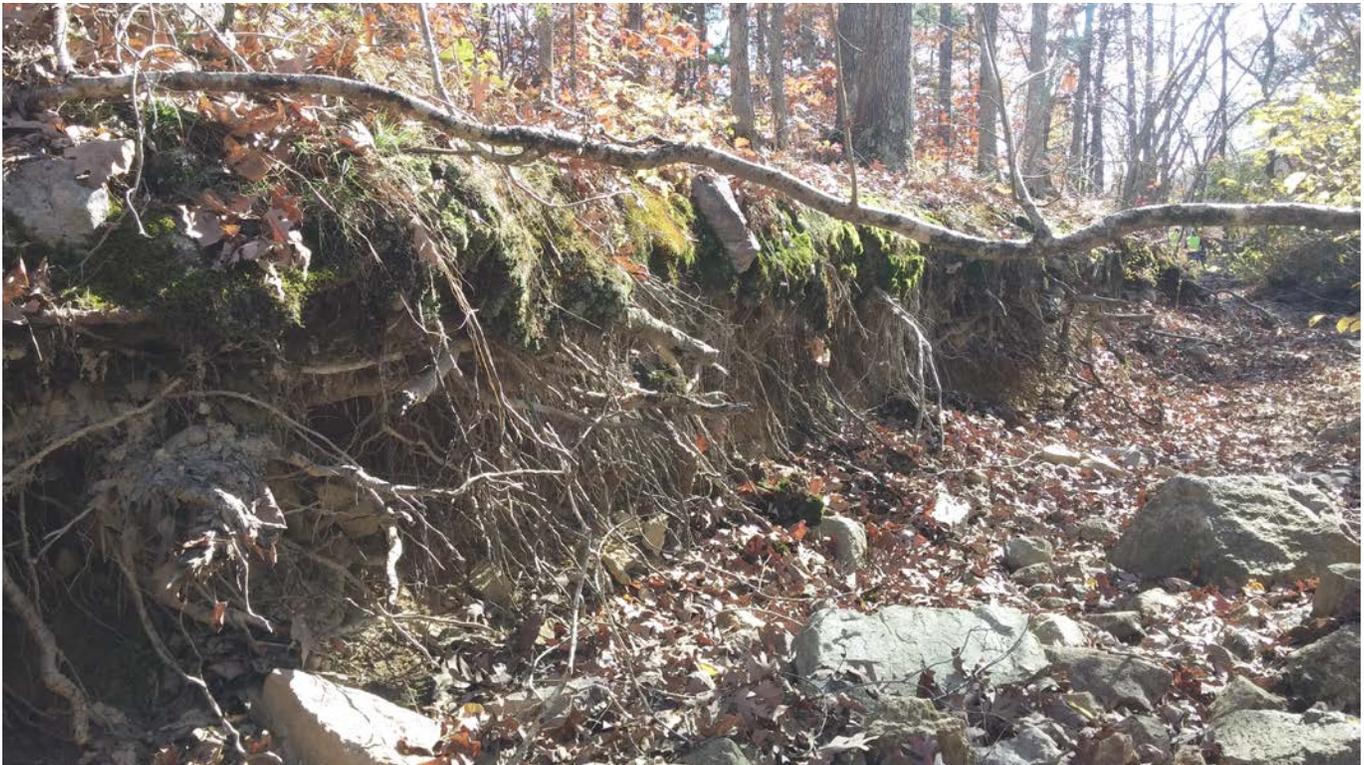
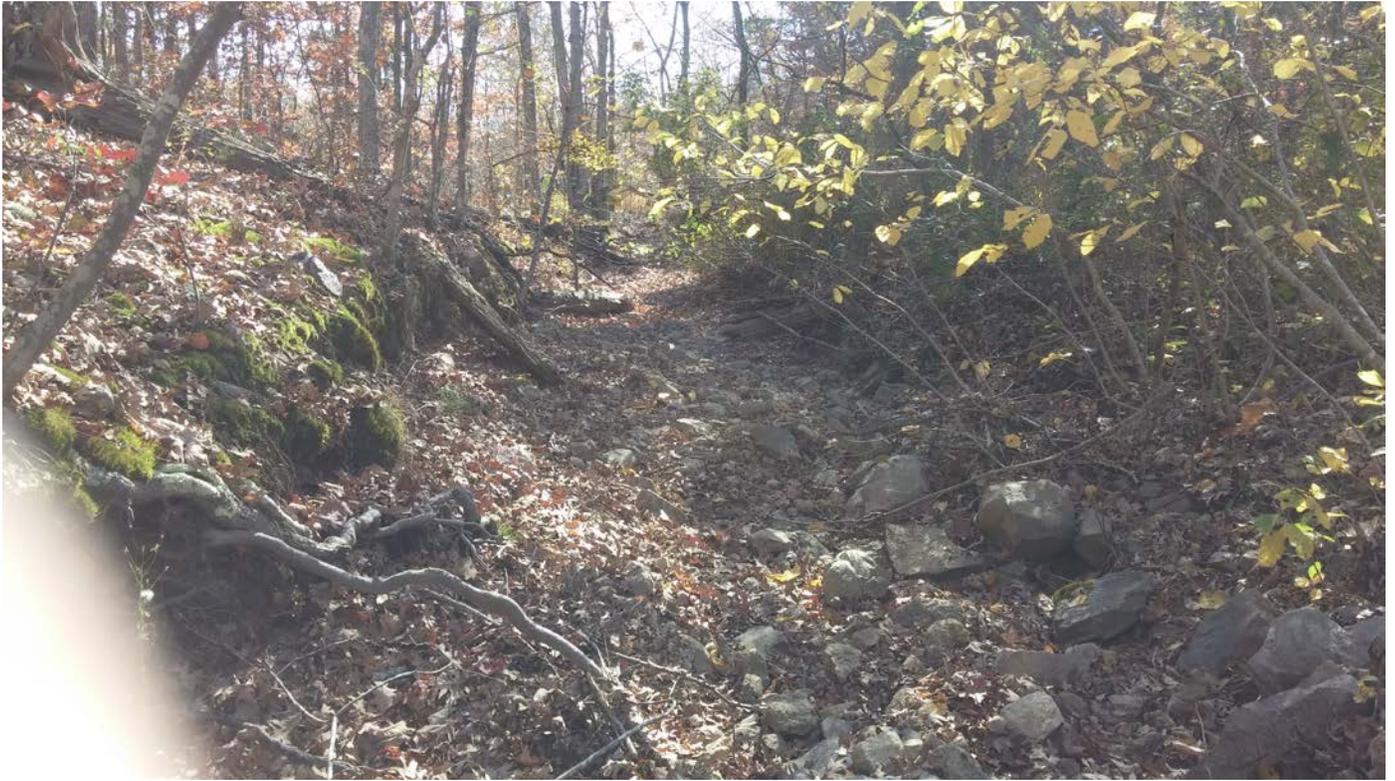
Photographs (2) of Stream 1 (Intermittent Reach) taken upstream of the point where the step-pool system begins. This picture was taken facing downstream.

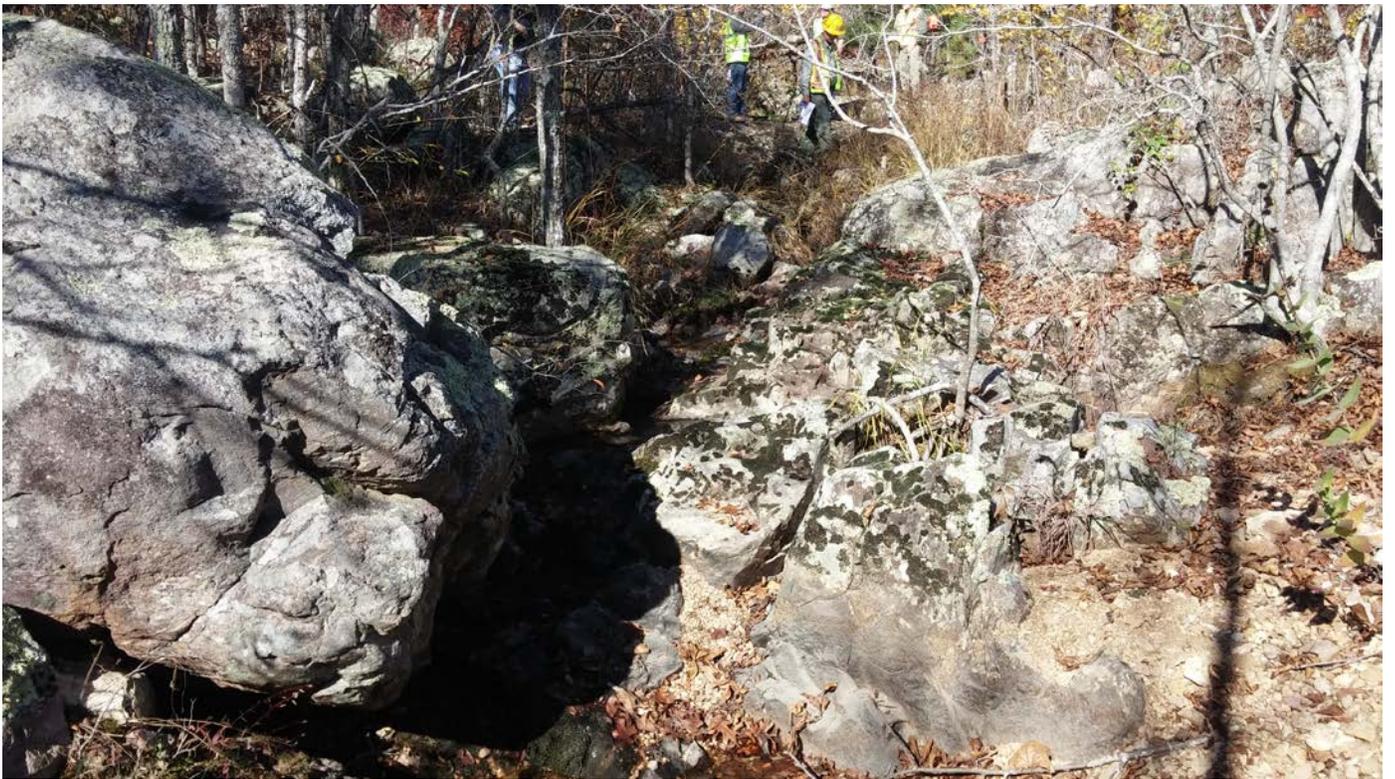
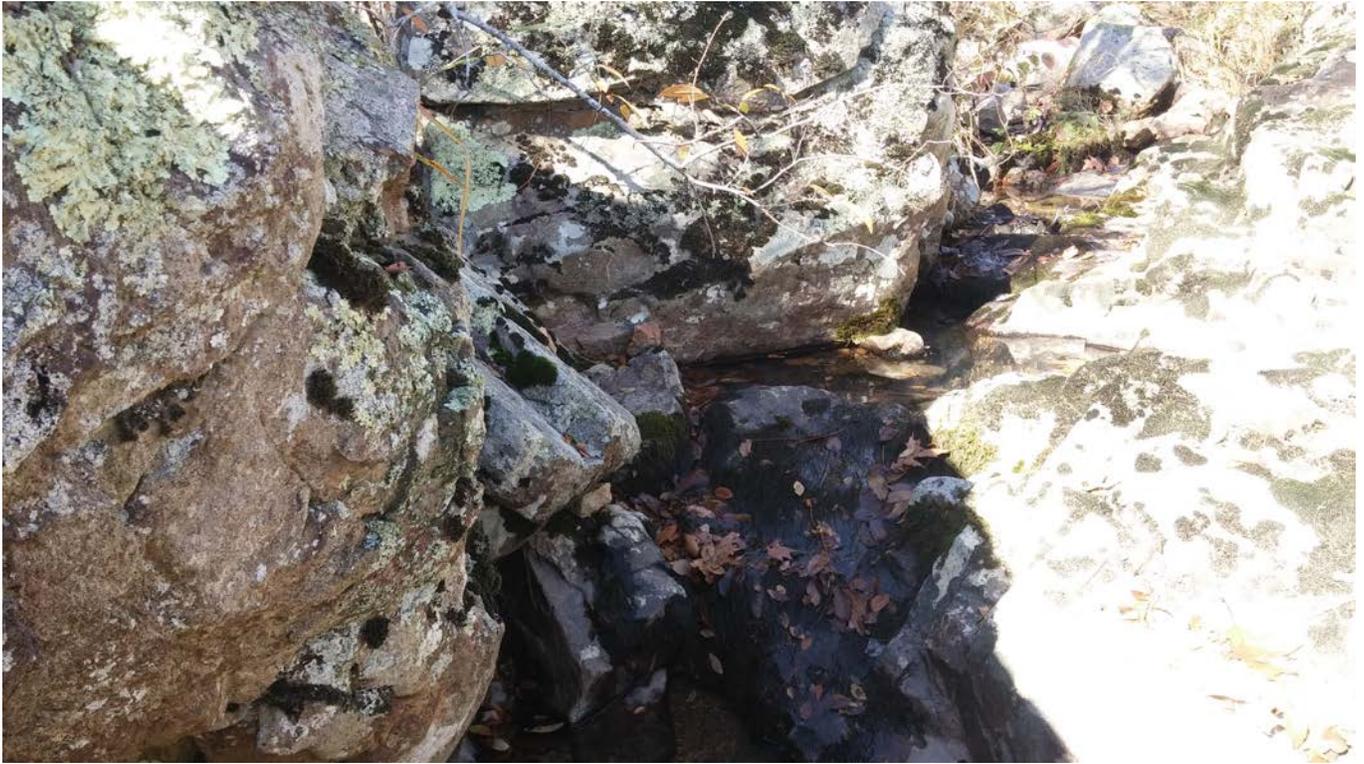
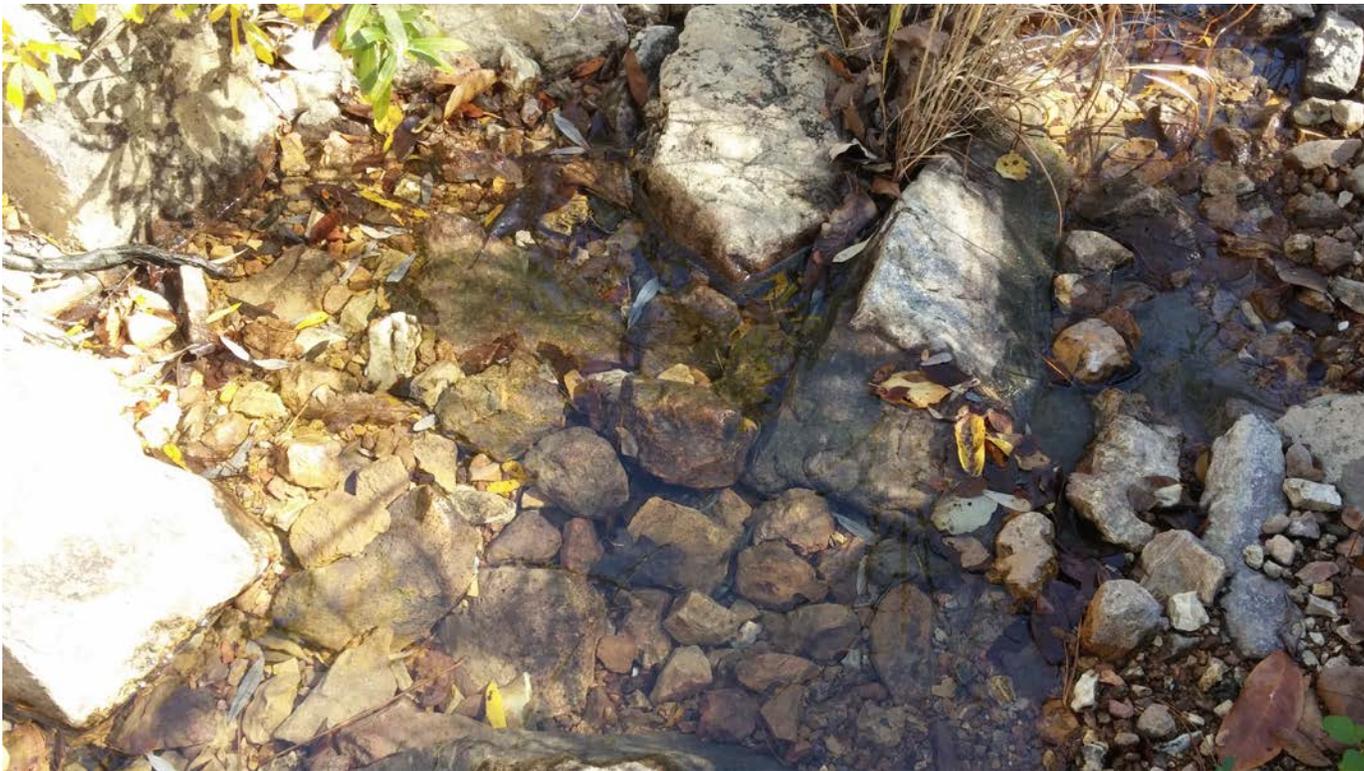
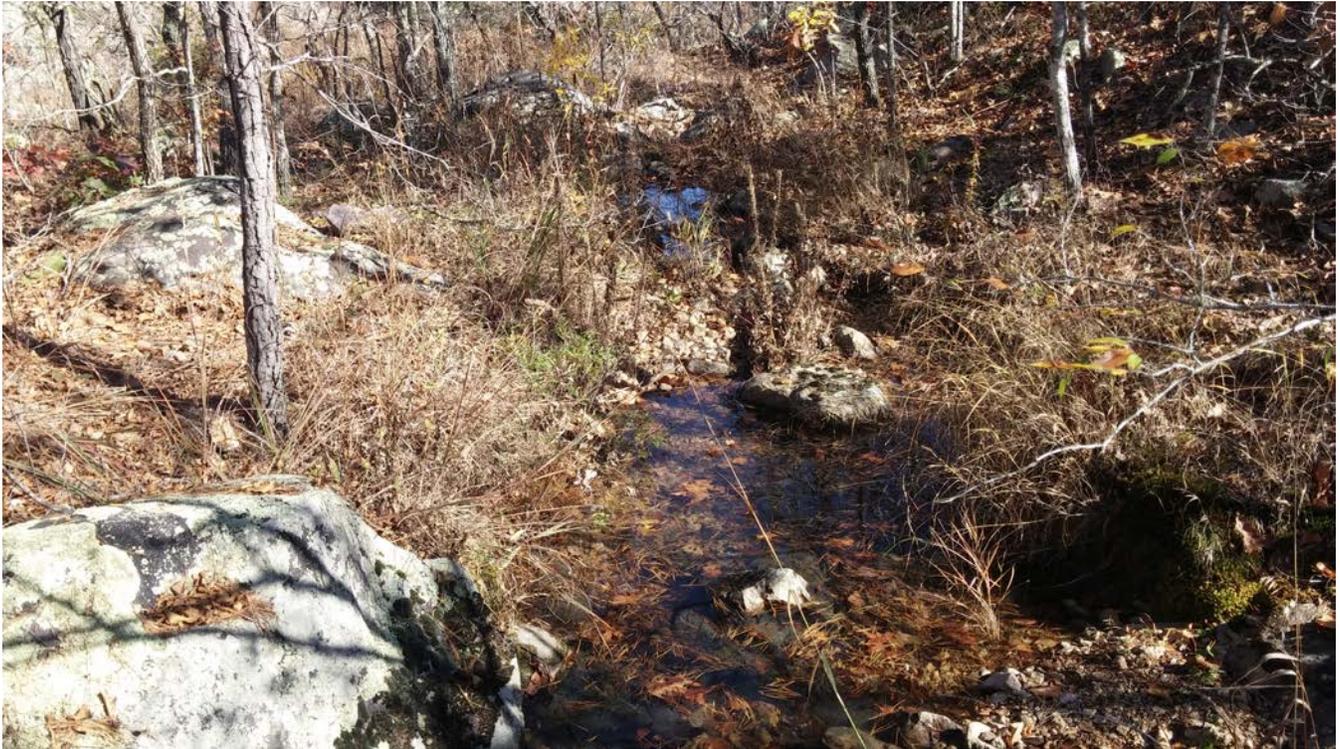
Photographs (4) of Stream 1 within the step-pool System (Glade Habitat). This reach of Stream 1 was determined to have perennial flow with pools present. This is within the middle reach of Stream 1.

The step-pool system (Glade Habitat) appears to be perennial. Flows were observed in October 2014 and again in March 2015. This step-pool system is 1,685-feet in length. At the bottom of the step pool system the stream channel transitions out onto a wider flood plain at which point flow disappears and stream flow becomes intermittent again. It remains

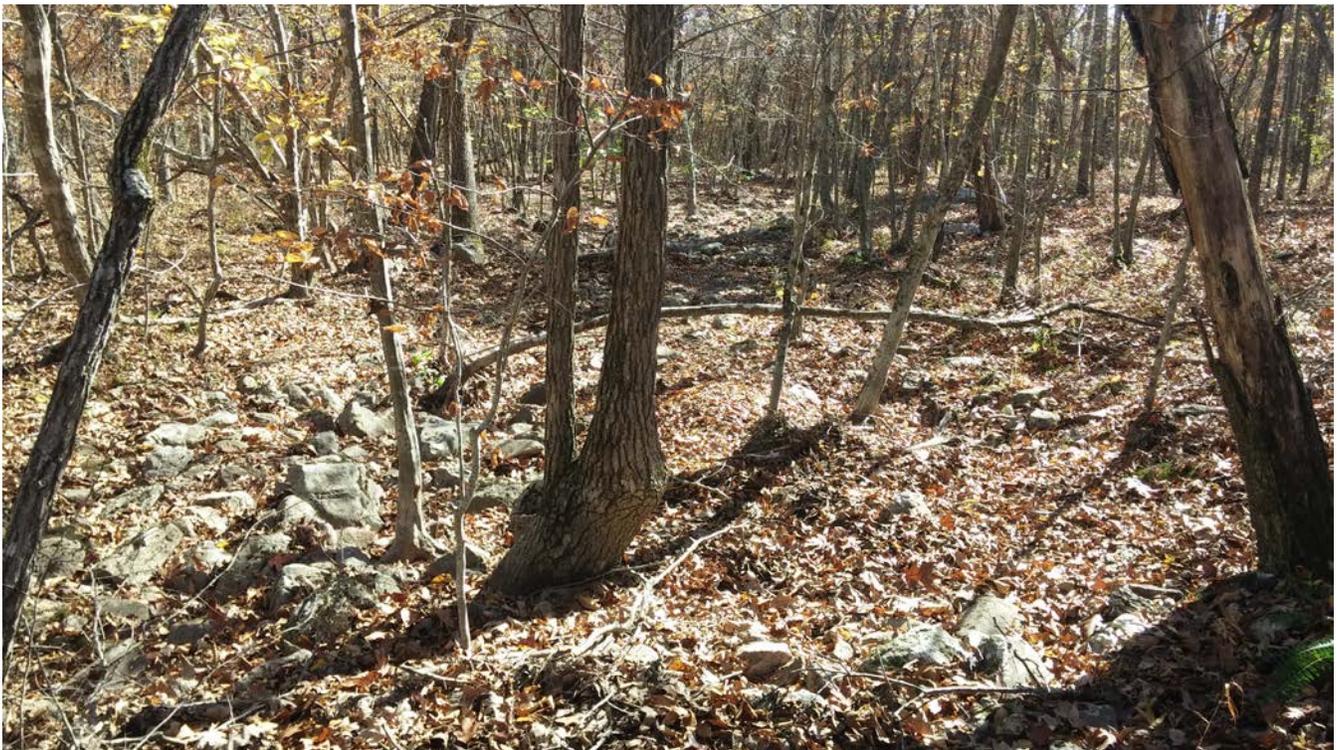
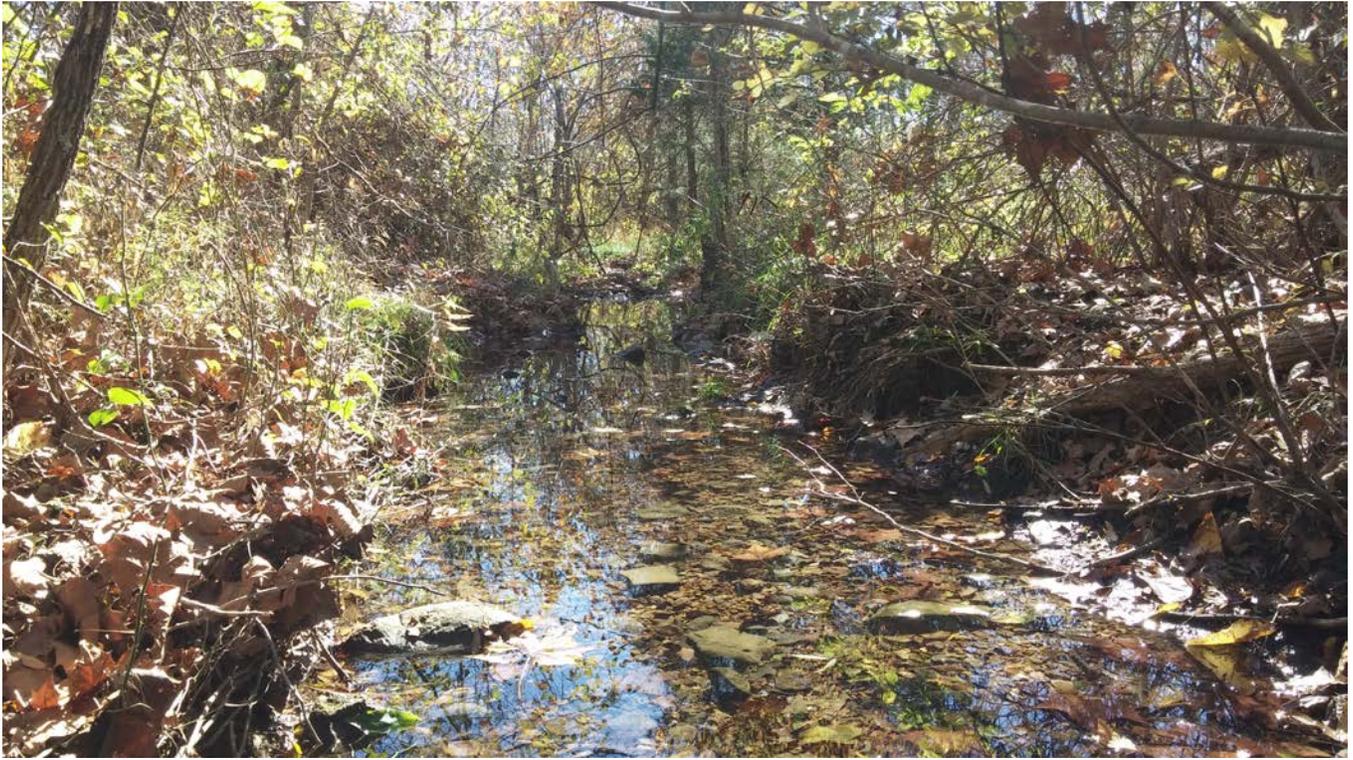
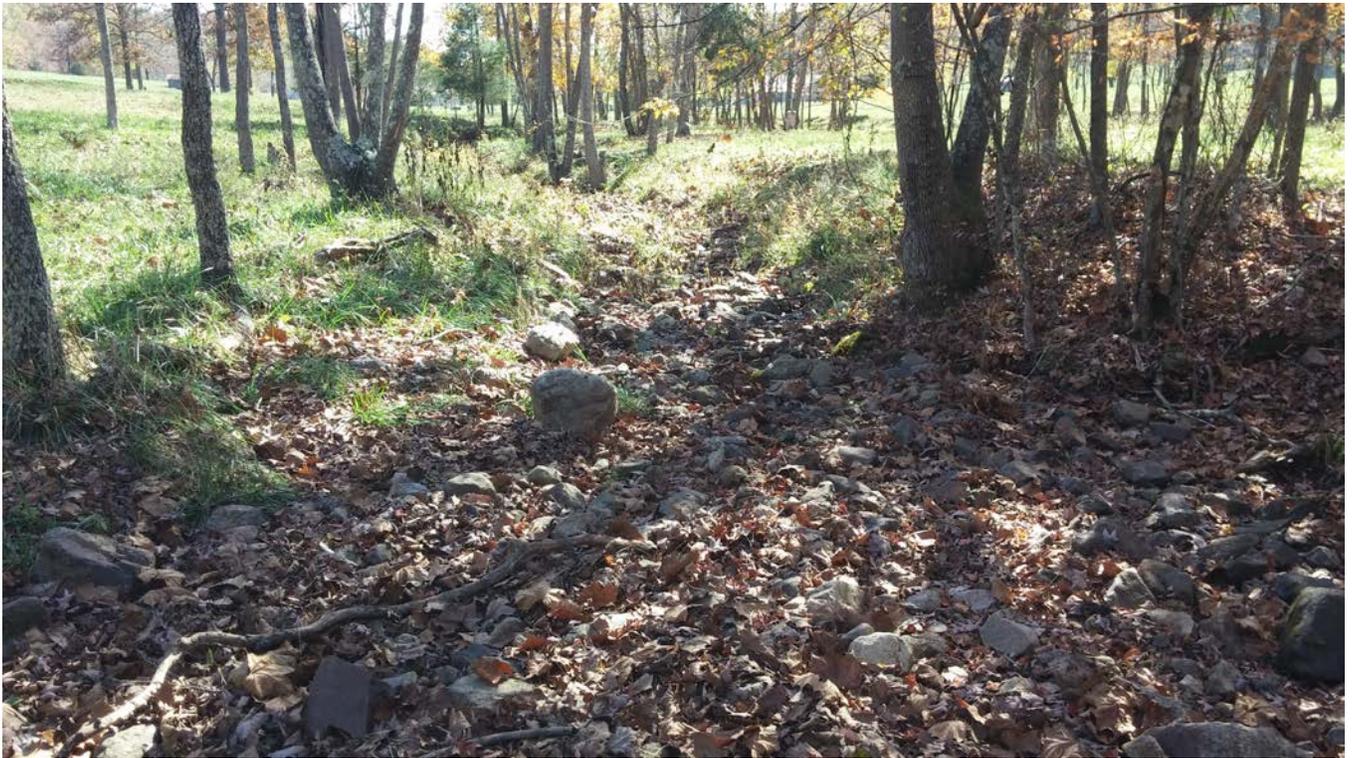
Photographs (3) of Stream 1 within below the step-pool System. This reach of Stream 1 was determined to have intermittent flow with pools present. This is within the lower reach of Stream 1 as it exits the SGI Property.

intermittent through the remainder of the Study Area, a distance of 188-feet. This stream continues as an intermittent stream feature as it flows from the Study Area through the Permit/Bonded Area and the remaining portion of the SGI property. Perennial flow resumes outside of the SGI property.
