An Archaeological Curation-Needs Assessment for the U.S. Navy, Engineering Field Activity, Chesapeake Division

Technical Report No. 19

**Mandatory Center of Expertise for the
Curation and Management of Archaeological Collections**

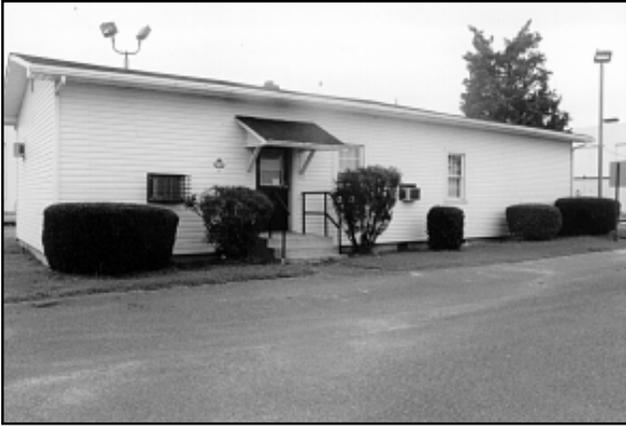
Figure 1. Exterior view of NSW Curation facility.

Building 337 currently serves as the NSWC Dahlgren Division cultural resources curation facility (Figure 1). The building encompasses approximately 1293 ft². Building 337 originally served as a guard office, but recently has been allocated for storage, display, and office space, with a kitchen/break room in the building in addition to the storage and display areas.

Building 337 is a steel-frame structure with a concrete foundation. Exterior walls are concrete

block, and the original roof is shingled. No cracks in the foundation or leaks in the roof have been noticed by staff members; however, the roof has been repaired in the past. Interior walls are made of plasterboard, and the ceiling is suspended acoustical tile. The floor is concrete with carpeting, and windows in the repository have blinds and aluminum window frames. According to staff, none of these windows have shown any evidence of water leakage.

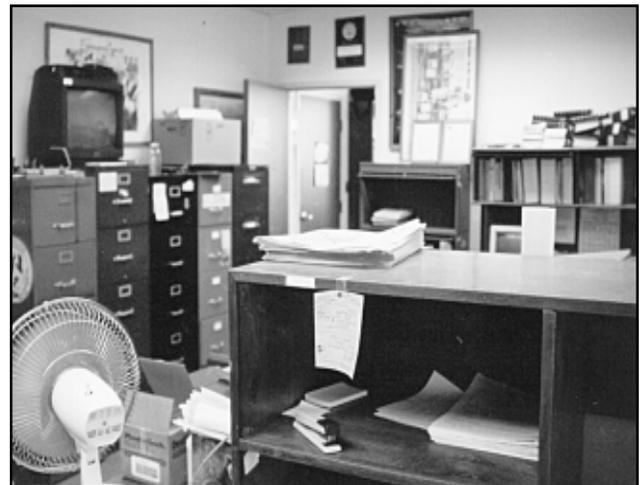
Figure 2. Interior view of NSWC Indian Head documentation collections area.

Collections from the NSWC Indian Head Division are stored in two repositories. Records are stored in the Environmental Office (Figure 2), and the artifacts are kept on display in a small natural history museum that the base acquired for its biological collections (e.g., indigenous species of snakes). Building evaluations were conducted for both repositories and are detailed below.

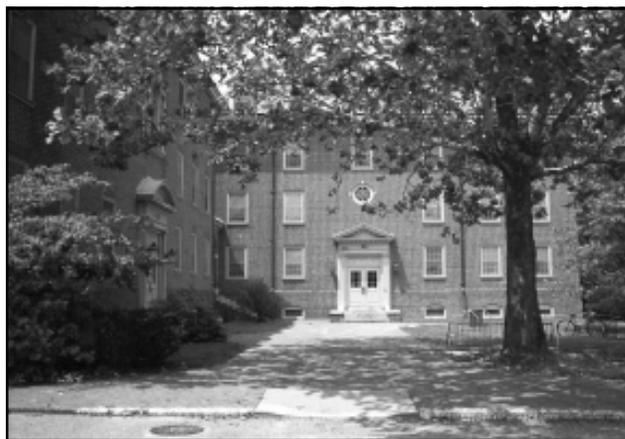
Figure 3. Exterior view of the William and Mary curation facility.

The collections and associated records are housed in the basement of a four and one-half story dormitory building on the College of William and Mary campus (Figure 3). The basement repository includes six major areas encompassing approximately 10,000 ft². There is a separate field equipment storage room, a drafting/report publication area, an archives storage area, an artifact collections storage area, a photograph processing/large-scale map storage area,

This repository was constructed in the late 1930s as a dormitory with the three floors above grade still being used for this purpose. The building has a concrete foundation (covered with tile in the storage areas), concrete block walls below grade, and concrete block walls with a brick facade above grade. The roof consists of slate tiles and is original to the building. Interior walls in the basement are also concrete block, and the ceiling is of poured concrete. Plumbing and electrical systems have been previously updated, and the heating system has been renovated within the last year. Overhead pipes are in close proximity to fluorescent lights in all rooms, but there have never been any problems with leaking.

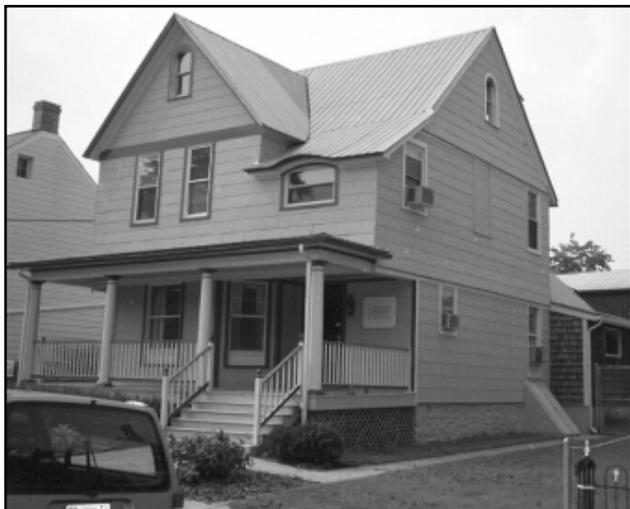
Figure 4. Exterior view of the Goodwin and Associates Frederick, Maryland, office.

Originally built in 1920 as a residence, the house was renovated about five years ago. The newest portion, an addition to the rear of the house, was

completed at about the same time as the renovation. The foundation of the facility is composed of concrete block, and the roof is tin. Exterior walls for the older portion are asbestos shingle and corrugated metal for the newer addition. The roof of the older portion of the house has been replaced in the past 10 years, whereas the roof of the newer addition was replaced in 1993. Both the foundation and the roof appear to be structurally sound and free of cracks and leaks.

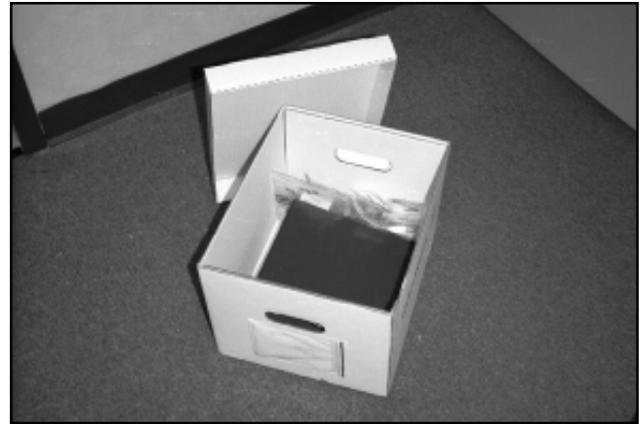
Figure 7. Primary container for artifacts and records.

The primary container consists of one acid-free cardboard box with a telescoping lid. The exterior tag is an acidic yellow paper sheet inserted in a plastic zip-lock bag and attached to the cardboard box (Figure 7). The paper tag is labeled with the facility name.

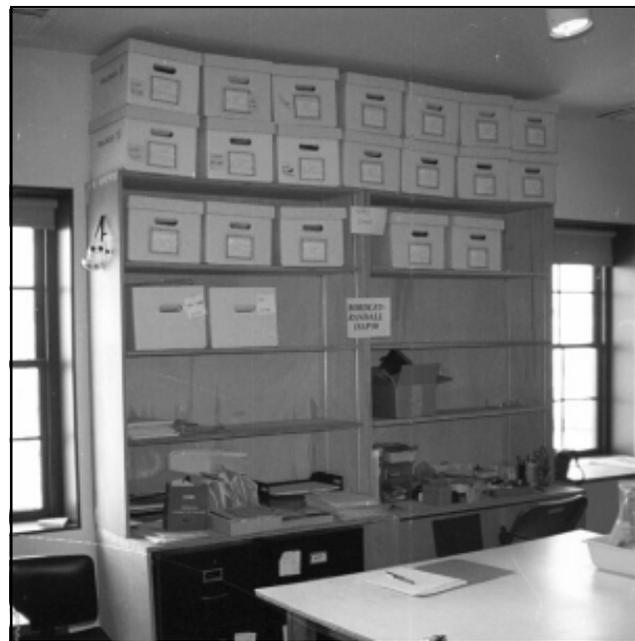
Figure 9. Storage units at the Historic Annapolis Foundation.

Artifact primary containers are stored on plywood shelves measuring 1.3 x 8 x 7.4 feet (l x w x h). Boxes are stacked two high on the top shelf (Figure 9).

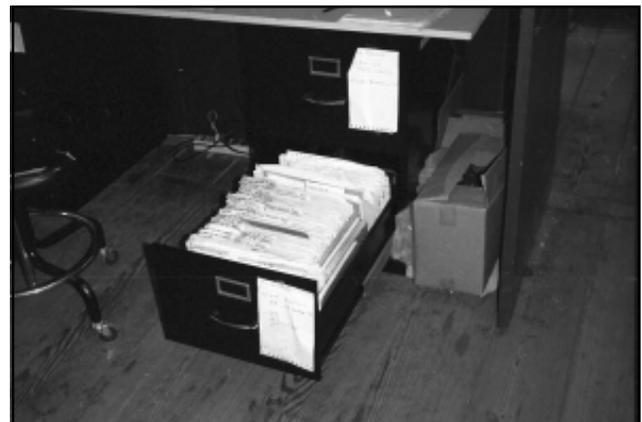
Figure 10. Extent of documentation from U.S. Naval Academy projects.

Approximately 0.9 linear feet of paper records associated with archaeological work conducted on the U.S. Naval Academy are stored in the office, which is set off from the collections storage area (Figure 10). Records are stored in a standard two-drawer, legal-sized file cabinet. The file cabinet is labeled with site number and contents written directly in marker on a paper tag taped to the cabinet drawer. Secondary containers for the records consist of manila folders; some records are stored loose. Manila folders are not labeled. Organization is by project and by provenience within project. Paper records consist of field notes, excavation records, and analysis records.

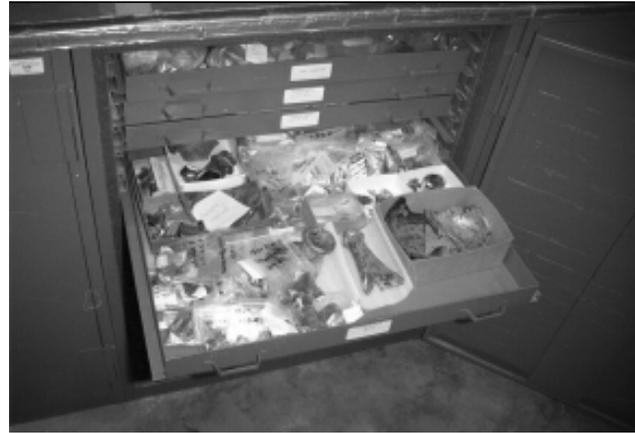
Figure 13. Metal lane case holding archaeological type collections.

Archaeological type collections are stored in a standard size, locking enameled metal lane case (Figure 13) that measures 3.5 x 3 x 3.5 feet (l x w x h). Each lane case contains a typed acidic paper label in a metal tag holder that includes project name, site number, and accession number information.

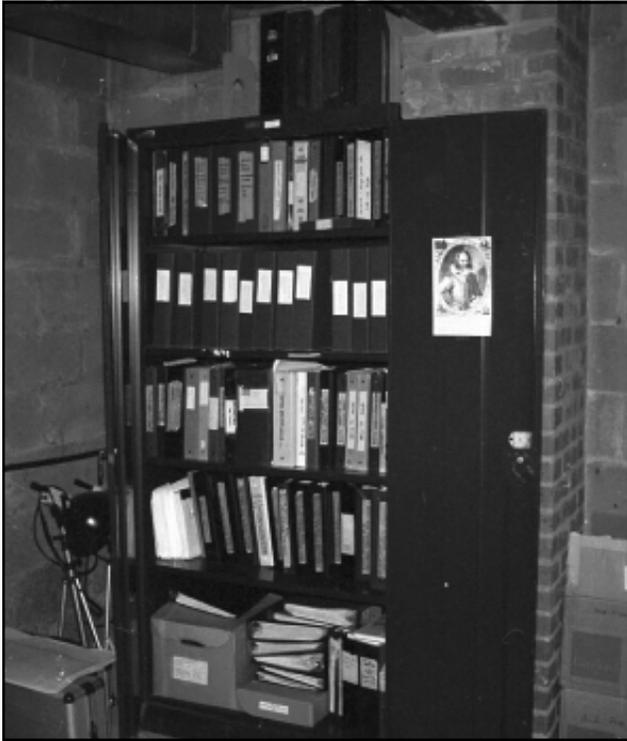
Figure 14. Storage unit for records.

Paper records are stored in 2.5-inch plastic three-ring binders on unsealed wooden shelving units measuring 6 x 2.5 x 1 feet (l x w x d) and in an

enclosed enameled metal cabinet (Figure 14) measuring 6.5 x 3 x 1.4 feet (l x w x d).

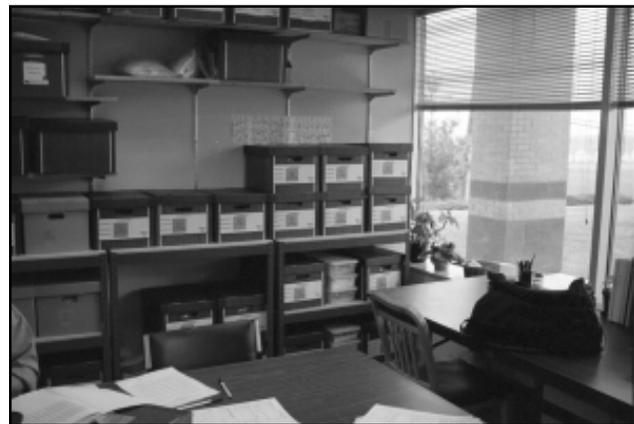
Figure 15. Primary containers for U.S. Naval Academy archaeological materials.

Artifact collections are stored on multiple sets of adjoining, nonmovable metal frames fitted with fiberboard shelves (Figure 15). Units measure 1.5 x 3 x 3 feet (1 x w x h). The U.S. Naval Academy collections total 29.6 ft³ (Table 12).

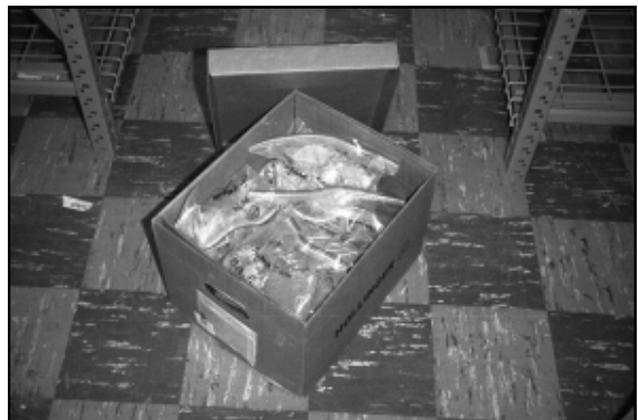
Figure 18. Primary and secondary containers used to hold artifacts.

Artifact collections are stored in 46 boxes, encompassing 45.2 ft³. There are multiple types of boxes, most (33) of which are acid-free cardboard boxes (measuring 1.3 ft³ each) with telescoping lids. The remainder of the primary containers are acidic cardboard boxes with telescoping lids (Figure 18), ranging from 0.9 ft³ to 1.2 ft³ in volume. Labels for all primary containers consist of a paper label placed

inside an adhesive plastic jacket that is directly attached to the container. The paper label is a computer printout that contains contents, box numbers, and site numbers.

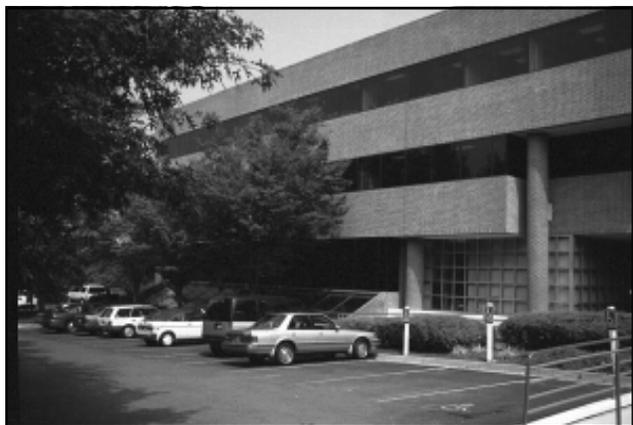
Figure 19. Exterior view of Parsons Engineering Science.

The repository has a concrete foundation, and exterior walls are composed of concrete block and steel framing with a brick exterior. The roof, which

is original to the building, is covered with built-up asphalt and has occasionally required repairs. Currently there are no cracks or leaks. There have been no major renovations or upgrades to the building, only minor interior wall remodeling to accommodate changes in office staff. There are multiple exterior windows and doors throughout the building.
